THE *TEMPIO DELLA CONSOLAZIONE* IN TODI: INTEGRATED GEOMATIC TECHNIQUES FOR A MONUMENT DESCRIPTION INCLUDING STRUCTURAL DAMAGE EVOLUTION IN TIME

F. Radicioni^{a,*}, P. Matracchi^b, R. Brigante^a, A. Brozzi^a, M. Cecconi^a, A. Stoppini^a, G. Tosi^a

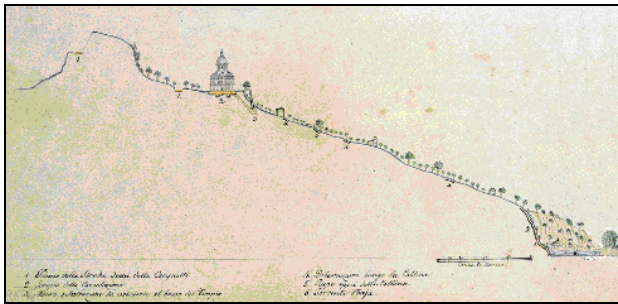
Figure 1

In the drawing of Figure 1, it is shown the profile of the slope along the direction N-S down to the Naja river. The original drawing indicates some areas of local shallow instabilities (properly *dilatazioni* in ordinary Italian – Comez, 1991), as well as the area at the foot of the slope, involving the cliff above the river. A proposal for intervention is also represented

in the drawing, which shows the section of a massive wall to be built on the south side of the church.

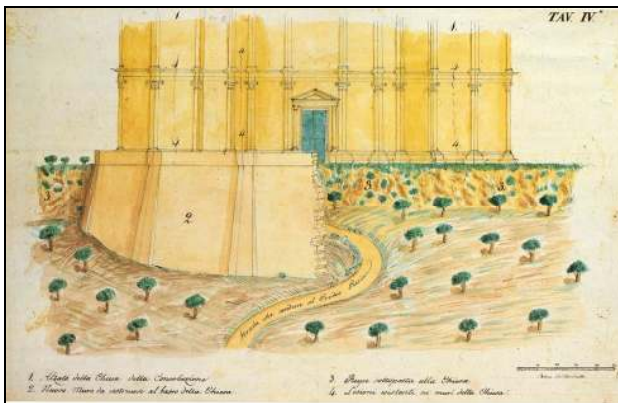
Figure 2 (*Tav. IV* in the original drawing) shows a view of the church along the west-east direction and the land around. The main vertical cracks observed on the structural walls are also shown. A half of the new massive wall is represented on the left side while the right side shows the existing situation with a view of the scarp.

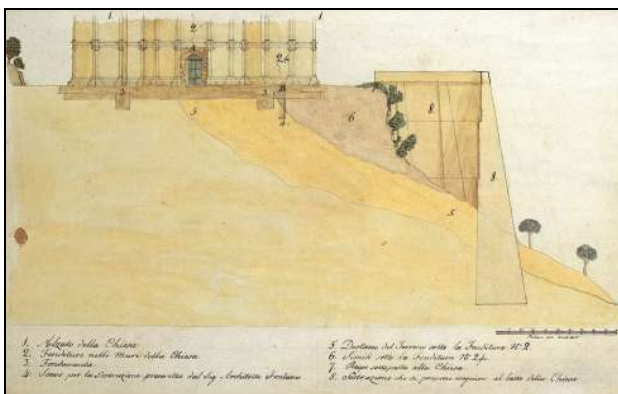
Similarly, in Figure 3, the west façade of the church is represented showing the existing vertical cracks in the *tribuna*. The drawing clearly depicts a subsoil region probably involved in a sliding mechanism, described as a *distacco del terreno sotto la fenditura n.2*. The section of the massive wall architect

Fontana proposed to build in order to retain the soil is represented in Figure 3 with number 8 (number 2 in Figure 2). Also, the drawing shows a vertical wall to be built underneath the south *tribuna*, next to the existing foundations (number 4). The proposal of countermeasures consisting of underpinning beneath the southern apse and of a large polygonal retaining wall appeared to be a valid solution to be pursued. In 1839 Luigi Poletti led to the completion of the construction of a semi-circular gravity retaining wall with niches (Vaccari, 1991, pp. 152-155).

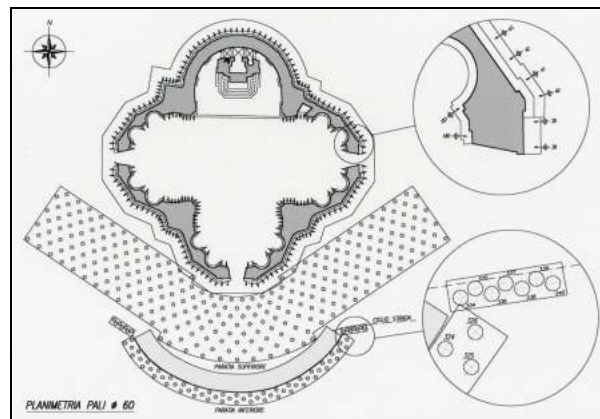
Figure 4. Recent interventions (Mariani, 2006 and 2008)

Finally, structural and geotechnical countermeasures have been undertaken more recently (1990s), consisting in underpinning (micropiles all around the existing foundations), diaphragm walls made of large piles and structural reinforcement (Mariani, 2006, 2008. Fig. 4).

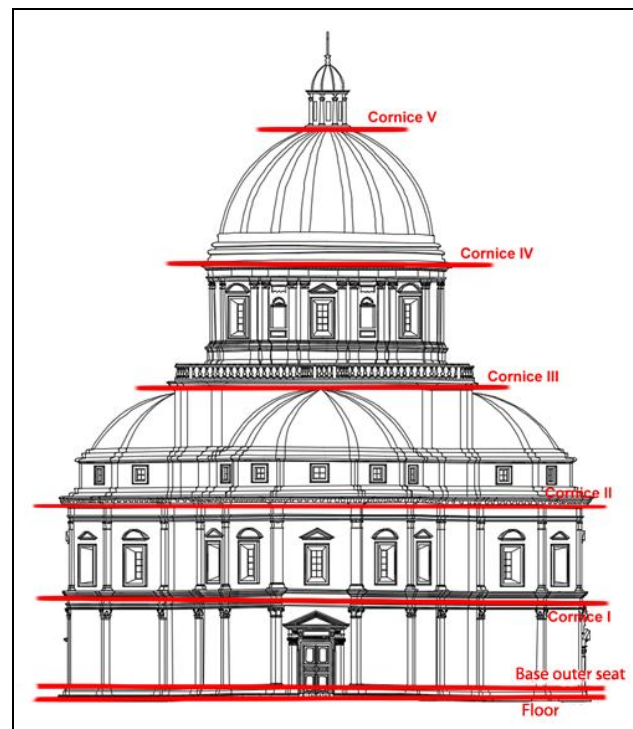
The precision leveling technique was utilised for a more accurate measure of the vertical displacements with respect to a horizontal plane for the external outer seat at the base of the building. The results show that the base is inclined along an approximately north-south direction, presenting a 37.7 cm lowering toward north (Fig. 5-6 and Tab. 1).

Figure 5. Location of some architectural elements

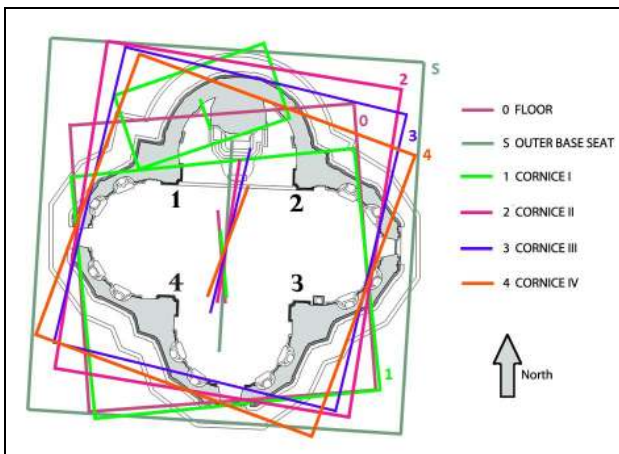
Figure 6 shows the maximum slope directions obtained for the various architectural elements, overlapping in a single plan: it can be seen, the higher the element altitude, the line tends to rotate slightly clockwise, thus putting into evidence a torsional deformation of the church.

Figure 6. Superimposition of the maximum slope directions for architectural elements at different levels (ref. Fig. 5)

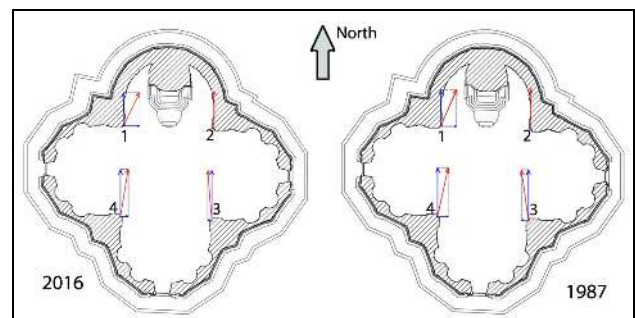
Table 2 shows the values of the off plumb (north and east components) from top to base for each pillar. In Fig. 7 the total off plumb of the four pillars was plotted in planimetry. It is clear as the vertical elements are inclined toward the north (altar area); such results are concordant with the slopes measured for the horizontal architectural elements.

Figure 7 also shows a comparison between the present pillar inclination with the values found in 1987 (Mariani, 2008): we can see that the situation has remained largely unchanged over the last 28 years.

Figure 7. 1987-2016 comparison of the pillars off plumb

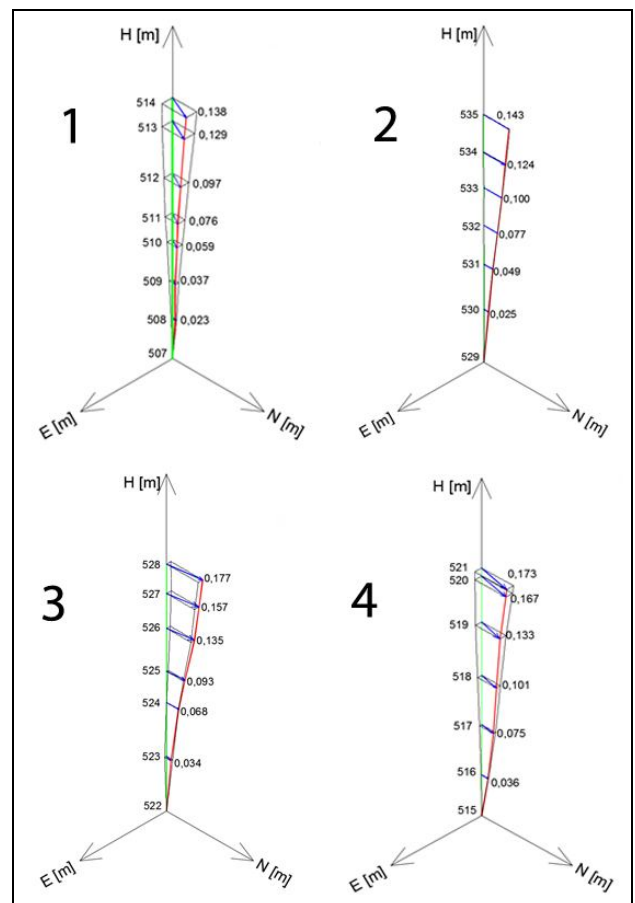
Figure 8. Axonometric representation of the pillars off plumb (amplified by a factor of 10)

Figure 8 contains an axonometric representation of the off plumb measured along the four pillars, amplified by a factor of 10. For each one, the red line corresponds the actual edge, while the green one is the vertical. These results were confirmed by analyzing the same elements from the cloud of laser points (see Par. 2.4).

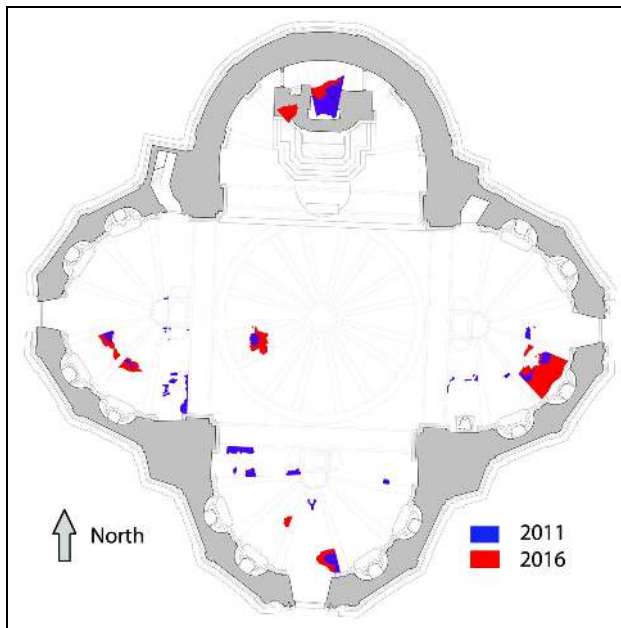
Thanks to post processing application of colour to the point cloud, it was finally possible to determine the status of the moisture spots at the intrados of the central dome and the apses semi-domes, and compare the 2016 and 2011 patterns. From the comparison (Fig.11), it is evident how the spots are considerably enlarged, especially the patches that affect the central dome, the north and east apses, and also some of new formation (north and west apses).

Figure 11. Moisture patches on the dome intrados

It has to be noted that the lead covering of the apses half-domes has been restored in 2016, so any rain infiltration should now be eliminated.

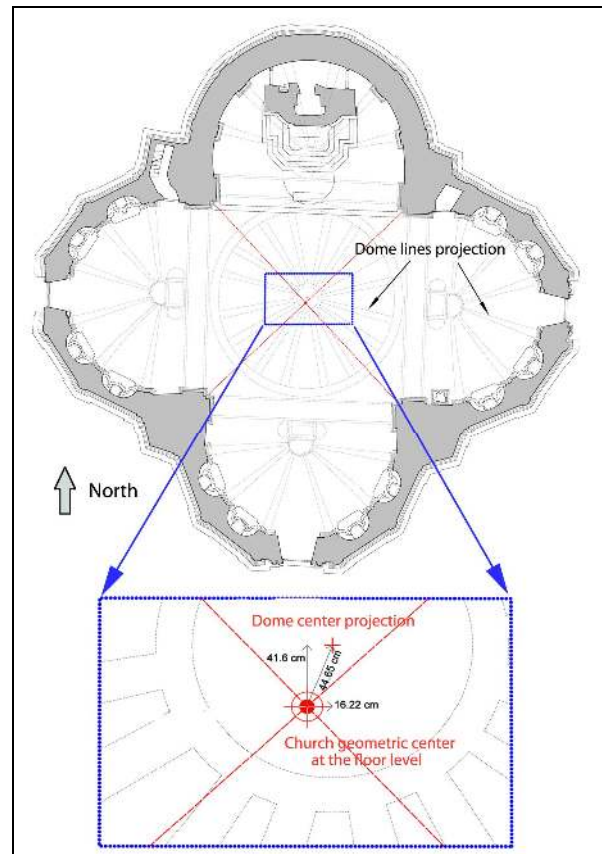
A starting point has been the determination of the offset between the dome center (lantern) vertical projection and the geometrical center of the floor. The resulting offset is 41.6 cm (north) and 16.2 cm (east) with a resultant of 44.7 cm (Fig.12). Confirming the results obtained from total station and leveling (Par. 2.1, Tab. 1), the angle of inclination of the church determined from the model section is about 0.45° toward north (Fig.13).

Figure 12. Vertical projection of the dome center on the floor

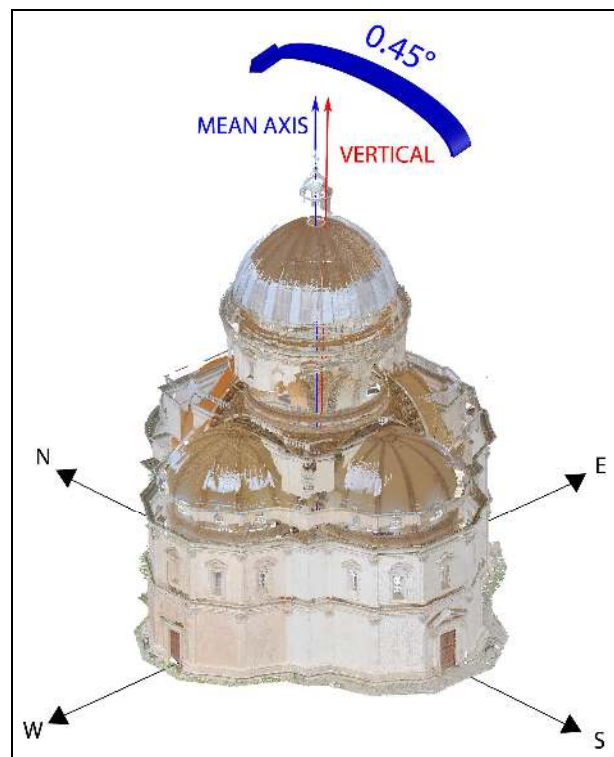
All the architectural elements of the church show a similar northward rotation: for the horizontal elements (cornices, floor, base seat) the angle of inclination is between 0.5° and 0.9° while for vertical elements (walls and pillars) the angle of rotation is between 0.6° and 1°. Summarizing, all measures and the 3D reconstruction show that the church has undergone an overall rotation leaning towards the north.

Figure 13. Overall rotation of the monument

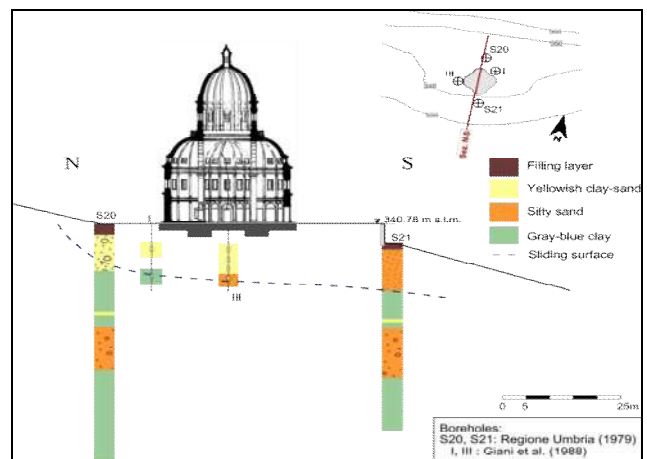
From a geological/geotechnical point of view the hill of the city of Todi is made up of clastic sediments in lacustrine and fluvial-lacustrine facies, from basal clays to conglomerates at the top (Cencetti et al., 2005). Based on the information gained from the geological data relative to two borings, S20, S21 (http://dati.umbria.it/dataset/banca-dati-indagini-geognostiche-geo-fisiche) and those reported by Giani et al. (1988), Figure 15 shows a section of the soil profile along the N-S direction. The dashed line represents the trace of a sliding surface documented in Mariani (2006). The main countermeasures adopted in recent years are not represented in this Figure (Mariani, 2006, 2008).

Figure 15. Soil profile from previous in-situ investigation.
