Tungsten coatings under high thermal loads in JET and Magnum-PSI

C Ruset¹, H Maier², E Grigore^a, G F Matthews³, G De Temmerman⁴, A Widdowson³
and JET-EFDA contributors⁵

Inspection of the W coatings from the ILW

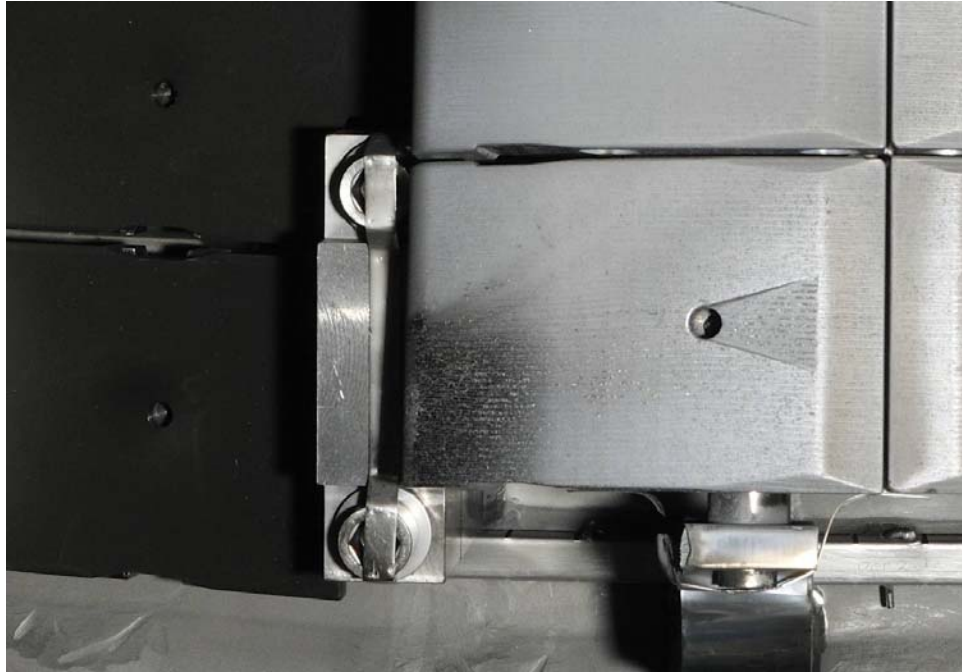
A thorough inspection of the W coated CFC tiles revealed the damage of one bottom tile, Inner Wall Guard Limiter placed in the same position in Octants 2, 5 and 7. It is shown in Fig.4. The W coating seems to be melted on the left round edge of the tile. The damage seems to be produced by the runaway electrons in the early commissioning phase of the ILW during an emergency shutdown (pulse 80263).

Fig.4 Local damage to W coatings at the bottom of the inner wall limiters which is due to the impact of runaway electrons

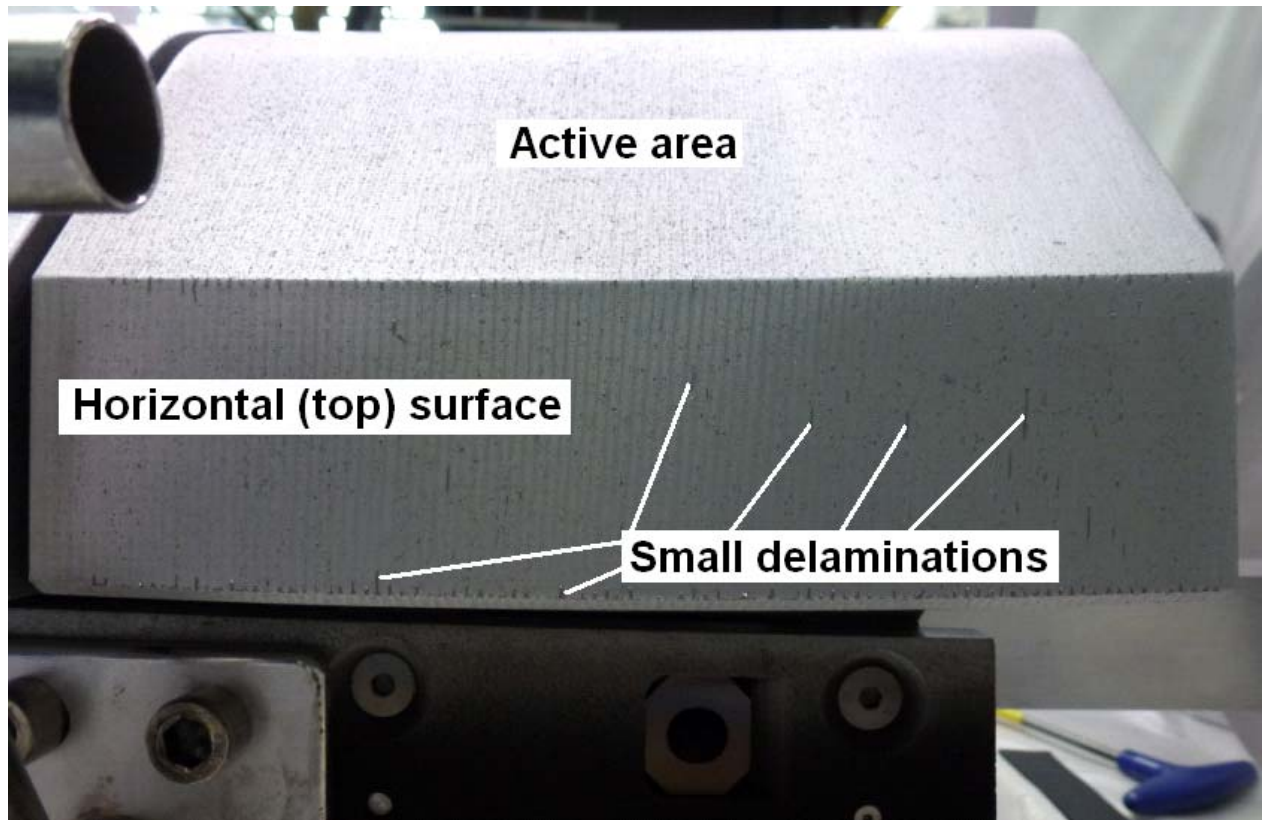
As far as the W coatings deposited on divertor tiles are concerned their current status is generally good except minor delaminations detected on a G6 tile, which are probably associated with the CFC structure and some delaminations on the top of about twenty G8 tiles, which seems to be systematic. All delaminations with a length of 1-15 mm are along the in plane fibers of the CFC material (Fig.6). The W coating is perfect on the main active area of the G8 tiles, where the thermal loading is supposed to be high, but the defects appeared only on the top of the tiles. The first signs of delamination appeared on the top of G8 in October 2011 after about two months of experiments. Examination of the pictures taken with IVIS on the same G8 tiles in Octant 8 in the period October 2011-May 2012 revealed no increase of the damages. The inspections revealed the presence of many small particles dropped on this horizontal surface of G8 tiles. Without any contact with the substrate these particles become very hot during plasma operation and in this way the temperature of the W coating is locally increased to high values. These hot spots might affect the W coating integrity. The strong erosion on the top of G8 tiles was noticed in 2007 with the carbon wall when a marker tile was used [12]. The defects on G6 and G8 appear random in that some tiles show a significant number while adjoining tiles may show none at all. This strongly suggests that plasma parameters are not the dominant factor and that variations in the CFC substrate are the dominant cause.

Fig.6 Small delaminations on the horizontal area of G8 tile; the picture was taken in the Be handling facility after removing of the tile from JET chamber
