Uplift of an Underground Tank in Northern Malabar Region, India

ABSTRACT: *An underground reinforced concrete tank was constructed for a project in the southwest region of India. The tank was 90 m x 35 m in plan and 7.3 m deep resting on partly filled-up and partly native soil. During the peak monsoon, a sudden uplifting of the base slab by about 300 mm and subsequent failure of the foundation raft and a partition wall was observed. Laboratory testing was executed and hydrogeological survey was carried out using ground penetrating radar, seismic refraction and infiltrometer testing, and an analytical study was carried out to identify the root cause of the tank uplifting. Based on this study, it was observed that the uplifting and structural failure was essentially due to the peculiar land terrain and soil properties and the development of excess hydraulic head below the bottom of the tank. After considering different options, the rectification measures were carried out by provision of dewatering wells along the tank periphery to release the excess hydrostatic pressure and stabilize the foundation raft. The structural repair of the top of the foundation raft and partition wall was

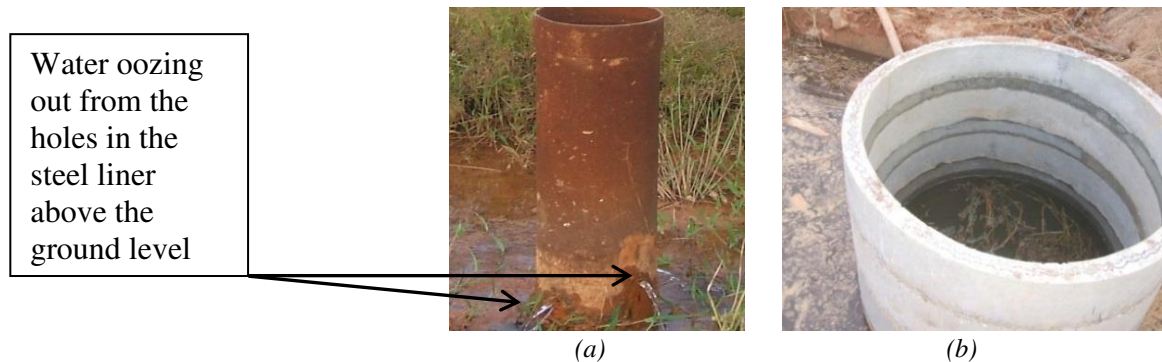
In the meantime, when the tank filling was ongoing and the rainfall intensity reduced, the boreholes with steel liner were drilled along the tank periphery and a 1.2 m diameter and 4 m deep ring well was also dug near the tank. The groundwater was observed to be coming out from the perforations in steel liner above the ground level due to high hydraulic head (Fig. 3a). The water level in an open well was also observed to be at the ground level (Fig. 3b).

Figure 3. Groundwater level in (a) borehole with steel liner and (b) ring well

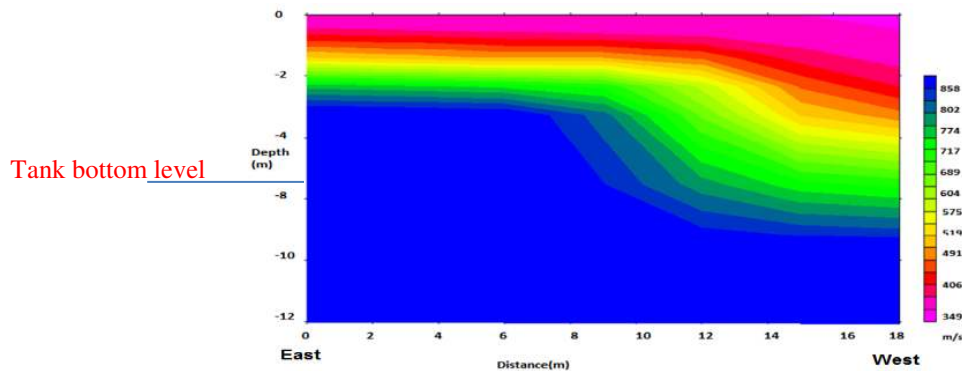
The seismic refraction survey data was used to classify the soil using correlations between typical velocities, type of formations and the density as suggested by Bourbie et al. (1987). Based on this classification, the top layer consists of clayey soil, which is moderately compacted up to a depth of 1.5 m with P-wave velocity of 349 m/s. It is followed by a layer of clay and gravel with a thickness of 1.5 m, having a velocity range from 377 m/s to 482 m/s and a layer of sandy silt strata up to 10 m with a thickness of about 7.5 m and a seismic velocity range from 491 m/s to 858 m/s, as shown in Fig. 6.

Figure 6. The soil strata profile obtained from SR2 data conducted on the south side of the tank near the closed water well (see Fig. 5 for survey location with respect to the tank).

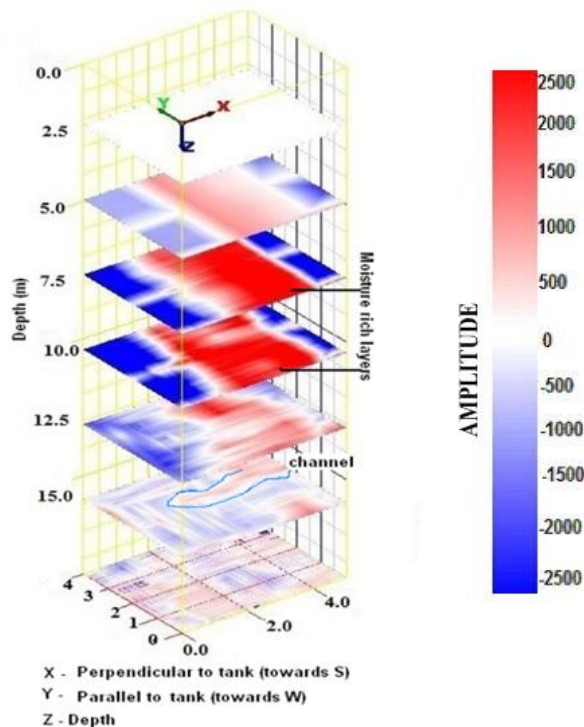
3D data near the tank clearly indicates the clay rich strata at the depth of 2.5 m below ground level and the moisture is more concentrated at the depth of 7.5 m to 10 m from ground level (see Fig. 10). This visualization assisted in confirming the presence of water channels between the well and the tank.

Figure 10. 3D view of the grid from GPR2 near the tank, data collected with 2 m interval at X axis and 1 m interval at Y axis. X is the direction perpendicular to the tank; Y is direction parallel to the tank and Z is the depth of penetration of the GPR2 antenna, i.e., 20 m.
