JHRP-75-15

USE OF PRECAST-PRESTRESSED  
CONCRETE FOR BRIDGE DECKS

### USE OF PRECAST-PRESTRESSED CONCRETE FOR BRIDGE DECKS

July 30, 1975  
Revised Dec. 1976  
Project: C-36-56N

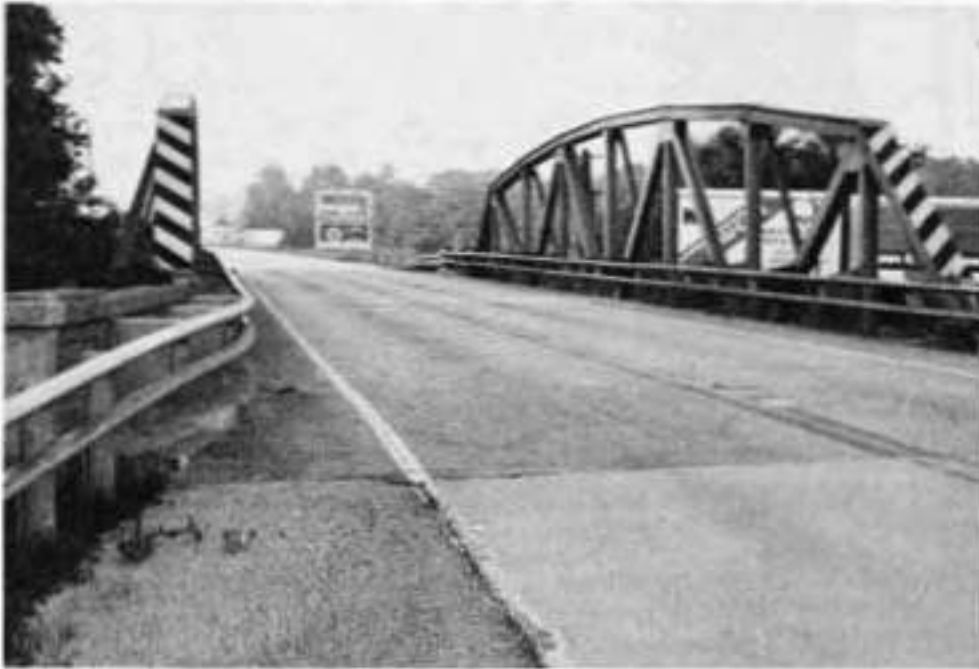
Figure #24. Bloomington Bridge Deck, September, 1974

The deck at Bloomington has been in service for five years and for the most part has performed very well. Figure #24 shows the present condition of the Bloomington deck and Figure #25 shows a typical wearing surface joint in the south-bound lane. Most of the problems that have arisen can be traced to poor construction procedures and are not due to the concept used in the design of the precast prestressed deck.

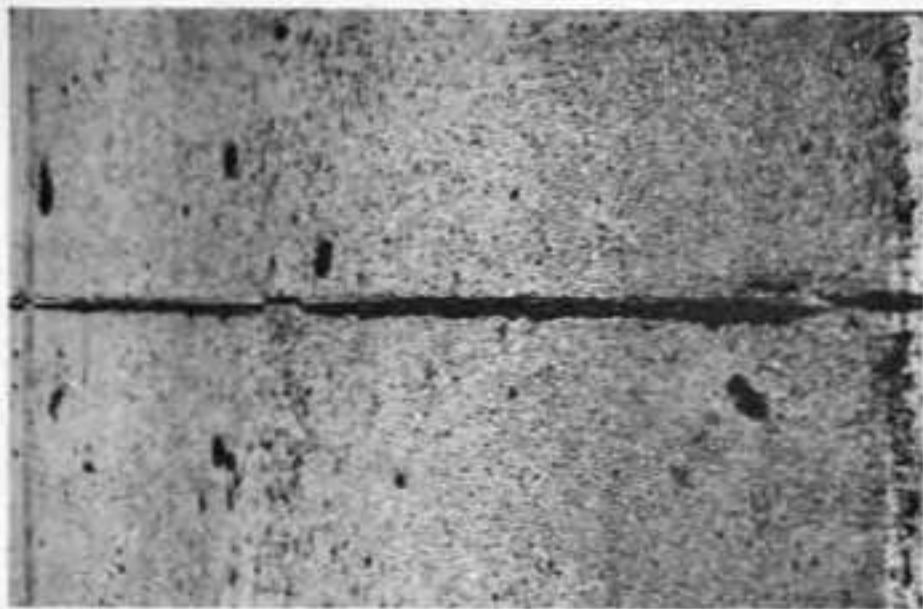
Figure #26. Bloomington Bridge - Repaired Joint in the Southbound Lane. See Figure #27 for Location.

Since all of the sealant repaired and shown on Figure #28 was replaced in late 1970, it is approximately four and one-half years old. DuPont "Imron" was used in all of the repair work and to date has performed satisfactorily, with the exception of minor gravel penetration. A repaired joint can be seen in Figure #26.

of the female joints and after a couple of weeks, traffic pressure worked out the cracked portions of the joint. These joints were repaired by cleaning the joint, forming the joint with Masonite and then filling the broken joint with quick-setting epoxy mortar. The epoxy mortar was allowed to cure and DuPont "Imron" was then used to reseal the joint. One-way traffic was maintained on the bridge during the entire repair operation. One of these repaired joints in the southbound lane can be seen in Figure #26 and its location is shown on Figure #27. All the joints which were repaired at this time are performing satisfactorily.

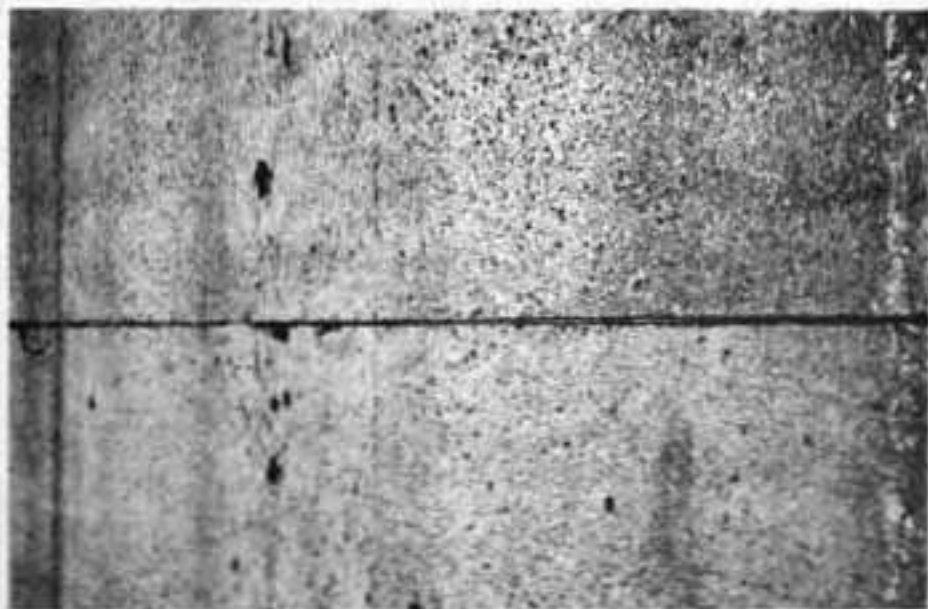
Figure #25. Bloomington Bridge - Typical Wearing Surface Joint in the Southbound Lane. See Figure #27 for Location.

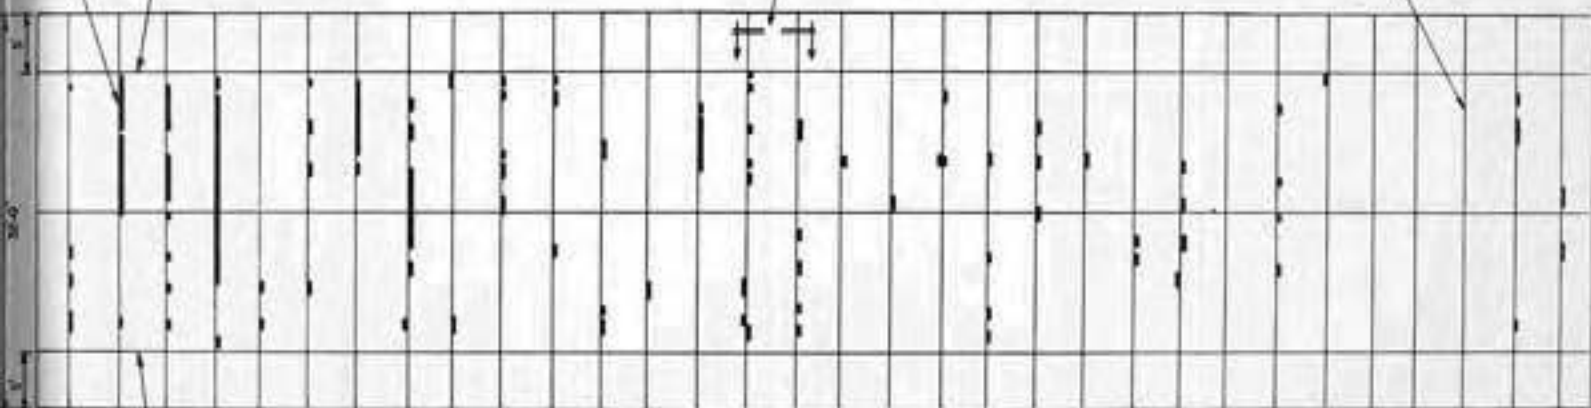
EDGE OF 22'-0" WIDE  
APPROACHING ROADWAYFIGURE NO. 27SCALE 1/8"=1'-0"

Figure #27 is a map of all the joints which have cracked or spalled since the bridge was opened to traffic. All of the distressed areas lay in the traffic lanes which tends to indicate that traffic wear is the major cause of the joint cracking or spalling. The two main reasons why the traffic is causing the cracked joints are variations in slab elevations and the use of snow removal equipment. The elevation between slabs vary as much as 1/4" and under repeated wheel load applications, the raised lip of the high slab will either ravel or crack. Usually if the raised edge is the female side of the joint, the female edge will crack and if the raised edge is the male portion it will ravel. The only solution to this problem would be making sure that the slabs were leveled during erection. The other major cause of the cracked joints is the impact load imposed on the slab joints by the blades from the snow removal trucks. Two solutions to this problem might be: (1) using more de-icing chemicals and not using the snow plow blade on the bridge or (2) in the future use a different joint configuration which would eliminate the weak edge inherent in the female portion of the joint.

PLAN VIEW OF BLOOMINGTON BRIDGE DECK.  
MAP OF SPALLED OR CRACKED JOINTS

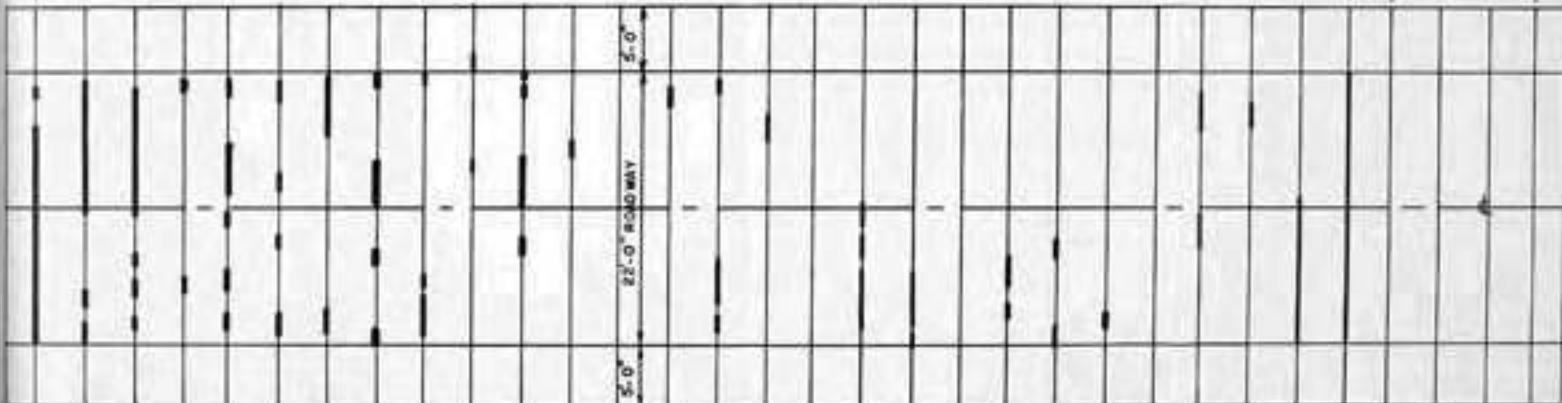
FIGURE NO. 28

will usually work out of the joint under traffic loads. Figure #28 is a map of the areas where the joint sealant has been replaced and shows which areas originally were sealed with the liquid polyurethane sealant and which joints were sealed with DuPont "Imron". In addition to the reasons stated above, the joint sealant also had to be replaced for the following reasons: (1) joint material itself, (2) application techniques which were mentioned earlier and (3) gravel punching the sealant into the joint.

PLAN VIEW OF THE BLOOMINGTON BRIDGE DECK  
MAP OF THE AREAS WHERE THE JOINT SEALANT  
HAS BEEN REPLACED

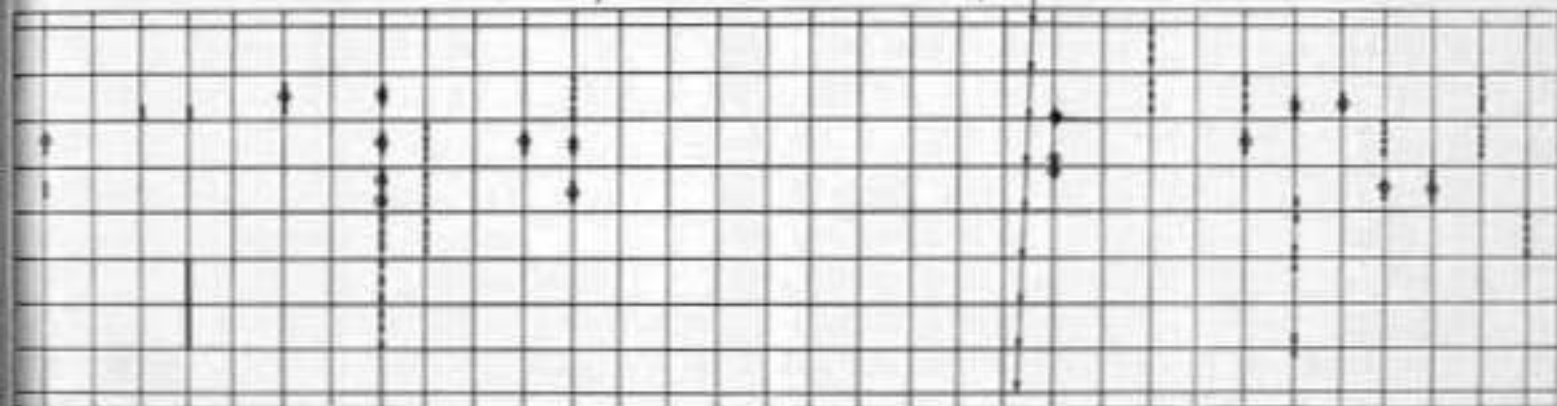
FIGURE NO. 23

Figure #29 shows the areas under the deck where the neoprene sheet has worked down out of the joints. The neoprene sheet was used to minimize stress concentrations between the joints due to minor surface irregularities. The compressive stress in the neoprene was relatively high in the areas where it has worked out of the joints. This high stress was due to a major irregularity in the surface of the joint which was in turn caused by warping of the forms where the slabs were poured. In order to relieve this high stress, the neoprene works out the joint under the repeated traffic load.

PLAN VIEW OF THE BLOOMINGTON BRIDGE DECK  
MAP OF THE BOTTOM SIDE OF THE JOINTS WHERE  
THE NEOPRENE SHEET HAS WORKED OUT OF THE JOINT.

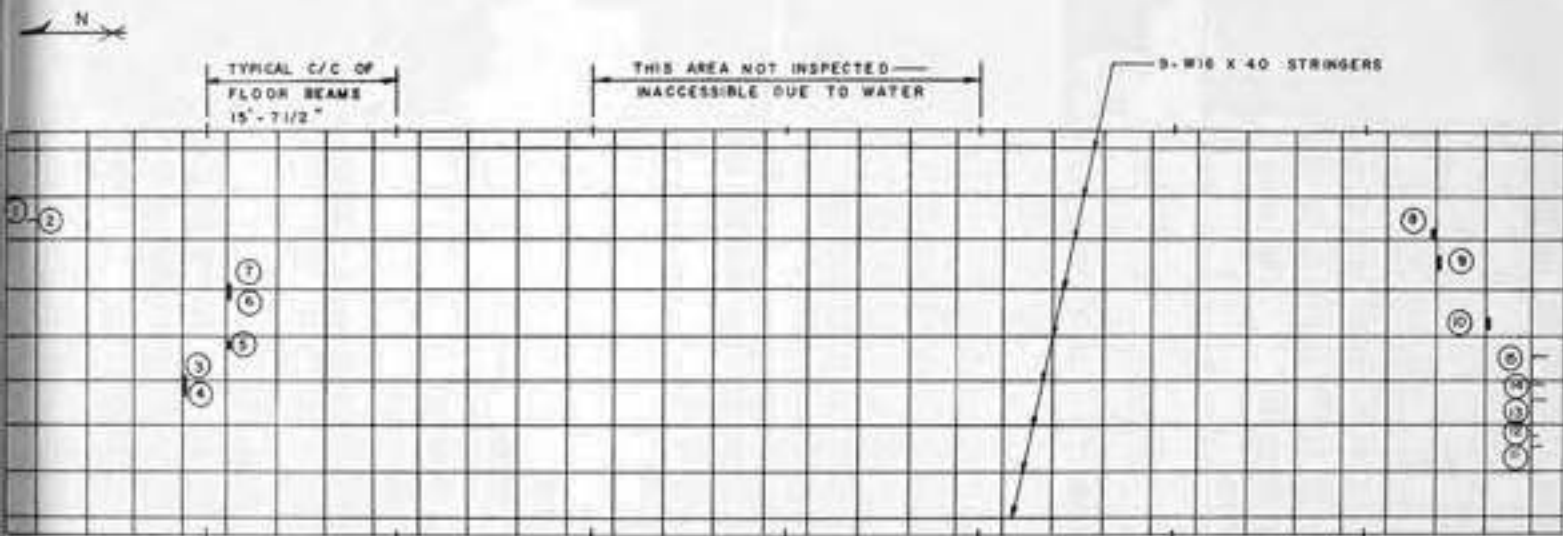
FIGURE NO. 30SCALE: 1/8"=1'-0"

PLAN VIEW OF THE BLOOMINGTON BRIDGE DECK  
MAP OF THE DISTRESSED AREAS ON THE  
UNDERSIDE OF THE BRIDGE DECK

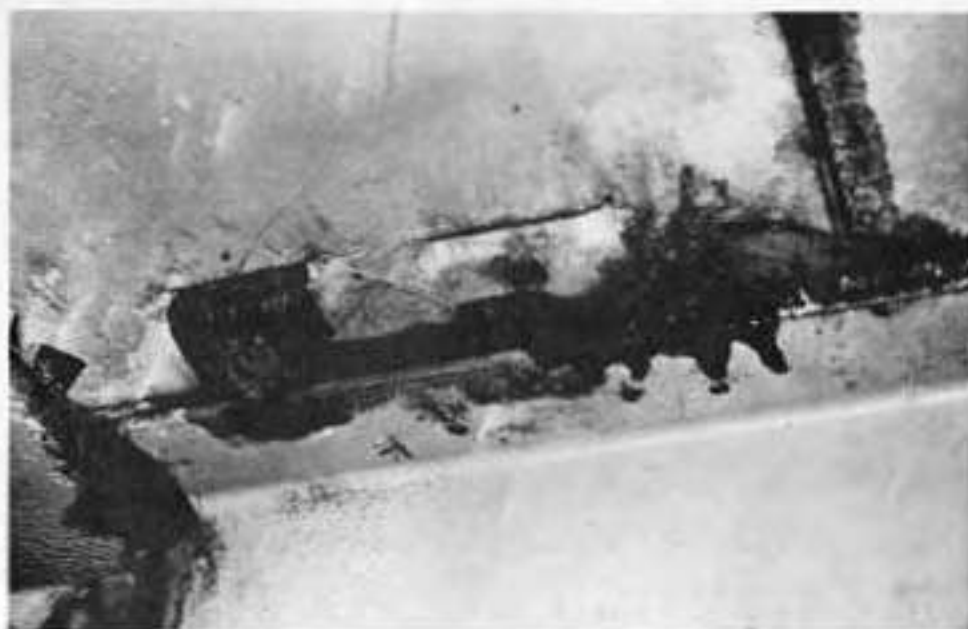
Figure #31. Area ① - One 3/4" diameter bolt broken, one tie-down clip missing; and one tie-down clip broken (See Figure #30 and Table 2).

Another problem which arose after the bridge was open to traffic was that some of the bolts clamping the slabs to the steel beams worked loose and had to be re-tightened. During construction a torque of 50 ft. lbs. was applied to each bolt, which was the torque applied to the bolts in the laboratory experiments. Since 50 ft. lbs. of torque was not sufficient, three quarters of all the bolts were re-tightened using a torque of 125 ft. lbs. after making sure that each bolt was greased. None of the bolts have since worked loose.

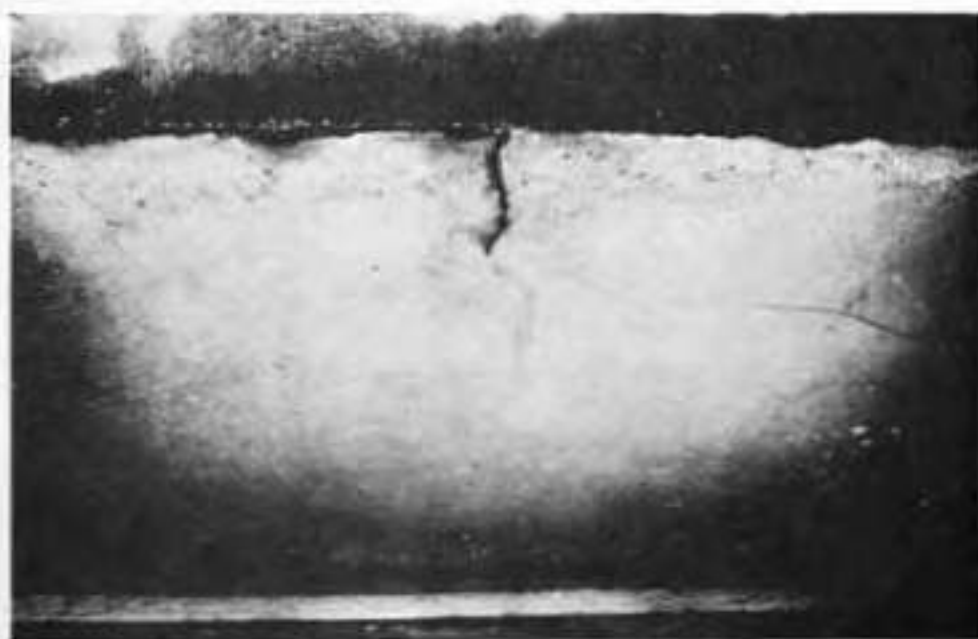
| ② 8" longitudinal surface crack | See Figure #32 |

Figure #32. Area ② - 8" longitudinal surface crack (See Figure #30 and Table 2)

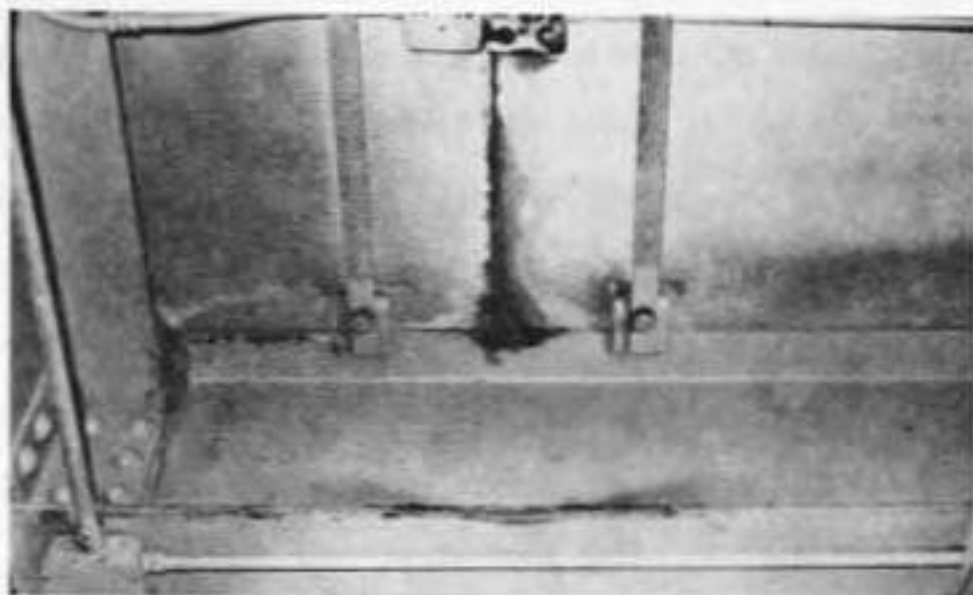
Figure #33. Area ⑤ - (Typical of Areas 3 thru 7) Cracked female joint at the stringer bearing point. (See Figure #30 and Table 2).

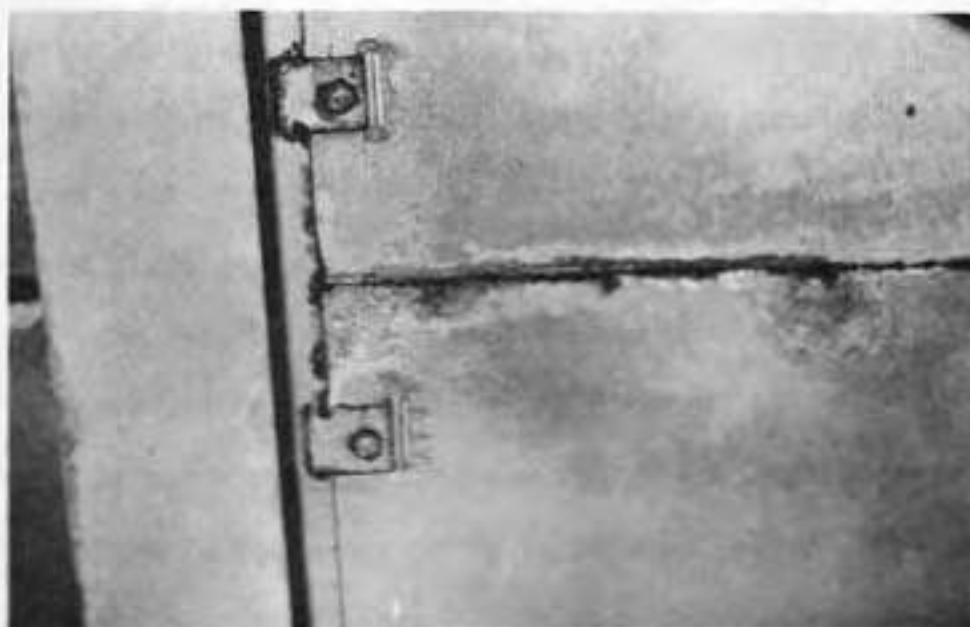
Figure #34. Area ⑧ - Spalled male portion of the joint--2"x2"x1/4" deep (See Figure #30 and Table 2).

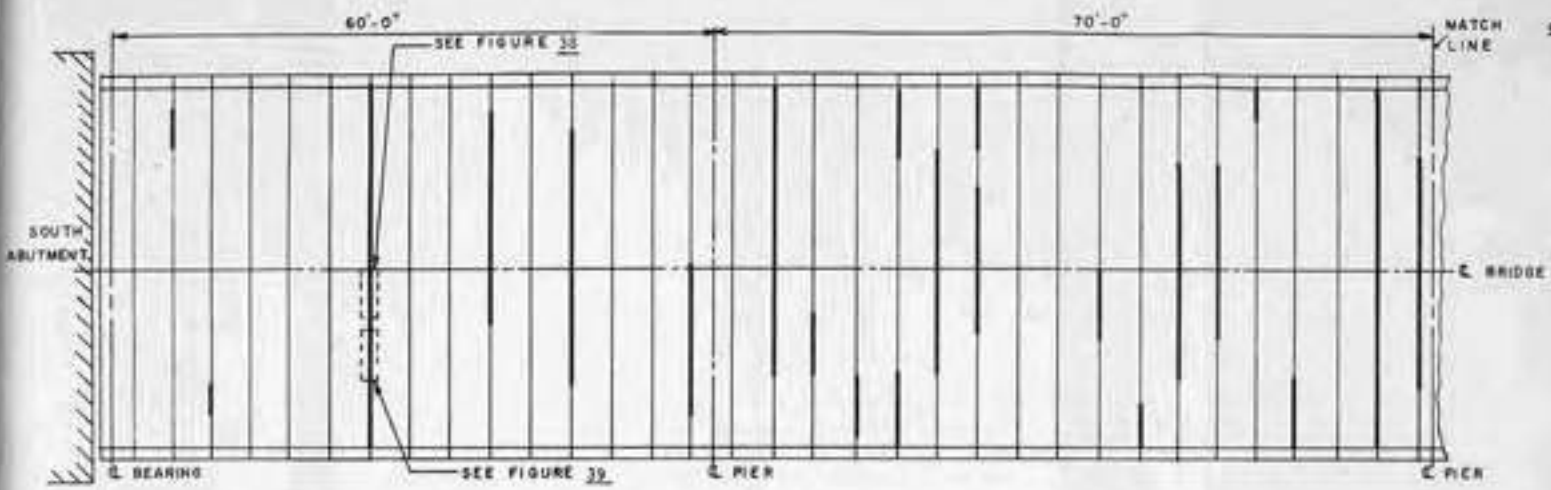
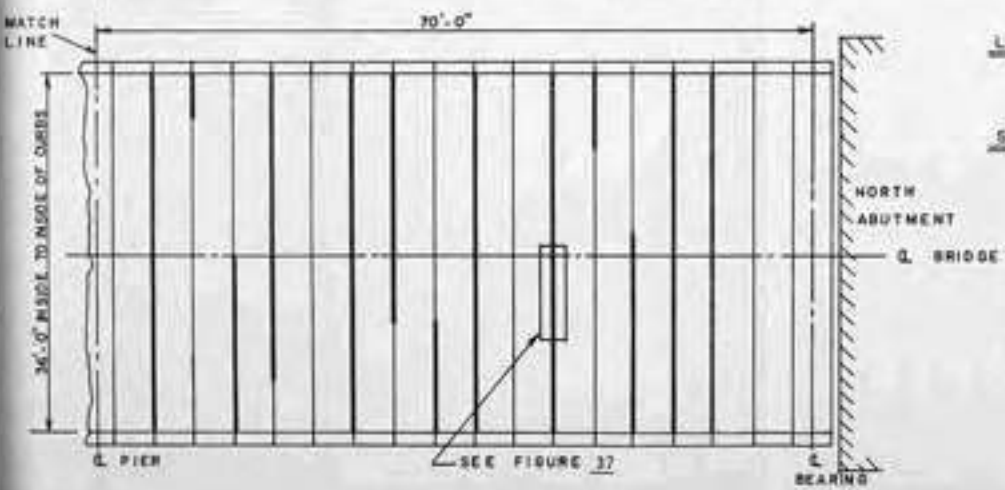
PLAN VIEW OF THE KNIGHTSTOWN BRIDGE MAP SHOWING AREAS WHERE THE WIDTH AT THE TOP OF THE JOINT IS LESS THAN 1/8 INCH.

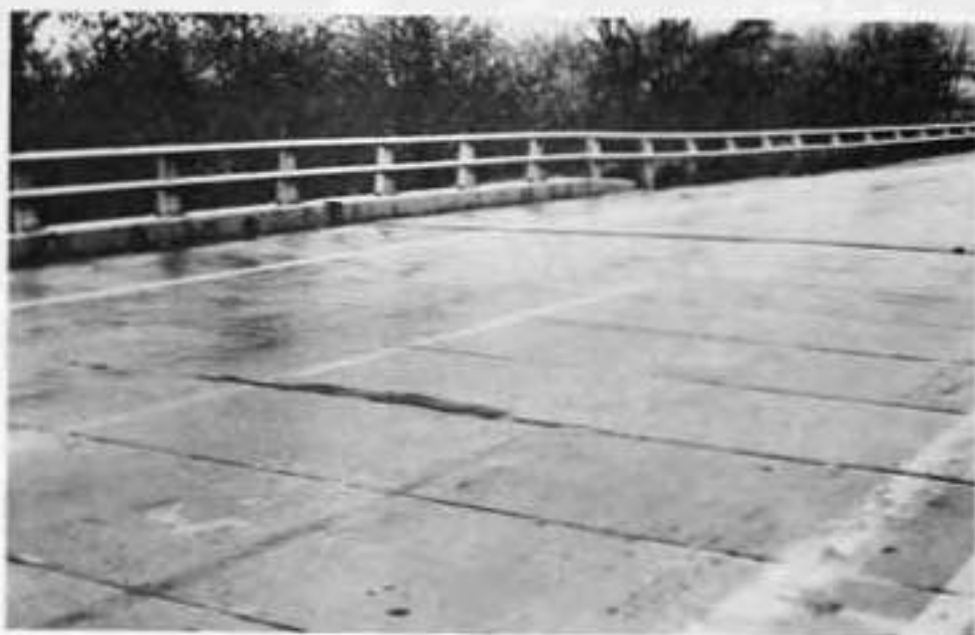
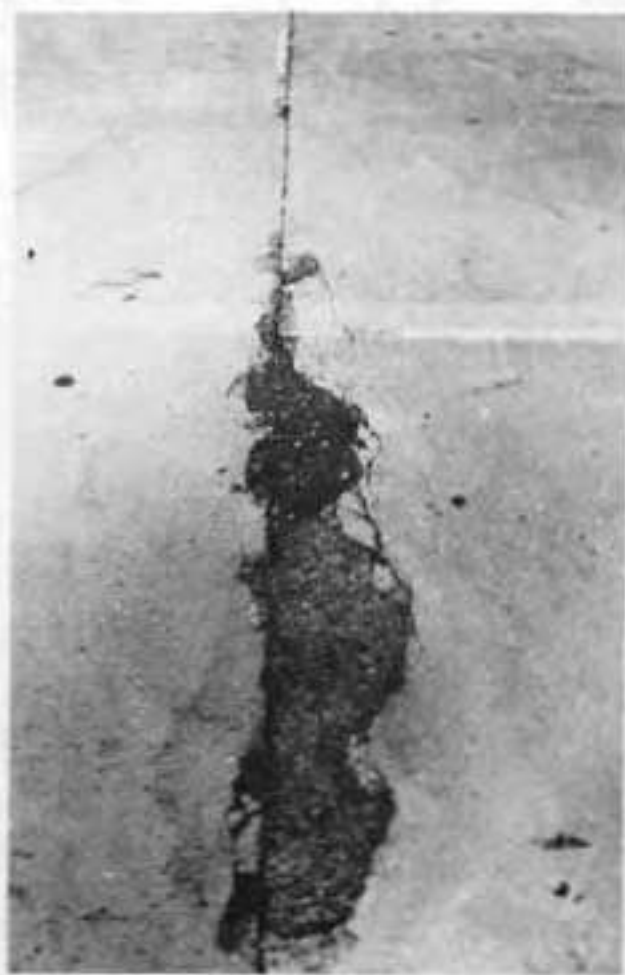
Figure 37. Knightstown Bridge - Progressive Failure of the Male Portion of the Joint. See Figure #36 for Location.

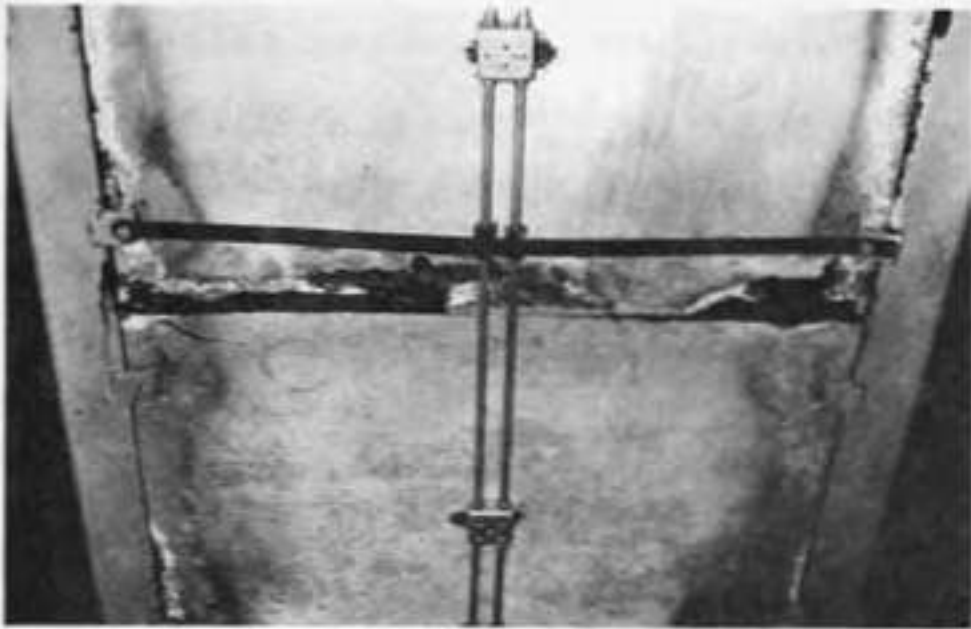
The only other problem observed at Knightstown was that concrete patches applied in the precastor's yard deteriorated after about one year. The photographs in Figures #38 and 39 show patched female joints on the underside of the slab where the patch has deteriorated or has fallen out of the joint. Also there are only a few places where the neoprene has started to work out of the joint.

Figure #38. Knightstown Bridge - A Patch Applied in the Precaster's Yard Which Has Failed. See Figure #36 for Location.

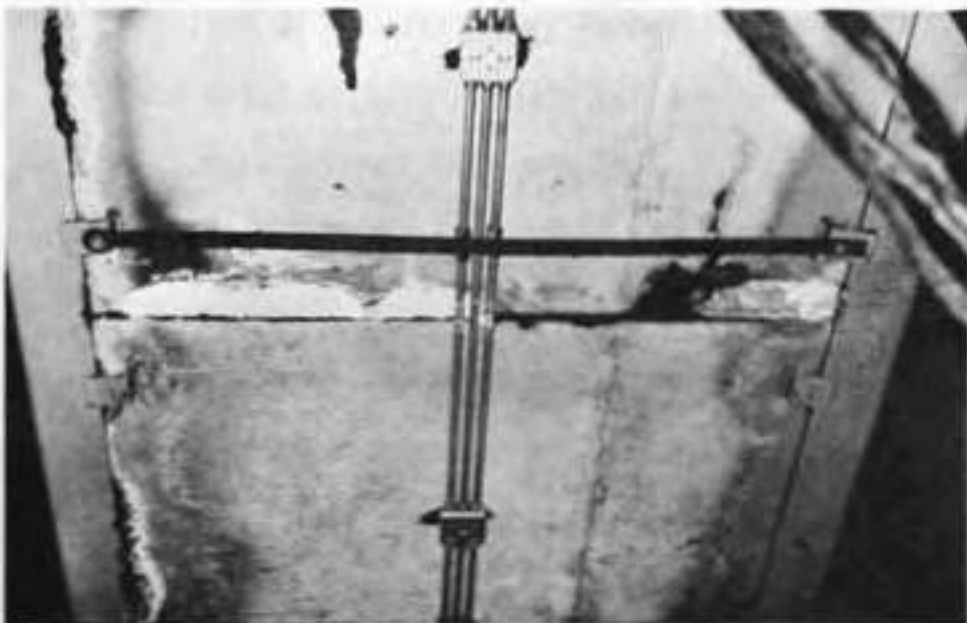
Figure #39. Knightstown Bridge - A Patch Applied in the Precaster's Yard Which Has Failed. See Figure #36 for Location.
