## Using electrical, magnetic and acoustic sensors to detect damage in segmental concrete pipes subjected to permanent ground displacement

This paper describes results of an experimental study that used sensing methods for monitoring damage along segmental concrete pipelines resulting from permanent ground displacement across a simulated earthquake fault. The literature contains examples of such damage occurring during actual earthquakes, significantly impacting the functionality of the pipelines. Detecting the location of the damage and the extent of the damage in pipelines can significantly accelerate post-earthquake repair efforts. In this paper, electrical sensing methods, magnetic sensing, and acoustic emission are used to monitor structural damage in a segmental concrete pipeline during a large-scale test. In this test, the segmental concrete pipeline was subjected to a concentrated transverse permanent ground displacements (PGDs). The majority of the damage to the pipe segments was localized at the joints, especially the bell sections while the damage to the spigots was minimal. The damage extended away from the joints in the pipe segments in the immediate vicinity of the f

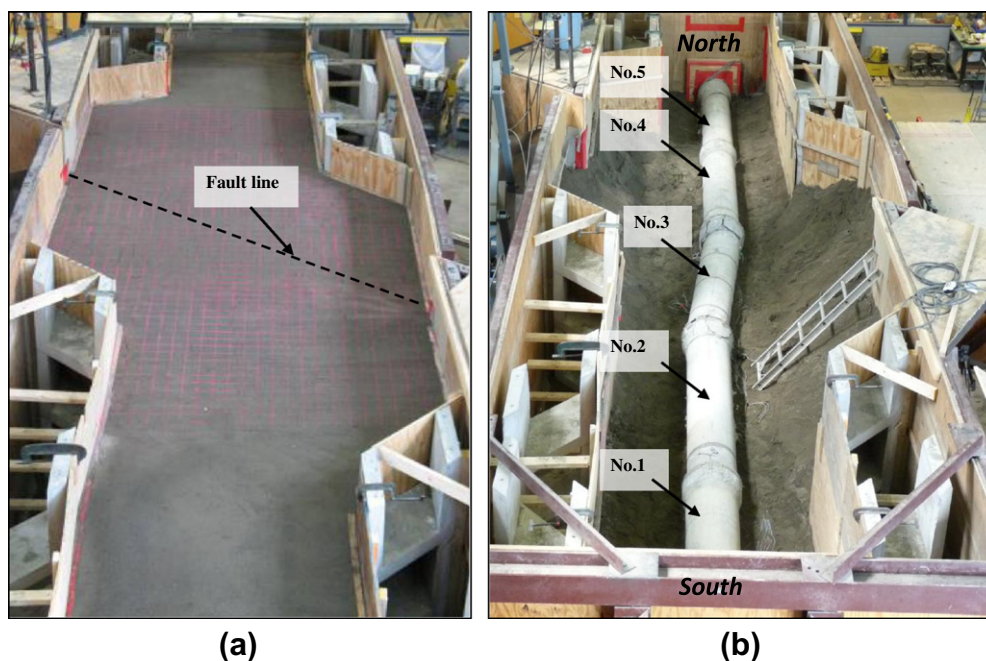
Fig. 1. (a) Test basin after backfilling, (b) full-scale segmental concrete pipeline (after excavation) tested at the large-scale testing facility at the George E. Brown, Jr. Network for Earthquake Engineering Simulation (NEES) site at Cornell University.

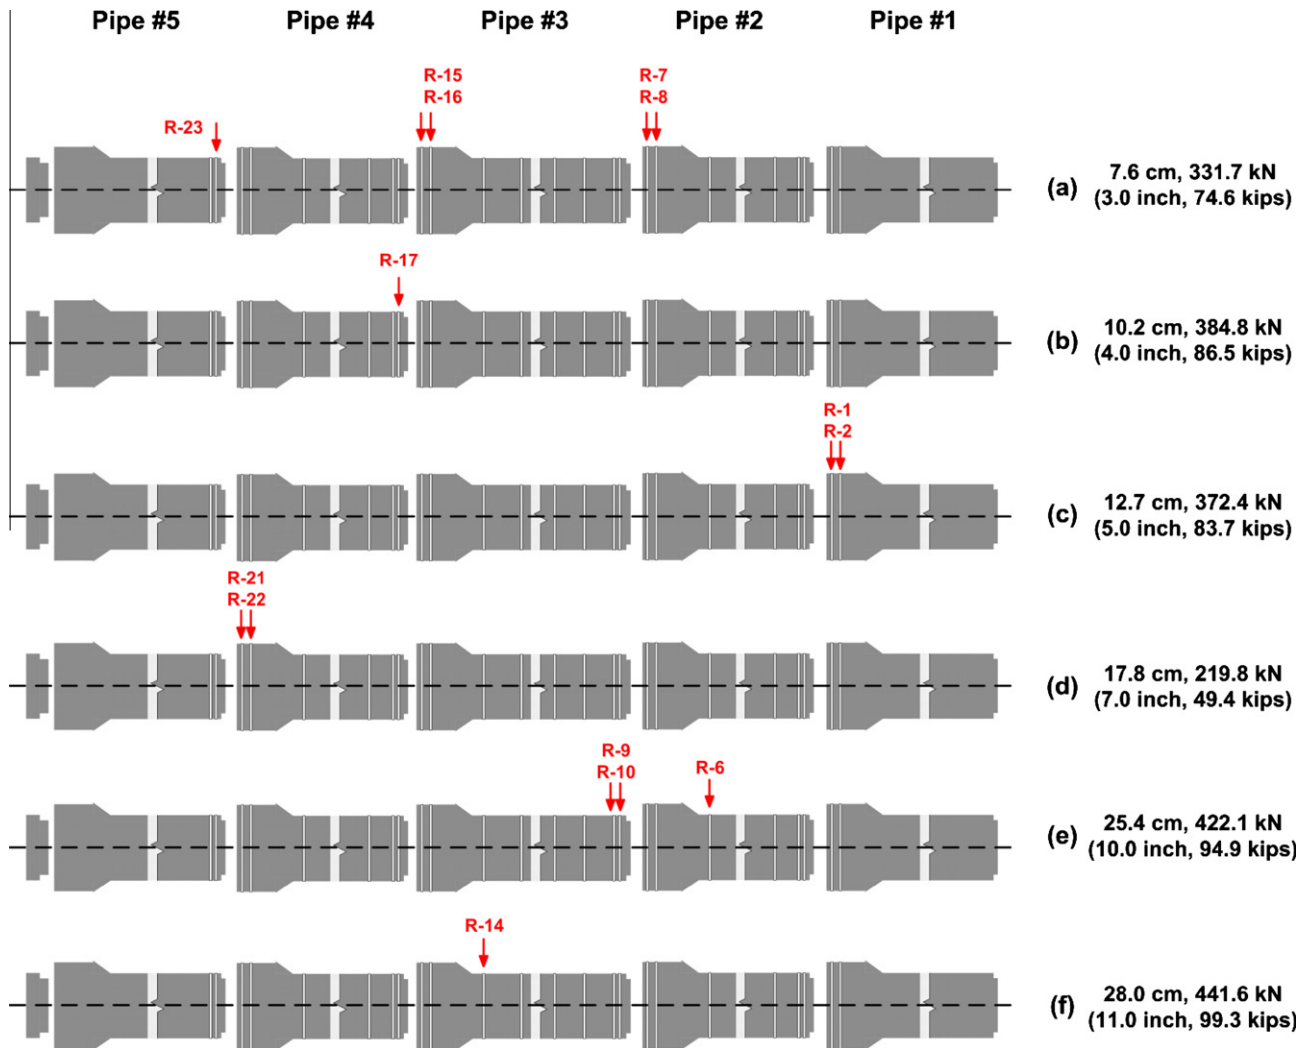
As may be observed from Figs. 7 and 8, significant damage occurred during the second displacement step in the bell sections of Pipe Segments 2 and 3 (Joints 2 and 3, respectively). This damage extended beyond 3.8 cm ( $\approx 1\frac{1}{2} \text{ in.}$ ) on the bell section of both pipe segments since both sensors installed on the bell sections of Pipe Segments 2 and 3 detected the damage. The mode of damage that occurred is schematically illustrated in Fig. 9a and can be attributed to the relative rotation of the spigot inside the bell section.

With an increase in the displacement during the fourth step (Figs. 7 and 8), further damage developed at Joint 3 where R-17 is located (Fig. 8b). This damage is probably due to wedge-breaking action and did not extend beyond 1.27 cm ( $\approx 1/2 \text{ in.}$ ). Up to the fifth step, the majority of the damage is localized at the joints in the vicinity of the fault line (i.e., Joints 2 and 3). Damage at this point began to occur at Joint 1. The signals slightly lag the displacement of the actuators.

Fig. 8. Location of the detected damage by sensors. Arrows indicate the location of the damage captured by conductive surface tape (CST) sensors.

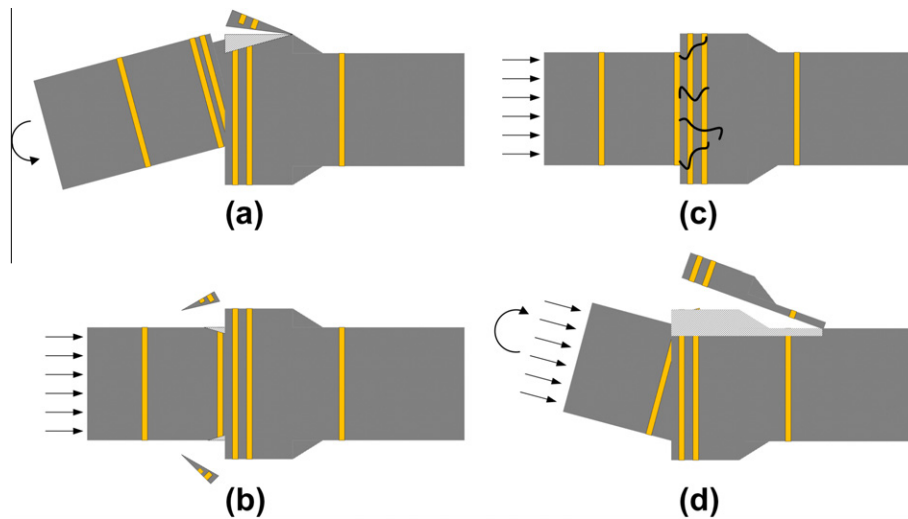
**Fig. 9.** Schematic illustration of (a) failure of bell due to angular rotation, (b) wedge-breaking due to compressive force, (c) failure due to telescoping and (d) failure of the joint due to rotation and telescoping.

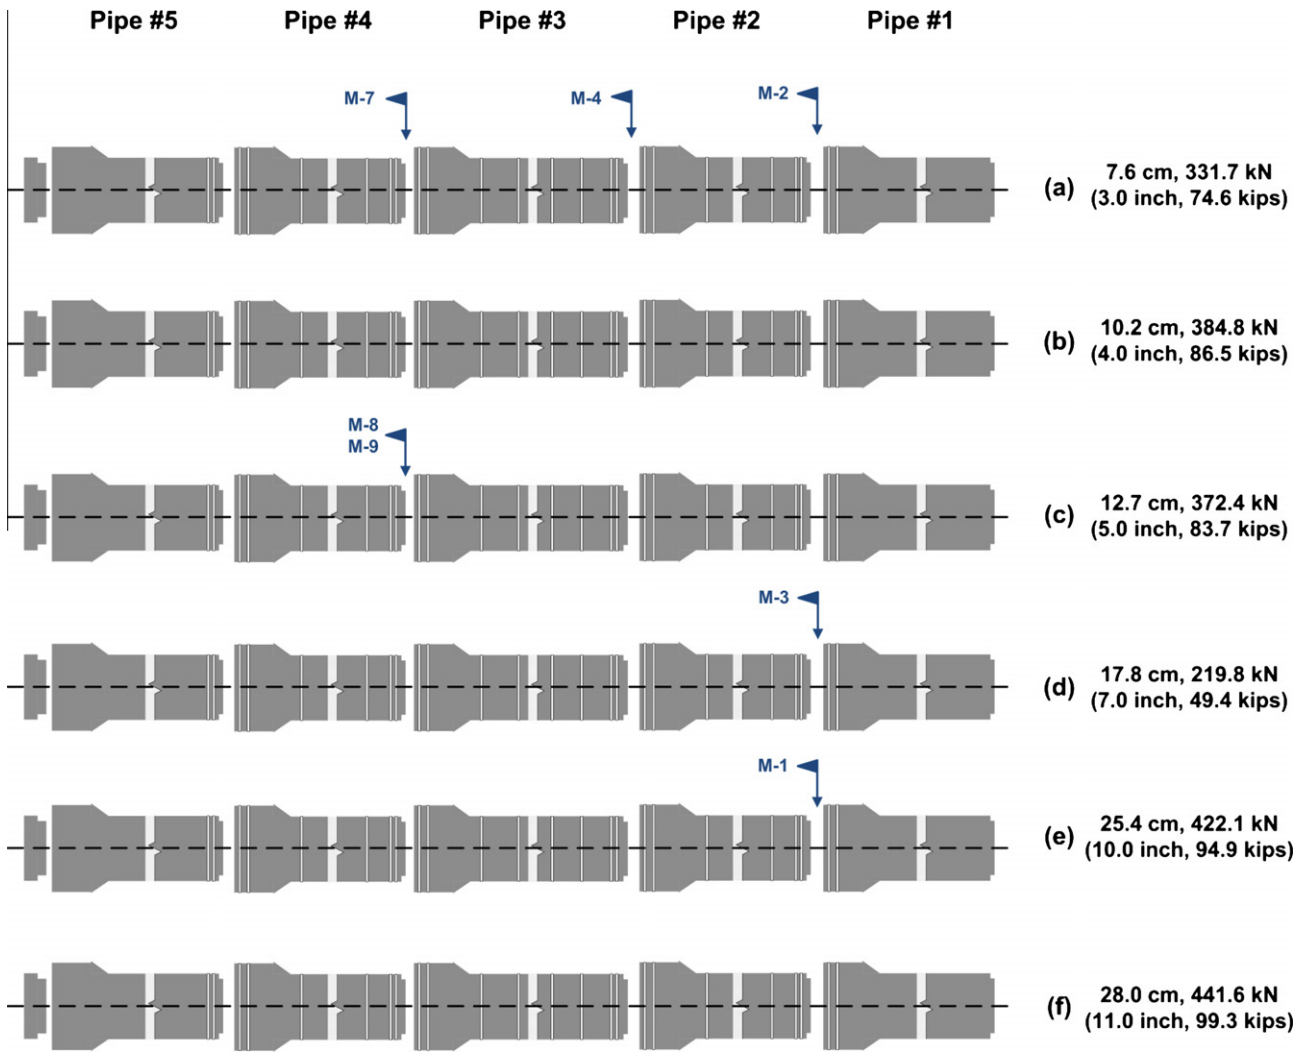
Fig. 10 shows that the magnetic sensors at Joints 2 and 3 indicate relative movement of the spigot with respect to the bell. These

Fig. 11. Location of the detected damage by sensors. Flags indicate the location of the damage captured by magnetic (M) sensors.

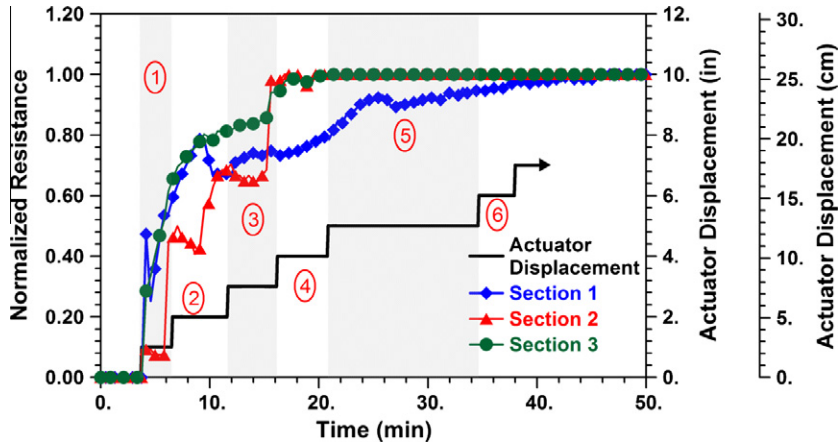
All three sections of Joint 4 approximately follow the same trend of resistance increasing; this indicates that the damage is almost uniformly distributed around the joint (i.e., telescoping). The majority of the damage is accumulated in the joint up to the end of the third displacement step. These results are consistent with the results obtained from CST sensors in Fig. 7a (Fig. 8a) where the damage is detected at spigot section of the Joint 4.

Fig. 14. Resistance increase of conductive grout due to damage at Joint 4.

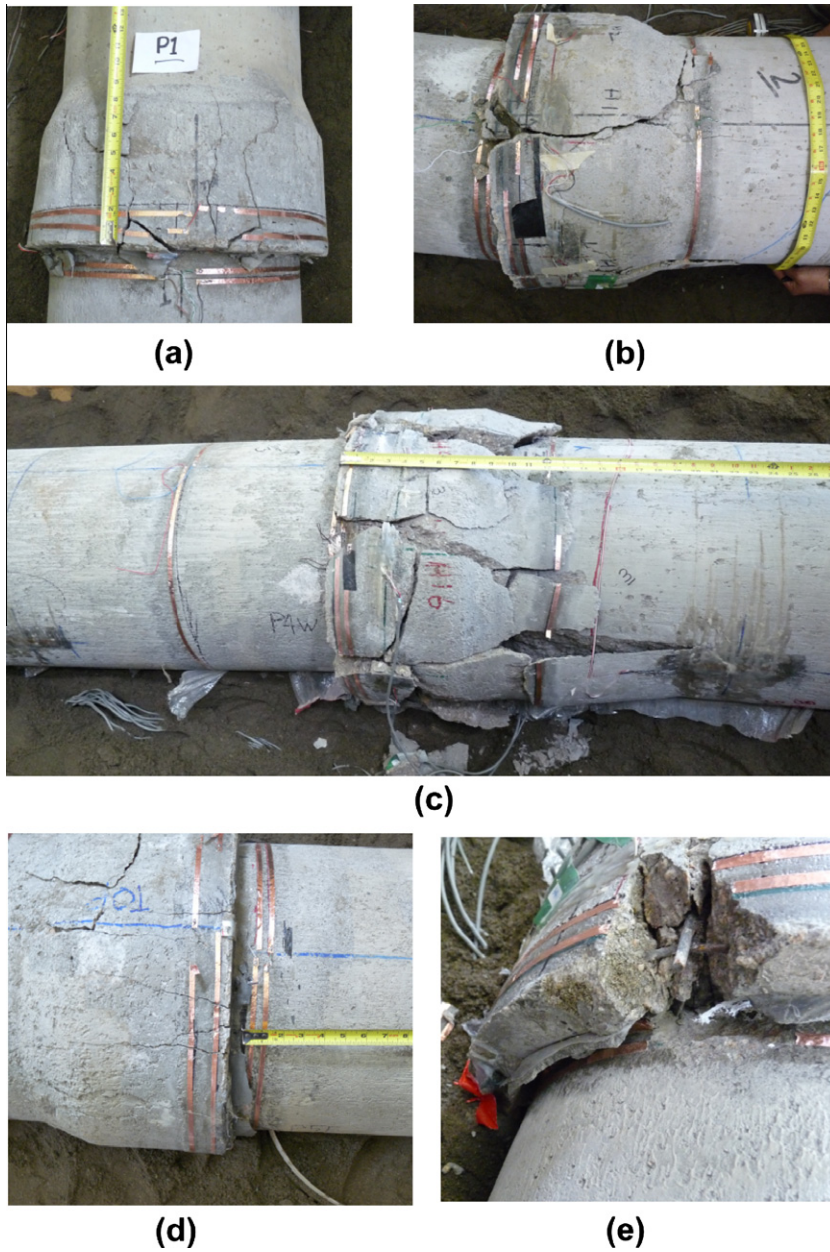
At the end of the experiment the pipeline was excavated and visually inspected. Fig. 15a through 15d illustrate the damage that developed during the test at Joints 1–4. Clearly, each of these joints was damaged. The observed damage is in agreement with the damage detected using the sensing methods. Specifically, the CST

Fig. 15. Damage to joints observed after excavation (a) Joint 1, (b) Joint 2, (c) Joint 3, (d) Joint 4, and wedge-breaking type of damage seen in Joint 2.

The types of damage illustrated in Fig. 9 can be seen in the photographs shown in Fig. 15. Figs. 15b and c show the damage to Joints 2 and 3, which appear to have rotated and telescoped (Fig. 9d). It should be remembered that the photographs in Fig. 15 show damage at the time of excavation, however, the damage to Joints 2 and 3 increased progressively over time, from wedge-breaking damage to the spigot (Fig. 9b) to telescoping and crushing of the bell (Fig. 9c), and eventually to rotational and telescoping type failure (Fig. 9d). The wedge-breaking type of damage that was observed at Joint 3 is shown in Fig. 15e. The damage to Joints 1 and 4 is similar to the schematic illustration shown in Fig. 9c.
