## Using resistivity measurements for dam safety evaluation at Enemossen tailings dam in southern Sweden

Sjödahl, Pontus; Dahlin, Torleif; Johansson, S

*Published in:*  
Environmental Geology

2005

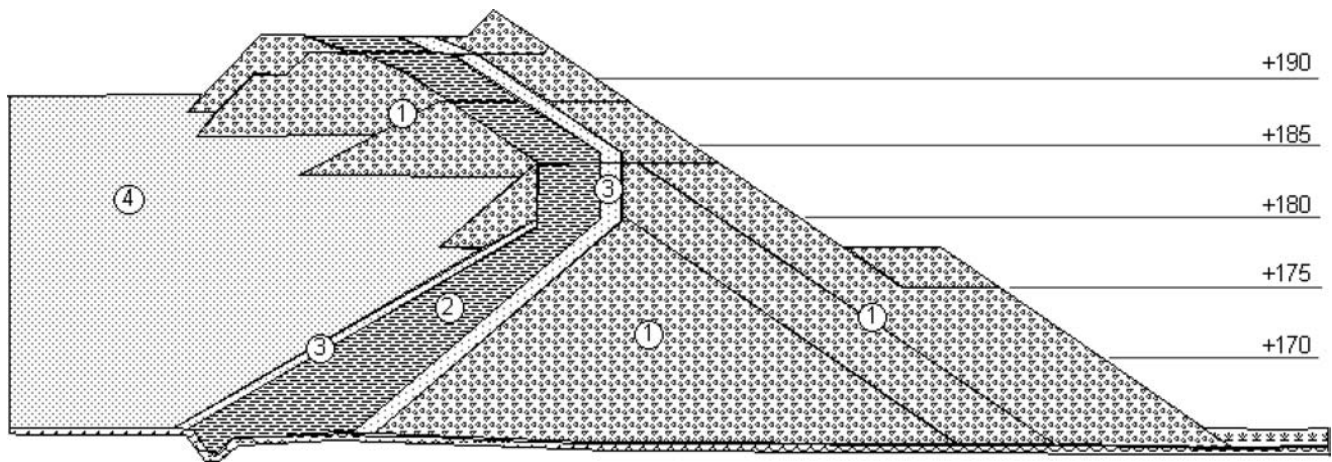
**Fig. 1** Cross section of the X-Y dam. 1 Support fill (downstream and upstream), 2 core, 3 filter, 4 tailings. Level refers to meter above sea level

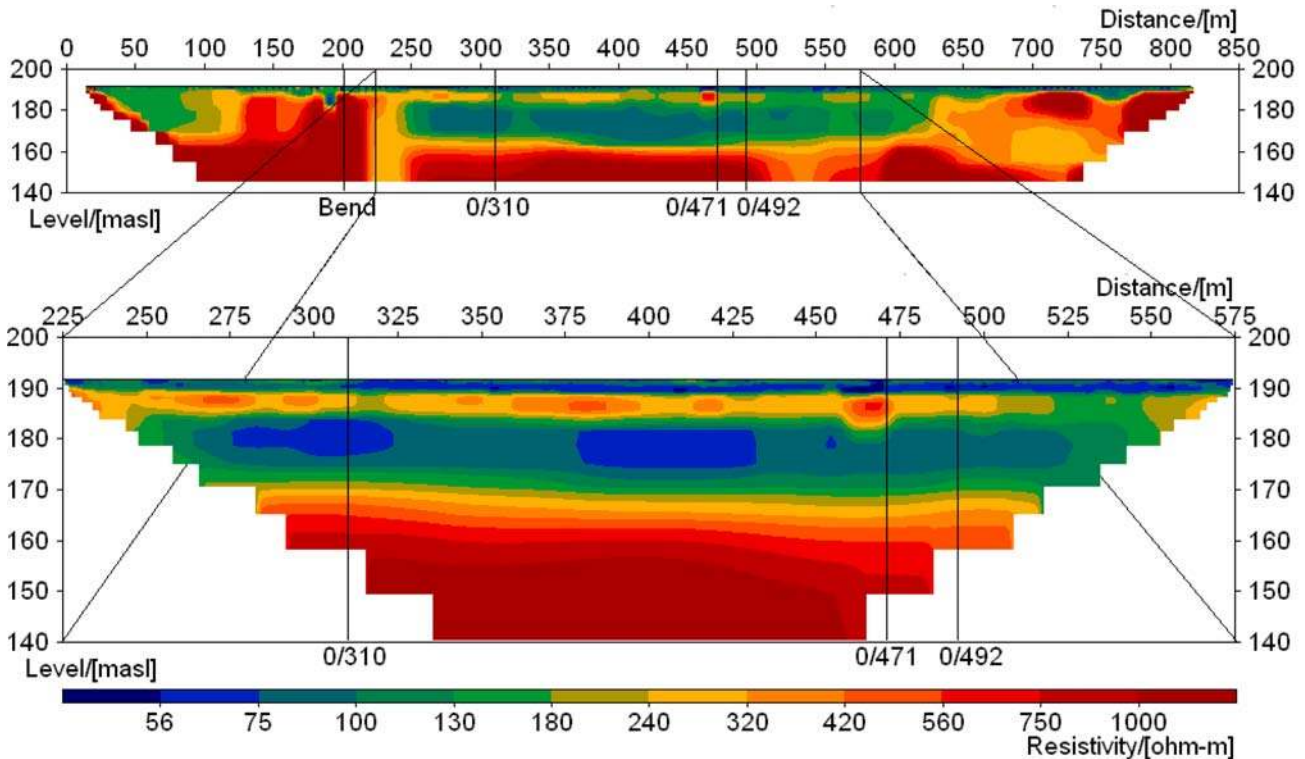
The resistivity measurements along the dams as well as the cross lines provided data of high quality, resulting in low model residuals ( $\approx 1$ –3%) for the inverted sections. The upper part of Fig. 2 shows an inverted section from the 5 m spacing survey along the entire dam X-Y. Data from the 2 m spacing and the 5 m spacing survey along the central part of the dam were combined and inverted jointly (Fig. 2).

A high-resistive bottom layer is evident throughout the section, at depths that correlate well with the somewhat sparse and uncertain information available about variations in bedrock level. The high-resistivity bottom layer comes close to the surface at the ends of the line. The central part the line exhibits three principal layers above the high-resistive base layer. Starting from the top; a couple of metres thick layer of around  $100 \Omega \text{ m}$ , a medium-resistive layer of a few hundred Ohm m down to approximately 10 m depth, and below that a layer around  $100 \Omega \text{ m}$  reaching circa 30 m depth.

**Fig. 2** Inverted resistivity section from the X-Y dam. Above: based on measurements from the 5-m spacing survey (mean residual 2.5%). Below: based on measurements from both the 2-m electrode

spacing and the 5-m spacing survey (mean residual 1.4%). Cross section profiles at 0/310, 0/471 and 0/492 m are marked out. Level refers to meters above sea level

Fig. 2 corresponds to the uppermost part of the dam core, and the second layer corresponds to the upstream support fill. The third layer in the length sections show the combined effect of the dam core, the water-saturated support fill and the saturated tailing sand.

The resistivity profiles along the dam show low-resistivity areas at chainage 0/280–0/340 m, 0/390–0/

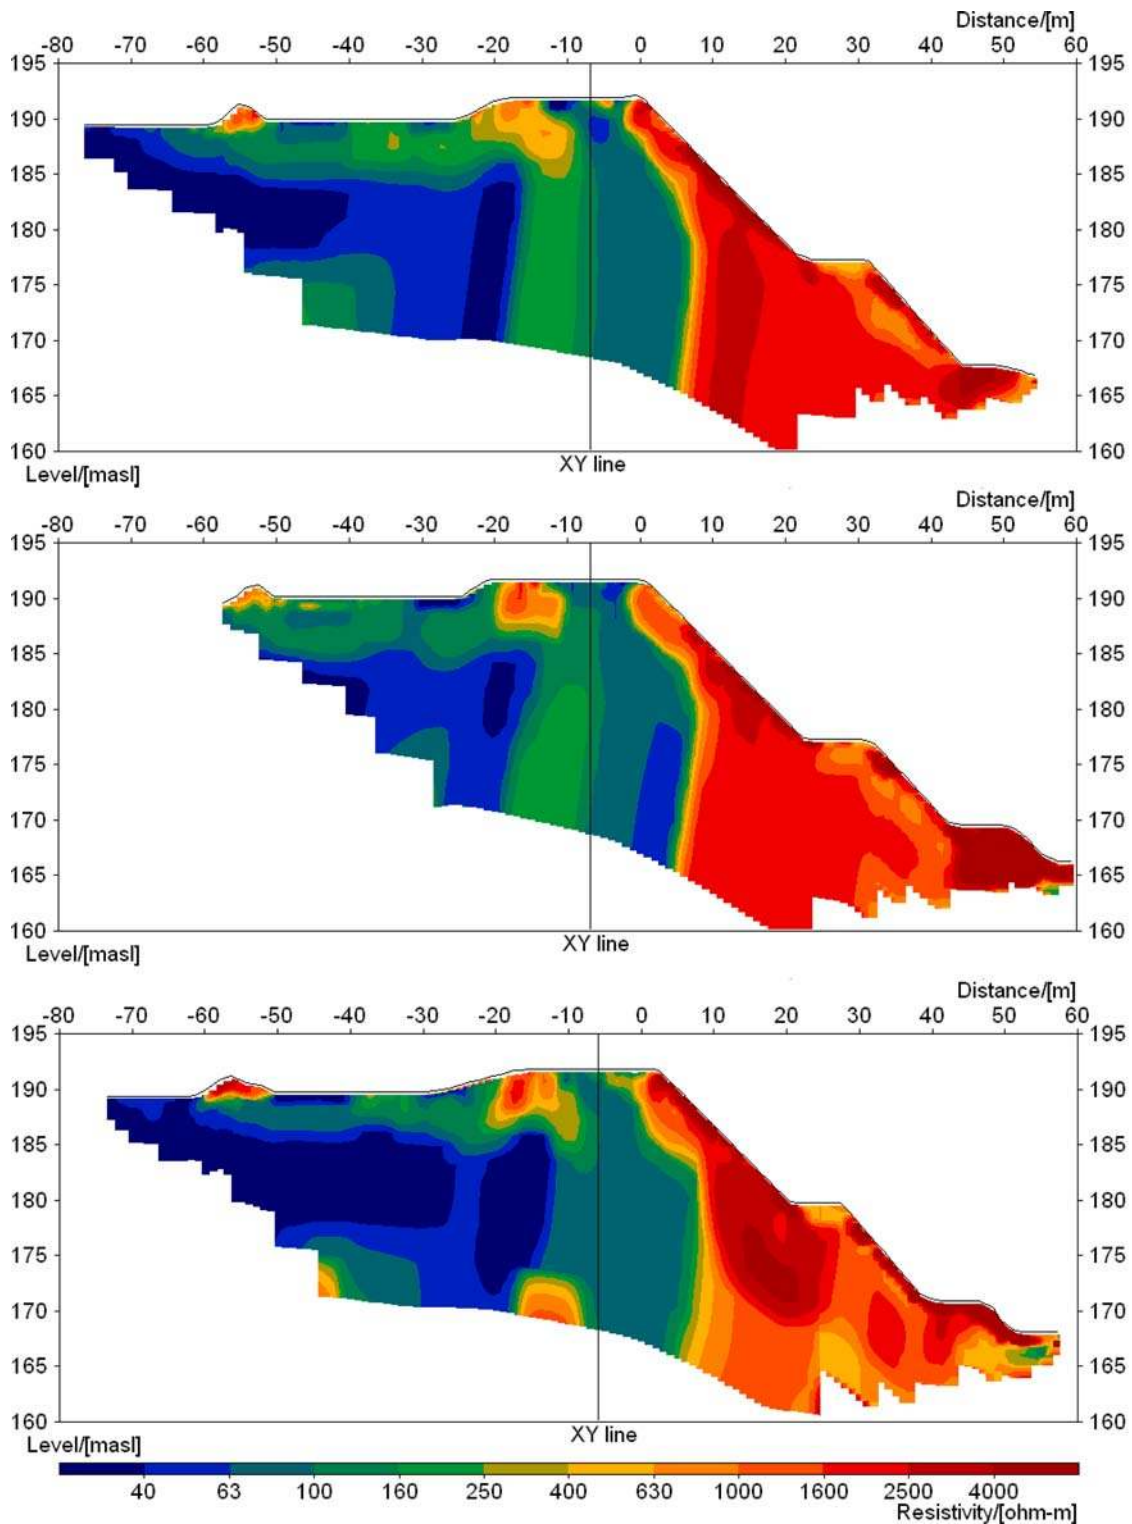
The cross section at chainage 0/471 m (Fig. 3) shows a sequence of zones with different resistivity with steep to vertical interfaces, going from low ( $\approx 40 \Omega \text{ m}$ ) over intermediate ( $\approx 200 \Omega \text{ m}$ ) and rather low ( $< 100 \Omega \text{ m}$ ) to very high ( $> 1,000 \Omega \text{ m}$ ). These zones correspond well with that which can be expected from the way the dam is built. Starting from the upstream side on the left in the diagram, the low-resistive zone that continues up to –

The cross section at chainage 0/492 m (Fig. 3) agrees well with the one at 0/471 m, but the top high-resistive part corresponding to the upper part of the upstream support fill is not so well developed. The latter explains the high-resistive zone at 0/471 m in the sections measured along the dam (Fig. 2). The extra low-resistive part of the zone interpreted as the core might be an indication of a change in the properties connected to the sinkhole development. The groundwater level was recorded at elevation 165 masl at +3 m on the cross section (chainage 0/500 m).

The cross section at chainage 0/310 m (Fig. 3) is similar to the one at 0/471 m with one important exception. The high-resistivity zone corresponding to the upstream filter is interrupted by a large zone (around 10 m high) with resistivity below  $100 \Omega \text{ m}$ . This can be interpreted as an effect of anomalous seepage through the dam, which fits well with the occurrence of old sinkholes. Measured groundwater levels at elevation 187 masl at –40 m and elevation 185 masl at –20 m fit well with the image. At +3 m the measured groundwater level at 171 masl is not visible, as would neither be expected in fine-grained material. The bedrock level at elevation 165 masl at –15 m may be situated below the depth penetration. At +20–25 m the bedrock at elevation 171 masl appears to be slightly less resistive than the downstream support fill.

425 m, and 0/525–0/550 m. The resistivity in the area of the latest sinkhole (at chainage 0/500 m) is similar compared to the other parts of the dam. The cross section at chainage 0/492 m shows, however, a lower resistivity in the downstream part of the core. This is similar to the result at chainage 0/310 m where a high-resistivity zone (corresponding to the upstream support fill) is interrupted by a large low-resistive zone. This can be interpreted as an effect of anomalous seepage through the dam, which fits well with the occurrence of previous sinkholes. The overall conclusion, based on the result from these investigations, is that none of the detected resistivity or temperature anomalies immediately need any further investigation, but the result shows the importance and need of the ongoing monitoring program for the dams.

**Fig. 3** Inverted resistivity cross sections from the X-Y dam. Above: chainage 0/471 m (mean residual 3.1%). Centre: chainage 0/492 m (mean residual 3.3%) Below: chainage 0/310 m (mean residual

1.7%). Level refers to meters above sea level and chainage to length along the dam in meters

Known problem areas were associated with low resistivities even though the resistivity measurements alone did not provide enough information to confidently come to a decision about the status of the dams. However, repeated measurements would provide possibilities to detect changes in the material or seepage-induced resistivity changes, the latter mainly due to temperature changes. This approach is used in an ongoing dam-monitoring programme at two Swedish embankment
