# **WIND POWER DEVELOPMENT IN SUB-ARCTIC CONDITIONS WITH SEVERE RIME ICING**

John F. Maissan, P.Eng.,  
Director, Technical Services  
Yukon Energy Corporation

Circumpolar Climate Change Summit and Exposition

March 19-21, 2001  
Whitehorse, Yukon  
Canada

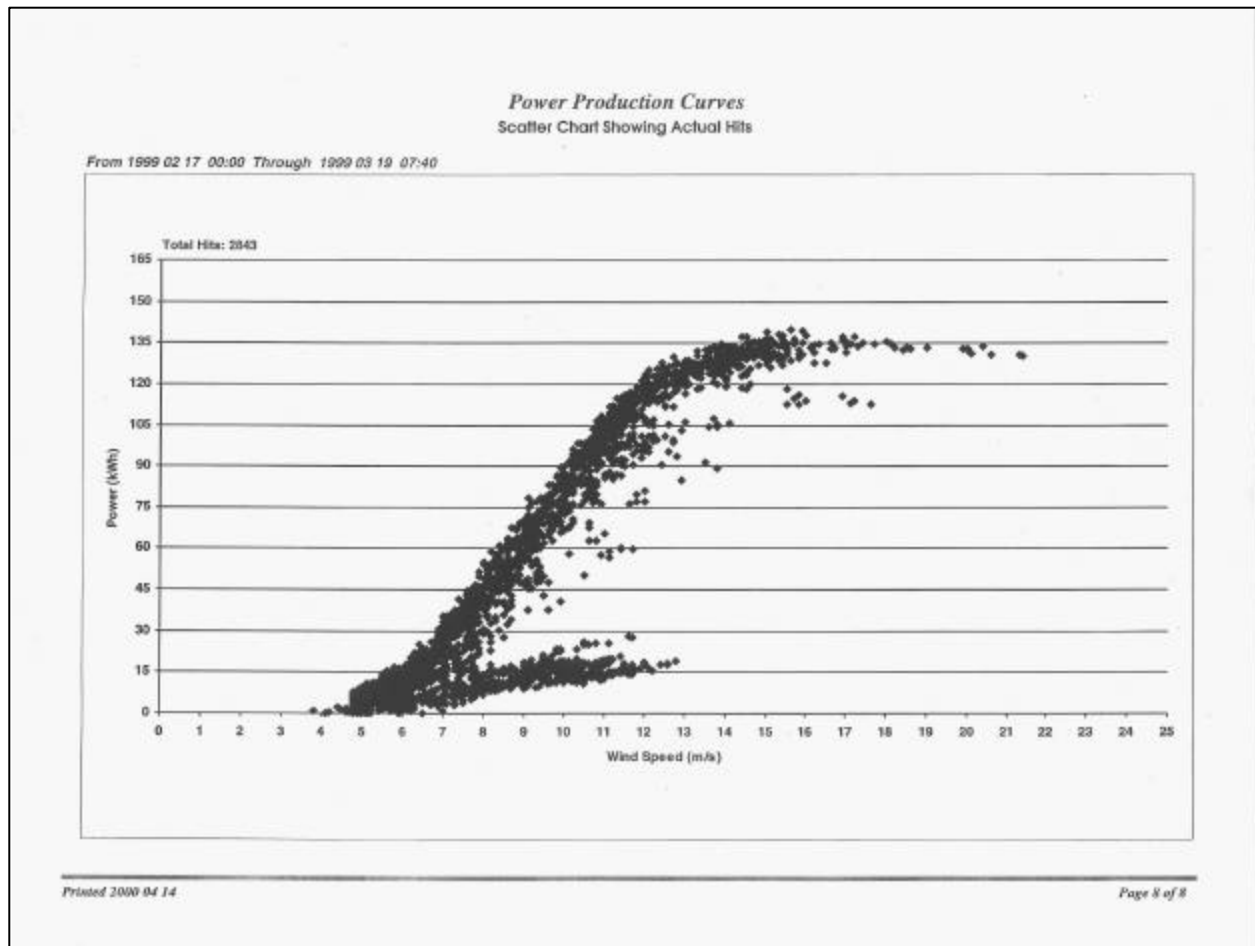
**Graph 1 Rime Icing Effects on Power Production Curves**

The effect of rime icing on the blades of the wind turbine is such an important issue that it is worth examining in detail. Without blade heaters rime ice builds up especially heavily on the leading edges, and the build up increases with distance from the blade root (Photograph 4). It seems to be directly related to the velocity at any point and therefore perhaps the amount of moisture or moist ice contacted. When shut down the ice builds up on the edges of the blade surface facing the wind, the pressure side. When running through an icing event the ice build up on the "back", or suction side, of the blade is much less than on the "front" (Photograph 5). Ice can also build up on the trailing edge. Power production drops off dramatically when the blades are coated with rime ice and without leading edge blade heaters can stop altogether (Graph 1).

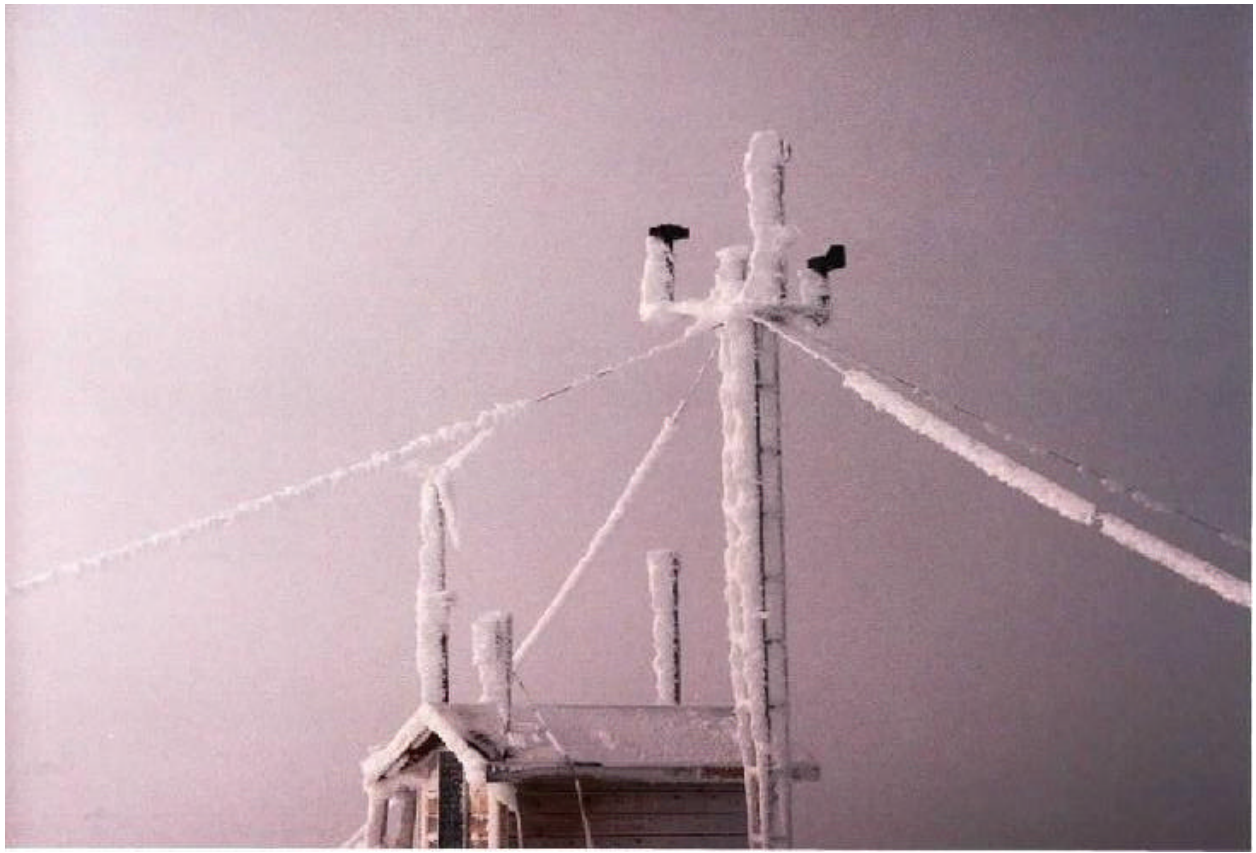
The climate in Whitehorse is sub-arctic, mean daily January lows are  $-25^{\circ}\text{C}$  with the lowest temperatures around  $-40^{\circ}\text{C}$ , and occasionally to  $-45^{\circ}\text{C}$  or lower. Weather data analyses have shown that at altitudes of 4,000 to 6,000 feet rime icing can occur from 800 to 1200 hours per year -- equivalent to a continuous duration of 4 to 7 weeks per year. Rime icing is the buildup of ice on anything solid from moist, supersaturated air at sub-zero temperatures. Essentially whenever and wherever there is a cloud on a mountain there is rime icing (cover photograph). Rime ice looks like the pretty frost that builds up on trees around open water in the winter. In our location rime icing is most severe in the early winter: mid October to the end of December. Severe rime ice on wind monitoring equipment is illustrated in Photograph 1.

Photograph 1: Rime ice on monitoring equipment, only heated instruments stay clear

1. The heated bearing anemometer and wind vane were still immobilized by ice and were replaced with fully heated Hydro-Tech instruments which have not iced up (Photograph 1).
2. The overhead power line was causing about five outages per month due to the heavy accumulation of ice in combination with wind, and was replaced with a buried cable which is not affected by the ice.
3. The Ice detector supplied with the turbine was not effective and was removed from the control circuit. The heating circuits are now simply switched on for the winter. A Rosemount ice detector was purchased in 1996 and has been running reliably on site since then, but has not been installed into the turbine control circuit. This ice detector has indicated that we average over 800 hours of rime icing per year on the site.

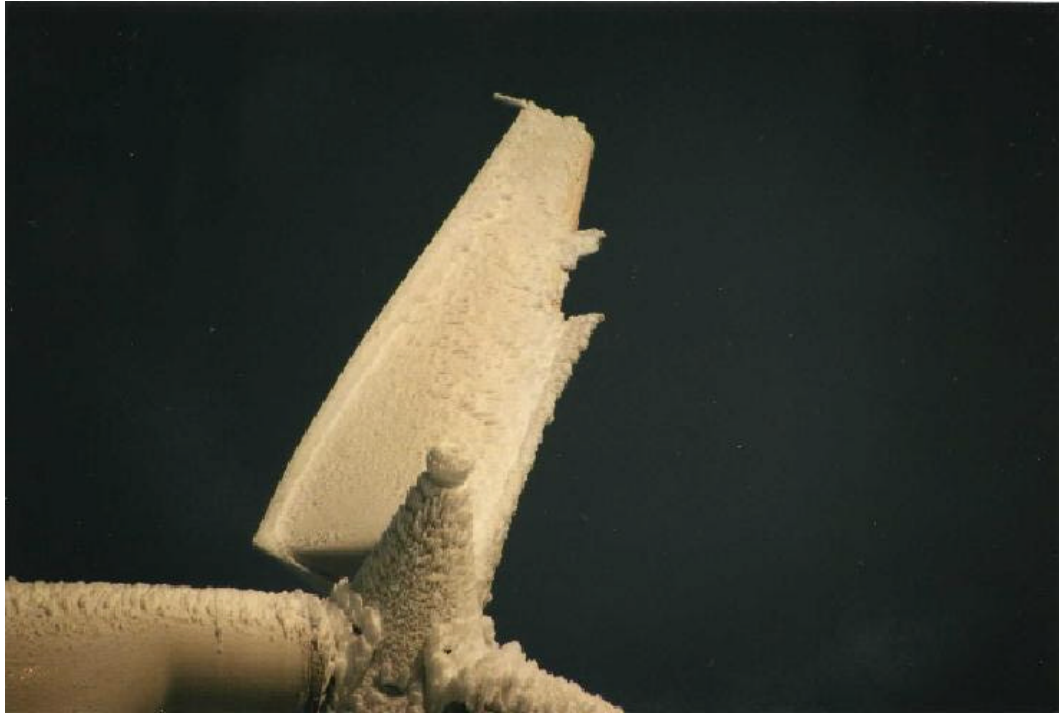
Rime icing causes were briefly described in the introduction. The practical effects can be substantial. Any solid object accumulates ice which “grows” into the wind (Photograph 3). Trees become ice domes, towers become ice posts, power lines grow to six or eight inches in diameter, and chain link fences become solid walls. As you can see it is no wonder that exposed equipment has difficulty working under these conditions. Low temperatures and severe rime icing are the challenges we need to overcome.

Photograph 3: turbine heavily iced, did not run through icing period

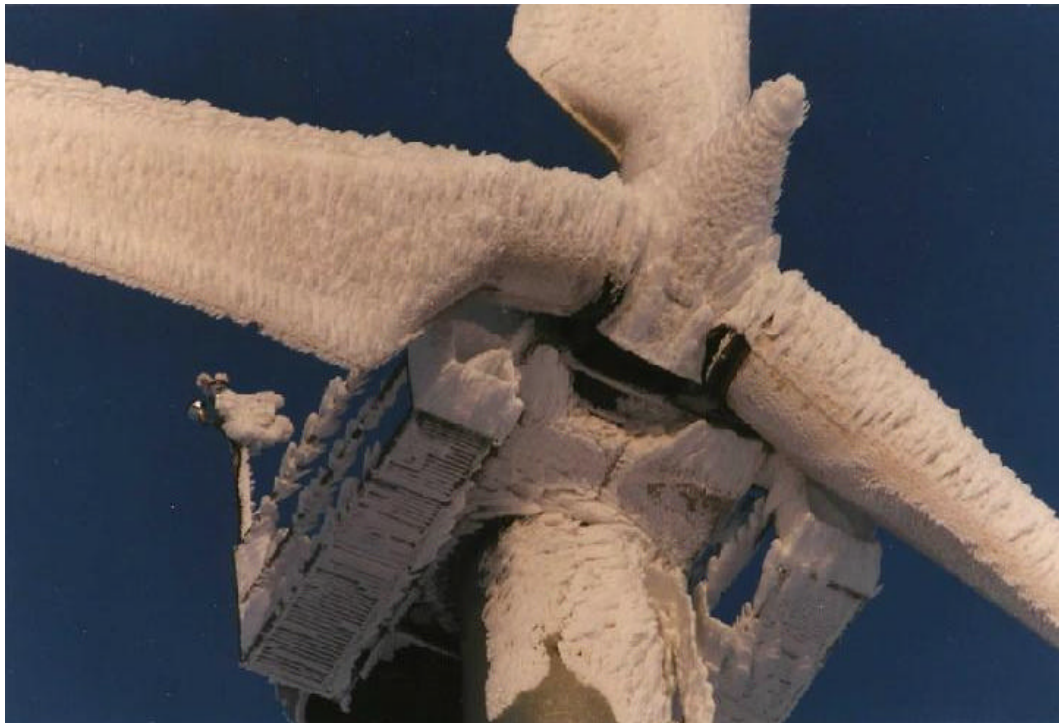
Photograph 4: wedge shaped ice builds up on the blades when running through icing events – leading edge heaters not working

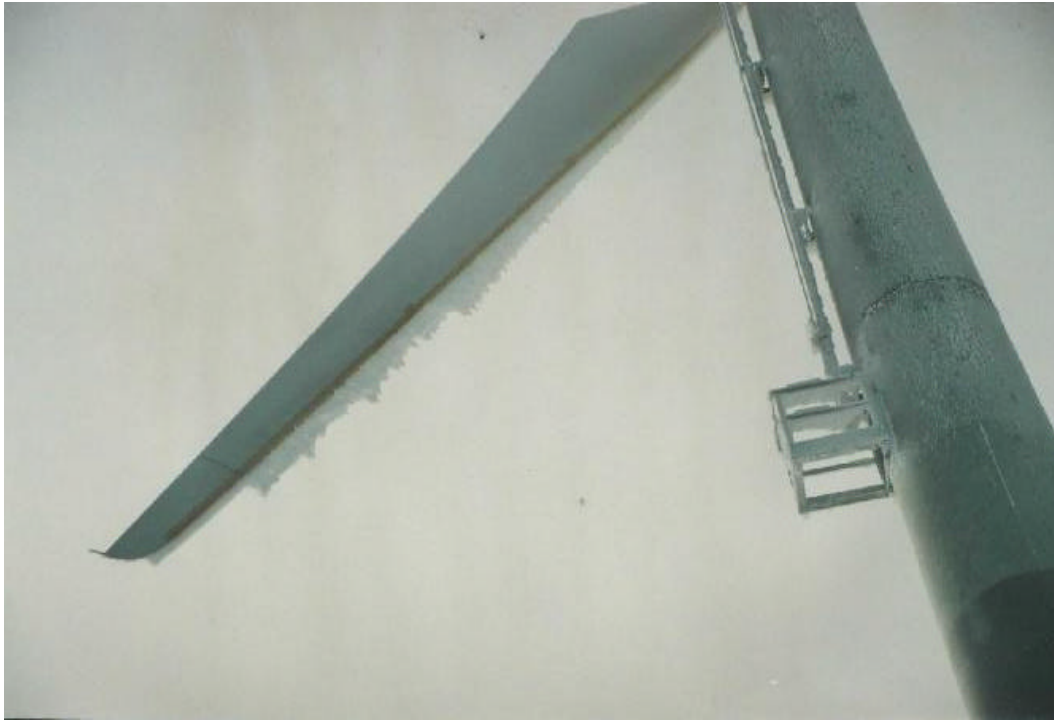
Photograph 5: wedge shape build up from back, note clear back of blade – leading edge heaters not working

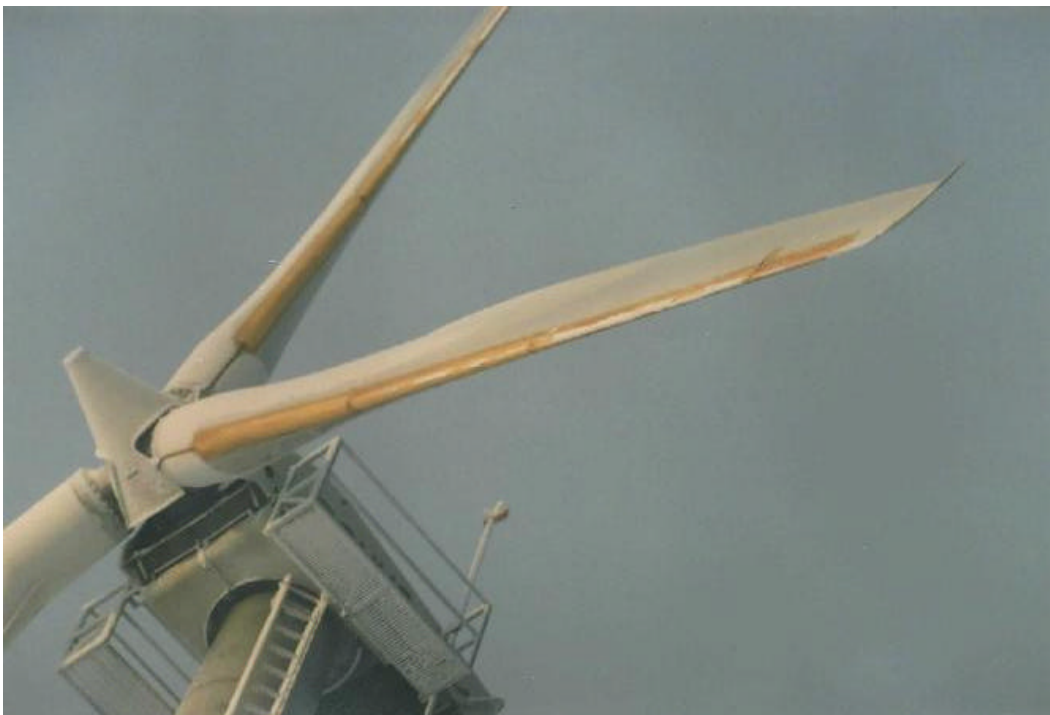
The 6 inch wide heaters did, under lighter icing conditions, keep portions of the blade downwind of the heater clear (Photograph 6). Under heavier icing conditions ice would build up on the blade right up to the heater (Photograph 7). Build up of ice on the leading edges did not occur except under the most severe conditions, and it cleared off quite quickly afterwards. It was from this that we concluded that more heat on the front of the blade in the form of wider leading edge heaters would be of benefit if the increased area was applied to the front (pressure side) of the blade. It was also obvious that the leading edges of the blade tip would need to be heated to minimize the air drag and associated production losses.

Photograph 6: in less severe rime icing the effect of the leading edge heaters extends past the leading edge

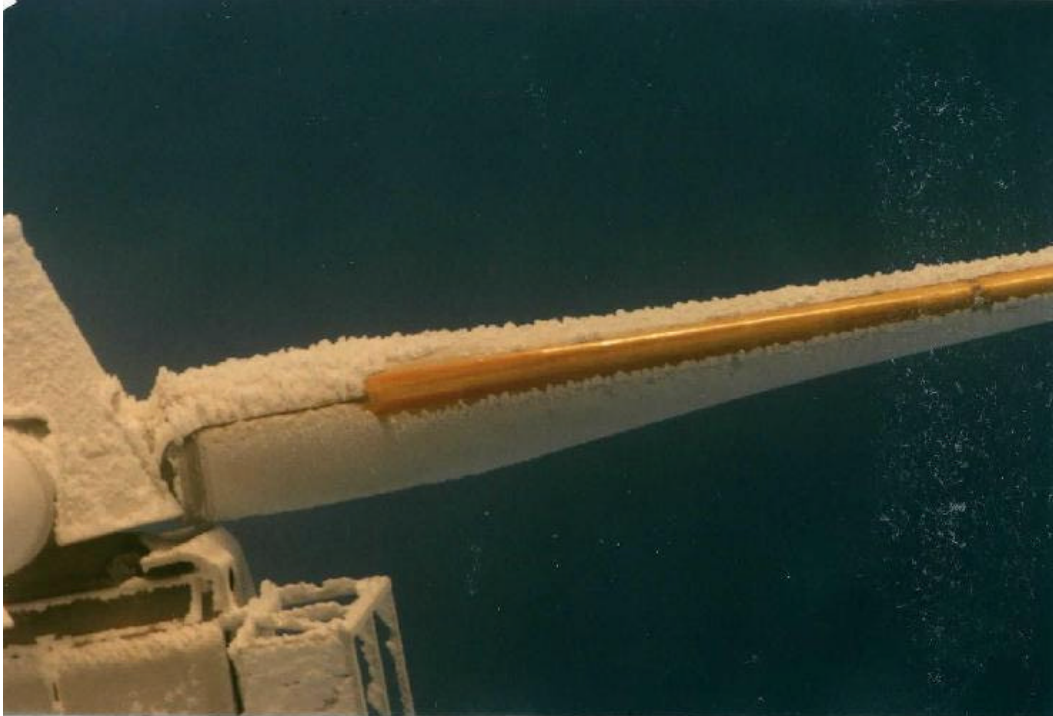
Photograph 7: in severe icing conditions the effect of the leading edge heaters does not extend as far

The leading edge blade heaters (1/4 watt per square inch) have worked reasonably well even though one burnt out in 1996. We replaced them all in 1998 with heaters 12 inches wide, rather than 6 inches, to improve performance in very severe rime icing and in very cold temperature conditions. Perhaps because of other problems and advances we have not been able to attribute specific production improvements to the larger heaters.

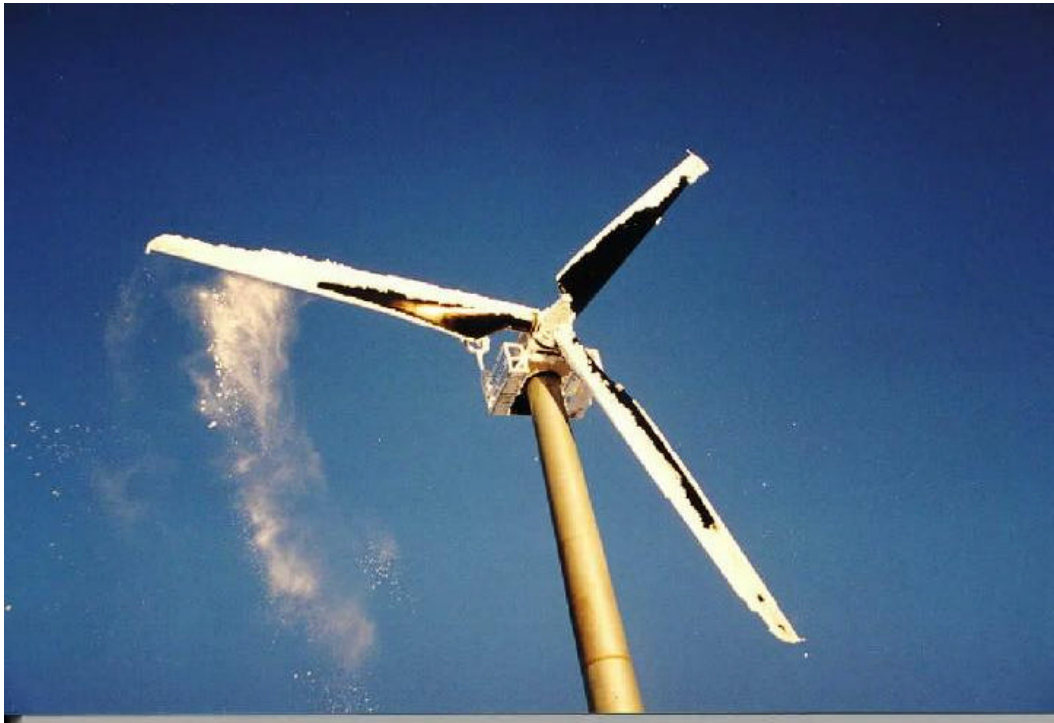
Repairs to the power line (a local feeder) were made in 1996 and since that time there have been very few of the electronic problems that bothered us early on, and turbine availability has been very high. Also in 1996 we "painted" the blades with a black coloured coating called StaClean. We believed that the solar heating from the black colour would assist in clearing the blades of accumulated rime ice, and we felt that the special low adhesion formula for ice could be beneficial too. We saw an immediate noticeable improvement in performance, 1998 and 1999 have been the best production years yet. Photograph 8 shows accumulated ice shedding from the blades.

Photograph 8: accumulated ice shedding from black blades
