Aging studies for the ATLAS Transition Radiation Tracker (TRT)

Abstract

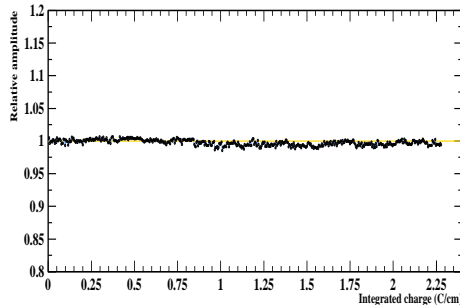
Fig. 3. TRT material tests: relative amplitude variation as a function of accumulated charge for a $1 \mu\text{A}/\text{cm}$ current density in the straw

No noticeable gas gain drop was observed under any of the test conditions. Some materials produced a detectable amount of hydrocarbon outgassing, but no wire deposits were observed after detailed wire analysis under an electron microscope. No indication of Si-deposits was found from G10 nor from FR4 materials, even if some of them smelled rather strongly after machining and irradiation (this outgassing was not detected by the gas chromatograph/mass spectrometer).

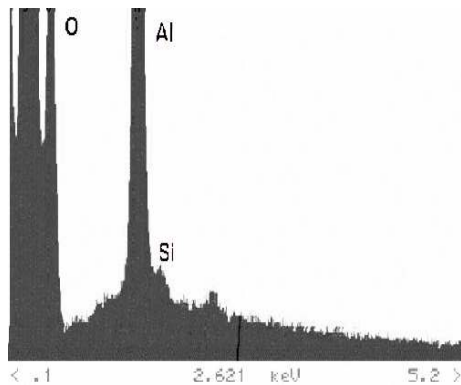
Fig. 6. EDX (Energy Dispersive X-ray) spectrum of the straw cathode surface for a straw produced without lubricant. The peak in the middle of the picture corresponds to 1000 Å of Al. A very small Si peak can barely be distinguished close to the right-hand side of the Al-peak.

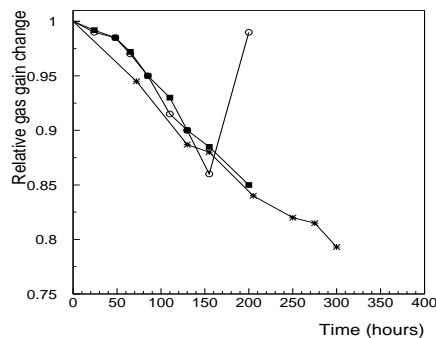
Fig. 7. Relative amplitude variation as a function of irradiation time with a 1 mm wide X-ray beam for three different beam positions along the straw. The last open circle shows the recovery obtained by irradiating that particular point in the straw with a 2 cm wide X-ray beam and a current density of 1 μA/cm over less than 24 hours (see text).

last open circle in Fig. 7). The narrow beam irradiation was then repeated at points situated 3 cm and 10 cm upstream of the cleaned area. No indication of any aging effect during at least 400 hours was observed for the nearest of the two points, whereas some aging was observed for the one farther away. Finally, the same treatment, with a 2 cm wide beam and a current density of $1\mu\text{A}/\text{cm}$ during 20 hours, was carried out at the upstream part of the straw and the tests with a narrow beam were then repeated in a few places along the full 30 cm length of the straw. No aging effects were observed in any position along the straw over at least 600 hours of irradiation.

These tests prove first of all that the active species responsible for Si-cleaning survive for a rather long time and remove Si from the cathode surface as they travel with the active gas. A certain amount of diffusion of these active species is observed but is not sufficient to clean the upstream surface of the straw over distances more than a few cm. In this particular case, the Si source in the straw is quite small in quantity and is removed after an accumulated charge of less than $3 \cdot 10^{-3}$ C (about one day of LHC operation). The other important conclusion from these tests is that aging effects arising from the presence of such small amounts of Si in the straw may not be observed at all, if the irradiation area is wide, which will of course be the case during LHC operation. As a final confirmation that there should be no concern about operation at the LHC, the wide-beam test was carried out with a current density of $0.03 \mu\text{A}/\text{cm}$ (corresponding to initial operation at the LHC) on a straw, which had manifested aging effects in narrow beam tests. All the aged areas were under irradiation in this tests. After 70 hours of irradiation, not only had no aging been observed in the irradiation zone and its edges, but the deposits in the aged areas had been removed from the wire through the etching process.

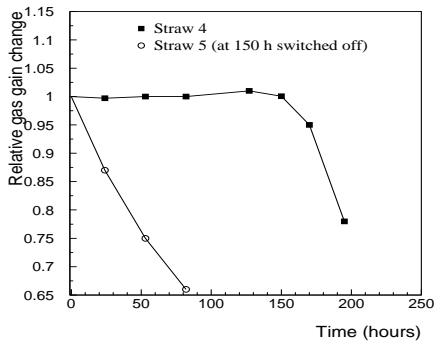
Fig. 8. Relative amplitude variation during irradiation with a narrow beam of 1 mm width where the gas flow is serially from straw 5 to straw 4, and so on. The Si-source in this case is a lubricant used for the assembly of a flow regulator.

In the case of Fig. 8, five straws were connected serially and each of them was irradiated by a 1 mm wide 6 keV X-ray beam (5 kHz) near the middle of the straw. The active gas flow was from straw 5 to 4, and so on. During the first 150 hours, all straws were connected to high voltage. Straw 5 showed significant aging immediately, but all the other straws remained stable. After 150 hours, straw 5 was disconnected from the high voltage (but left in the gas flow), and significant aging was observed immediately in straw 4. The Si-source in this case was a lubricant used during flow-regulator assembly. The conclusion is that even a 1 mm wide irradiation area is sufficient to stop downstream Si-transport in this particular case. If the beam is wider, the amplitude degradation is observed first at the gas inlet, but it has a tendency to propagate further. This is shown in Fig. 9, where a 50 cm long straw was irradiated by a 40 cm wide beam, and, after 64 hours, a significant amplitude drop was observed up to a distance of 5 cm from the gas inlet. In this test, the main source of Si arose from pollution of the gas system by traces of oil.

As already mentioned, the main source of Si in the gas systems arises from Si-based lubricant residuals. For instance, the case shown in Fig. 8 corresponds to a test, in which one of the standard flow regulators (“rotameter”) was connected directly to the straw, as received from the manufacturer. Even a short exposure of the detector to such a component may very often leave residuals in the detector itself. For example, the use of this particular flow regulator for 70 hours resulted in a significant pollution of the straw: after connection to a clean gas supply line, the straw displayed an amplitude drop of 5% over 100 hours of irradiation with a narrow X-ray beam.

- Validate samples from the manufacturer in all cases;
- Specify and control the production process of all components as carefully as possible;
- Examine the parts carefully after delivery and carry out some aging tests with samples;
- If possible, clean parts ultrasonically;
- Verify the gas-system cleanliness in a dedicated test after assembly;
- Si-lubricant traces can be cleaned by DME-flushing after the gas system has been assembled (in this case the gas-system components should tolerate a short-term exposure to DME).

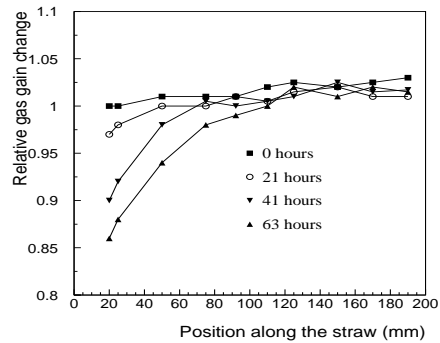
Fig. 9. Relative amplitude variation along the straw for different irradiation periods for a rather weak external source of Si. The straw was irradiated over its full length.

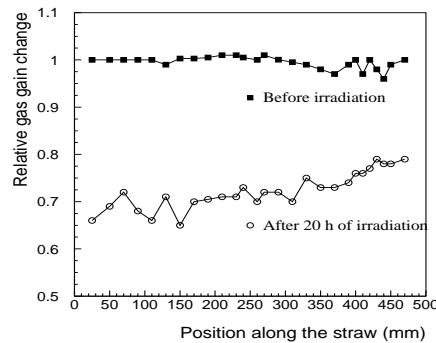
b) In the case of a much stronger external source of Si (large pollution of the gas system by a Si-containing lubricant), there is not enough ionisation to stop all the Si and it is distributed along the straw. In this case, fast aging happens along the whole straw at the same time, as shown in Fig. 10 for a

Fig. 10. Aging due to a strong external source of Si. The relative amplitude variation is shown as a function of the position along the straw before irradiation and after 20 hours of irradiation with an X-ray beam along the full length of the straw and at a current density of $0.03 \mu\text{A}/\text{cm}$.

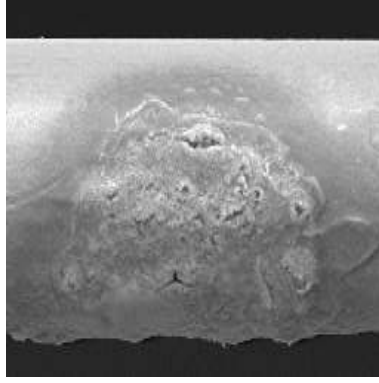
Fig. 11. Damage of the wire gold-plating after 2 C/cm of accumulated charge for a current density of $0.7 \mu\text{A}/\text{cm}$. Local deformation of the gold plating leads to an effective wire diameter increase.

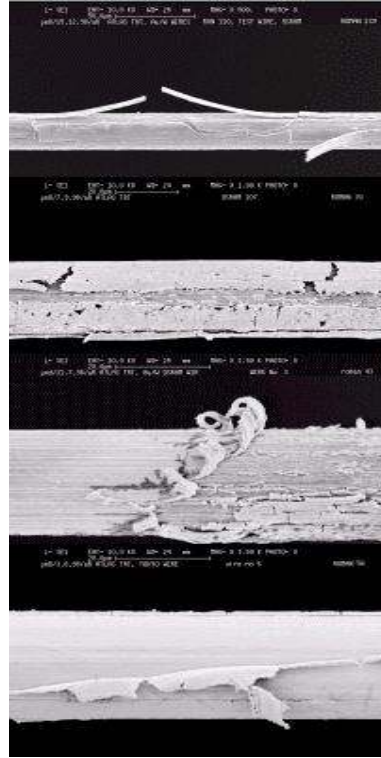
At higher dose rates, the damage is larger at the edges of the irradiation area. In some cases, active chemical processes under the gold-plating are clearly observed (the gold comes off in the form of chips). Wire swelling, or more precisely, swelling of the tungsten, has also been observed, but in contrast to the results reported in [10], this is not a very reproducible phenomenon: it happened just twice out of about 30 tests. In some tests, damage of the tungsten wire itself was observed, but these are rare occasions. The gold-plating layer very often becomes porous before further damage occurs. Tungsten oxide deposits are observed in certain cases, but not regularly; these deposits are most often observed outside the irradiation zone; they are sometimes very soft (they disappear under the electron beam during the electron microscope analysis), but sometimes they are hard. No fluorine-based deposits were observed at all.

Fig. 12. Various manifestations of damage to gold plating on wire surface after 2-6 C/cm of accumulated charge for different current densities (1-4 $\mu\text{A}/\text{cm}$).

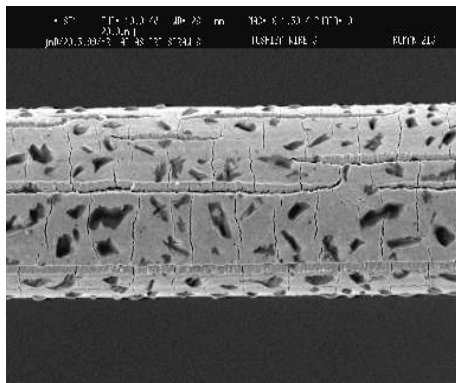
The tests were carried out with a 4 $\mu\text{A}/\text{cm}$ current density up to an accumulated dose of 6.5 C/cm. The results of the wire analysis are shown in Figs. 13 and 14. The impact of water contamination is clearly observable in Fig. 13, whereas no gold-damage was observed for the other two sets of straws (pure gas mixture and gas mixture with 1.5% of Oxygen) as illustrated in Fig. 14.

Fig. 13. Damage to gold-plating on wire surface observed after 6.5 C/cm of accumulated charge for the wire manufacturer chosen for the TRT (Toshiba). The gas mixture was the standard one with an additional 1.2% of water.

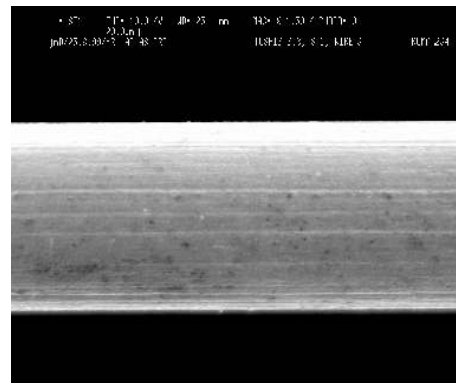
Fig. 14. The same as in Fig. 13 for the standard gas mixture with an additional 1.5% of Oxygen. No gold damage is observed.

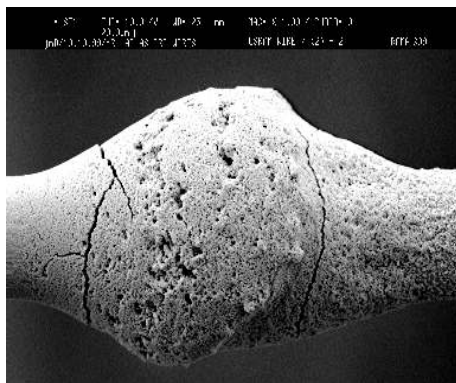
Very interesting results were obtained when combining H_2O and O_2 in the gas mixture. The results were found to depend very strongly on the type of wire. Figs. 15, 16 and 17 display the results obtained for the standard gas mixture with an additional 1.2% of H_2O and 1.5% of O_2 and for another wire manufacturer (OSRAM). A huge amount of WO deposits were found on top of the gold-plating already after 0.5 C/cm of accumulated charge. These WO deposits exist as an amorphous substance (Fig. 15) or even as a crystalline

Fig. 15. Surface of wire (OSRAM) observed after 0.5 C/cm of accumulated charge, for the standard gas mixture with 1.2% of water and 1.5% of oxygen added. Amorphous deposits of WO are observed (see Fig 16).

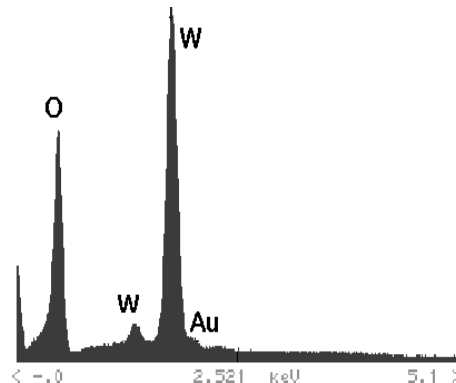
Fig. 16. EDX (Energy Dispersive X-ray) spectrum of the deposit on the wire shown in Fig 15. The two largest peaks correspond to oxygen (left) and tungsten (right).

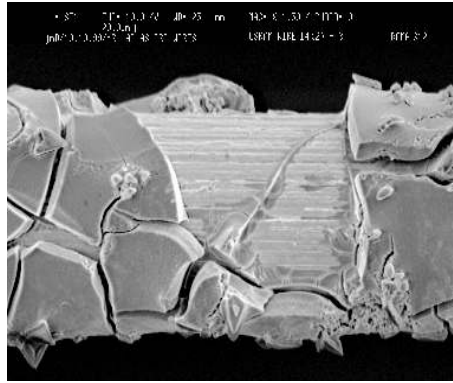
structure (Fig. 17). In spite of this large observed amount of WO deposits, no significant gold-plating damage was observed for this accumulated charge. One can clearly distinguish the undamaged gold surface in the cracks of WO deposits in Fig. 17.

Fig. 17. The same as in Fig 15 for a different wire sample: crystalline deposits of WO are observed.

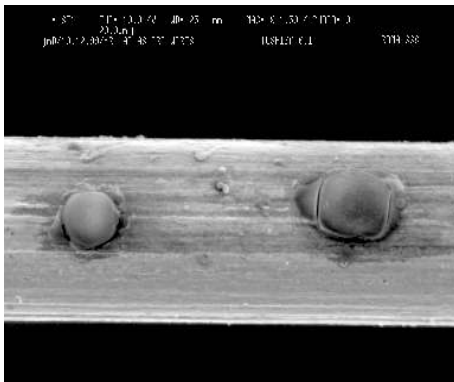
If the water content is kept at a low level, the damage to the gold-plating is minimal. Fig. 18 shows a wire surface (Toshiba), tested with the standard mixture and an additional 0.4% of water after 5 C/cm of accumulated charge (the current density in this test was $1 \mu\text{A}/\text{cm}$). For water concentrations below 0.1%, no gold-plating damage is observed up to 20 C/cm of accumulated charge, as illustrated in Fig. 19. Last tests were carried out with a current

Fig. 18. Toshiba wire surface after 5 C/cm. Gas composition: standard mixture + 0.4% of H₂O .

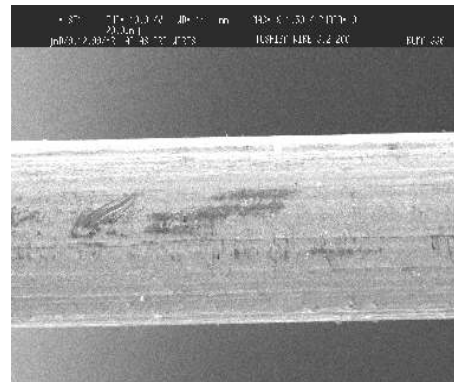
density of 4-5 $\mu\text{A}/\text{cm}$, and some of them were repeated with 1 $\mu\text{A}/\text{cm}$ up to 10 C/cm of accumulated charge. The result was the same: no gold-plating damage is observed for any type of wire if the water content is below 0.1%.

Fig. 19. Toshiba wire surface after 20 C/cm . Gas composition: standard mixture, water concentration less then 0.1%

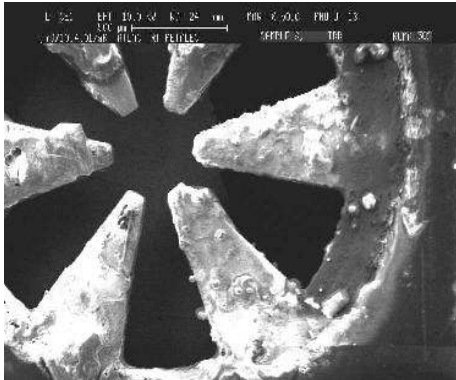
Fig. 20. SiO/SiO₂ deposits on the gold-plated surface of a printed-circuit board after 300 hours of glow discharge tests (see text).

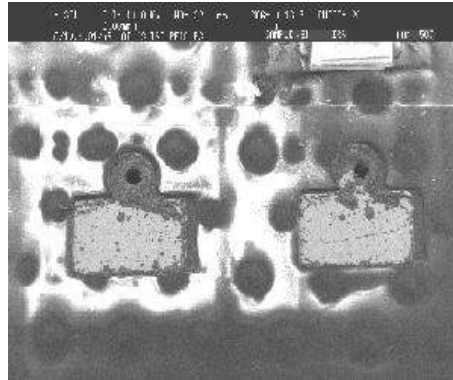
Fig. 21. Printed-circuit board with coverlay partially etched off after 300 hours of glow discharge tests (see text).
