Damage Detection in Rotorcraft Composite Structures Using Thermography and Laser-Based Ultrasound

Robert F. Anastasi¹, Joseph N. Zalameda¹, and Eric I. Madaras²

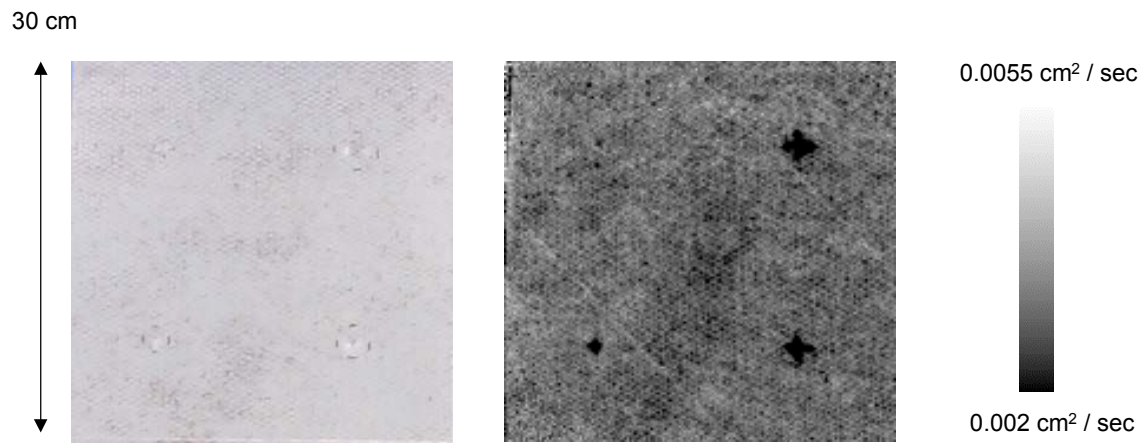
Figure 1. Visual (left) and thermal diffusivity inspection image (right) are area I of the honeycomb panel.

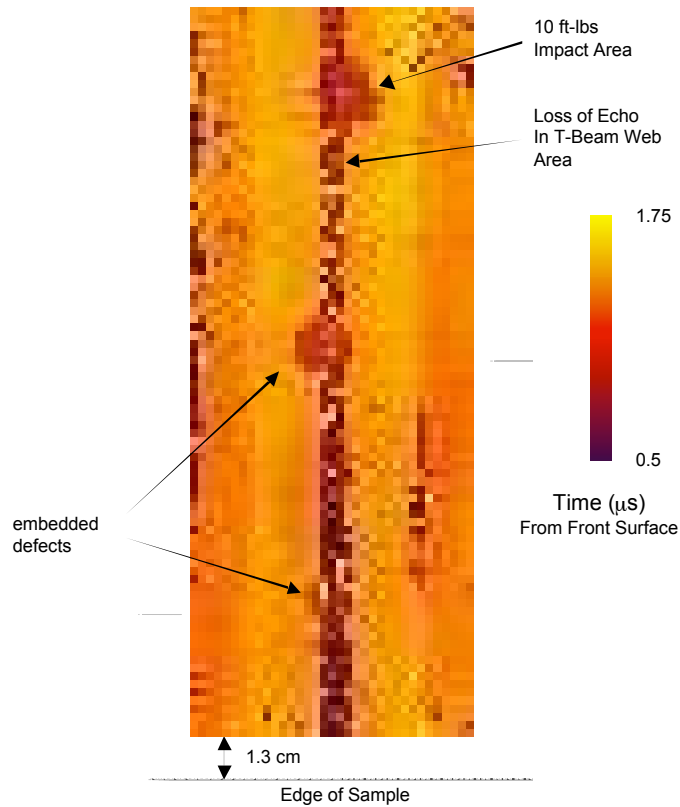
Figure 6. Time-of-flight C-scan image showing the loss of echo in the T-blade web area, the 10 ft-lb impact, and two embedded defects. The scan area is 8.9 x 22.9 centimeters.
