Fatigue damage analysis of GFRP composites using digital image correlation

Hassan Gonabadi¹ · Adrian Oila¹ · Arti Yadav¹ · Steve Bull¹

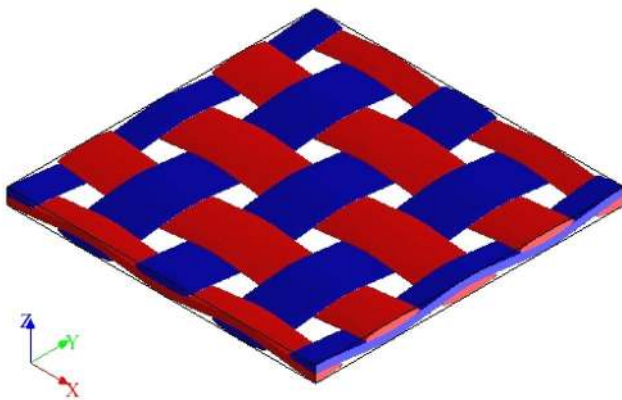
Fig. 2 Schematic of plain-woven fabric, (ply thickness: 0.2 mm)

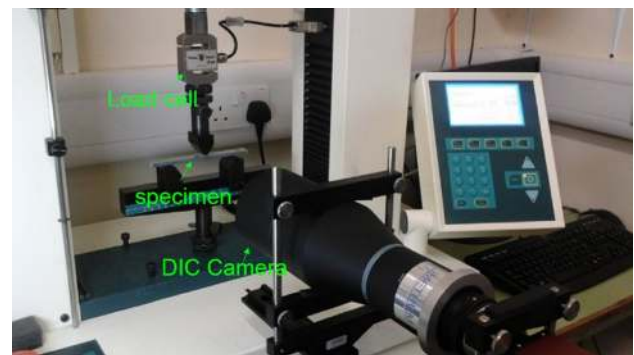
Fig. 3 Experimental set up for a 3 PB test equipped with DIC system

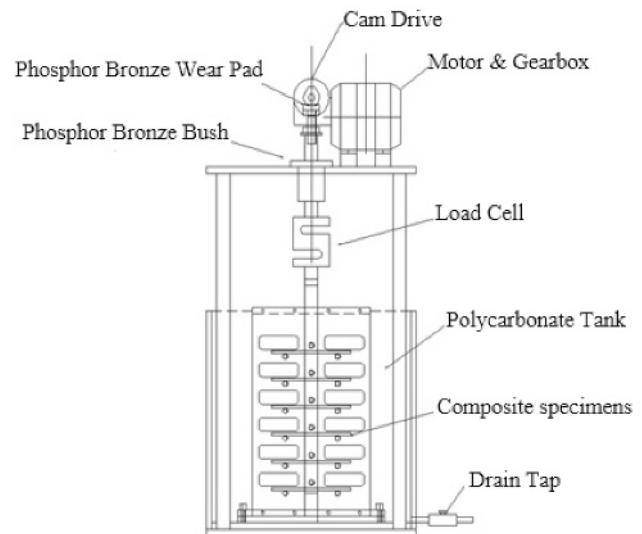
**Fig. 4** Exploded-view schematic of 3 PB fatigue rig

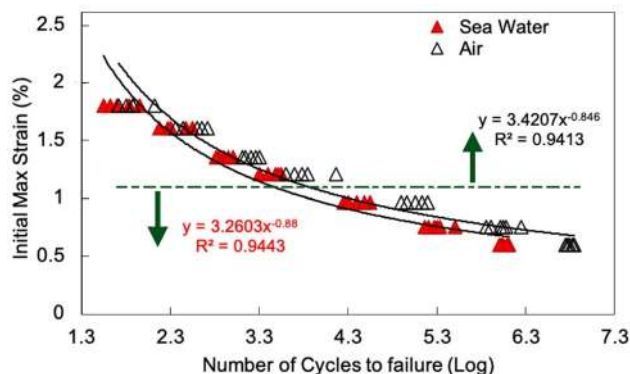
Fig. 7 Strain–Number of cycles to failure plots of GFRP composites under different strain level in wet and dry conditions. The standard uncertainty in the maximum applied strain is estimated as 0.1%

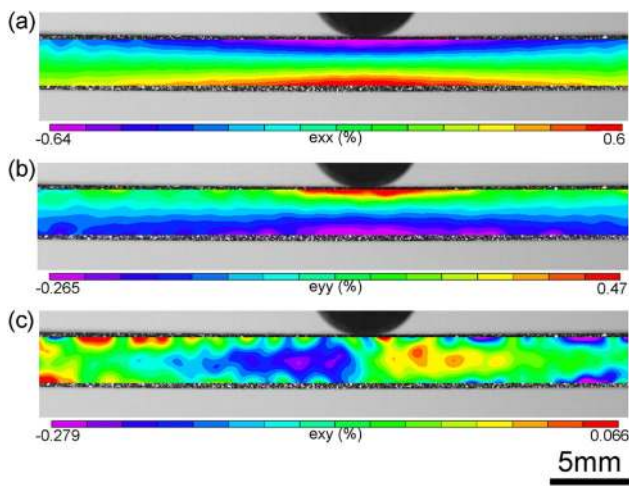
Fig. 9 Lagrange strain tensor components for a 3 PB fatigue test at peak strain equal to 30% of ultimate static strain at the beginning of life cycle **(a)**, longitudinal normal strain, e_{xx} **(b)**, transverse normal strain, e_{yy} and **(c)**, shear strain, e_{xy}

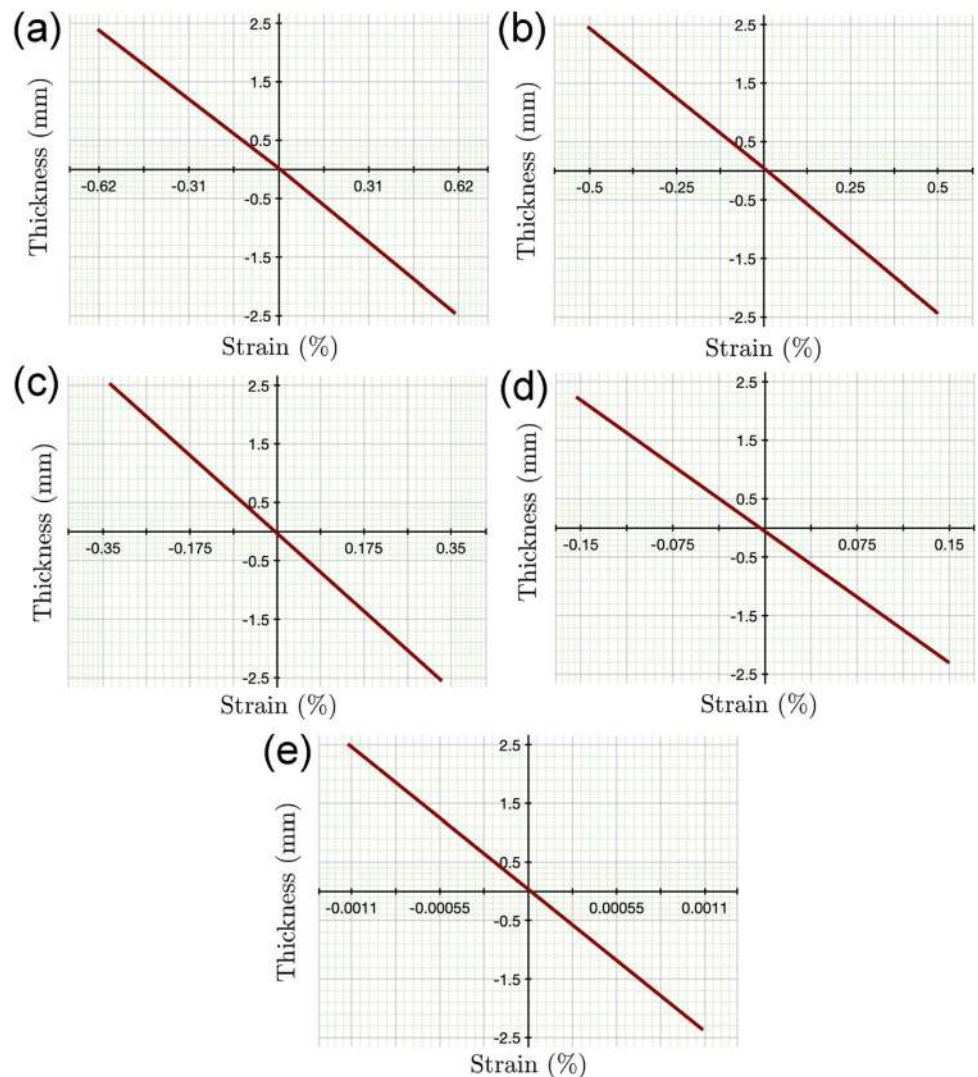
Fig. 10 DIC calculated distribution of axial strain through the thickness direction at the length coordinates of **a** $x=0$ (centre), **b** $x=12.5$ mm, **c** $x=25$ mm, **d** $x=37.5$ mm, **e** $x=50$ mm (at support)

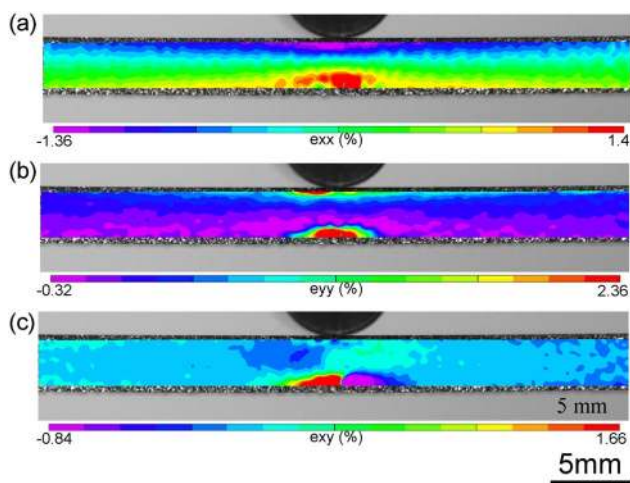
Fig. 12 Lagrange strain tensor components for a 3 PB fatigue test (air environment) at peak cyclic strain equal to 30% of ultimate static strain and 5.900 million cycles. (a), longitudinal normal strain, e_{xx} (b), transverse normal strain, e_{yy} and (c), shear strain, e_{xy}

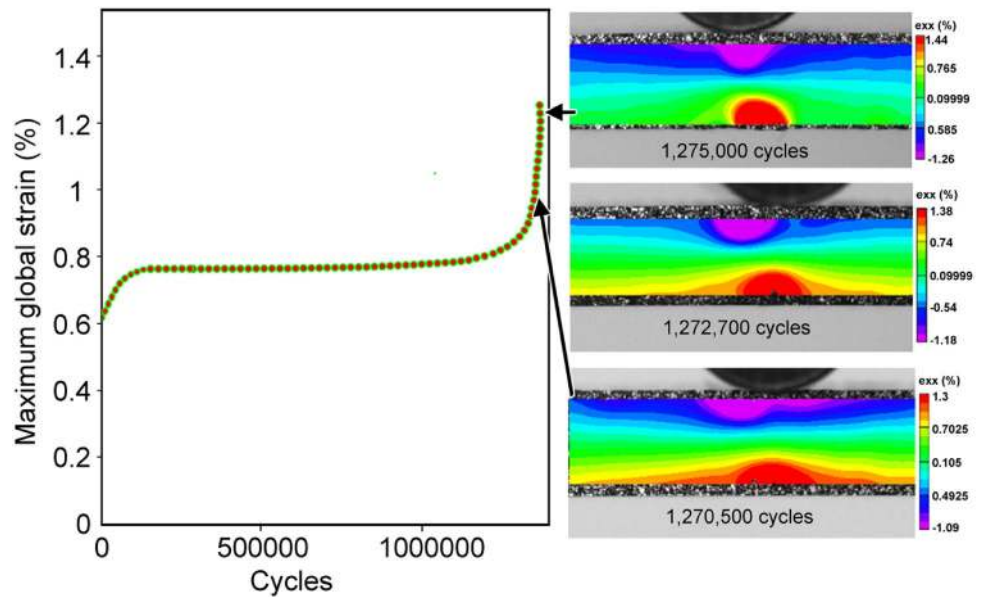
Fig. 14 bending engineering strain history for a 3 PB fatigue test (air environment) at peak cyclic strain equal to 30% of the ultimate static strain and 5.900 million cycles

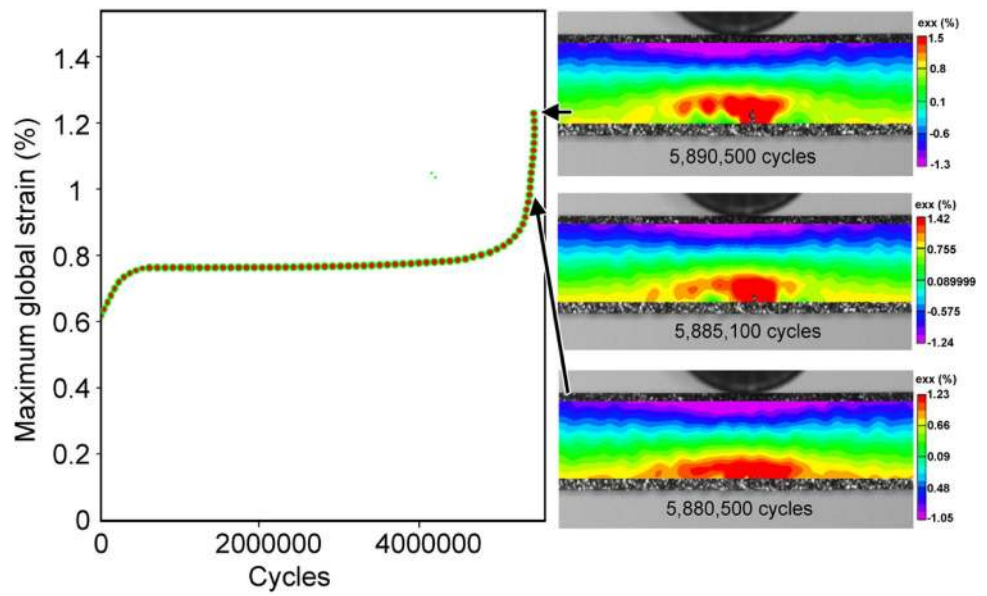
Fig. 15 **a** Scanning electron micrograph shows interfacial de-bonding between fibres and matrix, **b** inter-laminar cracks with delamination

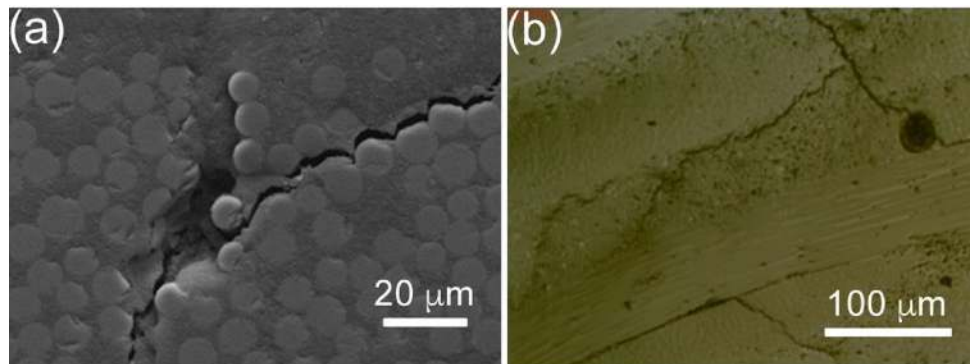
This leads to the creation of fiber-matrix interfacial de-bonding and the crack growth in the fibers.

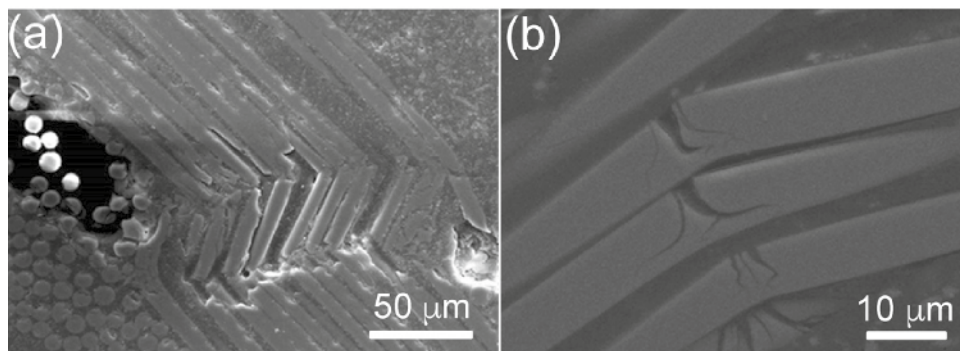
Fig. 17 Scanning electron micrographs of glass fibre surface for specimen failed by cycling in **a** air and **b** seawater

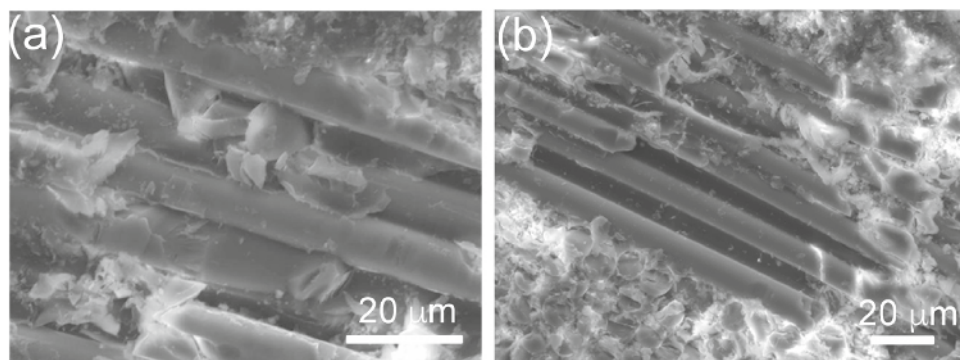
Fig. 18 Modulus decay in woven fabric composites during fatigue life in **a** dry **b** wet condition, the relative standard uncertainty in the normalized modulus data is estimated as 2.5%

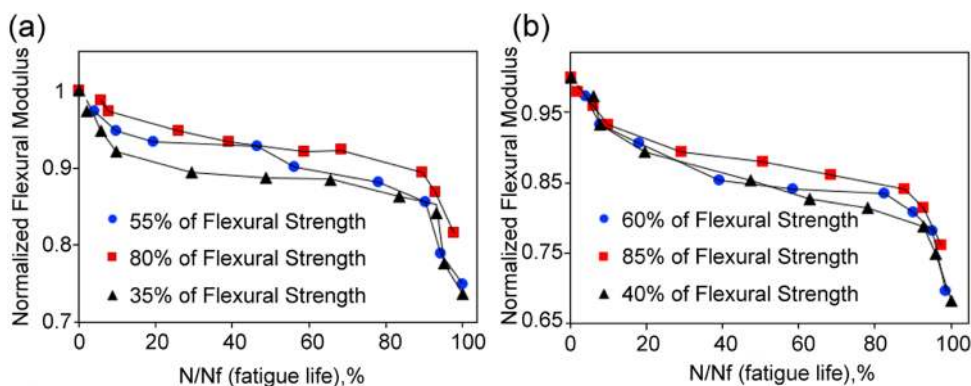
of the number of cycles are positioned at around 10–90% of total life. Given the modulus decay graphs, the initial phase is dominated by a reduction in stiffness in the order of 5–10%, until an equilibrium stage is reached. This behaviour is influenced by internal fibre-matrix viscoelastic interactions and crack accumulation in several stress concentration locations. The second stage occupies 90% of consumed fatigue life and is in the same life percentage range for all samples. In addition, the trend in this second phase is quite linear and represents a similar slope regardless of the strain level and environment. The final stage is characterized by coalescence of defects and a huge stiffness reduction can be observed.

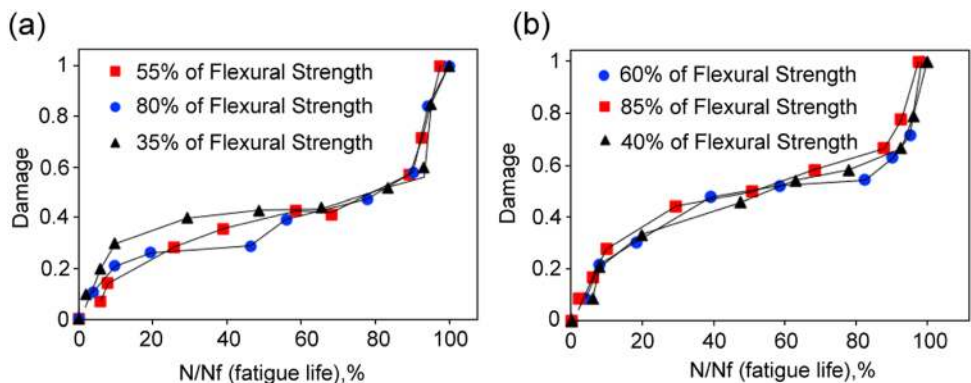
Fig. 19 Damage accumulation in woven fabric composites during fatigue life in **a** dry, **b** wet condition, the relative standard uncertainty in the normalized modulus data is estimated as 2.5%

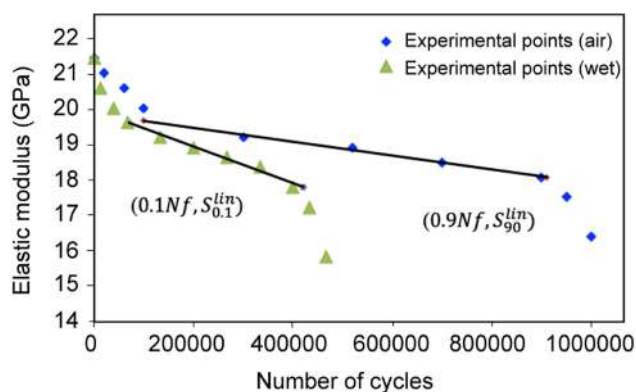
Fig. 20 Elastic modulus evolution and line fitting the second stage (40% of ultimate Flexural deflection)

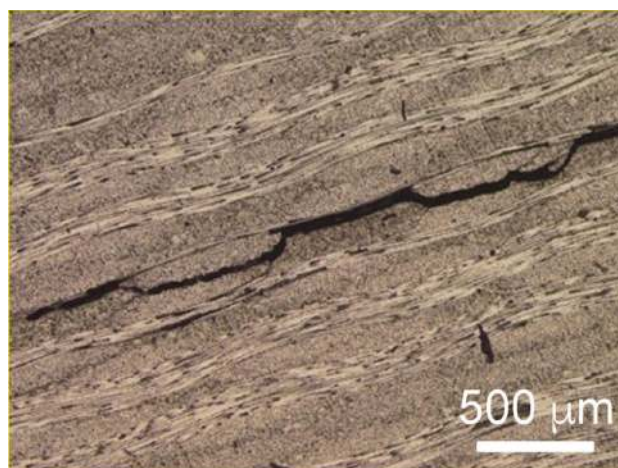
Fig. 21 Micrograph of a typical delamination pattern. The micrograph is taken from the edge of composite test specimens near mid span after fatigue

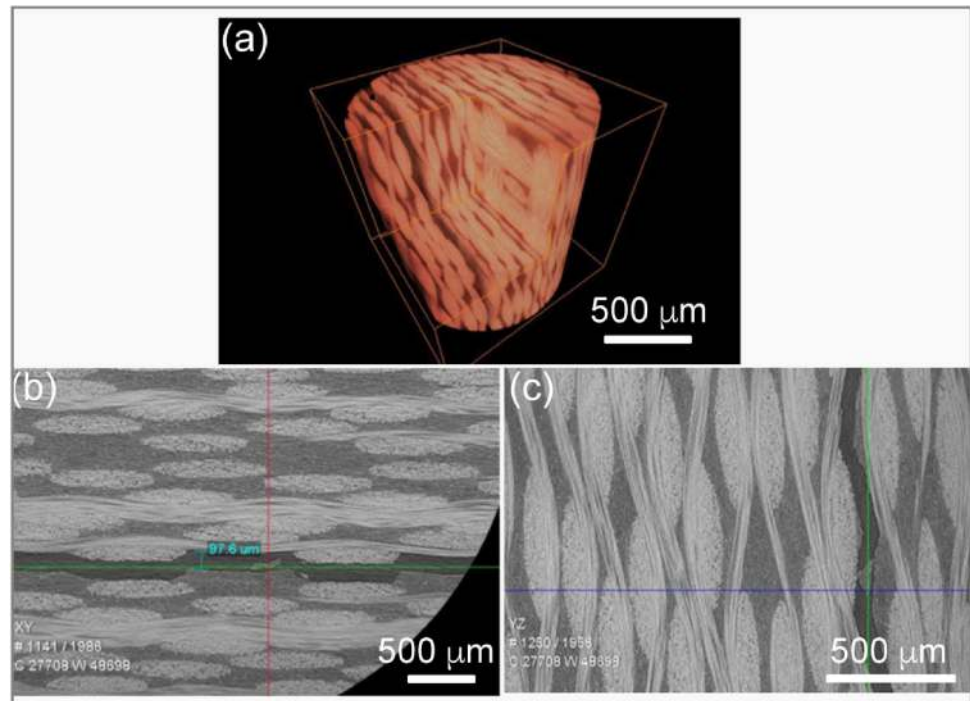
failure was observed. The delamination is resolved based on the difference in X-ray absorption between the glass/epoxy material and air. The delaminated area had a lower absorption coefficient than the composite plies and appears darker in the image. This clearly matches the delamination geometry observed at the surface by optical and electron microscopy (comparing Figs. 21 and 22b). Therefore, the μ -CT can provide an excellent characterization of the 3D damage geometry.
