### Fractographic Analysis of Tensile Failures of Aerospace Grade Composites

This paper describes fractographic features observed in aerospace composites failed under tensile loads. Unidirectional Carbon Fibre Reinforced Plastic (UD CFRP) and Unidirectional Glass Fibre Reinforced Plastic (UD GFRP) composite specimens were fabricated and tested in tension. The morphology of fractured surfaces was studied at various locations to identify failure mechanism and characteristic fractographic features. CFRP composites displayed transverse crack propagation and the fracture surface showed three distinct regions, viz., crack origin, propagation and final failure. Significant variations in the fractographic features were noticed in crack propagation and final failure regions. Crack propagation region exhibited brittle fracture with chevron lines emanating from the crack origin. The entire crack propagation region exhibited radial marks on the individual fibre broken ends. On the other hand, the final fracture region revealed longitudinal matrix splitting and radial marks in majority of locations, and chop marks at some locations. The change in fracture mode in the final fracture with extens

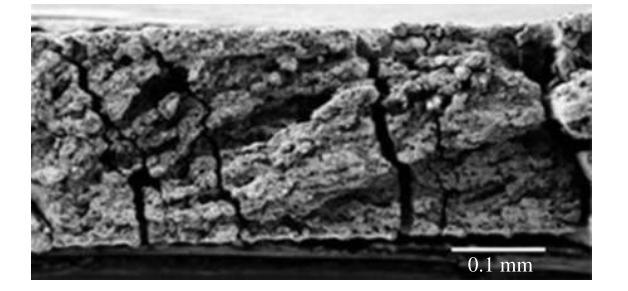
**Figure 3.** Longitudinal splitting in (a) crack propagation region, and (b) final fracture region.

from the crack propagation region. The final fracture region displayed a step fracture at different plane with extensive longitudinal splits. In this case, the step fracture was not related to bridging failure where in interaction of two cracks initiated in different zones during longitudinal fracture of the matrix, rather it was created due to successive fracture. It is important to note that longitudinal splits observed in the final fracture region has an extension to its mating part and hence, it appears to be a primary fracture event. The macrofractographic features that are present on final fracture region are also helpful in identifying the failure origin.

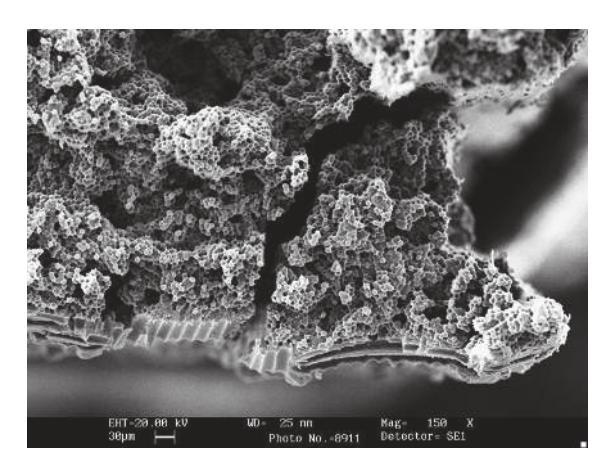
Figure 4. Close-up view of the crack initiation region.

The crack initiation, propagation and final fracture regions were examined in detail under SEM. At crack origin, a set of fibre bundles was found to be broken (Figure 4). This acted as stress concentrator for initiation and propagation of crack under tensile load. The entire fracture surface revealed fibre pull out (Figure 5a). However, the pullout lengths were found to be minimal and hence, they exhibited more or less uniform fracture. At higher magnifications, microscopic radial marks were observed on the fractured fibre surfaces. These radial marks are a typical characteristic feature of tensile failure of composite (Figure 5b). The crack origin and propagation direction identified in the macroscopic study were further confirmed by examining the radials direction on the individual fractured fibres. The local crack propagation direction (Figure 6) was resolved by examining the direction of individual fibre fracture ends. Directly Attributable Fibre Failures (DAFF) concept<sup>11</sup> was used for identification of local crack propagation direction. The resultant of local crack propagation directions at several regions on the fracture surface were correlated to find out the overall crack propagation direction (Figure 7). The crack propagation direction identified in this manner was found to match well with the direction of chevron lines that were present on the overall fracture surface. Longitudinal split surface revealed hackles<sup>24</sup>. In this case, the hackles were not well delineated because of the toughened nature of the matrix. Figure 8a shows hackles bending towards left. This

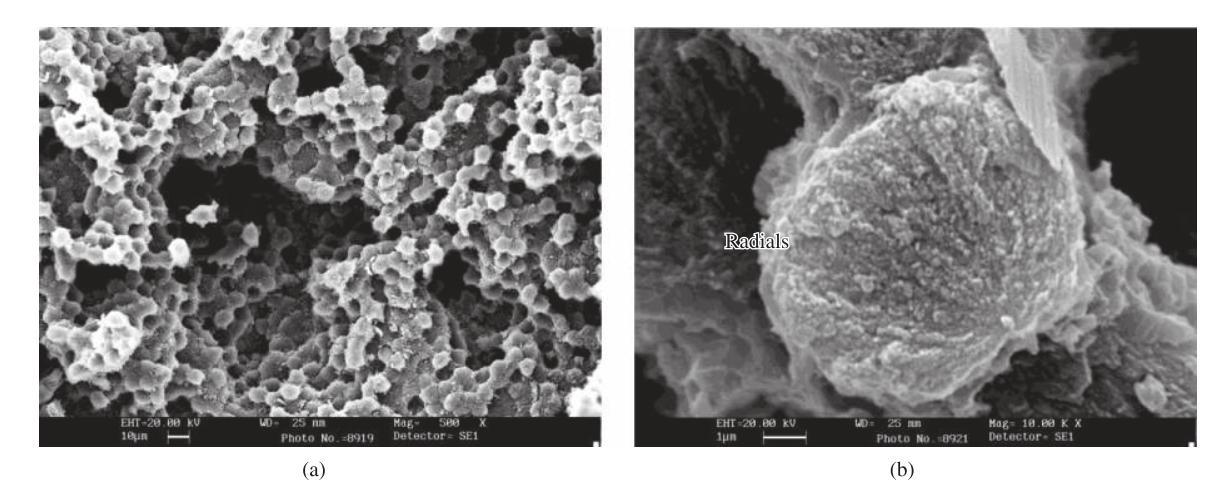
Figure 5. Microfractographic features showing (a) fibre pull out, and (b) fibre radials.

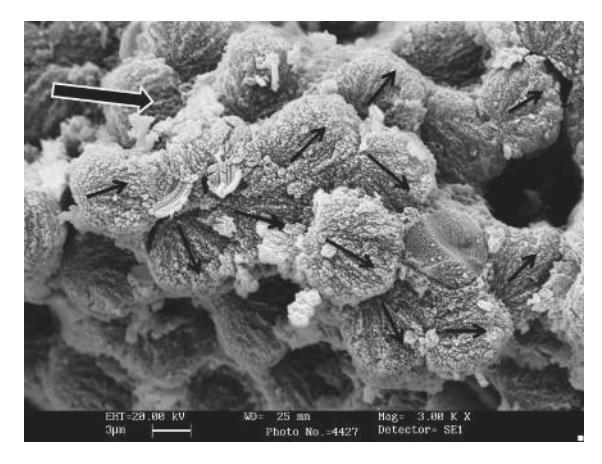
**Figure 6.** Identification of local crack propagation direction; small arrows indicate individual fibre fracture directions and big arrow represents crack propagation direction in a localized zone.

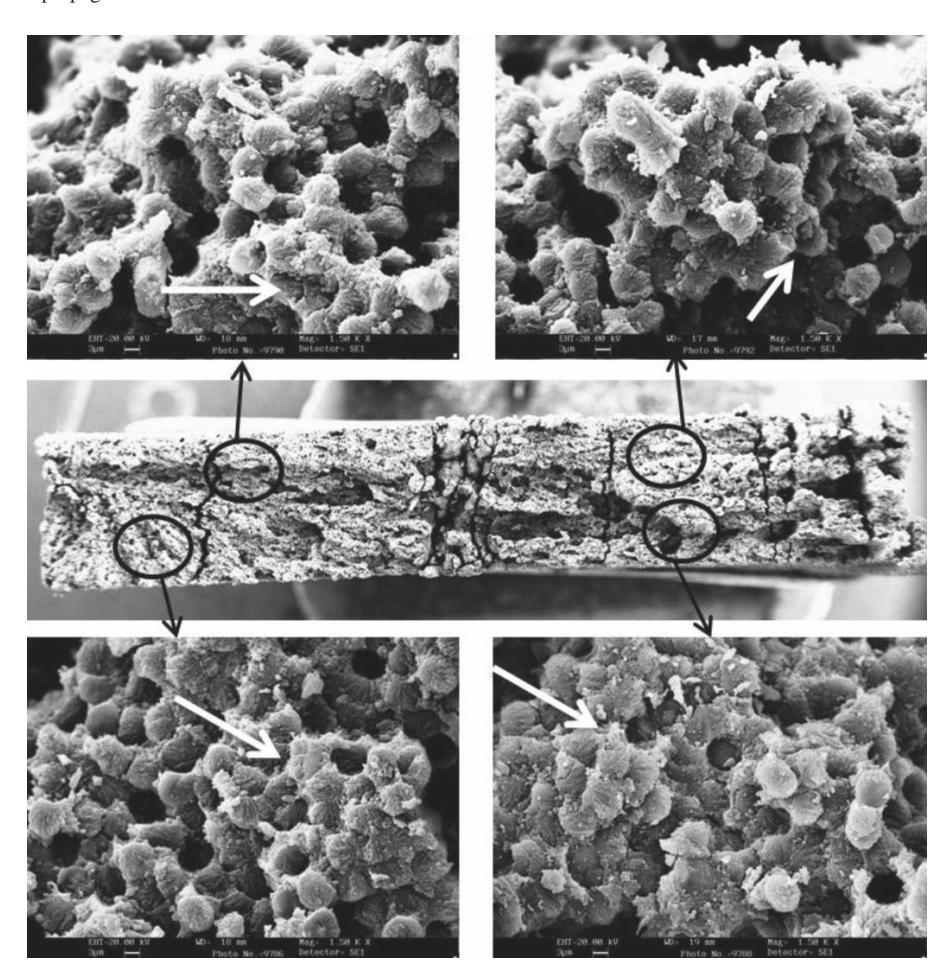
Figure 7. Map of overall crack propagation direction; white arrows indicate local crack propagation direction; dotted arrow indicate the over all crack propagation direction.

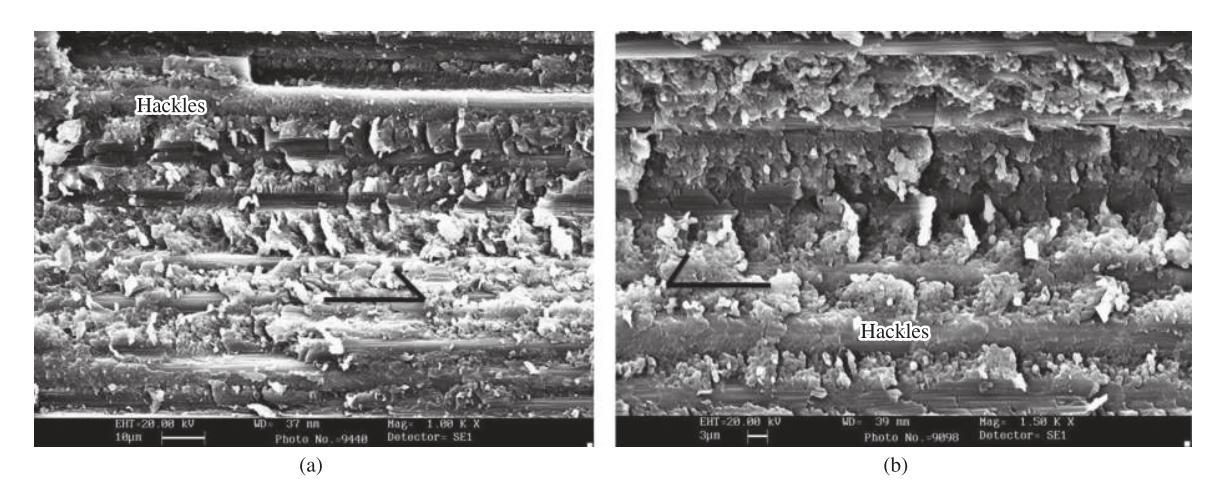
indicates that the mating surfaces sheared in a direction shown by half arrow. However, it is interesting to note that the orientation of hackles is in opposite direction on a similar surface of the mating transverse fracture (Figure 8b). This indicates that the transverse fracture occurred prior

to the longitudinal splits, and it corroborates with the macrofractographic observations. The microfractographic features in the final facture region were different from those in the crack propagation region. This is consistent with the macrofractographic observation. The other common fractographic features such as buckled fibres, crushed fibres, resin fragments were also observed (Figures 9a, b). The final fracture region depicted radials in random direction (Figure 10) which was found to be not in agreement with the general crack propagation direction. At higher magnifications, the chop marks at some locations were indicative of buckling failure (Figure 11). Examination of longitudinal split surfaces in the final failure region revealed hackles. However, the orientation of hackles was found to be identical on a similar longitudinal surfaces of two fractured pieces (Figure 12). This indicates that longitudinal splits occurred prior to transverse fracture and the splits were related to the primary fracture.

Figure 8. Hackles observed in the longitudinal split surface at crack propagation region; half-arrow shows the shear direction.

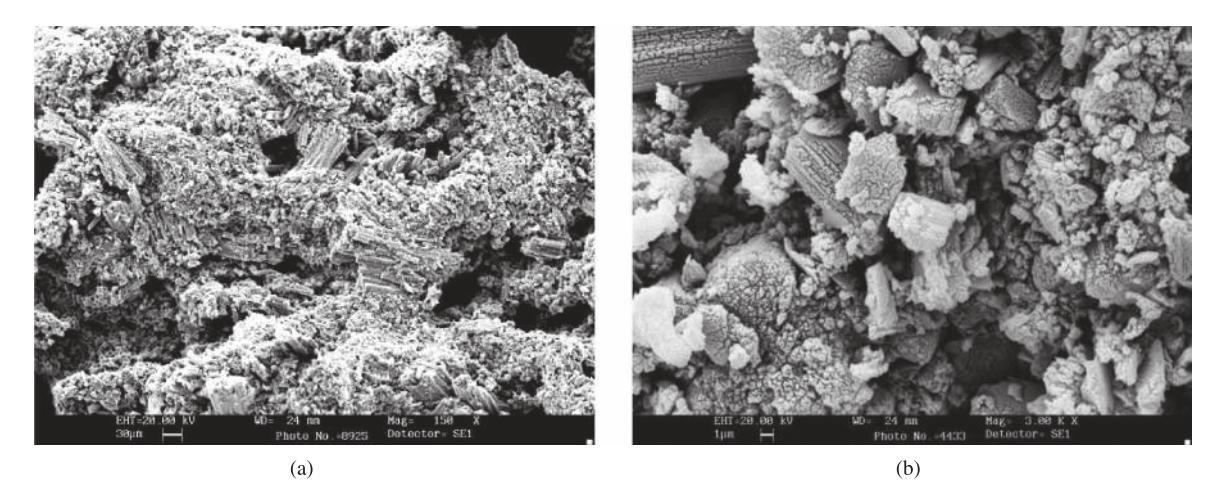
Figure 9. Microfractographic features in final fracture region showing (a) crushed fibres, and (b) fibre and matrix debris.

debonding. This is evident from the SEM image where hardly any bare fibres are visible. The final fractured area exhibited buckled fibres and chop marks at few locations. Chops marks represent bending of fibres. It is unusual to observe these features during tensile failure of composite. The presence of chop marks can be explained through the study of state of stress.

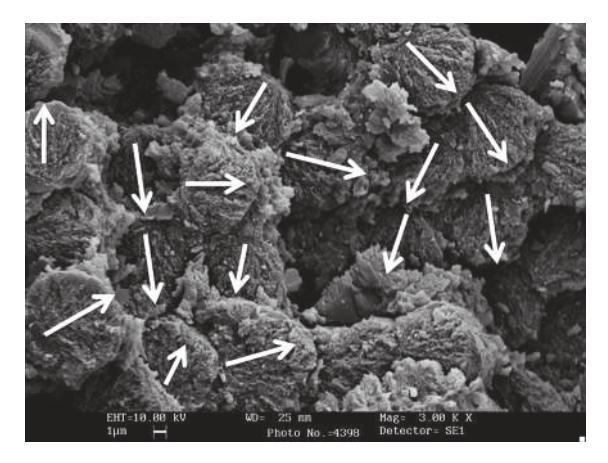
Figure 10. Random fibre fracture directions indicated by white arrows.

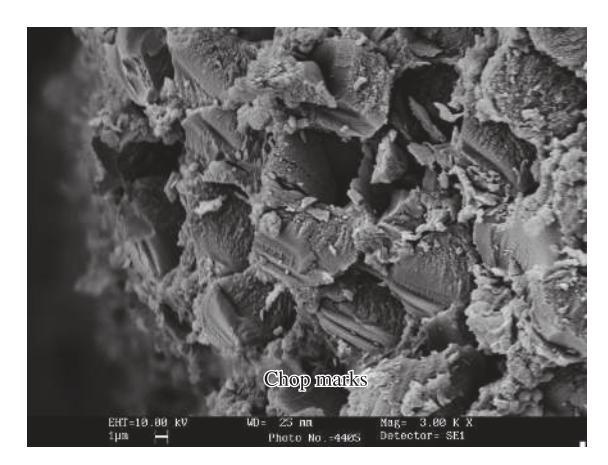
Figure 11. Chop marks indicative of buckling failure.

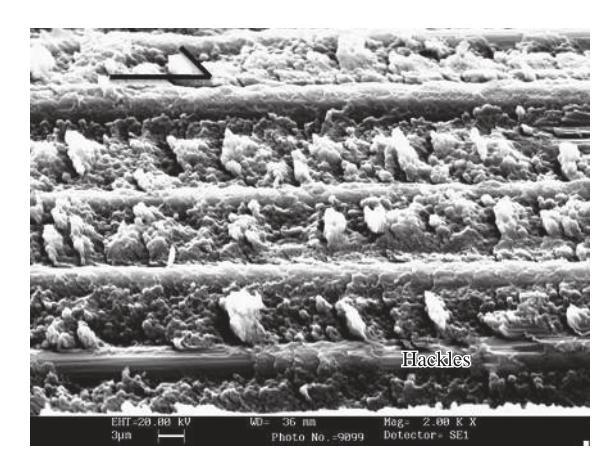
**Figure 12.** Hackles observed in the longitudinal split surface at final fracture region; half-arrow shows the shearing direction.

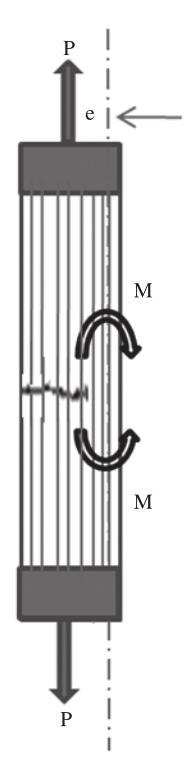
The state of stress in the final fracture is shown schematically in Figure 13. As the crack propagates, load (P) path deviates from the line with center of gravity of the specimen resulting in eccentricity (e). The eccentricity produces bending moment (M). The maximum deflection at mid point in such a stuation can be calculated as per the procedure given in Khoshbakht et al.<sup>25</sup>. It appears that the bending loads combined with the tensile overload resulted in extensive longitudinal splitting, fibre bending and step fracture.

Figure 13. Schematic of state of stress during final fracture region in a composite specimen that failed under tensile load.

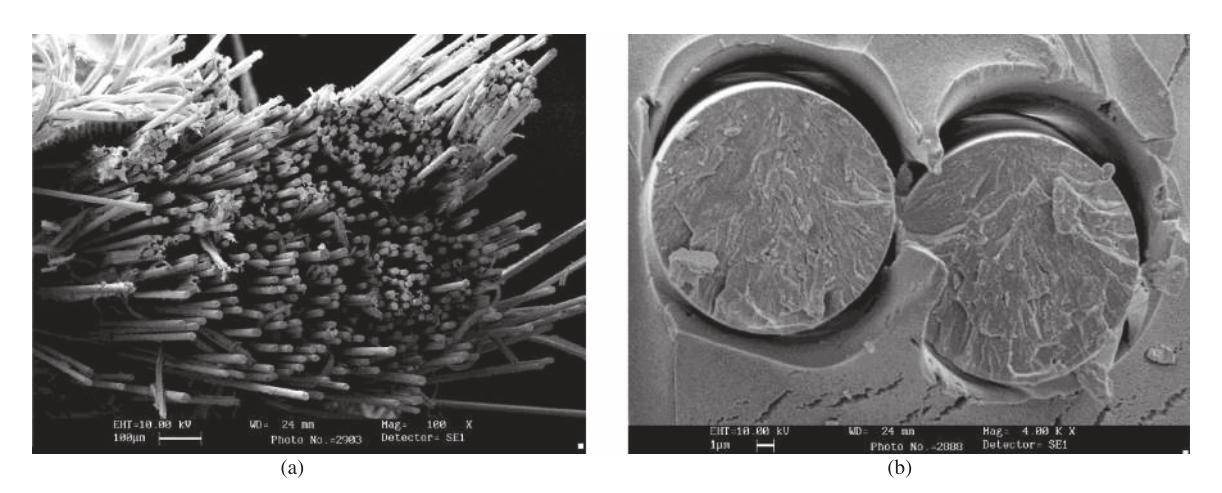
In GFRP composites, fibre bundles got separated from the matrix along their length like in a broom. There was extensive longitudinal splitting. The longitudinal

splitting observed could be a primary or a secondary event. However, in the present case, longitudinal splitting was a primary event. The mechanism by which longitudinal splitting occurs due to debonding is induced in fibre reinforced composites was first identified by Cook and Gordon<sup>9</sup>. When the crack initiates and propagates through the matrix in unidirectional laminates, the tensile stress ahead of the crack  $\sigma c$ , is associated with shear  $\tau m$  and the ultimate shear stress near the fibre  $\tau$ mu. The fibre matrix interface strength is weak in GFRP composites, and the debonding stress  $\tau d$  is less than the ultimate shear stress of the matrix, tmu, Hence, longitudinal splitting due to debonding is favoured. This leads to broom-like failure (Figure 14). The longitudinal splitting due to debonding produces large difference in heights between the ends of the individual fractured fibres. Secondary transverse fractures of individual fibres occur in certain regions. Examination of fibre fracture ends revealed that the tensile fracture features like pull outs (Figure 15a) radials (Figure 15b) were oriented in random direction in each fibres. Since the tensile fracture was like broom, it was not possible to identify the crack propagation direction on the fracture surface.

Figure 15. Fractographic features showing (a) longitudinal splitting, and (b) fibre radials (GFRP specimen).
