Fractographic Analysis of the Low Energy
Fracture of an Aluminum Alloy

National Aeronautics and Space Administration
Research Grant NGR 39-087-300

NASA Technical Report No. 1

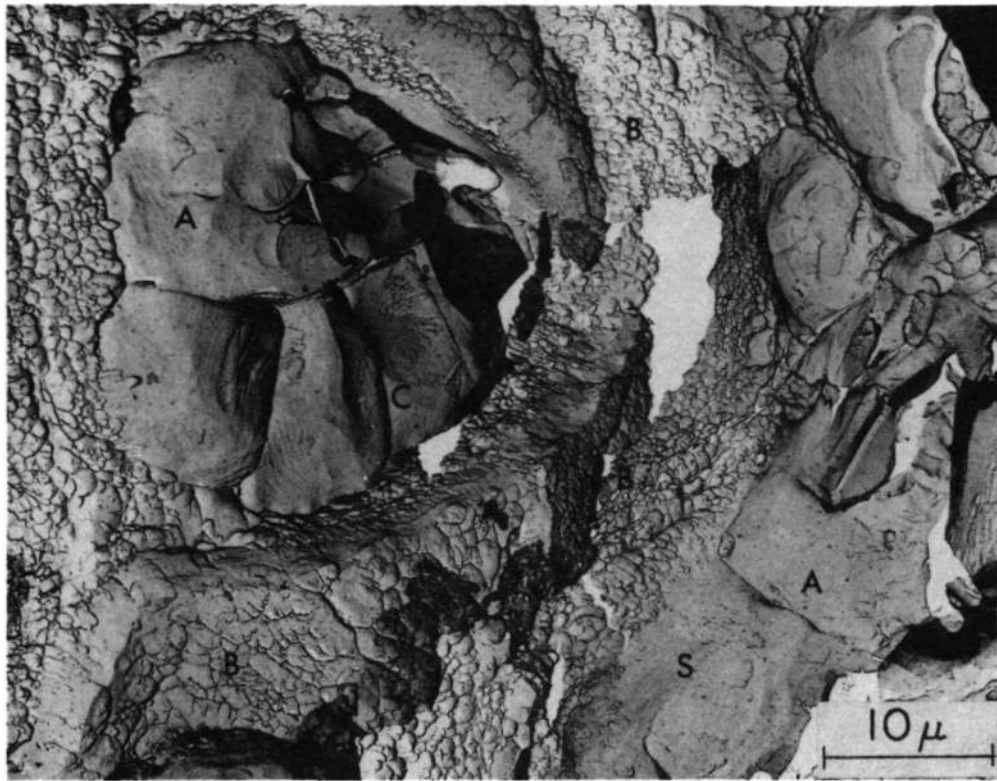
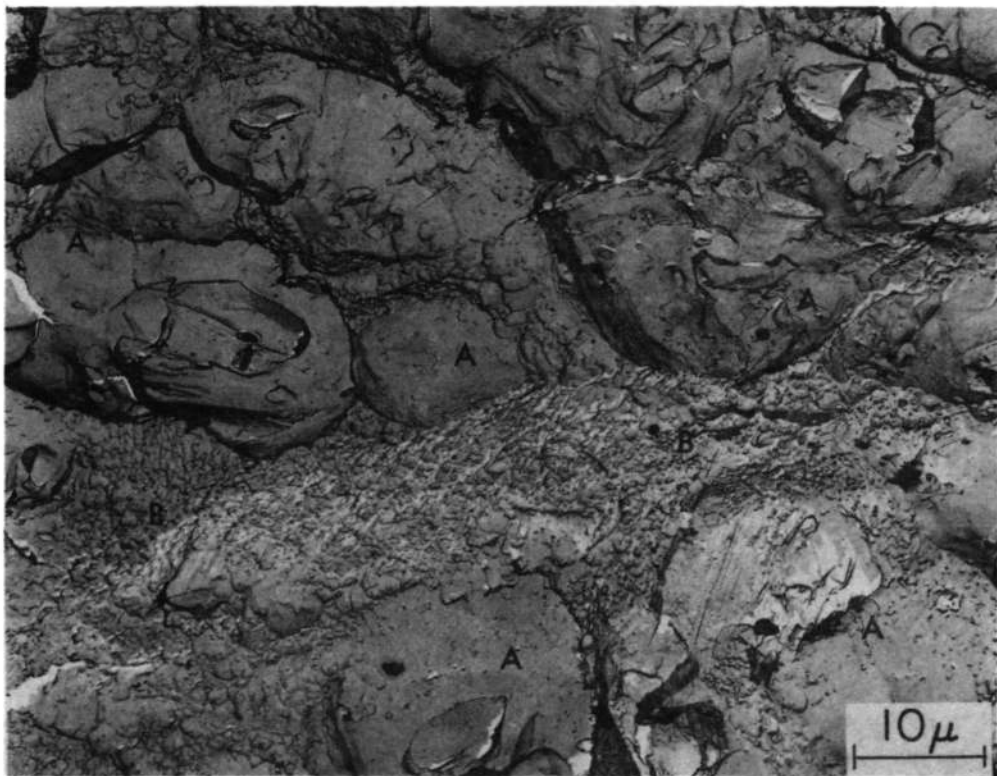
Figures 2 and 3 show typical electron microscope fractographs. A dimpled topography was found over the entire fracture area observed. The most salient feature to be noted here, is that two widely different sizes of dimples are present; moreover, they are not randomly distributed but form groups, or colonies, of large (10 to 30 microns) dimples (A) separated from similar areas by bands of small (0.5 to 2 microns) dimples (B). In some areas of some of the large dimples, features typical of a cleavage pattern, (C) are observed. These are thought to be due to the fracture of an inclusion which failed by cleavage and nucleated the void. The greater proportion (50-60%) of the fracture surface is covered by large dimples and it is very likely, then, that the most important factor leading to the low toughness of the alloy is the existence of the particles which nucleate the large size dimples.

Figures 2 and 3 Two Stage Plastic-carbon Replica of Fracture Surface. Large Dimples at A - Small Dimples at B - Cleavage Pattern at C

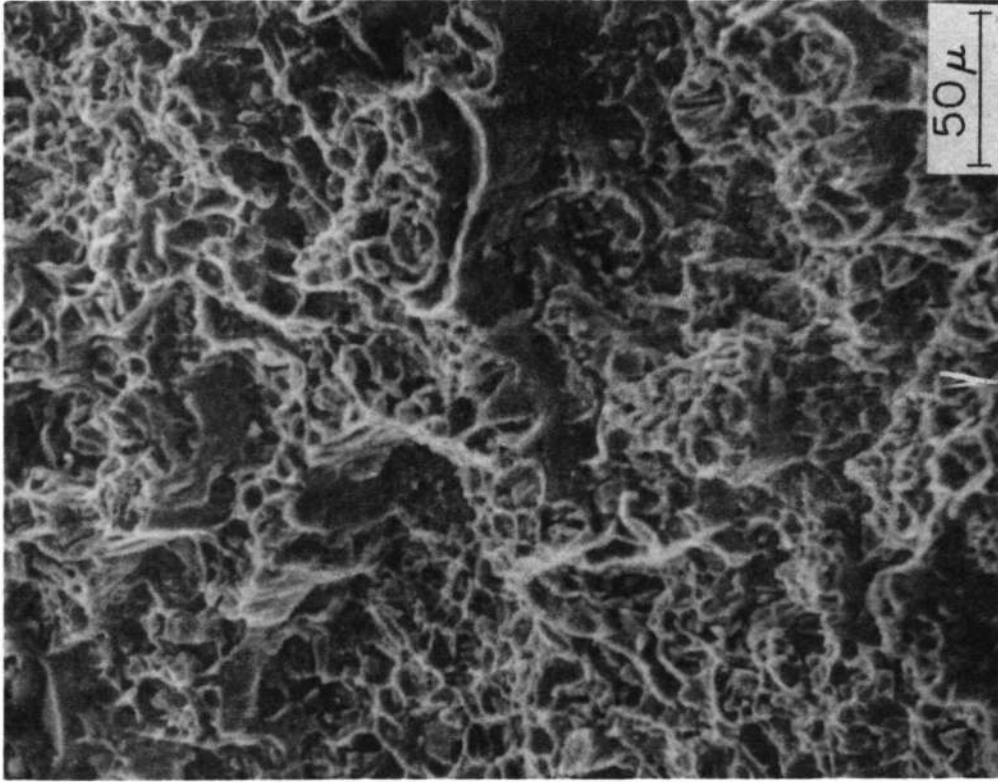
Figure 4 shows a low magnification fractograph taken with the SEM of the fracture surface of one of the toughness specimens. By careful examination it is possible to distinguish areas with the same large dimples seen in the replicas and smoother areas which at higher magnifications, Figures 5 and 6, show the topography of the small dimples. "A" marks the same point in the three micrographs of Figures 4, 5 and 6. All these micrographs were taken with secondary electrons. Figures 7 and 8 compare, at low magnification, the same area taken with secondary electrons and with back scattered electrons. When back scattered electrons are used, deep shadows appear where secondary electrons showed areas of small dimples (smooth at low magnifications). This means that these areas of small dimples are steps on the fracture surfaces joining areas covered by large dimples that lie at different levels (back scattered electrons give an effect similar to highly oblique light in the optical microscope). The reason why these areas did not appear as steps on the fractographs obtained by replicas is that these steps are too large and the replicas probably collapse, showing large size and small size dimples at the same level. (See Figures 2 and 3)

Fig. 4 Scanning Electron Microscope Micrograph Showing Large Dimples and Smoother Areas at A (secondary electrons).

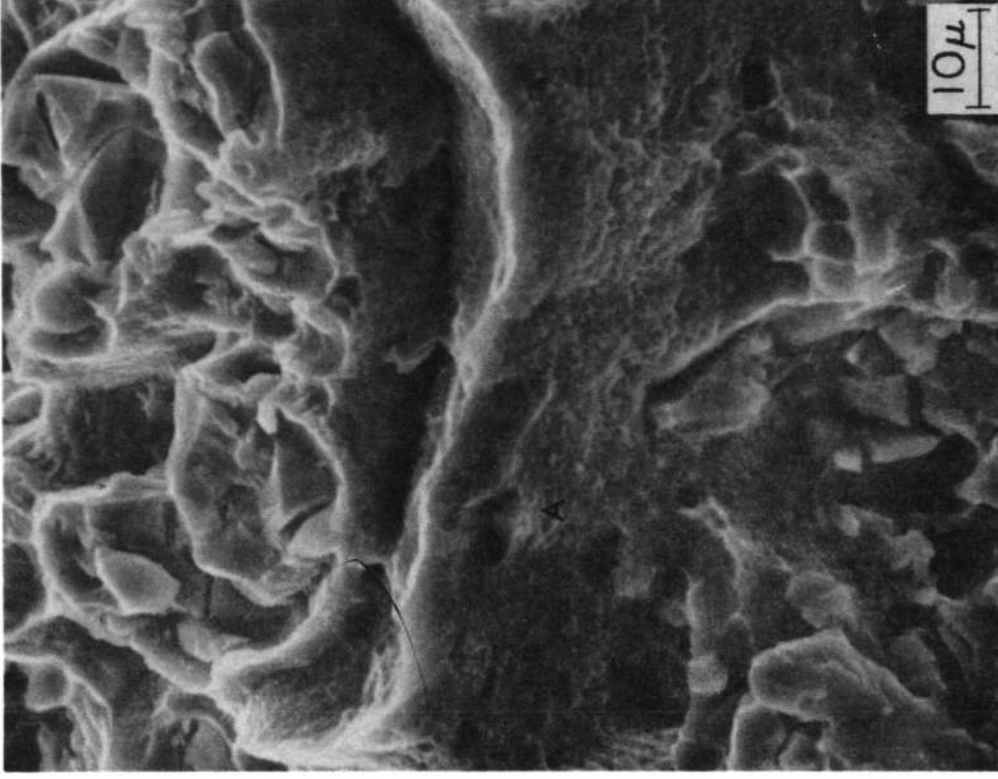
Fig. 5 Same as Fig. 4 at Larger Magnification (secondary electrons) A is the Same Spot as in Fig. 4

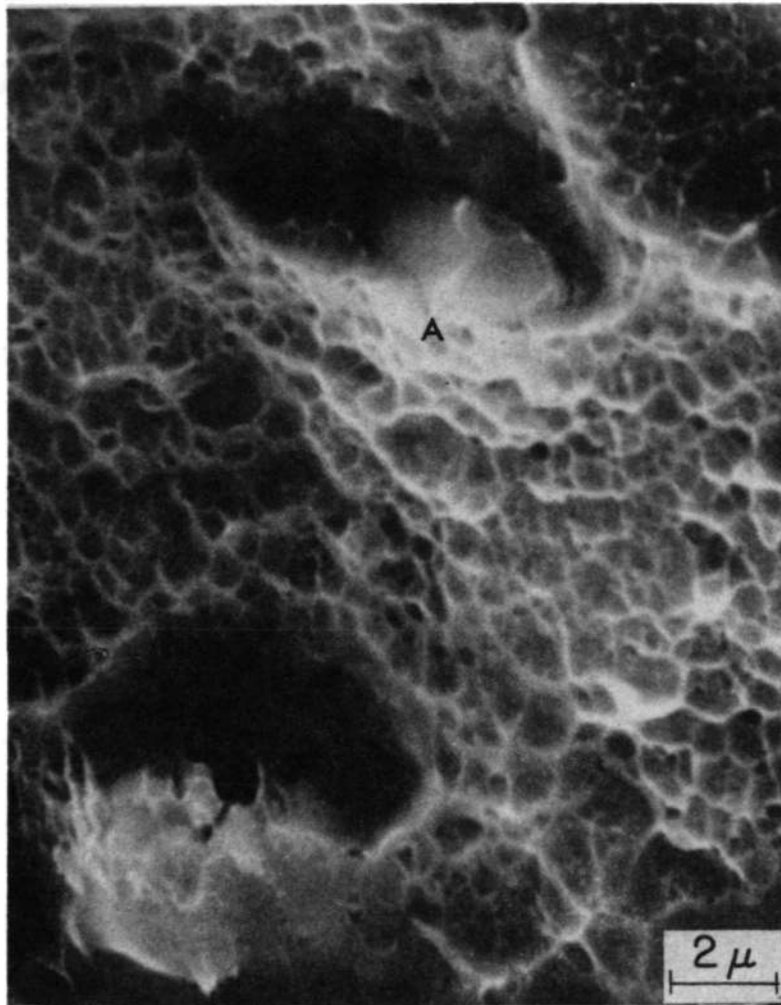
Fig. 6 Same as Fig. 4 and 5 at Higher Magnification Showing Small Dimples on Smoother Areas of Fig. 4 (secondary electrons) A is the Same Spot as in Figs. 4 and 5

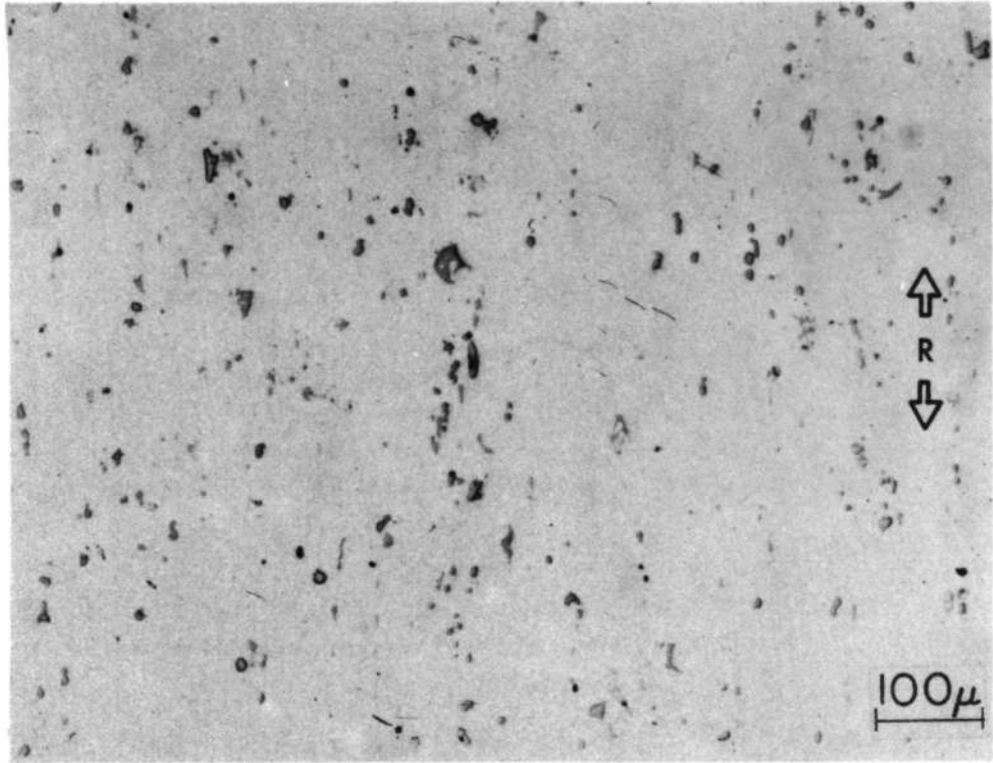
Figure 9 shows an optical micrograph of a mechanically polished section of the material. Large inclusions, 3 to 10 microns in diameter, separated by a distance of 5 to 15 microns from each other, may be seen. In some cases, grouping of these inclusions into colonies were observed, but the general distribution was quite uniform except for a certain tendency of the inclusions to be aligned along the rolling direction (marked as R in Fig. 9).

Fig. 9 Optical Micrograph of a Mechanically Polished Surface of the Alloy

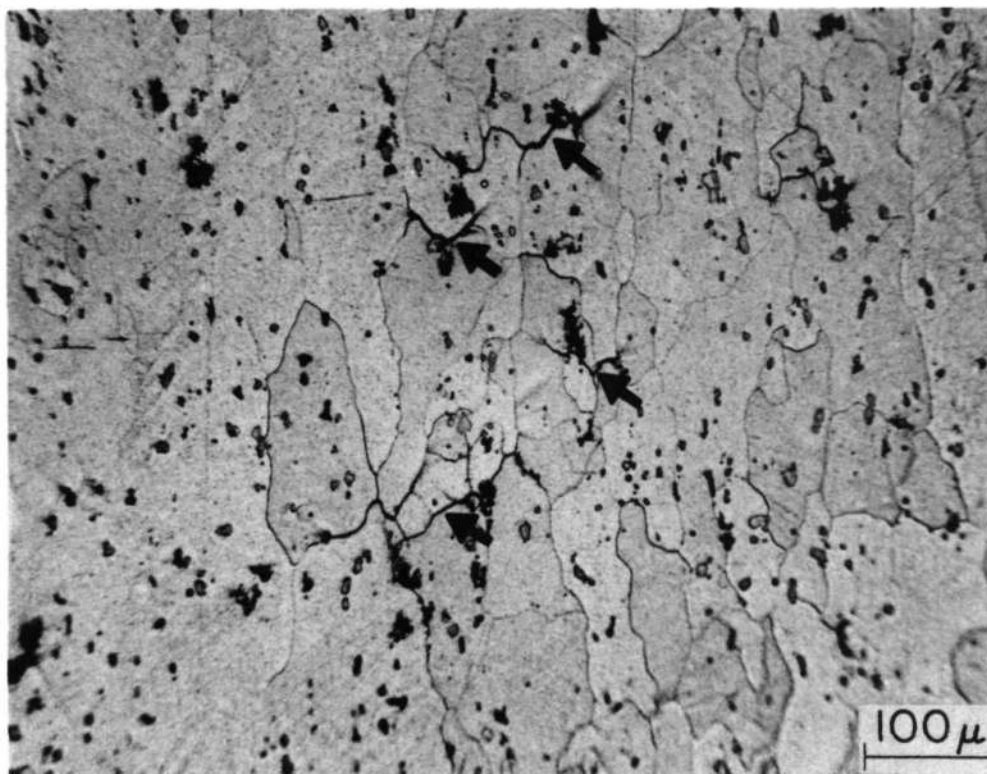
Fig. 10 Optical Micrograph. The Polished Surface was Etched to Delineate Grain Boundaries After Cracks (arrows) had Appeared as a Result of Bending Deformation

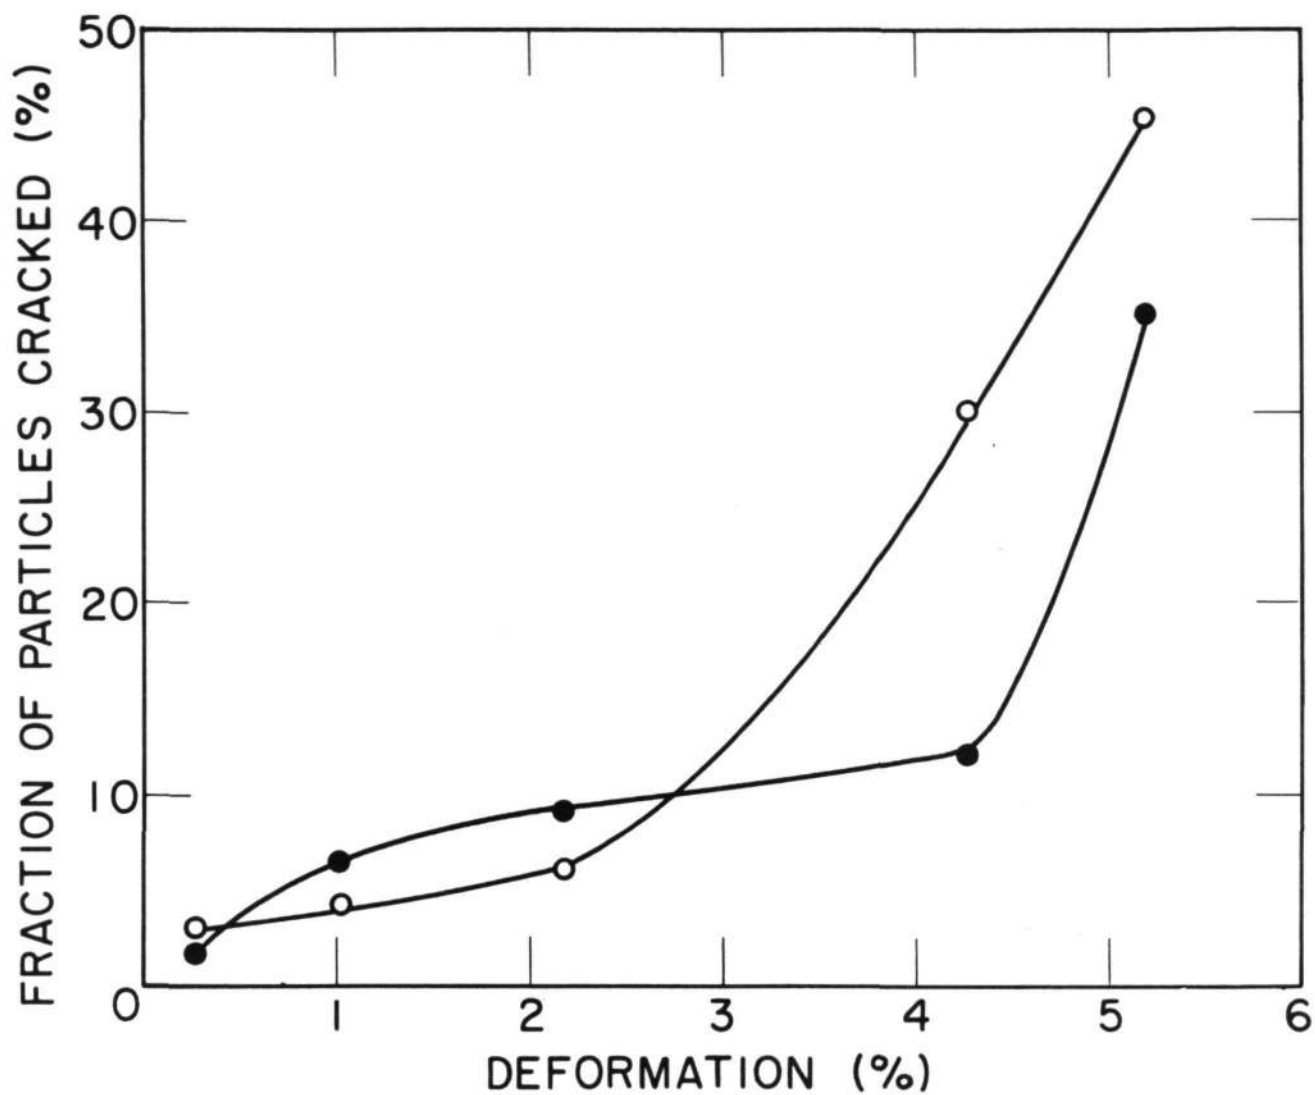
mid section and the other to the free surface of the specimen. The ratio of cracked particles to the total number of particles greater than 1 micron in diameter, is shown in Figure 11 as a function of deformation. The solid circles correspond to the observations made at the free surface and the open circles at the mid section. It is clear that the particles start cracking at the early stages of deformation. The fraction of cracked inclusions increases steadily up to a point where the maximum load is reached, after which the rate of cracking increases sharply.

Fig. 11 Fraction of the Inclusions Greater than 1 Micron Found Cracked as a Function of Tensile Plastic Deformation. Solid Circles Correspond to Observations Made at the Free Surface of the Specimen and Open Circles at the Mid Section

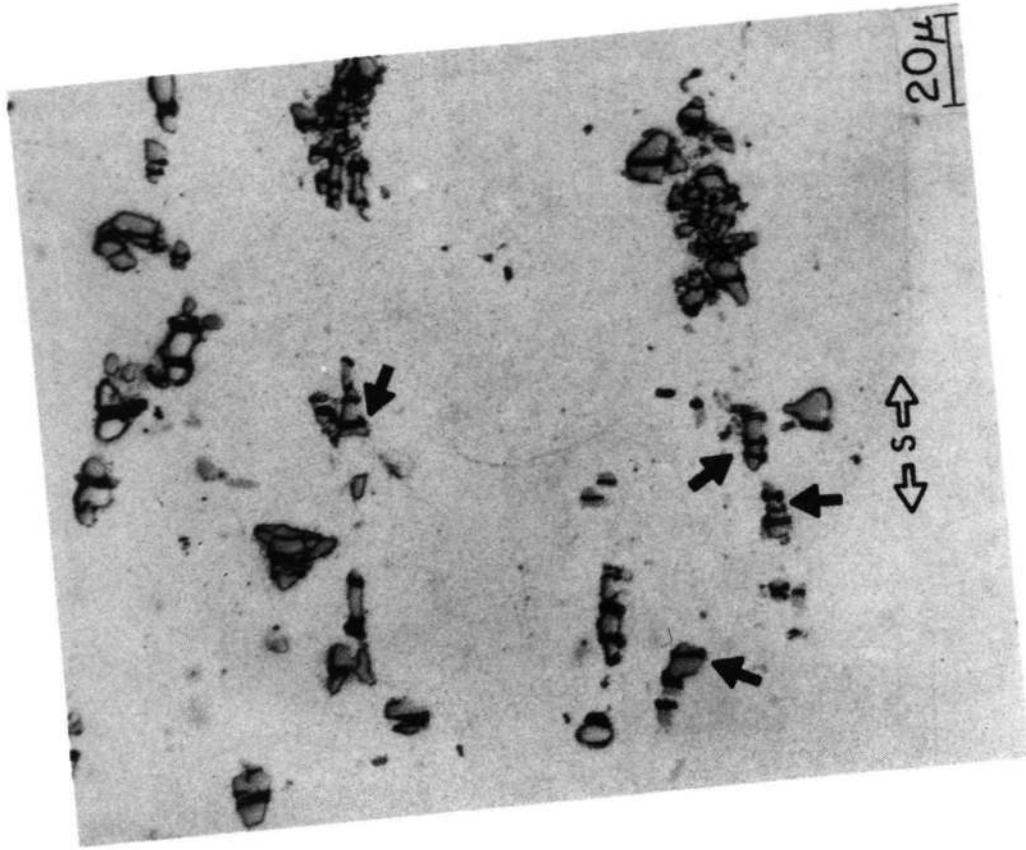
Fig. 13 Polished Surface of Tensile Specimen Showing Blunting of the Cracks in the Inclusions (arrows). S is the Tensile Axis

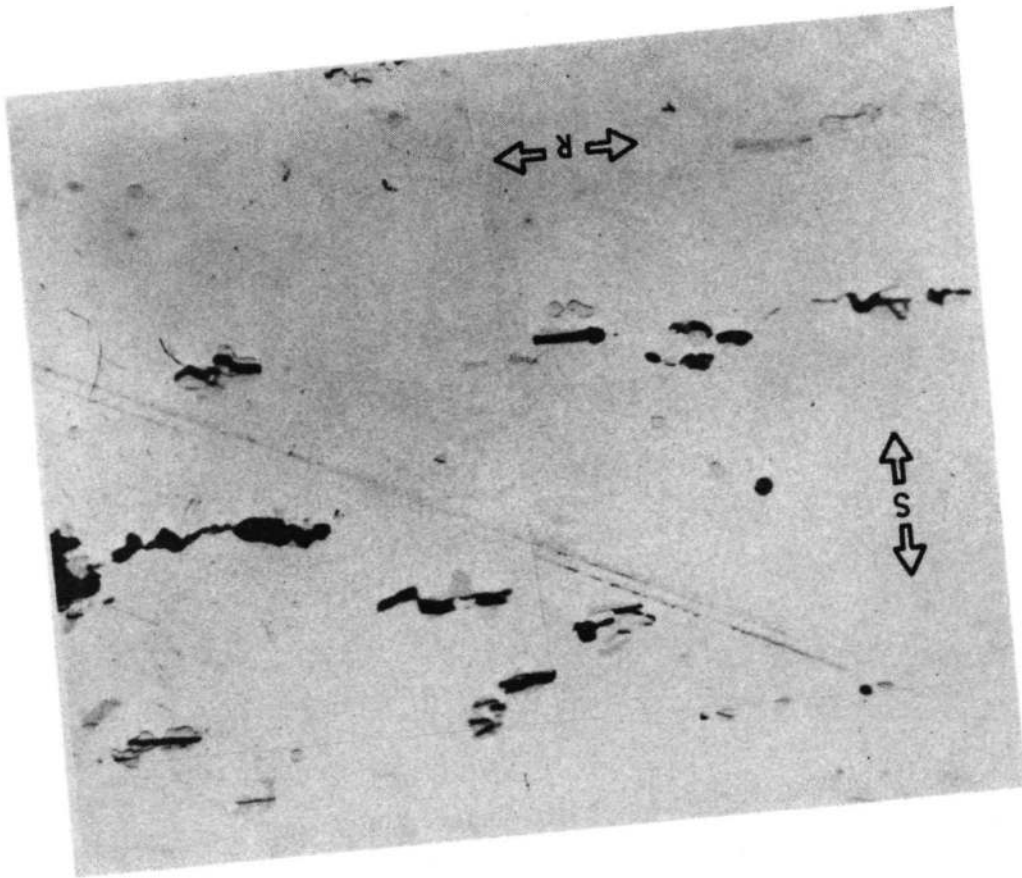
The cracks formed at the inclusions were only seen to propagate into the matrix for the largest deformations and this was observed more frequently at the mid section, Figure 12 (S shows the stress direction). Blunting of the cracks formed at the inclusions were observed in some cases and this was due to failure at the particle matrix interface, as shown in Figure 13 by arrows. Some evidence of grain boundary cracking is found in specimens with the larger deformations. This is shown in Figure 14 by arrows. The different appearance of the crack as compared with that in Figure 10 is believed to be due to rounding of the edges by polishing.

Fig. 12 Polished Surface of Fractured Tensile Specimen Showing Growth of Cracks. S is the Tensile Axis and R the Rolling Direction

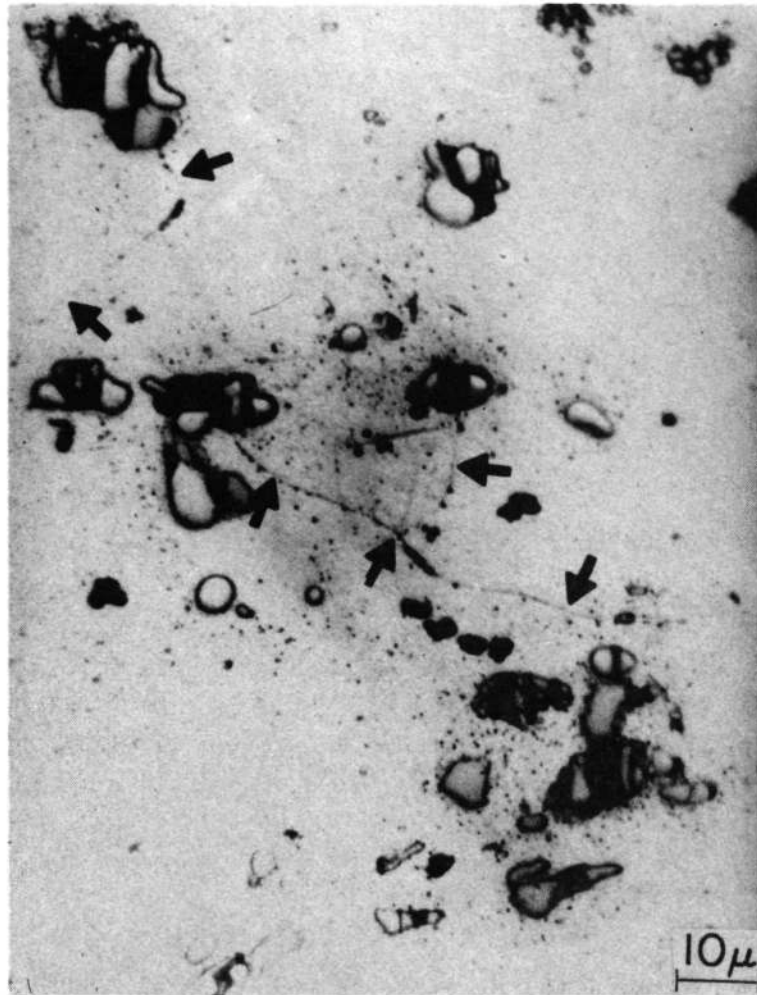
Fig. 14 Polished Surface of Tensile Specimen Showing Grain Boundary Cracking (arrows)

The fractographs seem to show a situation by which several voids nucleated at large particles coalesce somewhat at the same level and parallel to the main fracture surface. Thereafter they join with other similar areas by a mechanism of void sheet formation⁽⁹⁾ leading to the rupture of the ligament between these areas. The void sheet formation mechanism seems to be developed through the formation of voids at small particles distributed uniformly in the matrix, or in some cases, at the small inclusions found at the grain boundaries. It is difficult to distinguish the areas covered by small dimples which are related to grain boundaries and those which are not. However, features such as the one seen in Figure 14, could well be related to grain boundary failure.

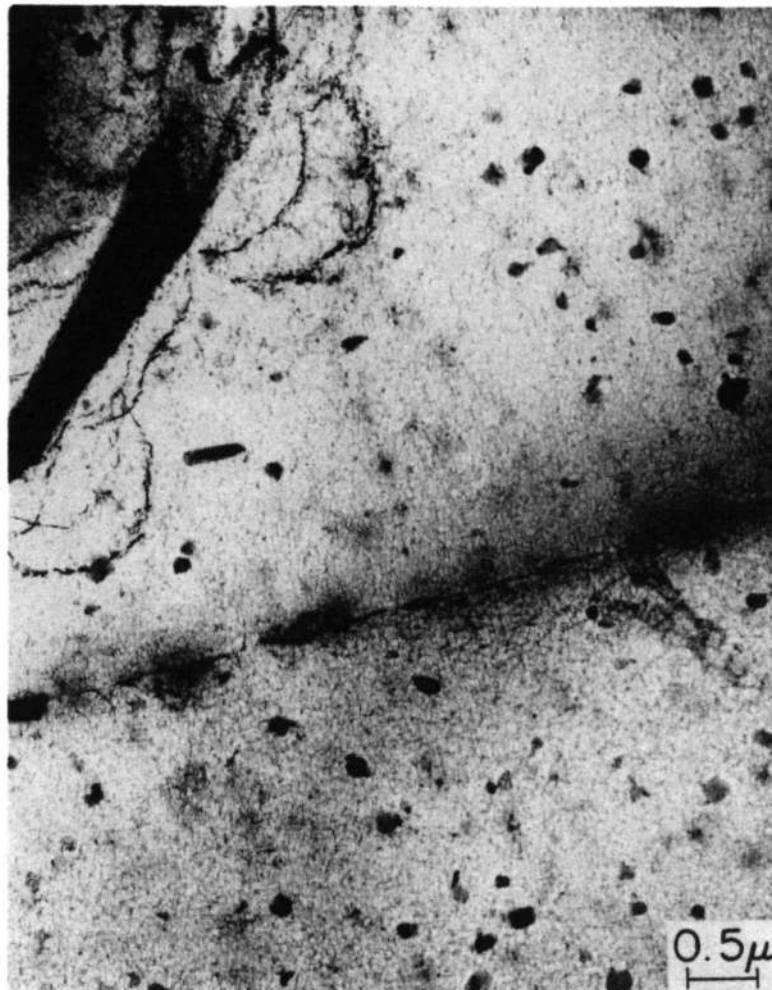
Fig. 17 Transmission Electron Micrograph Showing Small Inclusions at Grain Boundaries

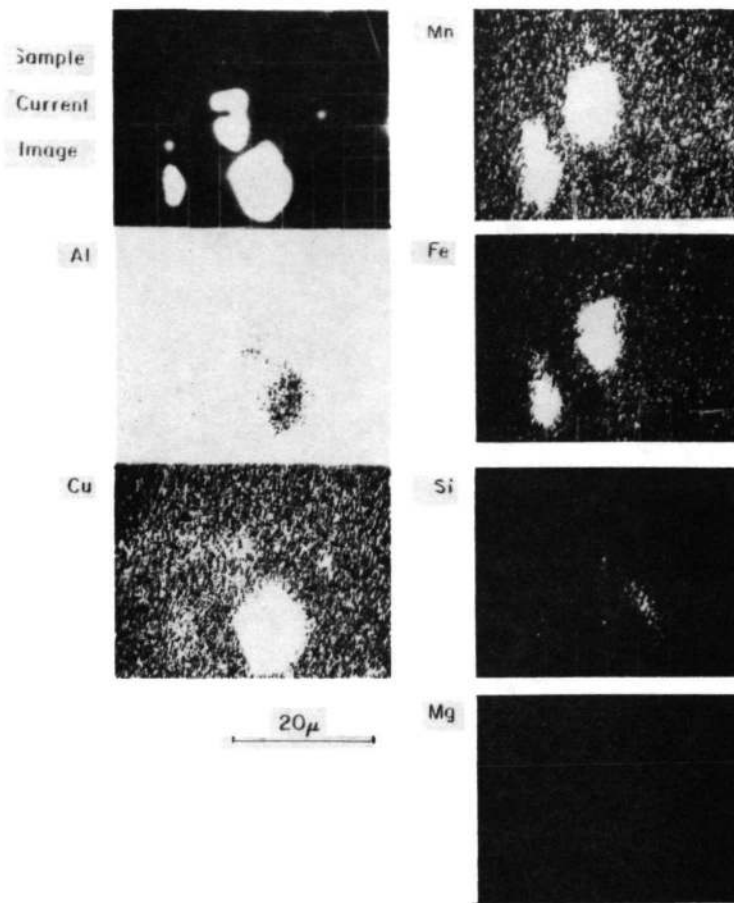
Polished samples, in which inclusions were easily seen in the optical microscope, were first analysed to determine the elements present in all of the large inclusions. Figure 18 shows typical micrographs obtained with the micro probe analyser. The top left picture shows the sample current by which it is possible to show the location of the particles. The remaining picture show the distribution of each of the specific elements investigated. Particles containing Fe, Mn and some Si are found in general, together with some particles containing large amounts of Cu. In these polished-section micrographs, it is not possible to decide if the particles contained Al because of interference from the Al matrix.

Fig. 18 Electron Micro Probe Analysis of a Polished Sample of the Alloy

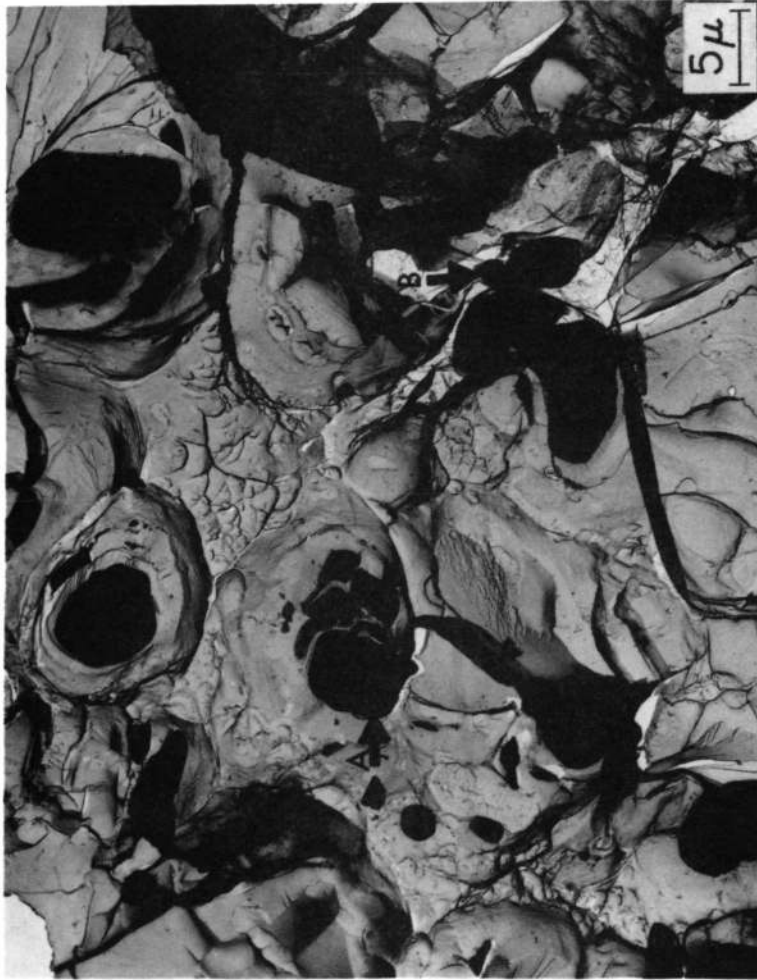
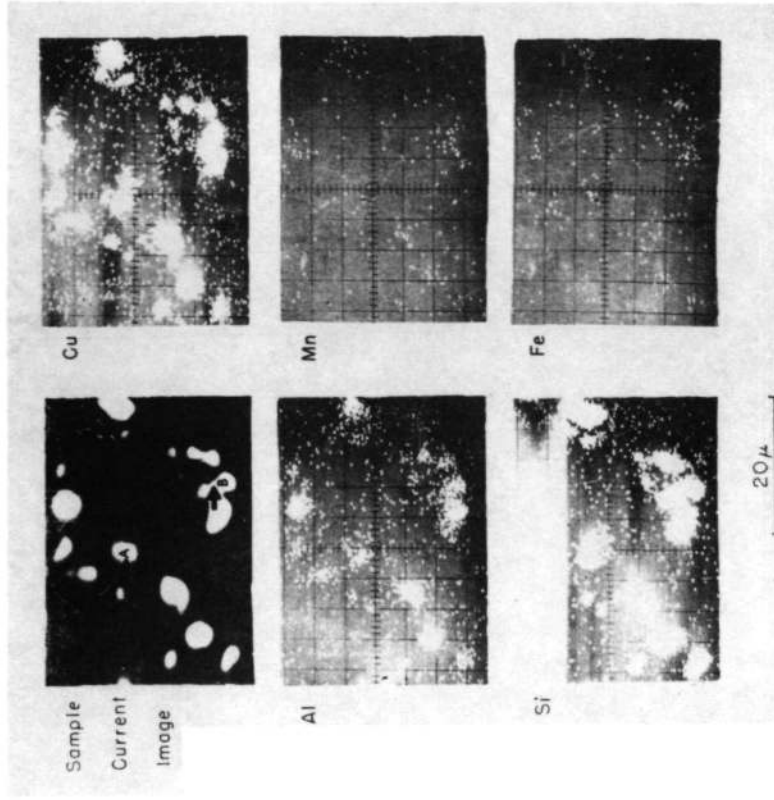
electron micrographs of typical extraction replicas. Many particles were extracted and seem to remain in the place corresponding to the dimple they had originated. However, some were found moved from their original position. The micro probe showed that the particles contained Cu, Si and Al, and some only Si, Figure 21. Comparing these results with those of the polished samples, it seems that either the particles containing Fe, Si and Mn were not extracted from the fracture surface or that they do not contribute to the formation of dimples. Direct micro probe analysis of the fracture surface with the micro probe, which detected the inclusions which contained Fe, and the fact that no special type of inclusions was found not to crack in the deformed samples seems to indicate that the inclusions were not extracted from the fracture surface.

Fig. 20 Electron Microscope Micrograph of an Extraction Replica

Fig. 21 Electron Micro Probe Analysis of Particles in Extraction Replica Shown in Fig. 20

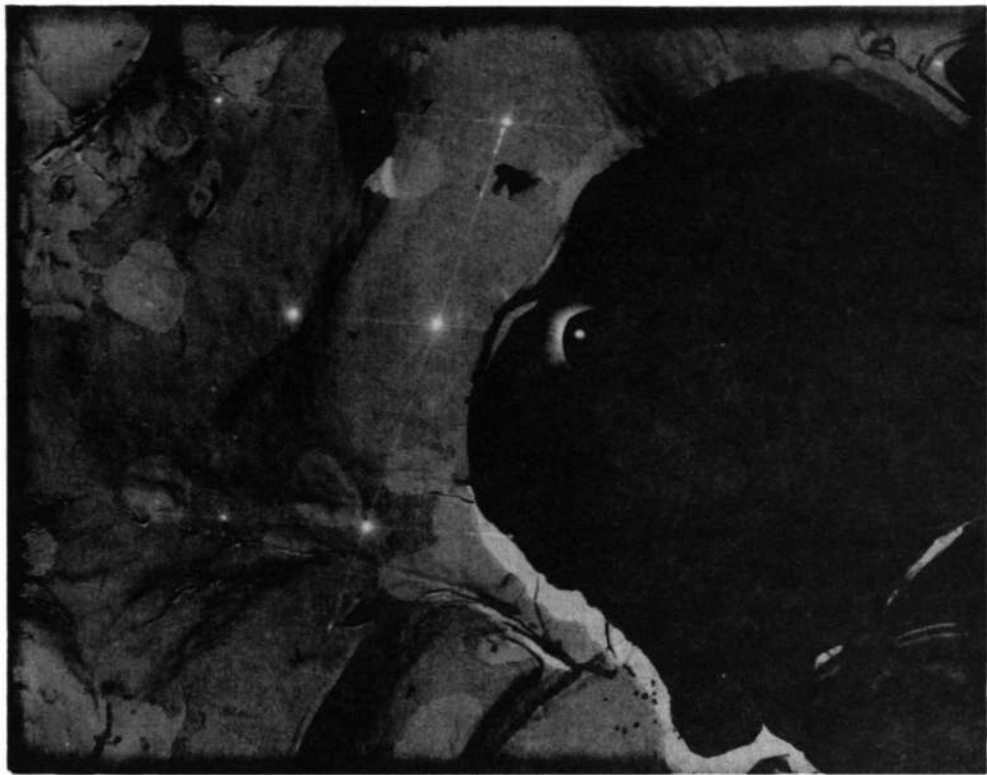
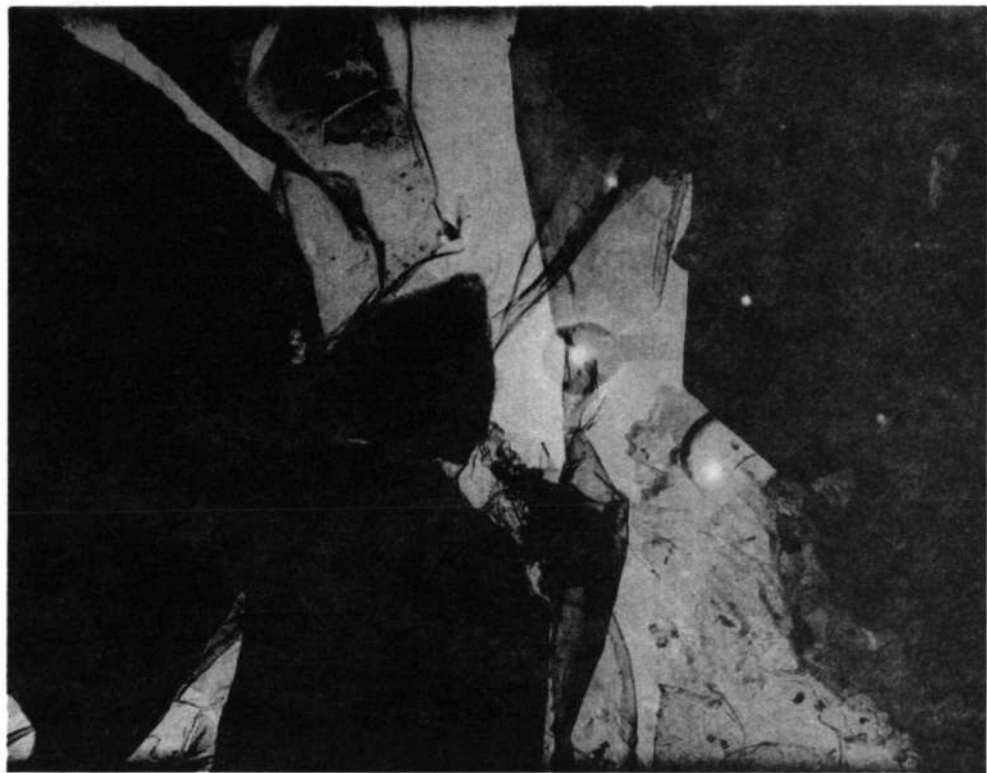
Fig. 22 a & b Electron Diffraction Patterns of Particles A and B of Fig. 20

Figures 22a and b shows diffraction patterns for the particles A and B shown in Figure 20 and in the micro probe micrograph in Figure 21. An analysis of the diffraction patterns obtained of the particles in the extraction replicas might correspond to Al_4Cu_9 or $\text{Cu}_{15}\text{Si}_4$ and pure Si or Cu_5Si or CuAl_2 .

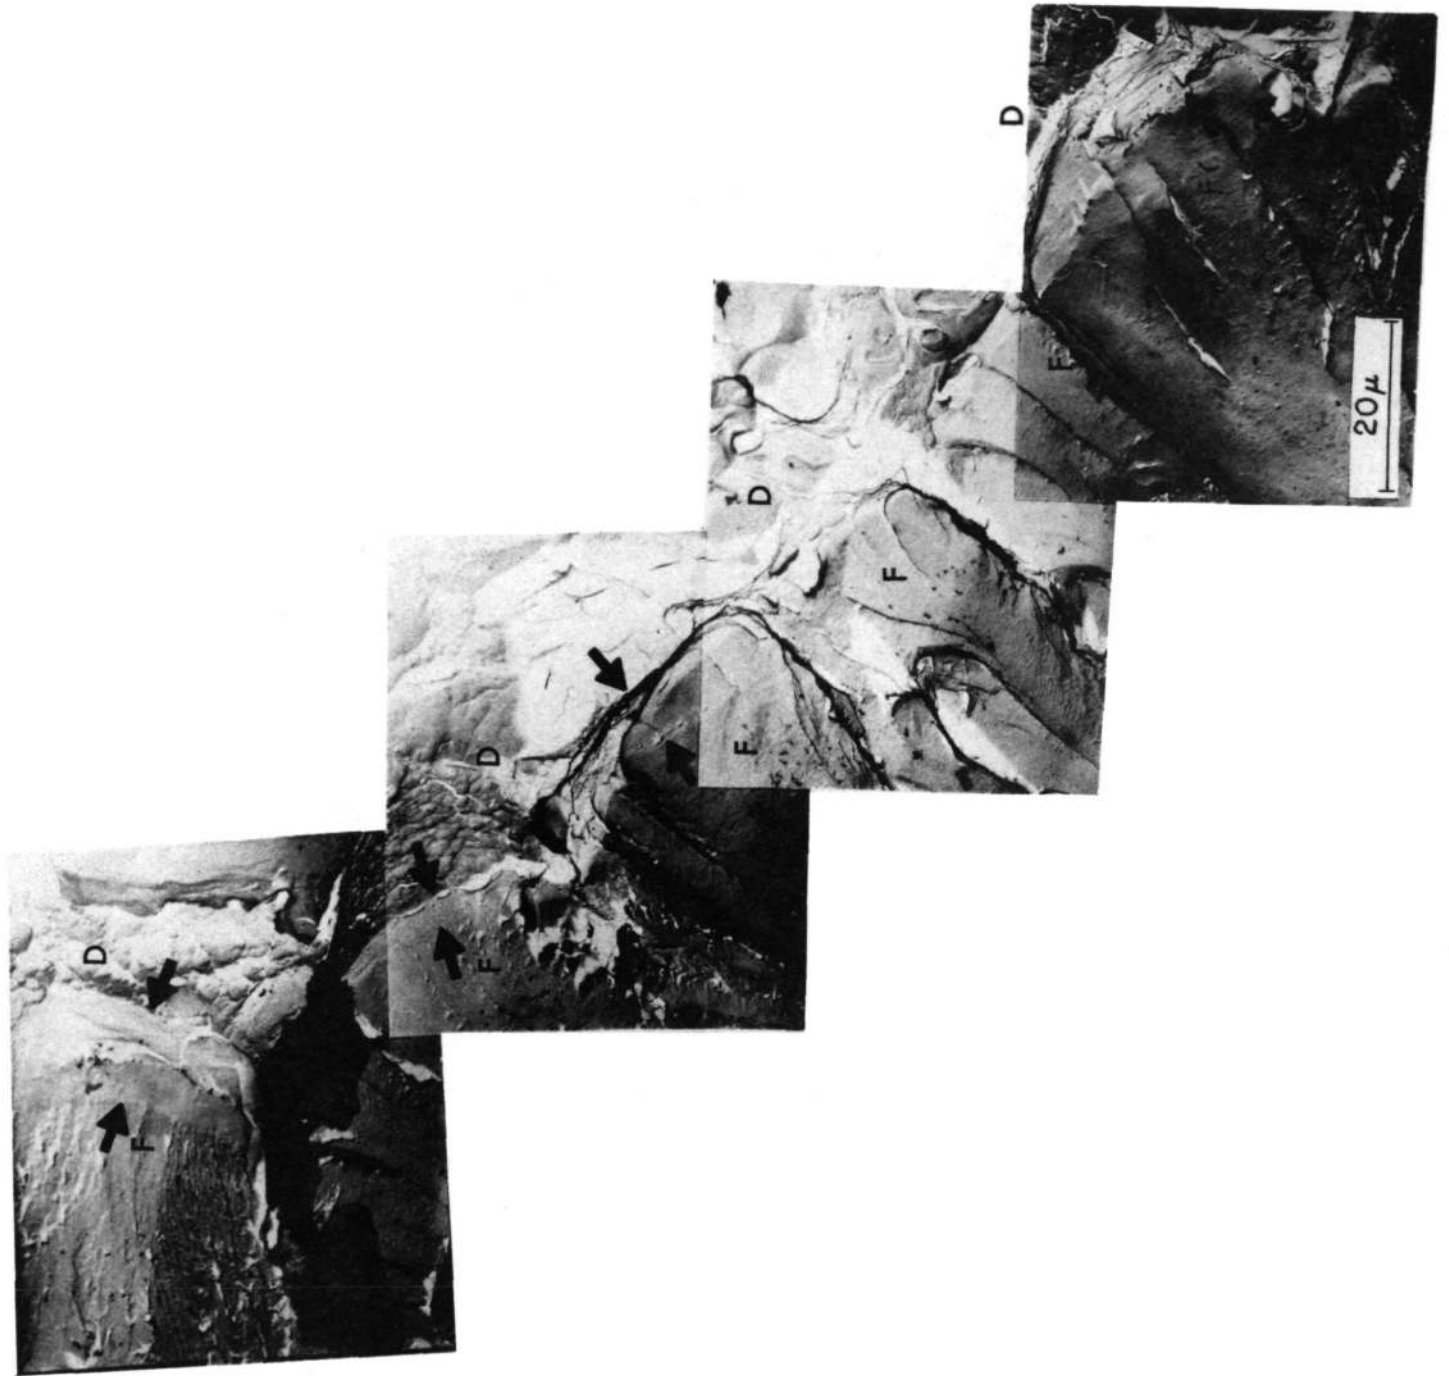
Figure 23 shows an electron fractograph taken from a two stage plastic-carbon replica made at the boundary between the fatigue (F) and the dimpled ruptures (D) regions of the fracture surface. The fatigue region in this material does not show the striations typical of fatigue. However, the features of the dimpled rupture region are quite different from these of the fatigue region which may be seen more clearly in a low magnification fractograph taken with the scanning electron microscope, Figure 24.

Fig. 23 Electron Microscope Micrograph of a Two Stage Replica of the Boundary Between Fatigue (F) and Overload Region (D).

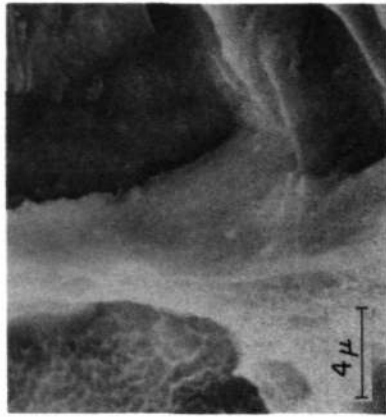
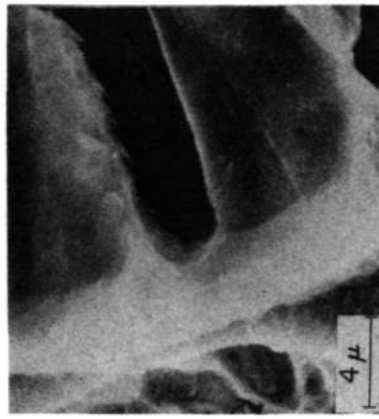
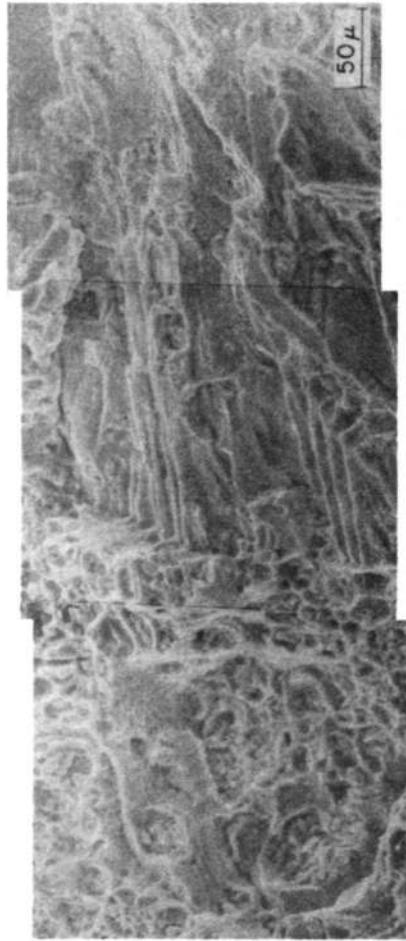
Fig. 24 Low Magnification Electron Micrograph Taken With the Scanning Electron Microscope of an Area Similar to that in Fig. 23

Fig. 25 High Magnification of Areas in Fig. 24 at the Boundary

At the boundary between the two regions, a step may be seen, Figure 24, which does not appear clearly in replicas due perhaps to collapse of the carbon film which will not support such a step. In any event, a topography different from both the dimpled rupture and the fatigue region is seen at the boundary, (shown between arrows) Figure 23. This transition area has been called the stretched-zone⁽¹³⁾ and its topography of the surface is said to be made up of almost wholly of "serpentine glide" due to slip⁽¹⁰⁾. It is apparent from Figure 23 that the extent of this region is quite irregular. Two scanning electron micrographs at higher magnification of the stretched zone are seen in Figure 25. The step seen at lower magnification in Figure 24 now appears to be rounded. The sketch shown in Figure 26 shows, we believe, the situation at the tip of the crack just before critical instability. We therefore believe that the stretched zone is produced during blunting of the crack tip and perhaps some stable crack growth. Several correlations have been made recently between the size of the stretched zone and fracture mechanics data. The result seems to be that the size of the stretched zone is of the order of $G_{Ic}/4\sigma_y$, where G_{Ic} is the critical crack extension force and σ_y the yield stress⁽¹¹⁾. If we take $G_{Ic}/2\sigma_y$ as a measure of the "crack opening displacement" (COD) at instability (the factor 1/2 is used when considering plane strain conditions)⁽¹⁴⁾, then, roughly, the radius at the tip of the crack just before instability is of the order of one-half to one times the crack-opening-displacement in size.

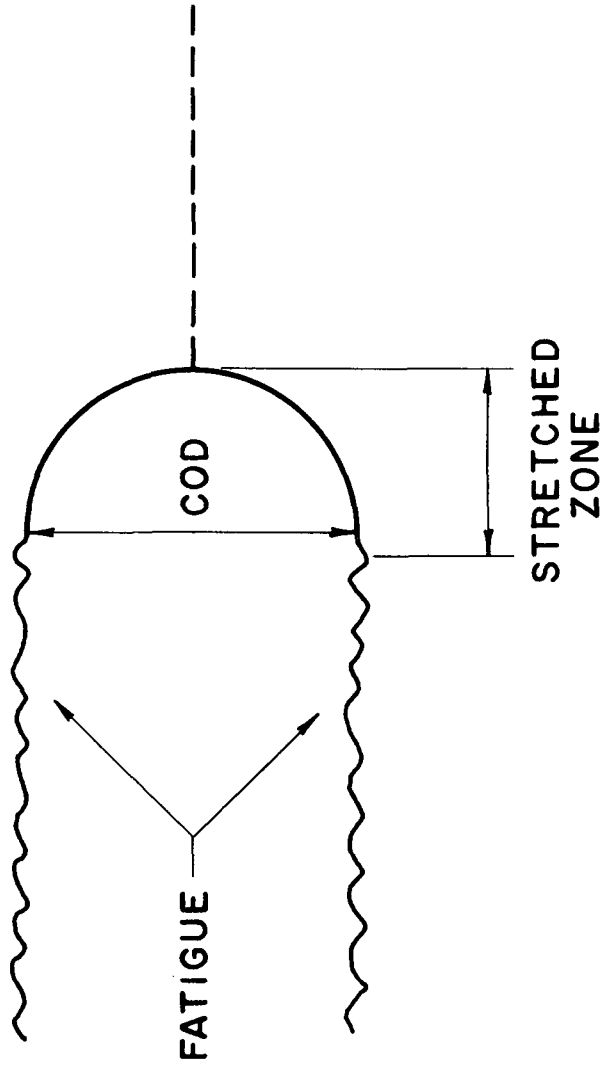
The formation of the stretched zone must involve some complex slip mechanism at the crack tip. We would like to suggest here that this mechanism should be similar to that proposed by Rogers⁽¹²⁾ to explain the formation of lips of a ductile copper tensile specimen that failed in a double cup fashion. The mechanism has been called "ductile cutting." Two factors, which we believe are also involved in the formation of the stretched zone are large amounts of plastic deformation necessary to provide the separation or "cutting" of the material and low triaxiality to inhibit void growth during its formation.

Fig. 26 Sketch Showing Blunting of the Crack Tip and the Stretched Zone
