## CARDIOVASCULAR FLASHLIGHT

doi:10.1093/eurheartj/ehv256

### It paces right but not in the right space!

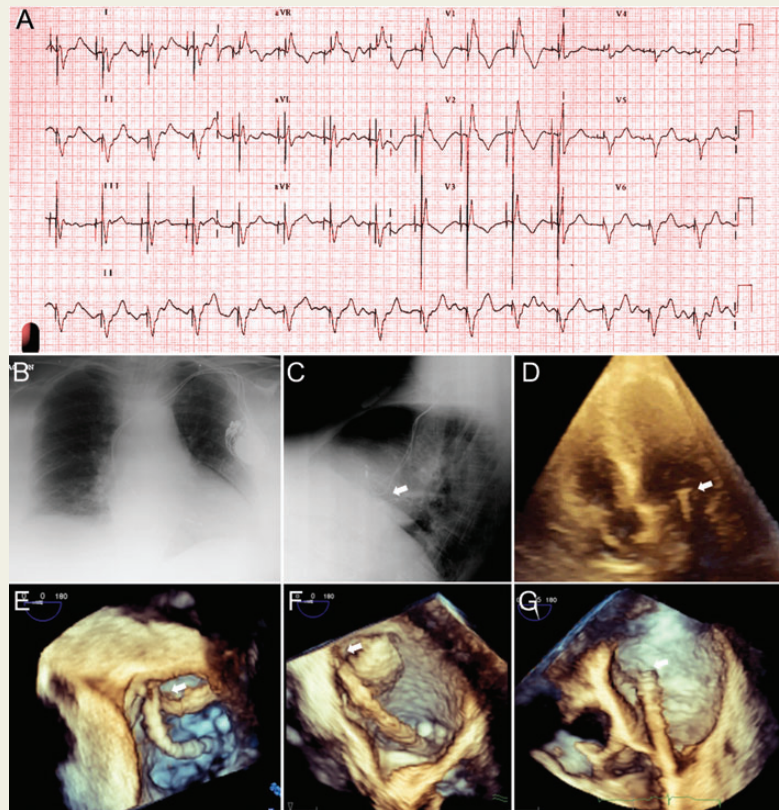
The electrocardiogram (EKG) showed right bundle branch block (RBBB) pattern during dual chamber pacing (Panel A). An RBBB-paced pattern suggests ventricular lead malposition that was confirmed on chest X-ray where a posterior deflection of the pacemaker electrode on the lateral view (Panels B and C, arrow) was noted. Transthoracic echocardiography showed abnormal lead position in the apical view with pacemaker lead localized in the left ventricle (LV) crossing the mitral valve (MV) (Panel D, arrow). Transoesophageal echocardiogram was thus necessary and sufficient to clarify the real route for the lead displacement. The 3D images show indeed that the electrode from the right atrium traversed the aneurismatic oval fossa in the interatrial septum through the foramen ovale (Panels E and F, arrow) into the left atrium and then reached the LV through the MV orifice (Panel G, arrow). The MV apparatus had normal function, with no damage to the valve leaflets and no signs of thrombus formation on the pacemaker lead.

Malposition of a pacemaker lead in several locations has already been reported but the diagnosis is often accidental. Twelve-lead EKG during ventricular pacing at the end of pacemaker implantation as well as chest X-ray should be routinely performed in order to confirm correct lead position and avoid potential serious complications that may occur from ventricular lead malposition.
