# Triboelectric simulation of pacemaker malfunction

(Europace 2002; 4: 325–327)

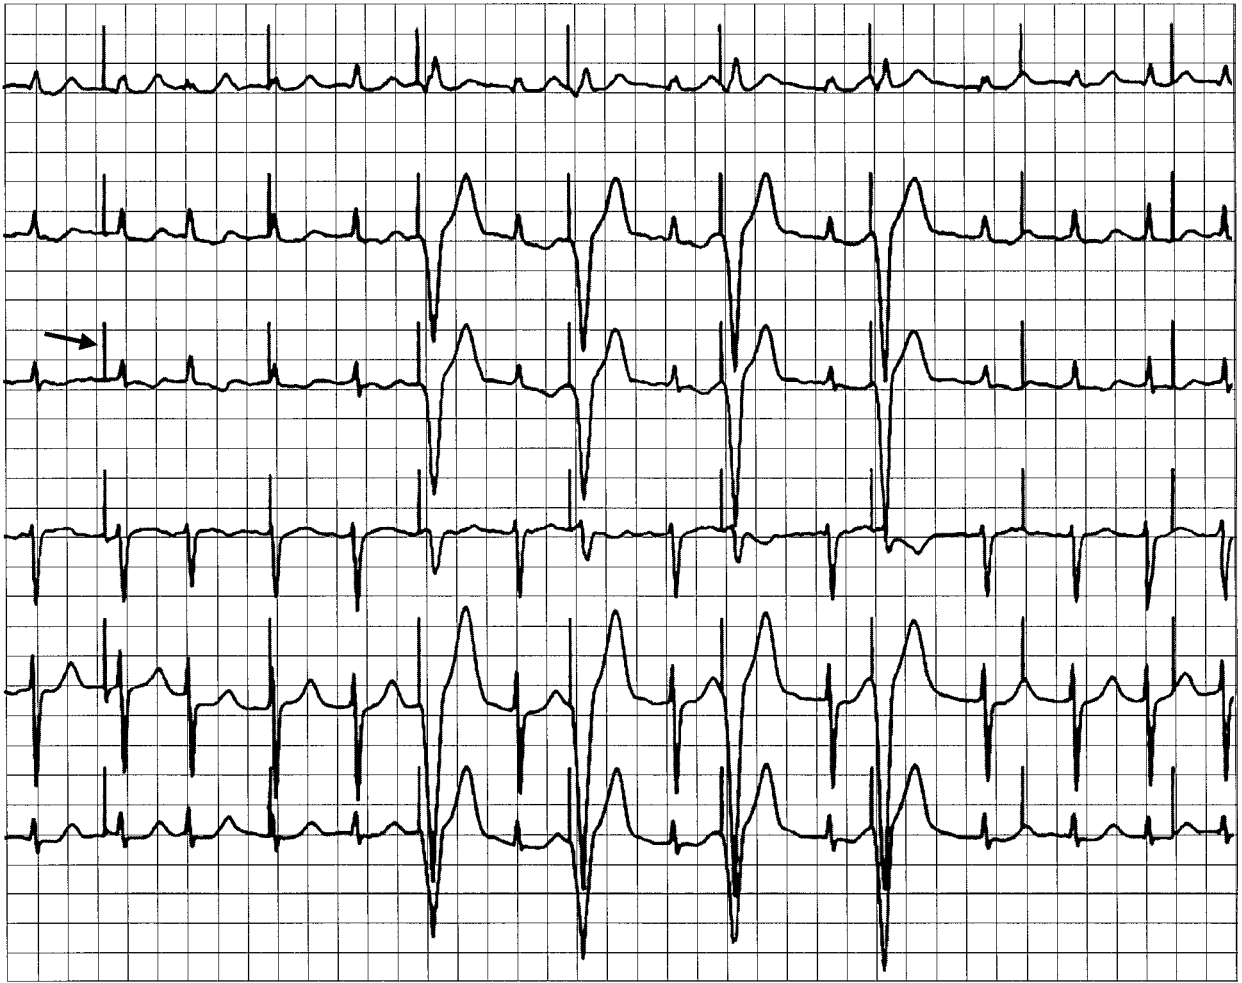
A 74-year-old female with a VVI pacemaker implanted 4 years earlier presented March 2001 for routine pacemaker evaluation. The pacemaker was programmed to a bipolar pacing and sensing configuration. An electrocardiographic rhythm strip was obtained during magnet application (Fig. 1). The tracing reveals an initial artifact that appears to be a pacemaker stimulus with failure to capture. Subsequently, appropriate ventricular capture occurs with each stimulus delivered whenever the ventricle is not refractory from intrinsic depolarization. The initial artifact clearly occurs at a time when the ventricle is not refractory and raised the question of possible intermittent failure to capture. However, the interval from the initial artifact to the subsequent stimulus measures approximately 1120 ms. At the time, the paced

*Figure 1* Electrocardiographic rhythm strip obtained during magnet application. The magnet was applied when the artifact in question was produced (arrow).

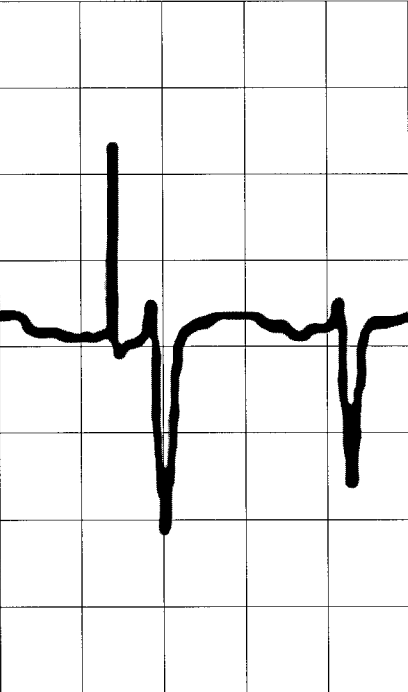
2a

cycle length with magnet application was 1000 ms (60 ppm). When the baseline of the electrocardiogram is inspected closely there is a definite difference between the ‘overshoot’ after the initial artifact (Fig. 2A) and the subsequent pacing stimuli (Fig. 2B).

*Figure 2* A: Left: Close-up of the initial artifact showing the characteristic overshoot of the triboelectric deflection. Right: The pacemaker stimulus does not produce a discernible overshoot.

Triboelectric signals are usually wider and more irregular than pacemaker stimuli and often recognizable as artifacts. Occasionally as in our case, the diagnosis depends on finding subtle differences from the pacing stimulus. Magnification of the questionable artifact clearly revealed a relatively prolonged overshoot not present with pacemaker stimuli. Such an overshoot is typical of electrostatic discharge (triboelectric signals) and should be sought in the evaluation of artifacts mimicking pacemaker stimuli to avoid the diagnosis of pacemaker malfunction. Electrocardiographically a rhythmic pattern to this phenomenon is not usually seen. The diagnosis may be more difficult when the isolated artifact is insulated.
