**200-BP-1 Prototype Hanford  
Barrier Annual Monitoring  
Report for Fiscal Year 2004**

## **200-BP-1 Prototype Hanford Barrier Annual Monitoring Report for Fiscal Year 2004**

## Summary

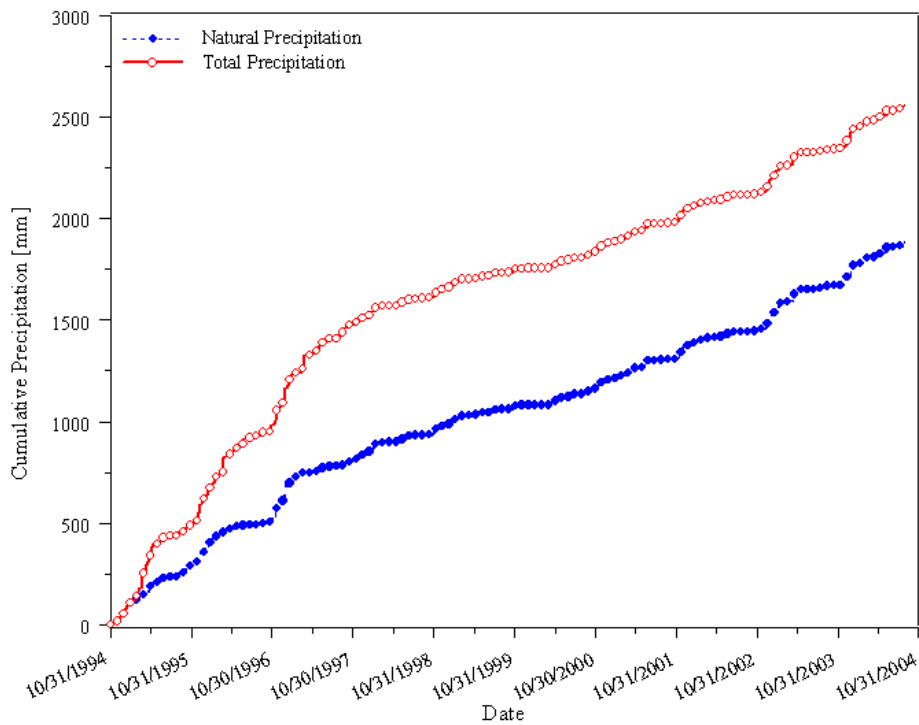
**Figure 2.5. Natural and Total Precipitation (Natural plus Irrigation) at the Prototype Hanford Barrier From October 1, 1994, Through September 30, 2004**

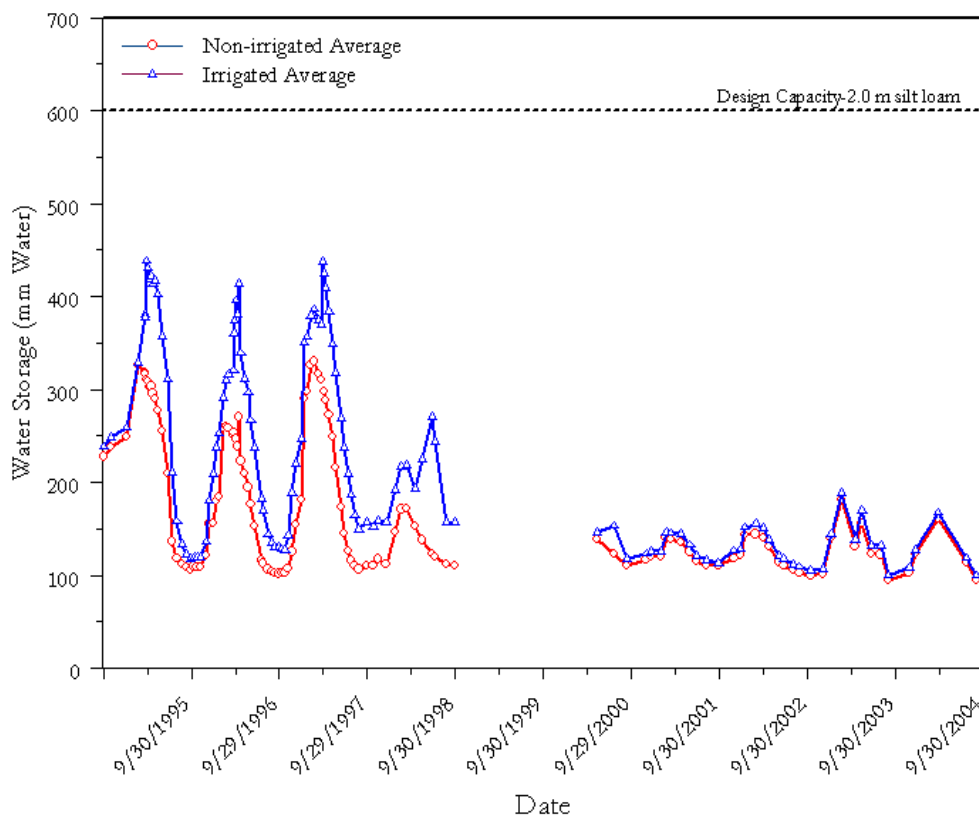
Figure 2.11 compares the mean storage on the north and south sections of the barrier. The mean storage for the north was calculated as the temporal average of  $W(t)$  measured at S1 through S6. The mean storage for the south was calculated as the temporal average of  $W(t)$  measured at S7 through S12. As of September 3, 2004, the mean storage was 100.68 mm on Plot 6W and 99.29 mm on Plot 6E, compared to 96.67 mm on Plot 3W and 94.51 mm on Plot 3E. In comparing water storage between plots for FY 2004, the distribution is quite similar to that observed around the same time in FY 2003. Although there are small differences between plots, differences in mean storage between plots at the end of monitoring in FY 2004 are not statistically significant. Mean storage on the north side of the barrier was 99.98 mm compared to 95.59 mm on the south side. The 4-mm difference is less than one half of the expected precision of 10 mm over the 2-m monitoring depth. These data highlight a convergence in measured water storage on the two sections of the barrier as time progressed beyond the cessation of irrigation.

**Figure 2.11. Temporal Variation in Mean Soil-Water Storage on the North and South Plots at the Prototype Hanford Barrier, October 1994 Through September 2004 (design water storage capacity is 600 mm)**

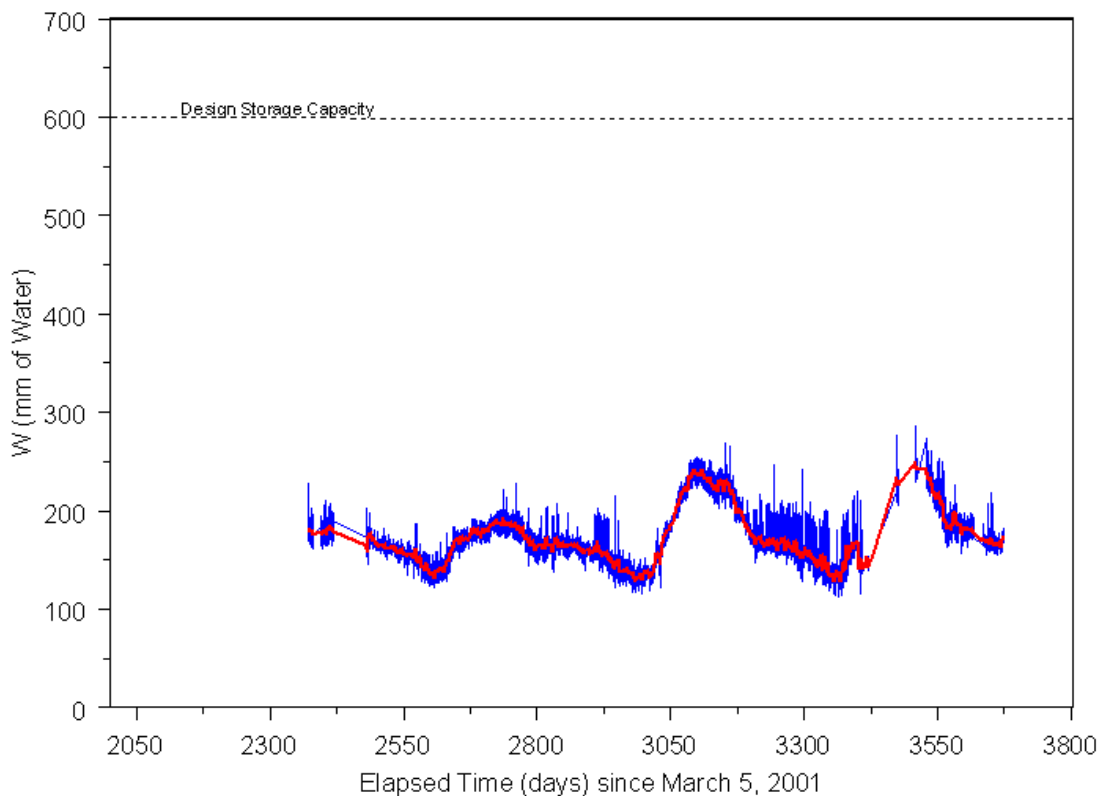
The most striking feature in these data is the large amount of noise in the storage values, particularly on the south side. Owing to the noise, the data were smoothed with a 20-point moving average filter. The temporal changes in storage show some similarity to that observed in the neutron data, although the similarity is much stronger for the TDR data from the north plots. However, short-term changes of over 100 percent in the TDR-measured moisture contents result in apparently erratic changes in storage, even in the absence of precipitation events. The error also appears to increase with decreasing saturation. These problems appear to be more significant in the data from the south plots where erratic changes in moisture resulted in storage changes of over 300 percent. Again, the observed trends resemble the expected with an increase in storage in the winter and a decrease in the spring and summer. However, use of these data for determining absolute moisture contents or for calculating an accurate water balance may be somewhat limited. In an attempt to overcome these limitations, the frequency of probe measurements has been increased to hourly so that temporal averaging can be done. However, this approach will likely limit the ability to distinguish real short-term changes in moisture and storage that may result from episodic events such as the thunderstorms observed in May of 2004.

**Figure 2.12. Temporal Variation in Mean Soil-Water Storage on the North Plots at the Prototype Hanford Barrier, March 5 1994 Through August 31 2004, Based on TDR Measurements. A 20-point moving-average filter was used to smooth the data (design water storage capacity is 600 mm).**

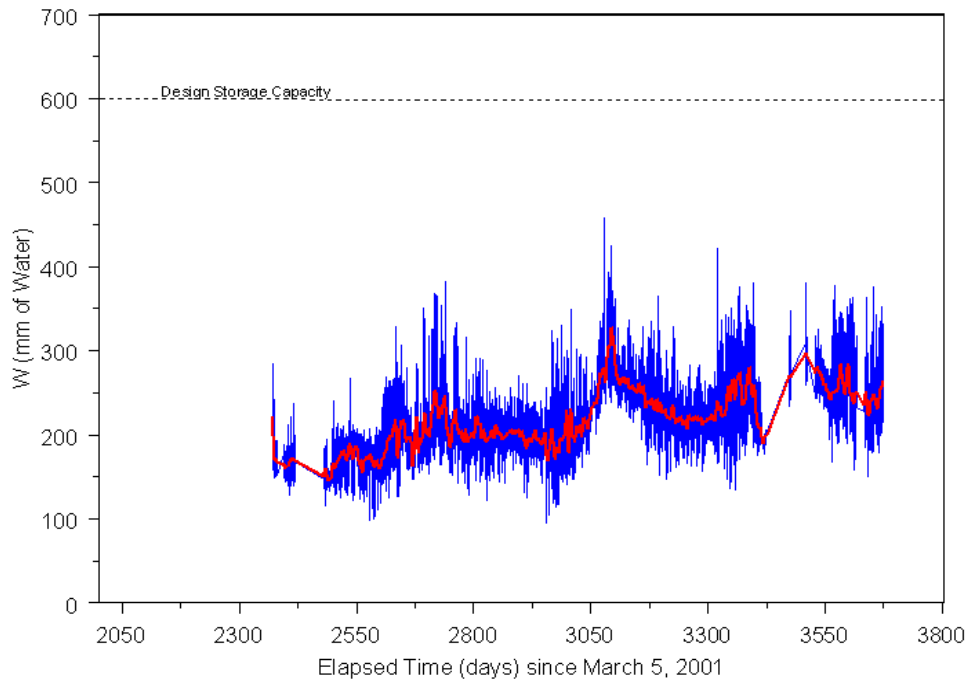
**Figure 2.13. Temporal Variation in Mean Soil-Water Storage on the South Plots at the Prototype Hanford Barrier, March 5 1994 Through August 31 2004, Based on TDR Measurements. A 20-point moving-average filter was used to smooth the data (design water storage capacity is 600 mm).**

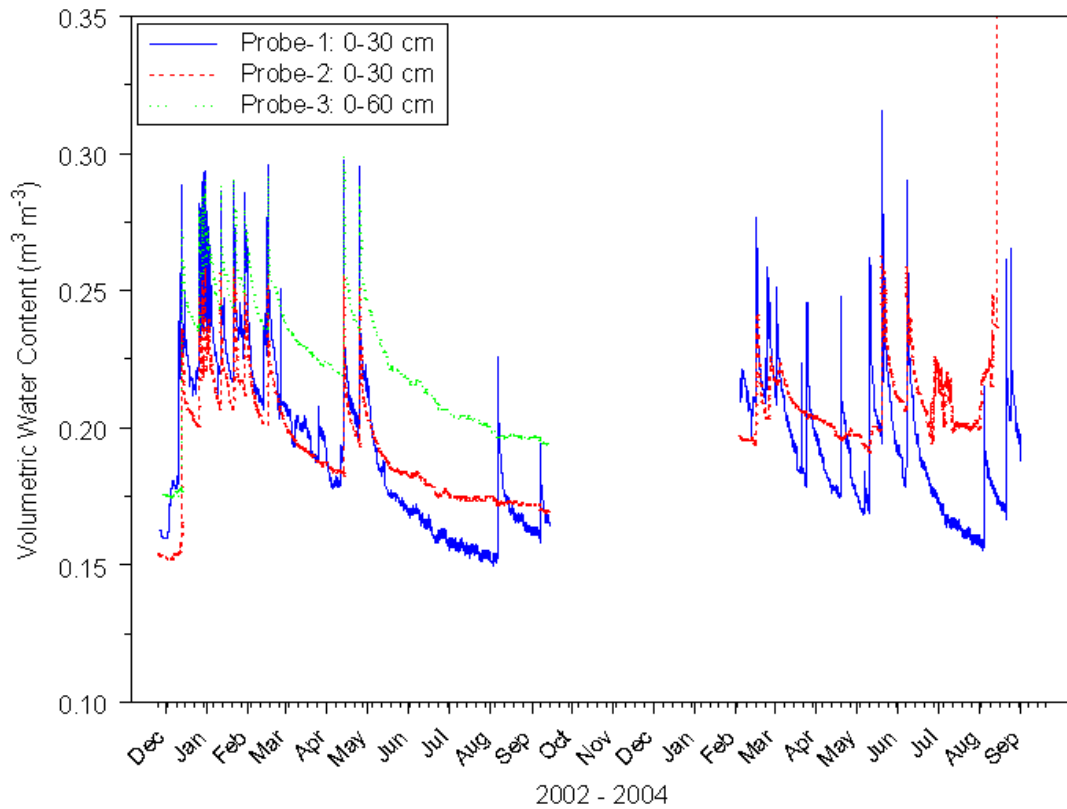
technologies. The probes show excellent response to precipitation events, registering sharp increases in water content. The response to moisture redistribution and drainage, manifested as a decrease in water content, is also quite remarkable. In fact, the thunderstorm of May 20 and 22, 2004, that is suspected to have caused erosion near the toe of the riprap slope, although difficult to distinguish from the noise in the TDR system, was clearly evident in the ECHO probe data (Figure 2.15). On May 20, Probe 1 registered a sharp increase in water content to around  $0.315 \text{ m}^3 \text{ m}^{-3}$  at 18:00 hrs, while Probe 2 recorded an increase to  $0.262 \text{ m}^3 \text{ m}^{-3}$  an hour later. Both probes showed a subsequent decrease in moisture, which is not surprising as the gravel slope has a relatively low water storage capacity. Water content continued to decrease until 17:00 hrs on May 22 when another sharp increase in moisture to  $0.28 \text{ m}^3 \text{ m}^{-3}$  and  $0.26 \text{ m}^3 \text{ m}^{-3}$  occurred on probes 1 and 2 respectively.

**Figure 2.14. Temporal Variation in Soil-Water Content Measured by ECHO Probes on the Gravel Side Slope at the Prototype Hanford Barrier, November 27, 2002, Through August 31, 2004**

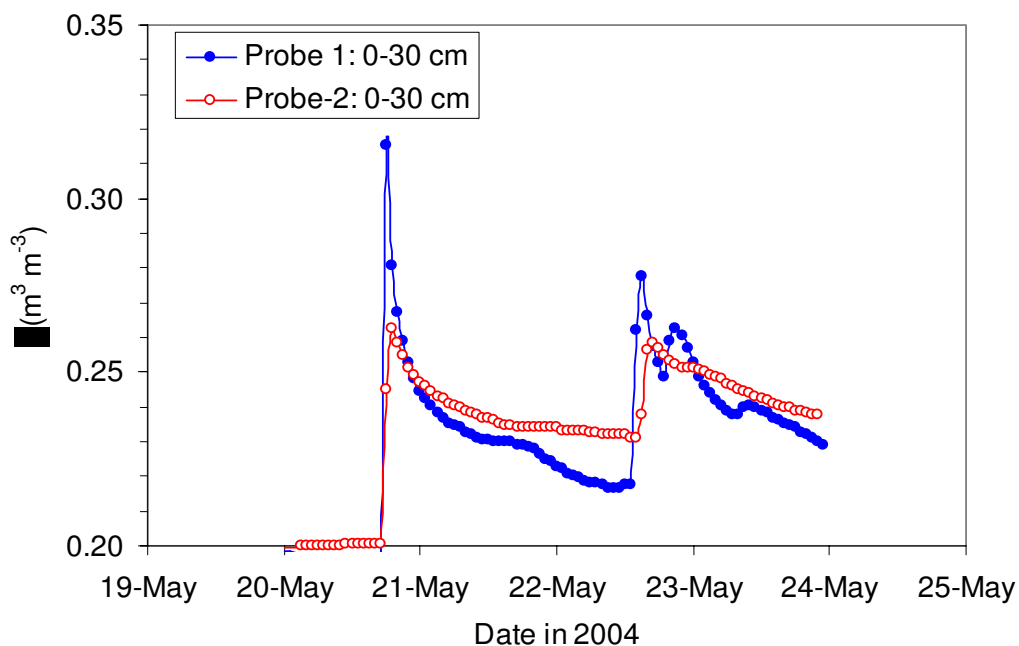
**Figure 2.15. Temporal Variation in Soil-Water Content Measured by ECHO Probes on the Gravel Side Slope at the Prototype Hanford Barrier During the Thunderstorms on May 20 and 22, 2004**

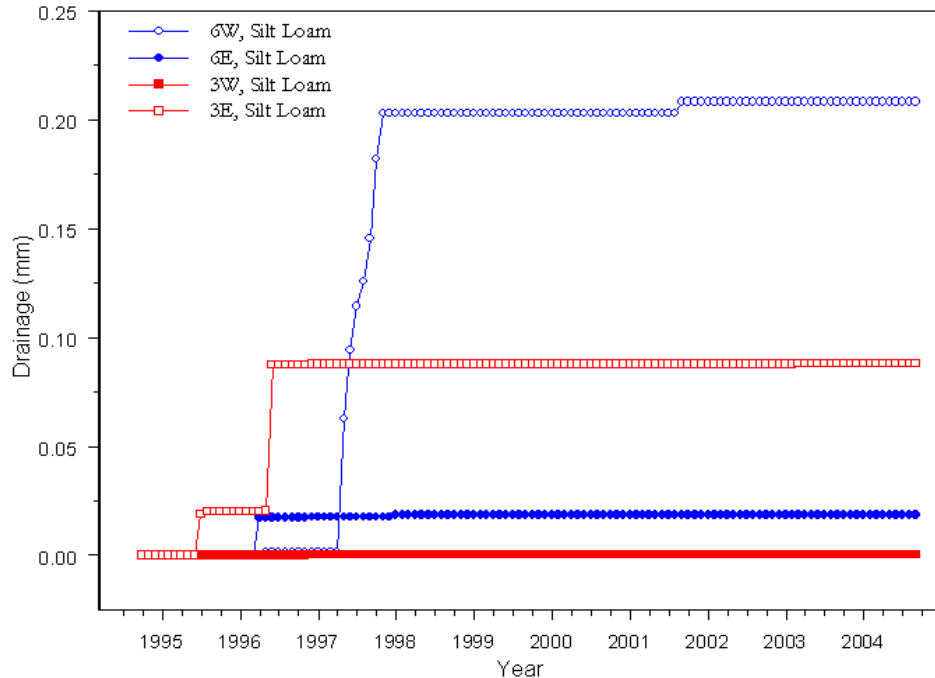
**Figure 2.16. Cumulative Amounts of Water Diverted by the Asphalt Pad (Drainage) from the Soil-Covered Plots at the Prototype Hanford Barrier in September 1994 Through September 2004. (Note: A 3-month reporting hiatus occurred from March 1999 through May 1999.)**

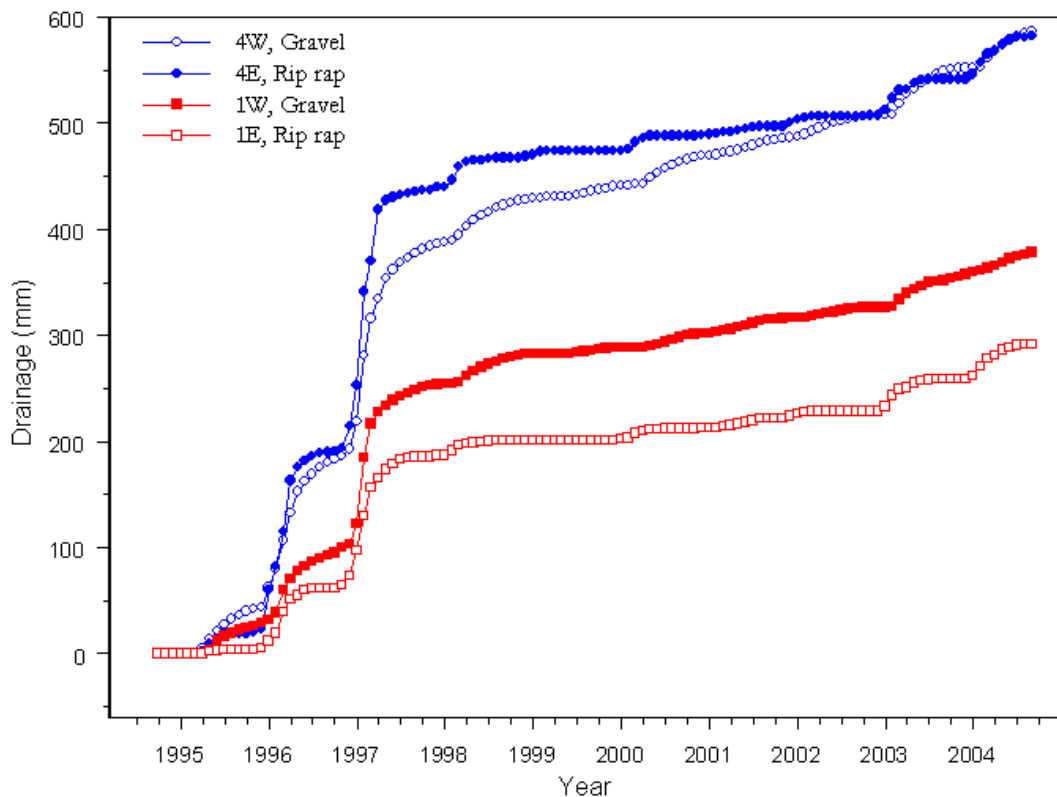
**Figure 2.17. Cumulative Amounts of Water Diverted by the Asphalt Pad (Drainage) from the Side-Slope Plots at the Prototype Hanford Barrier in September 1994 Through September 2004. (Note: A 3-month reporting hiatus occurred from March 1999 through May 1999.)**

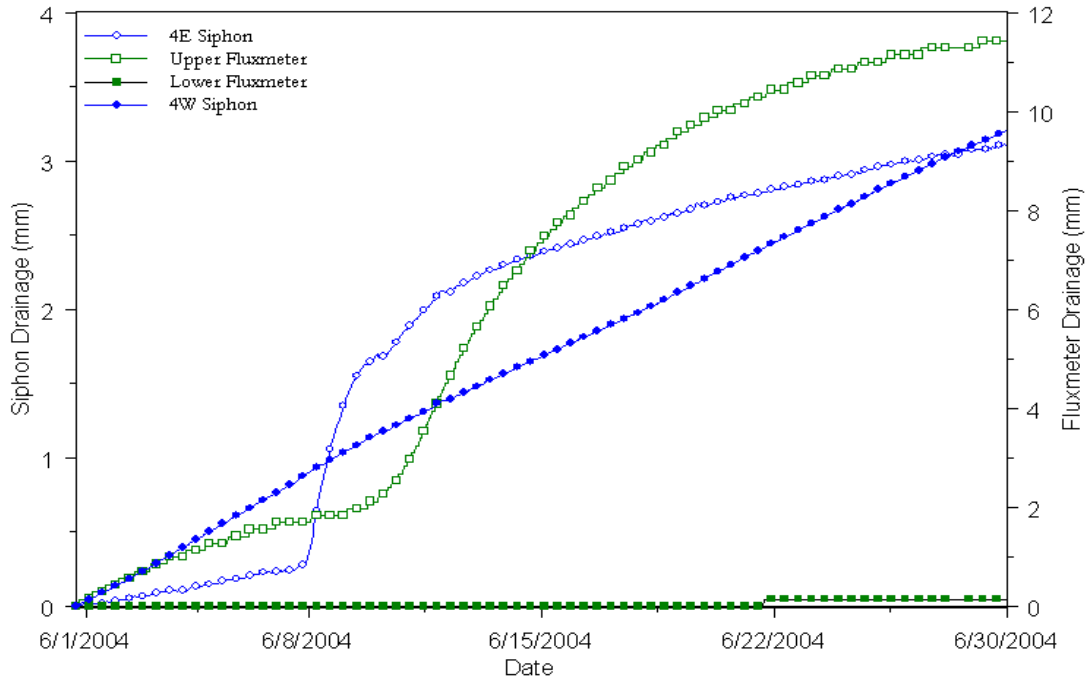
**Figure 2.22. A Comparison of Cumulative Amount of Water Diverted by the Asphalt Pad (Drainage) Under the Gravel Side Slope as Measured by Pressure Transducers in the Siphons Vaults and a Water Fluxmeter for the Period June 1, 2004, through June 30, 2004**

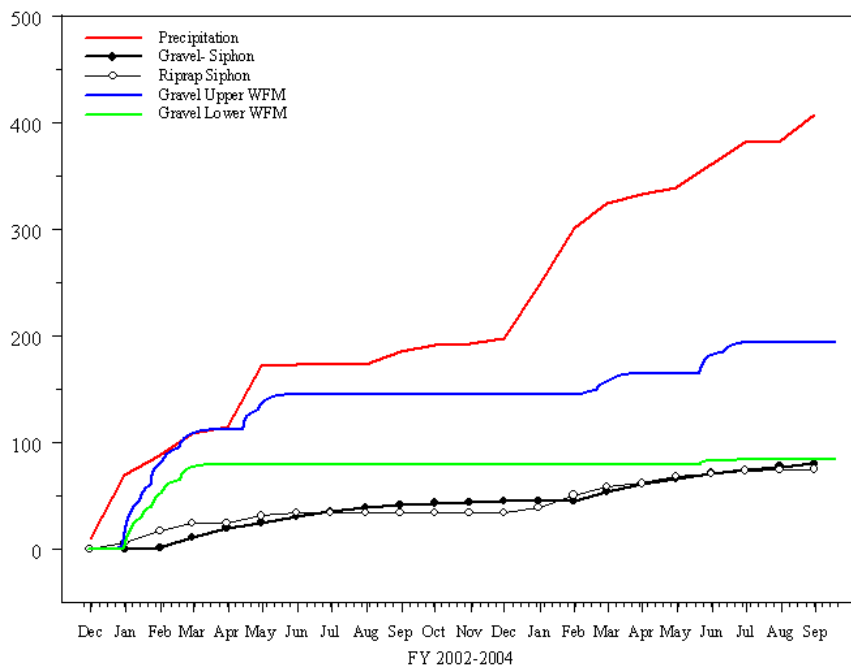
**Figure 2.23. A Comparison of Cumulative Amount of Water Diverted by the Asphalt Pad (Drainage) Under the Side Slopes Measured in the Siphons Vaults and Water Fluxmeters for the Period November 27, 2002, through September 17, 2004**

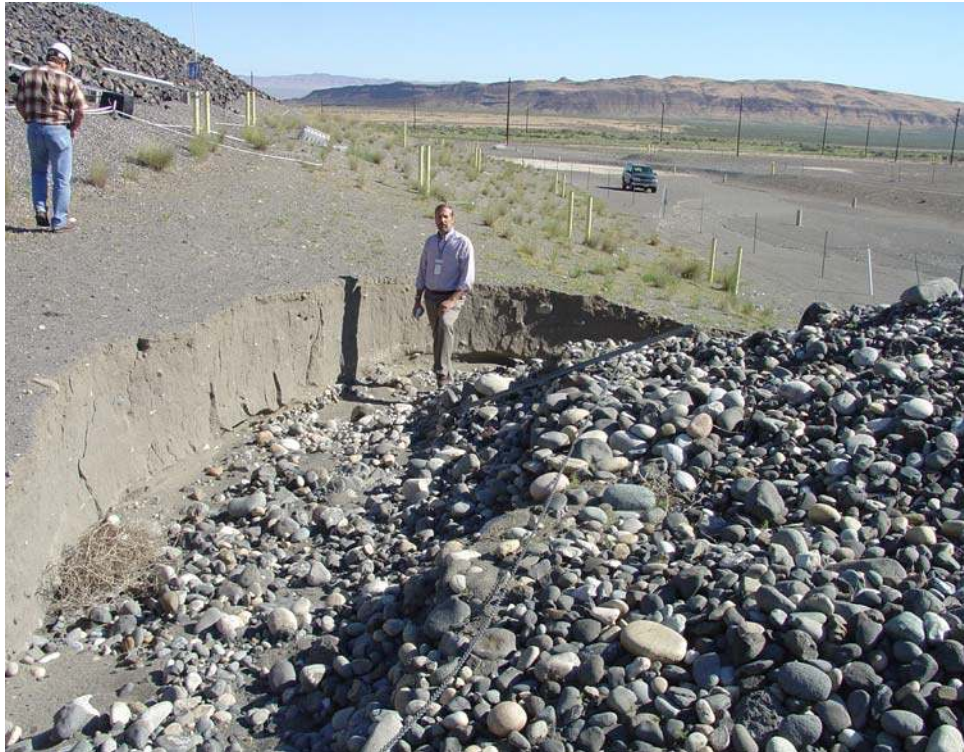
**Figure 2.25. North-Facing Photograph Taken on 6/16/04 from the BY Tank Farm During an Inspection by Kirk Christensen and Curt Wittreich (standing in channel). The light colored area behind the vehicle is the fine-textured sediment remaining after the ponded runoff water infiltrated and evaporated adjacent to the BY Cribs.**

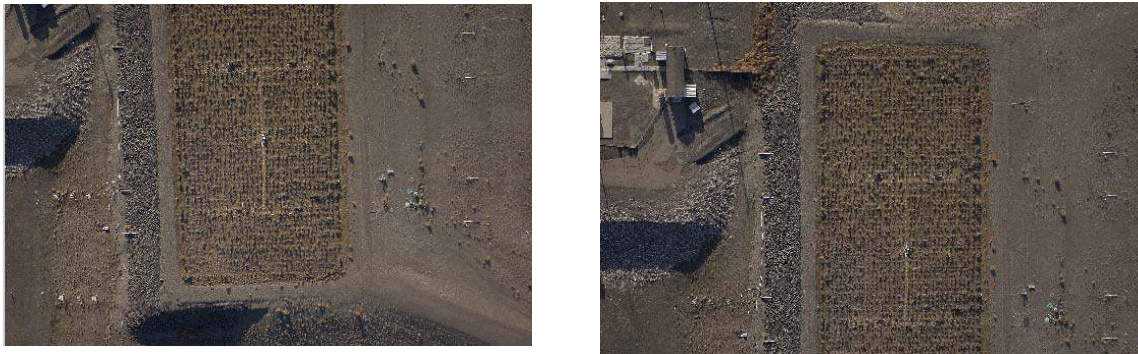
**Figure 3.1. Example of two Overlapping Images used to Extract Control Point of Generation of the Digital Elevation Model**

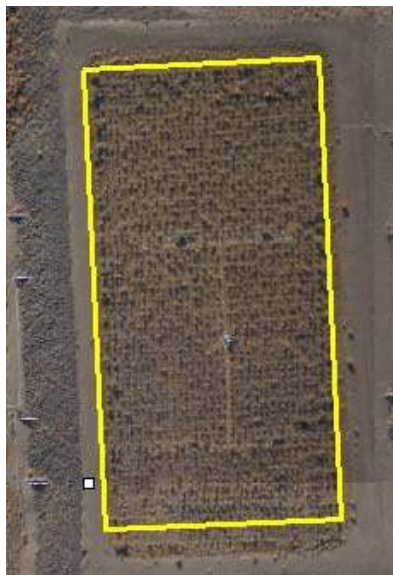
In this study, the area of interest was limited to the silt-loam surface of the barrier as depicted by the yellow rectangle in Figure 3.3.

**Figure 3.3. Outline of Sampling Area used for Calculation of Elevation.**

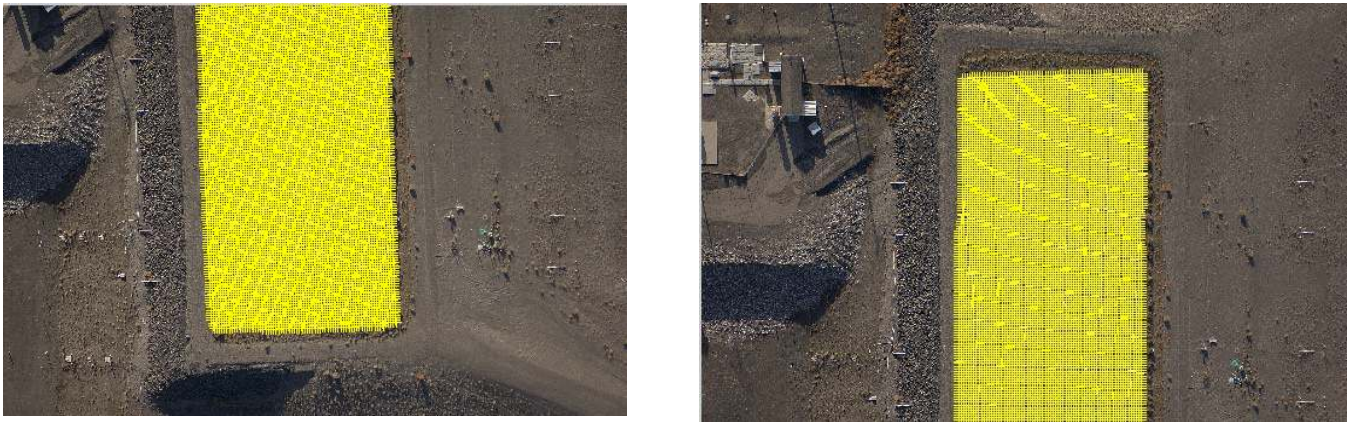
**Figure 3.4. Selection of Corresponding Points**

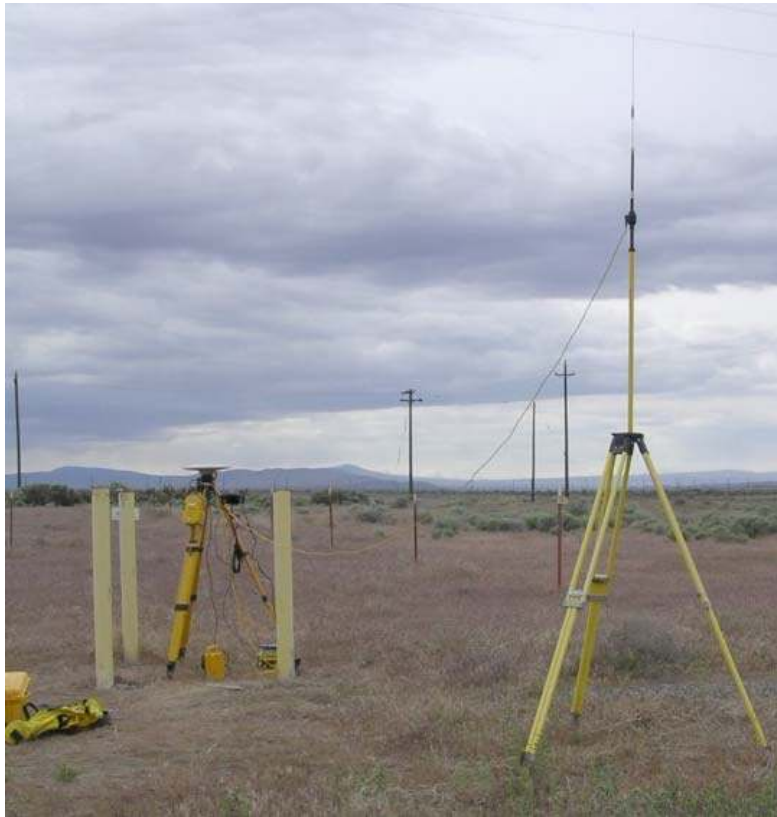
**Figure 3.5. Real-Time Kinematic GPS Surveying System with a 5700 Receiver and Trimmark 3 Base Station Radio with Whip Antenna**

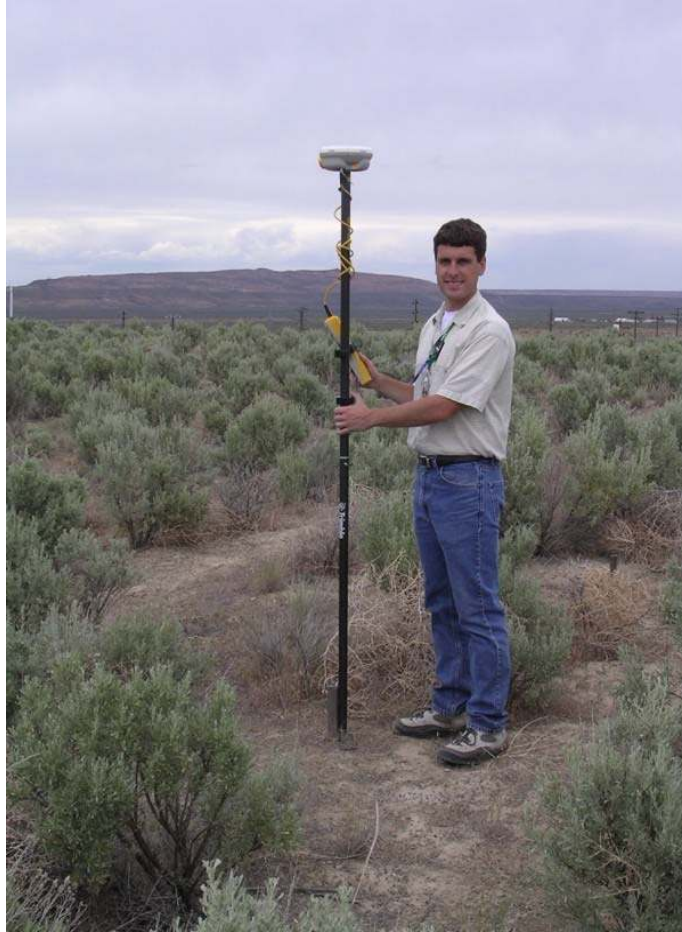
**Figure 3.6. Real-Time Kinematic 5800 Rover Unit at the Prototype Barrier (Jason Keller supports the unit)**

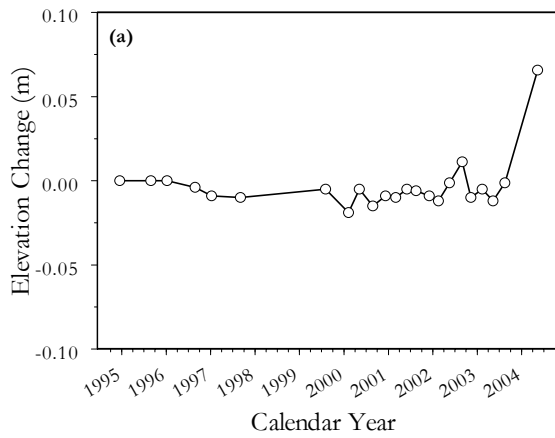
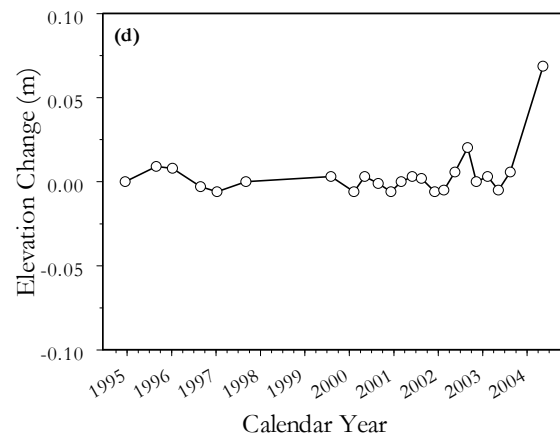
**Figure 3.14. Creep Gauge Elevation Changes Between December 1994 and May 2004: (a) CG5, (b) CG6, (c) CG7, and (d) CG8. (Elevation Measured by EDM except in May 2004 by GPS.)**

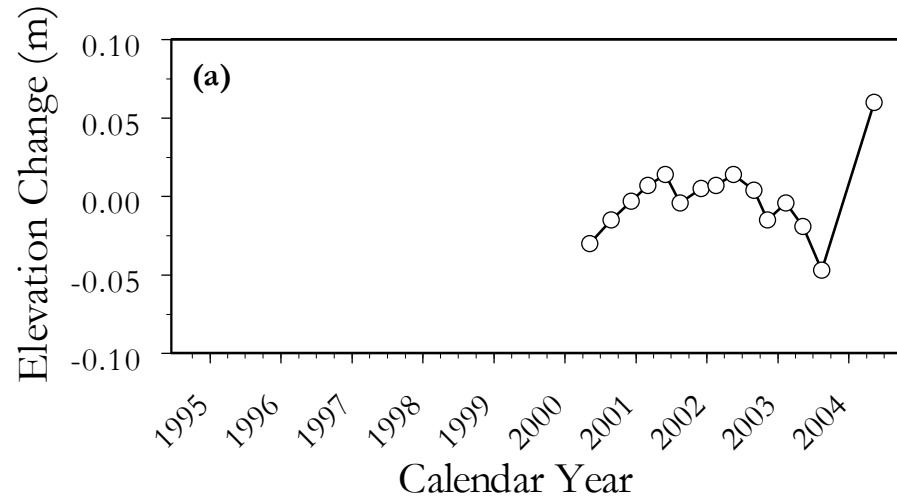
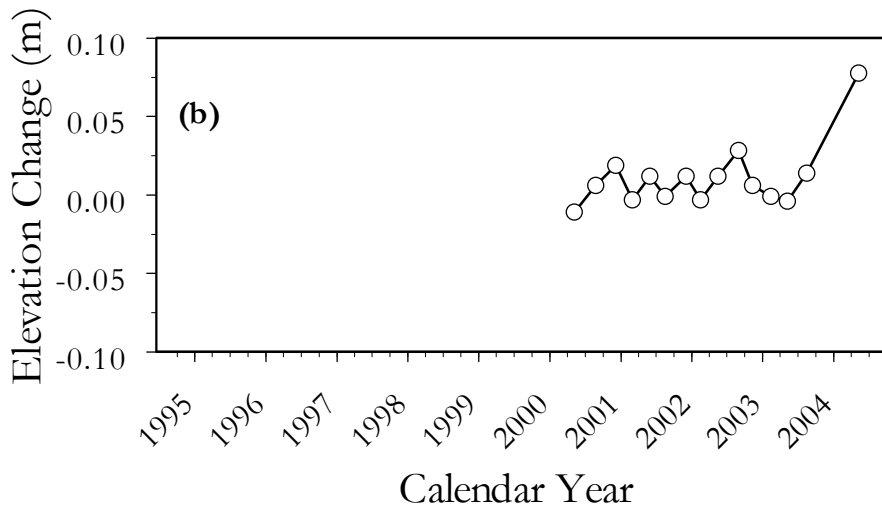
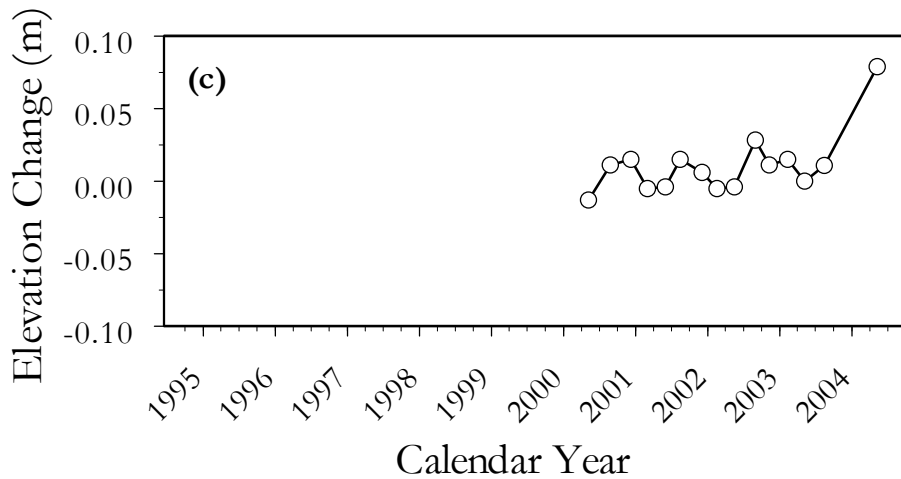
**Figure 3.16. Creep Gauge Elevation Changes Between February 2000 and May 2004: for New Gauges (a) CG12, (b) CG13a, and (c) CG13b. (Elevation Measured by EDM except in May 2004 by GPS.)**

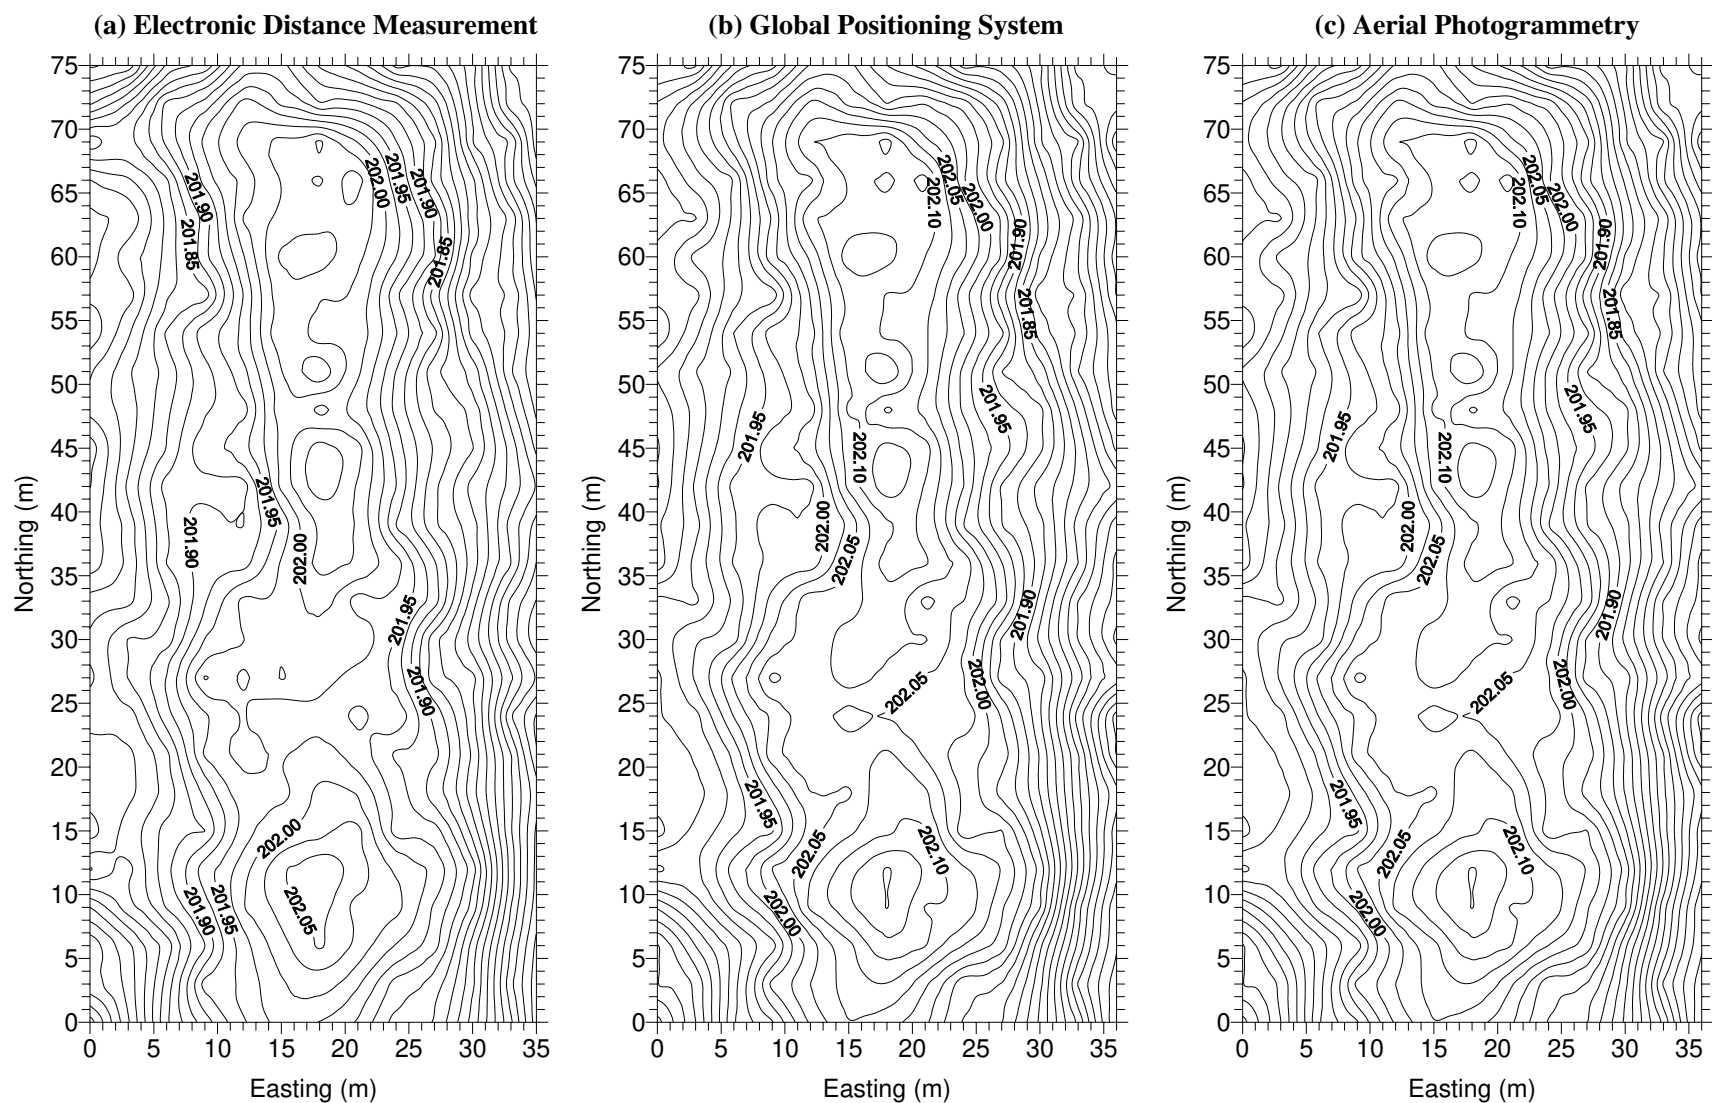
**Figure 3.17. Surface Elevations in Meters at the Prototype Hanford Barrier as Measured by Three Different Methods: (a) Electronic Distance Measurement on August 15, 2003, (b) Global Positioning System Survey on May 10, 2004, and (c) Aerial Photographs taken on August 17, 2004. The contour interval is 0.025 m.**
