A case of total pacemaker extrusion

Joro Nichev and Tosho Balabanski*

National Heart Hospital, Konyovitza 65, 1309 Sofia, Bulgaria

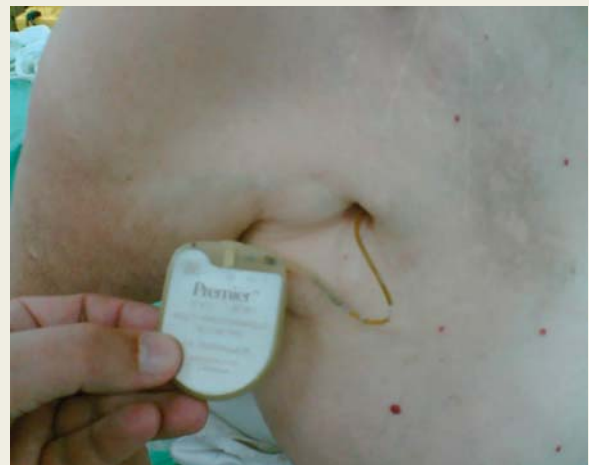
The patient finally reported to her primary care physician complaining of intermittent palpitation and requested to be hospitalized for re-implantation of her pacemaker. Upon admission, she presented with neither fever nor other manifestations of systemic or local infection. The pulse generator was totally extruded out of its pocket (Figure 1). An electrocardiogram revealed the presence of a junctional escape rhythm at a rate of 35–40 bpm.

Figure 1 Complete pacemaker extrusion out of its right subclavian pocket.

The extruded pulse generator was explanted. The electrode was cut at its entrance point into the cephalic vein, and reconnected to a new pulse generator, using an A1-N adaptor. The device was re-implanted in a new ipsilateral pocket, behind the major pectoral muscle, after the excision of the skin edges at the extrusion point. Prophylactic antibacterial treatment with ciprofloxacin was administered, in a dose of 500 mg po, twice daily for 5 days. The patient was followed for 3 months at our pacemaker department by the implanting physician who confirmed the complete healing of the wound and proper pacing functions. Her interim care was assumed by a regional pacemaker centre until February 2009, when the patient was asked to return to our department for a follow-up visit, 2.5 years after re-implantation of her pacemaker. That examination confirmed the persistence of a normally healed pulse generator pocket and normal functions of the pacemaker.
