**A Comparative Study of Insulator Materials
Exposed to High Voltage AC and DC
Surface Discharges**

*Thesis presented in partial fulfilment of the requirements for the
degree of Master of Science in Engineering*

Stellenbosch University

March 2009

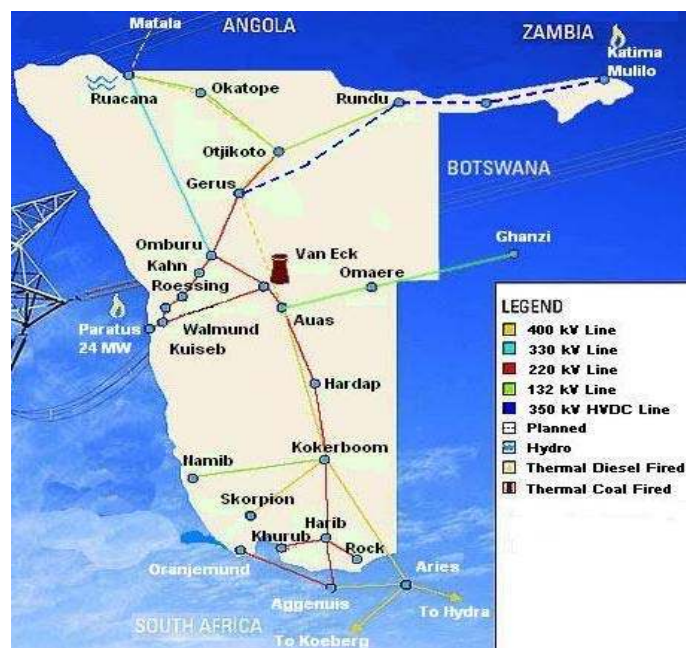
Fig. 1: Map of existing transmission lines in Namibia, also showing the planned 350 kV HVDC line (dashed blue line) [1].

This project entails the importing of power from utilities in the eastern part of the Southern African Power Pool (SAPP) into Namibia via a High Voltage Direct Current (HVDC) overhead transmission line. Voltage conversion will be accomplished via Voltage Source Converters, i.e. insulated gate bipolar transistors (IGBT) valves where switching control is independent of the current flow, instead of the more common used Thyristor valve. The line will connect the HVDC converter stations at Zambezi Transmission Station, near Katima Mulilo, with Gerus Transmission Station situated between the towns of Otjiwarongo and Outjo, covering a distance of 970 km. Transmission will initially be in mono-polar mode with metallic or earth return at negative 350 kV direct current (DC). Phase 2 of the project will consist of the installation of the second pole for bipolar operation at ± 350 kV DC. Fig. 1 shows the intended routes of the planned lines.

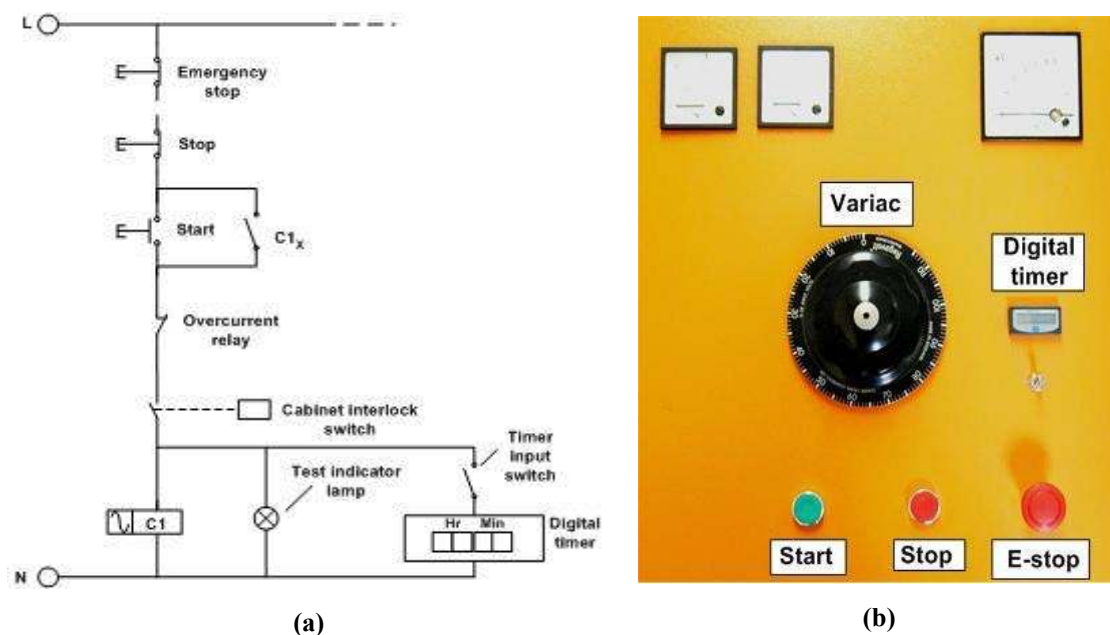
Fig. 15: (a) Circuit diagram and (b) Actual photograph of control circuit of IPT.

The test can be interrupted either by pressing the stop button or the emergency stop button, both of which are normally closed switches [37]. Both open the control circuit, de-energizing relay C1 and subsequently opening contactor C1 in the primary circuit, which interrupts the supply voltage. The emergency stop was introduced as a safety feature, since it locks into place once activated, permanently disabling the apparatus until it is reset by the user.

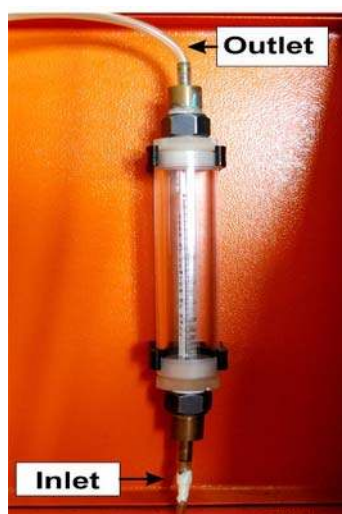
Fig. 32: Flow meter as installed in apparatus.

Previous tests performed on the IPT apparatus utilized a peristaltic pump to convey the liquid contaminant from its container to the sample. During these tests, difficulties were experienced in maintaining constant dry band arcing at the ground potential electrode. Observations documented by previous operators revealed this to be a common problem for this particular apparatus and test arrangement, and further suggested that careful adjustments to the contaminant flow rate might provide a solution [40]. In order to improve the control of the flow rate, a flow meter was installed between pump and outlet nozzle so as to obtain a true measurement of the flow rate at any given moment in time. The flow meter is shown in Fig. 32.

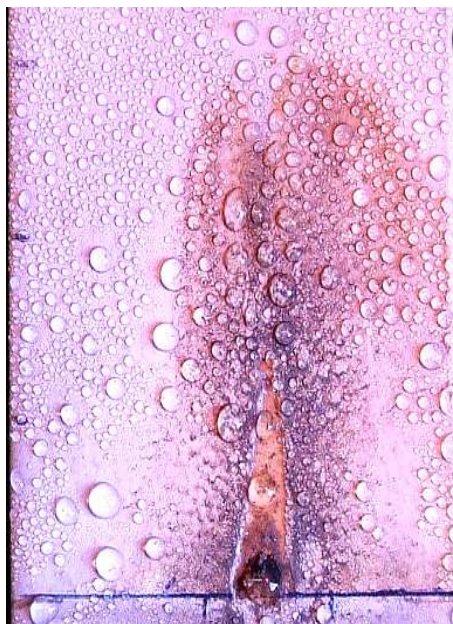
Fig. 58: Appearance of test sample AC4-A6 (not abraded) after washing.

A special mention must be made at this point of sample AC4-A6. This sample was not abraded during the cleaning procedure prior to testing like the other samples in the series in order to investigate the effect of the abrasion process on the samples. The visual observations revealed that there seems to be some improvement in the arcing stability at the ground potential electrode, but no major differences could be observed in the arcing behaviour. On the other hand, this sample also developed a glowing path towards the end of the second test hour, which resulted in this sample showing some of the largest erosion areas of this particular test series. Fig. 58 shows sample AC4-A6 after having been cleaned after testing. These observations call into question the validity of the abrading of hydrophobic test samples prior to testing to improve arcing behaviour, since no such improvements were observed. This sample will be closely observed during the other evaluation criteria in order to see if the absence of abrasion has resulted in other changes of sample performance.
