## A DETACHED BREAKWATER SYSTEM FOR BEACH PROTECTION

by James R. Walker<sup>1</sup>, Denton Clark<sup>2</sup>, and Joan Pope<sup>3</sup>

## SUMMARY

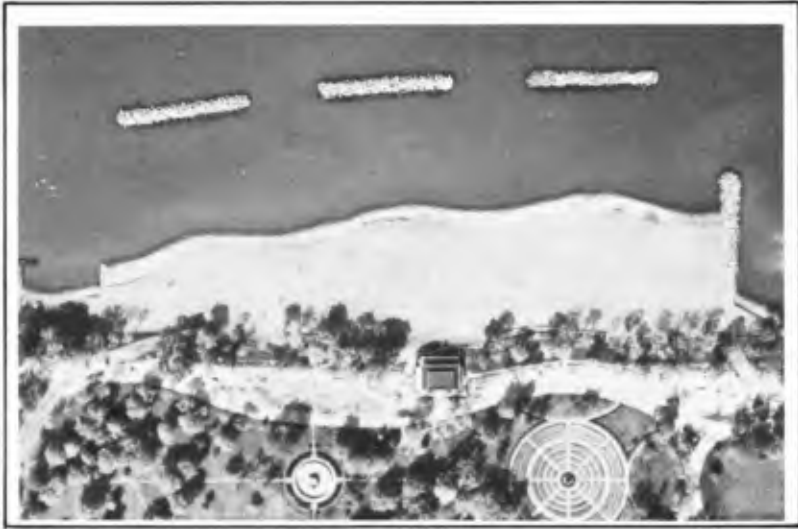
PHOTO 1: IMMEDIATELY AFTER CONSTRUCTION, OCTOBER, 1977

The project construction was completed in October 1977. Photograph 1 shows that the planform quickly adjusted to the shape predicted by the design. Salients soon formed in the lee of each of each breakwater, and the beach slopes flattened. Photograph 2 shows the configuration of the beach in May 1980. Figures 9 and 10 show the morphology of two representative beach and offshore profiles. Figure 9 was a section taken in the gap between the east and central breakwater and figure 10 was a section taken behind the west breakwater. The profiles in these figures show that the offshore slope during the first 6 months adjusted to 1 on 20 behind the breakwaters (figure 10), and to 1 on 15 in the gaps (figure 9). The foreshore slopes in both cases are 1 on 12. These slopes remained essentially the same, although the most recent survey (in November 1979) showed that the west end of the beach had eroded to within 20 feet of a seawall on the east side of the west groin at station 13 + 75. (Stations are at 100-foot incremental distances west of the east end of the Park, as shown in figure 5).

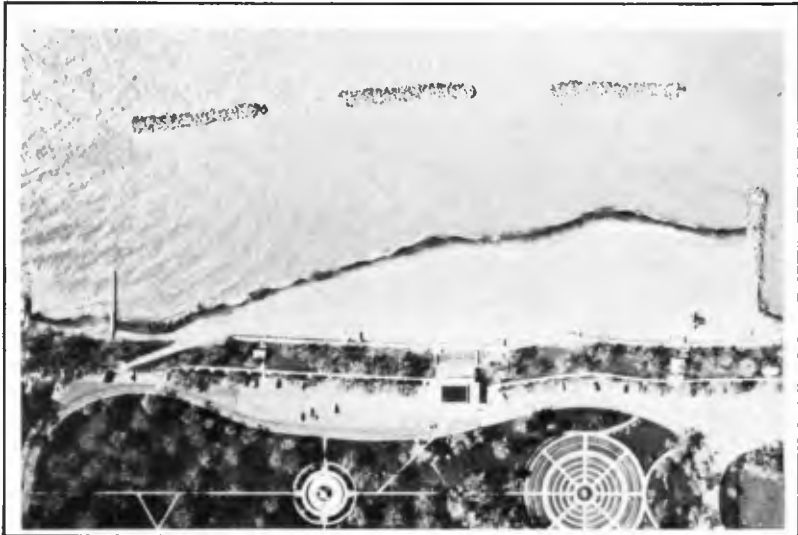
PHOTO 2: TWO AND A HALF YEARS AFTER CONSTRUCTION, MAY 1980
