A MICROSTRUCTURAL STUDY OF THE THERMAL FATIGUE FAILURES OF 60Sn-40 Pb SOLDER JOINTS

Submitted to Journal of Electronic Materials

D. Frear, D. Grivas, and J.W. Morris, Jr.

December 1987

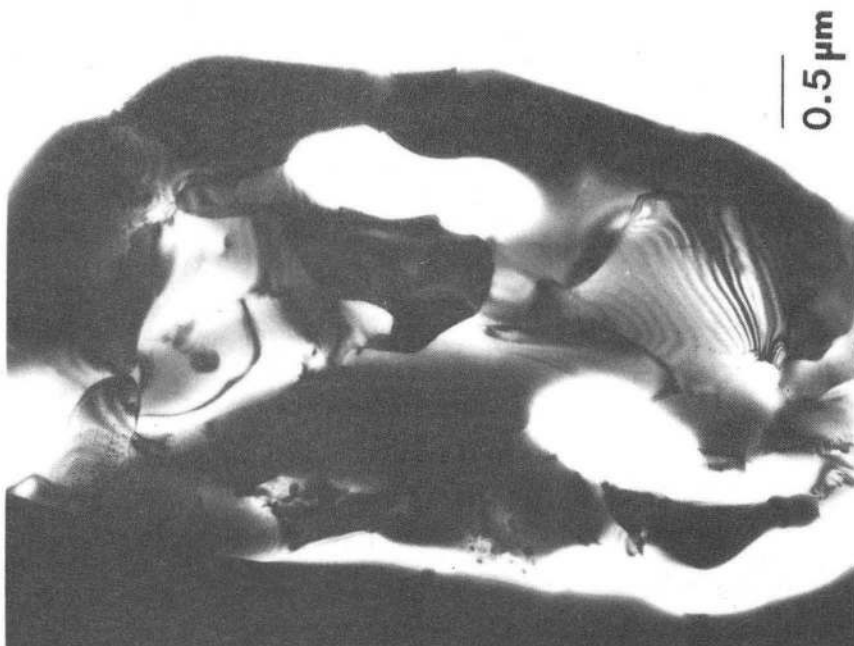
Fig. 8 TEM bright field image of polygranular  $\beta$ -Sn after 167 hours at 125°C illustrating Sn grain growth.

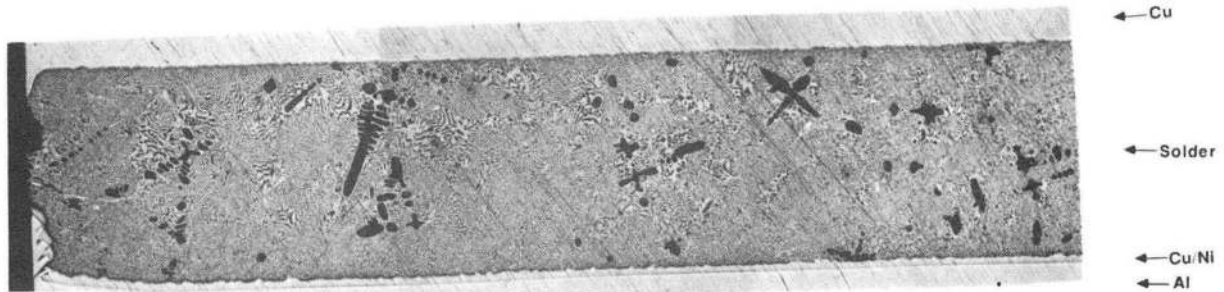
Fig. 9 Optical microstructure cross section of a 20 mil (0.51 mm) thick 60Sn-40Pb/Cu joint as a function of the number of thermal cycles between -55° and 125°C.

To determine the effect of joint thickness 60Sn-40Pb solder joint specimens of 20 mil (0.51 mm) thickness were also thermally cycled between -55°C and 125°C. By doubling joint thickness the shear strain was halved to 10%. The results of this experiment are

shown in Figure 9. Again heterogeneous coarsened regions develop throughout the solder. After 1000 cycles multiple coarsened regions occur parallel to the shear direction. More than one heterogeneous region was observed in each sample. Despite the halved strain the joints fail, through the coarsened region, after 1000 cycles. This is the same as for the 19% shear strained samples. The failures again occur through the Sn-rich regions in an intergranular fashion.
