A NOTE ON THE EARTHQUAKE PERFORMANCE OF REINFORCED CONCRETE SHEAR WALLS

Karl V. Steinbrugge,* Henry J. Degenkolb**

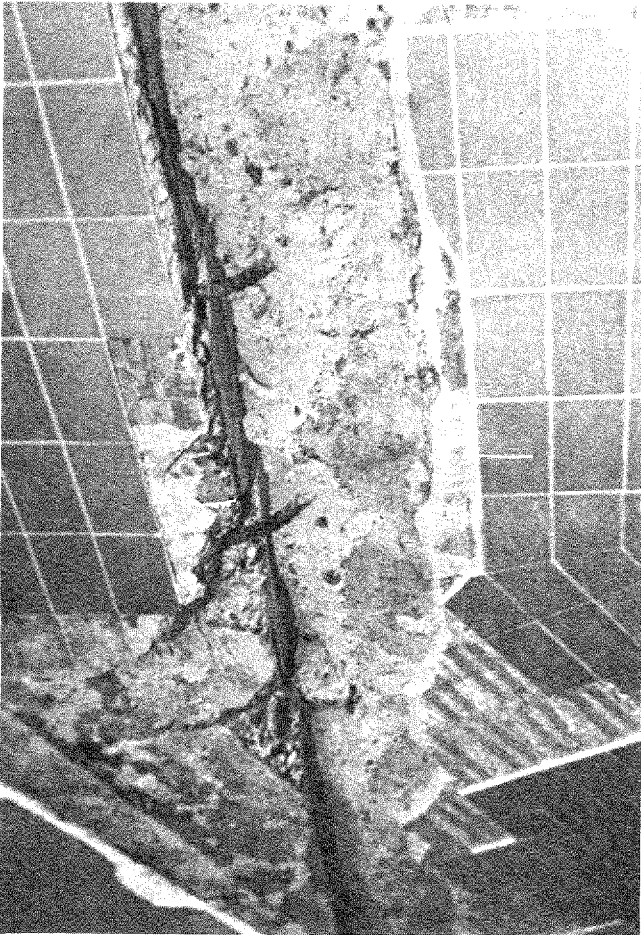
- Fig. 1 Construction joint movement in a shear wall in the West Anchorage High School during the 1964 Alaskan earthquake. Other structural damage was severe throughout much of this building.
- Fig. 2 Detail of Figure 1. Bent bars indicate the amount of lateral movement between the upper portion of the wall and its lower portion. Note the smoothness of the construction joint which provided an excellent slippage plane. Dowel action was inadequate.
- Fig. 3 Rear wall of the Cordova Building in Anchorage, Alaska after the 1964 Alaskan earthquake. The concrete was

Figures 1 and 2 show construction joint movement in a major shear wall in the two story West Anchorage High School during the 1964 Alaskan earthquake. The joint was so smooth that some persons called it a "troweled joint". Figure 3 shows the movement in a poorly built construction joint in the rear of the Cordova Building after the 1964 Alaskan earthquake. The aggregate in this instance acted as "ball bearings". Figure 4 clearly indicates the construction joint slippage that occurred in a wall of the Penney Building during the same shock. The authors' files contain similar examples from many other earthquakes.
