# A Review of Knowledge-based Defect Identification via PRPD patterns in High Voltage Apparatus

**INDEX TERMS** Partial Discharge (PD), high voltage motor, power cable, power transformer, GIS, GIL.

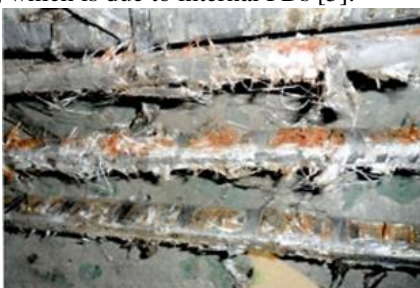
FIGURE 1. Stator windings aged for a long time due to internal discharge [5].

Internal defects are generated by air gaps in the main wall insulation of the stator windings during the manufacturing process to initiate the internal discharges which cause further damage to the insulation. Most of the generators and motors experience internal discharge inside the main wall insulation of stator windings at their rated voltage. The epoxy mica insulation has been manufactured as the main wall insulation, which can withstand the normal internal discharge activity for more than 40 years while maintaining excellent electrical properties [3]. Therefore, the internal PD does not attract much of the attention due to the less damage compared with other types of PDs. However, in case of large internal voids, the amplitude of internal PDs sometimes could reach a level which may overcome the PDs caused by other harmful PD sources. Also, due to an uneven size distribution of the internal air gaps, the related internal PD frequency can reach a wide band range which may cause troubles in the identification of PD types during online monitoring process. Meanwhile, it has been reported that in some cases, the internal PD causes abnormal destructive forces, sometimes resulting in delamination of the inter-turn insulation and the main insulation [4]. Figure 1 shows the stator bars from a 6kV motor after 20 years of service with serious damage observable in the main wall insulation, which is due to internal PDs [5].

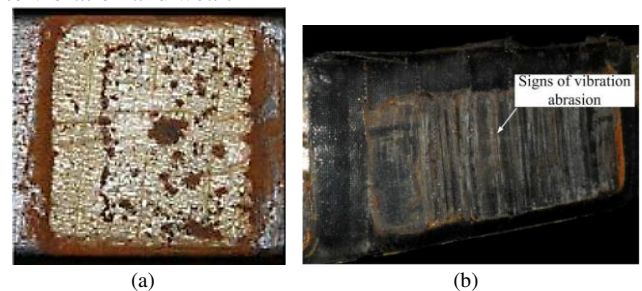
Figure 2. (a) Deposition of oxidized powder caused by slot discharge[10]. (b) A slot coil damaged to vibration abrasion[13].

- The loose stator bars in the core slots could take place due to the vibration during operation. This case is usually caused by an improper installation but may also be due to years of insulation shrinkage during material and thermal aging. If a bar begins to vibrate, the movement of the bar wears the slot conductive coating and the main wall insulation and initiates the PD inside the air gap, which results in depositing iron oxide powder in the depression of the insulating surface [7]. Figure 2(a) shows the deposition of the oxidized powder after a stator winding of an 8 kV air-cooled generator was aged for 1200h due to the slot discharge at 16 kV AC voltage. Figure 2(b) shows that the semi-conductive layer in the straight portion has been severely worn, and the surface has visible signs of aging due to vibration and wear.

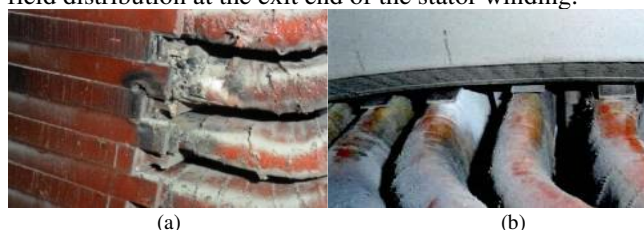
**Figure 4.** (a) Corona discharge at the slot outlet causes single phase ground fault on a 10kV three-phase asynchronous motor [18]; (b) Marks of corona discharge at the slot exit of a 2000kW/6kV high voltage motor [5].

This type of defect at the junction of the semiconductor coating and the stress grading paints at the end of stator windings initiates corona discharge [14]. At the exit end of the stator winding, the electric field distribution is extremely uneven. Under the action of the volumetric capacitance, the current distribution per volume unit is uneven, and the air gap is more prone to corona discharge where the electric field is higher. The deposition of iron oxide white powder in the gap at the joint have been determined as the source of such PD, which can be visually inspected (Figure 4). Such PD does not develop into a more severe spark discharge because of the blocking of the insulating medium. However, it is more likely to occur at the air gap at the exit end of the stator winding which is stronger than the corona discharge between the stator winding and core because of extremely uneven electric field distribution at the exit end of the stator winding.

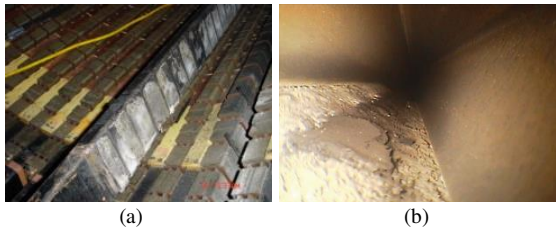
**Figure 6.** (a) The fault scene of the spark discharge after the stator bar near the neutral point of the winding is removed, (b) Borescope images of the side of a stator bar surface damaged by vibration sparking [23].

The vibration of the stator bars is the key initiation of spark discharge [21]. During normal operation, a loop current passes radially through the core lamination and moves axially along the back of the stator core to the bar [22]. As the bar vibrates, the conductive coating on the surface of the bar will be separated from the core. The induction current loop in the semi-conducting layer on the surface of the bar is cut off and an arc is generated at the same time, eventually forming a spark discharge which destroys the main insulation very effectively. Compared to other types of discharge, spark discharges have more released energy and are more destructive to insulation. It is reported that it takes about 5 years from the occurrence of spark discharge to insulation failure [14]. A typical feature of spark discharge is the presence of dust and significant pitting after insulation layer degradation. Figure 6 shows a typical generator stator bar, having been in operation for ten years and suffering from the spark discharge and a stator bar surface damaged by vibration sparking [23]. Simulated vibration spark discharge needs to meet two conditions: the presence of current in the semi-conductive layer on the surface of the bar, and vibration [24].

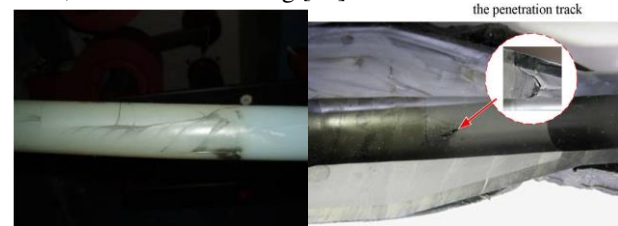
**Figure 7.** carbonization inside the cable termination (left) [28], penetration track on the cable joint (right) [29].

Dielectric surface damages are one of the major causes of insulation failure which are initiated by localized surface discharges and extends to the creepage discharges, flashovers and final breakdown of insulators and gas/solid interfaces in power system apparatus. It specially happens where outer insulation layer of the cable is damaged and/or where the screen is removed from insulation at cable joints and terminations. Ionized conductive path of discharge on the surface degrades the insulation which can be observed as carbonized track. Figure 7 shows an example of surface

discharge initiated carbonized paths on the cable surface due to two main possible reasons: void between the joint insulation and the central conductor due to inadequate heat shrink, or excessive carving [28].

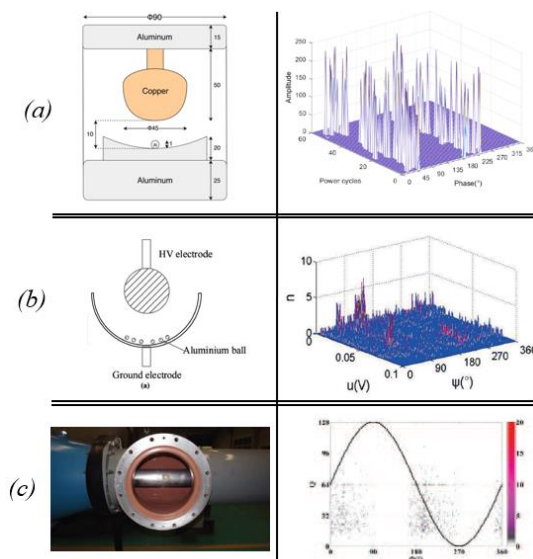
Figure 49. Floating particle model and corresponding PRPD: (a) sphere diameter 1mm (10kV HV electrode) and concave ground electrode[137], (b) HV ball electrode with 44mm diameter and half hollow sphere ground electrode 120mm [79], (c) flat metal washer with the diameter of 33mm suspended by insulation tape in real 220kV GIS [138].

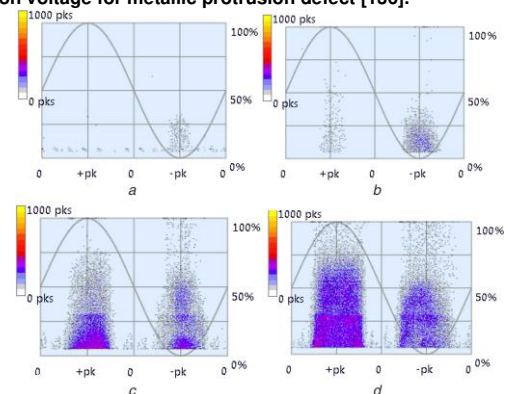
Figure 52. PRPD patterns for metal protrusion model on HV conductor inside a simulated GIS in the laboratory [139]
