Article

A Study of Concrete Slab Damage Detection Based on the Electromechanical Impedance Method

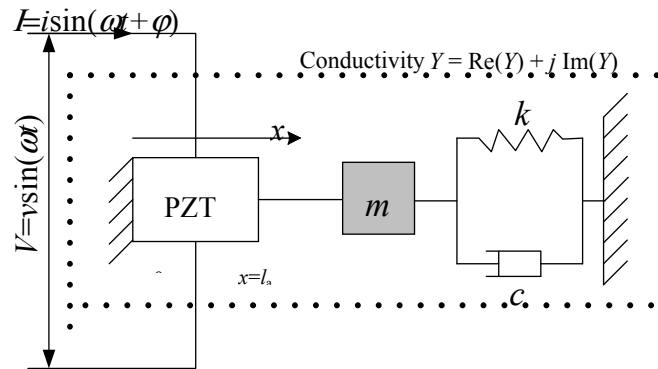
Figure 1. 1D model of PZT-structure coupled interactions.

structural system. Taking advantage of the inverse piezoelectric effect of piezoelectric materials, Liang and his colleagues derived a 1D model of the interaction between PZT and structures (Figure 1).

Under the impact of a simple harmonic alternating voltage V , the PZT pasted on the monitored structure surface acts as an element, of which one end was fixed, while the other end was connected to the main structure. The PZT impedance values can be expressed by the coupling relationship between the mechanical impedance of the piezoelectric and the main structure driving point. The piezoelectric equation is written as follows:

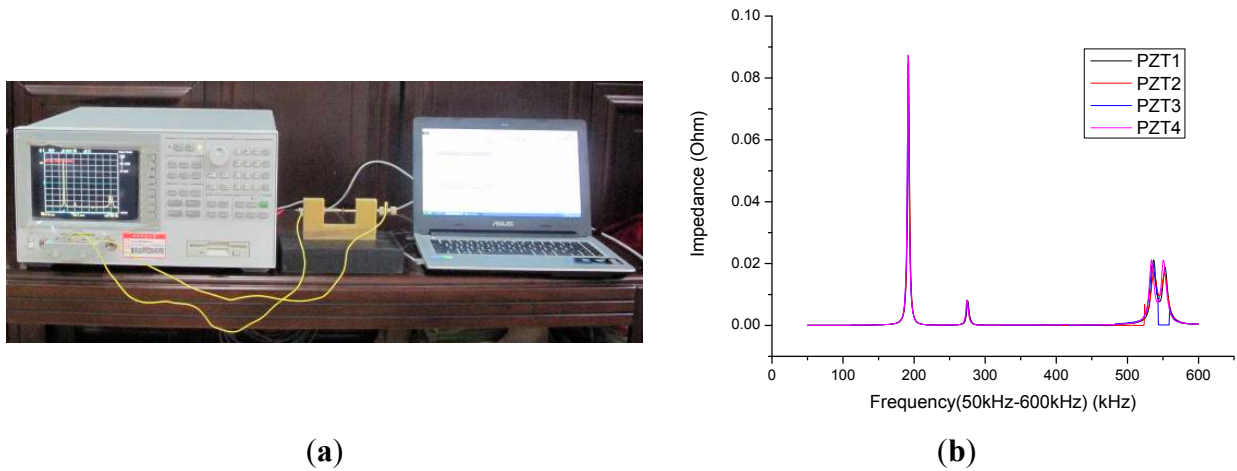
Figure 2. (a) Test equipment (b) Impedance curve of the bare PZT.

A PIC151 piezoelectric ceramic produced by PI Company (Lederhose, Thuringia, Germany) was adopted in the test. The size was $10 \times 10 \times 0.5$ mm, the impedance analyzer was an Agilent 4294A (Agilent Technologies, Santa Clara, CA, USA), the temperature was controlled at 20 ± 2 °C, and impedance signal test was carried out on the bare PZT, as shown in Figure 2.

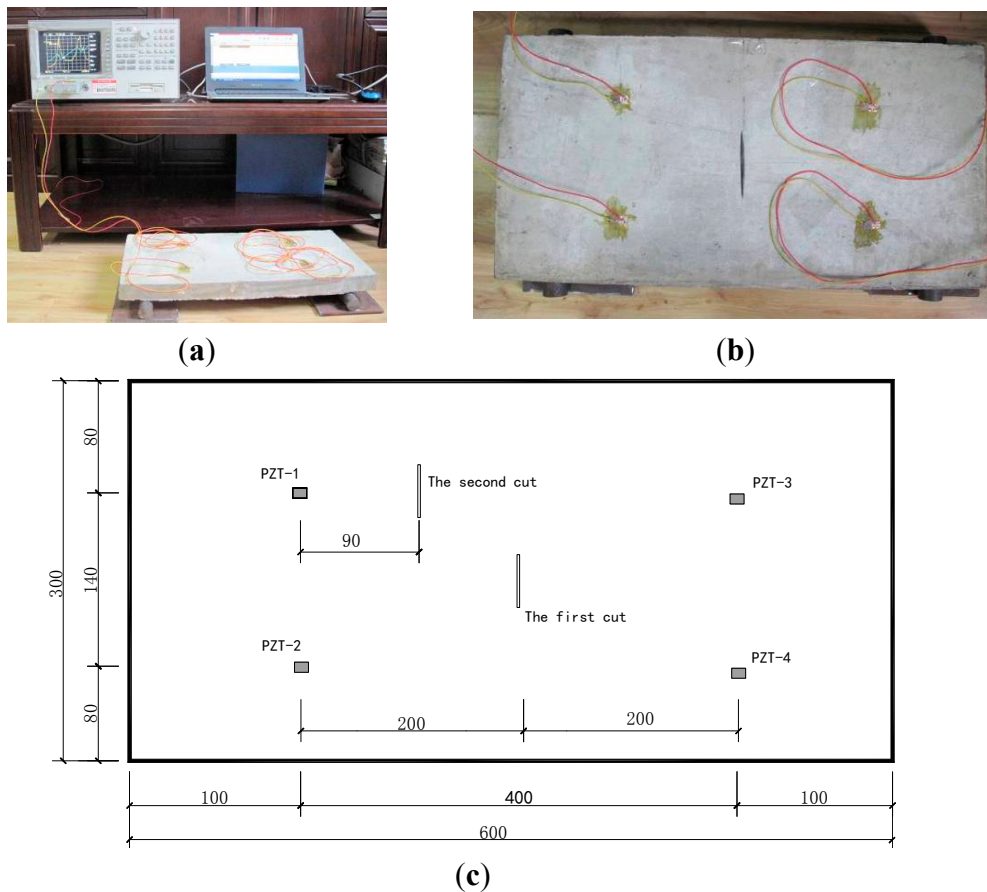
Figure 3. (a) Test equipment (b) First track of damage in reinforced concrete slab; (c) Plan of concrete slab.

In the test, the force of a one-way simply supported slab was simulated. The size of reinforced concrete slab was 600 mm × 300 mm × 40 mm, the concrete grade was C20, and the steel grade was HPB235, and both ends of the slab were simply supported, as shown in Figure 3a. The slab plane was divided into four parts, with each part has one piezoelectric attached to the center of the surface as shown in Figure 3b,c.

First the impedance curve of the undamaged concrete slab was tested, and different damage conditions were set later. Using the cutting machine, we cut the first damage track in the center of the concrete slab, as shown in Figure 3. Afterwards, the cut is enlarged and deepened continually to produce the four conditions. Then the second track of damage was cut at another location on the slab, and all its damage conditions are listed in Table 1. When testing the impedance curve, the frequency bands were divided as follows: 50–600, 50–150, 150–300, 300–450 and 450–600 kHz.

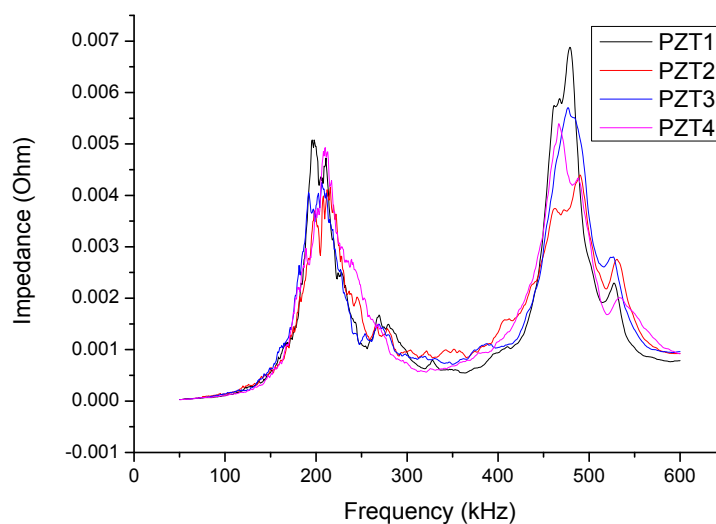
Figure 4. Impedance curve of PZT1-PZT4 (frequency 50–600 kHz).

The real part of the impedance curves of PZT1-PZT4, which is obtained when the concrete slabs are intact, is shown in Figure 4 (the frequency range is 50–600 kHz).

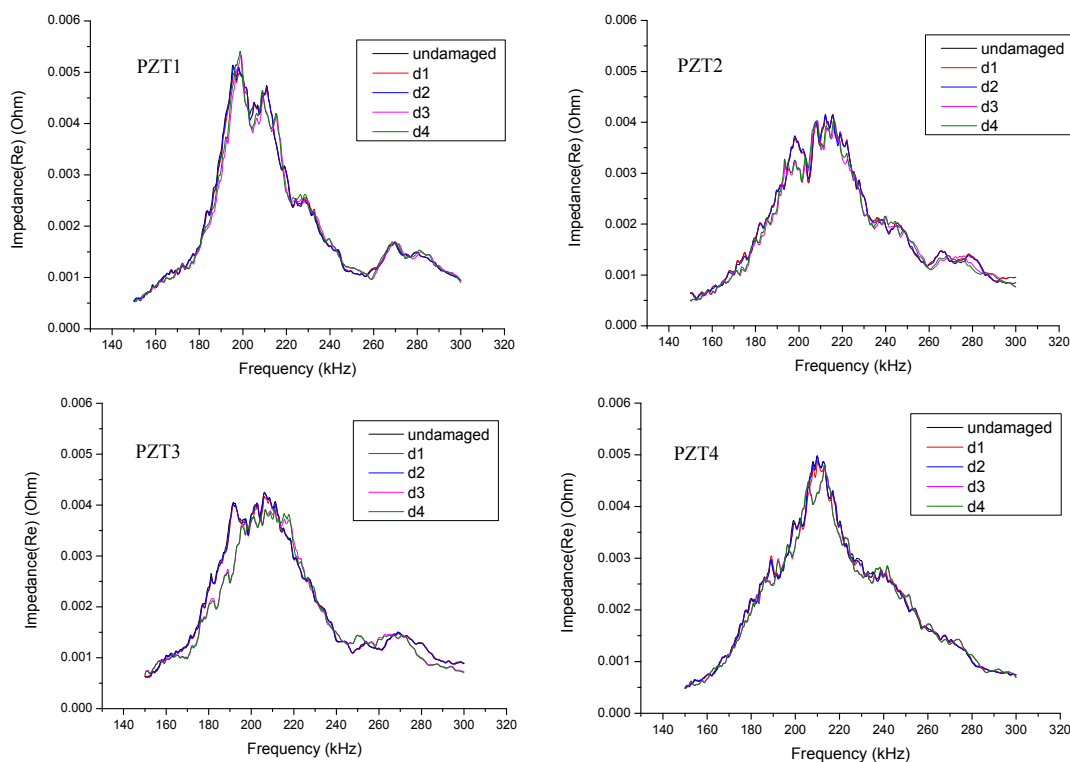
Figure 5. Real part of the undamaged and damaged impedance curves for PZT1–PZT4 (frequency 150–300 kHz).

The test was conducted in four separate frequency bands. Taking the impedance curves of PZT1-PZT4 in the frequency band of 150–300 kHz as an example, the impedance curves of the undamaged condition and the four damage conditions are plotted on the same graph as shown in Figure 5.

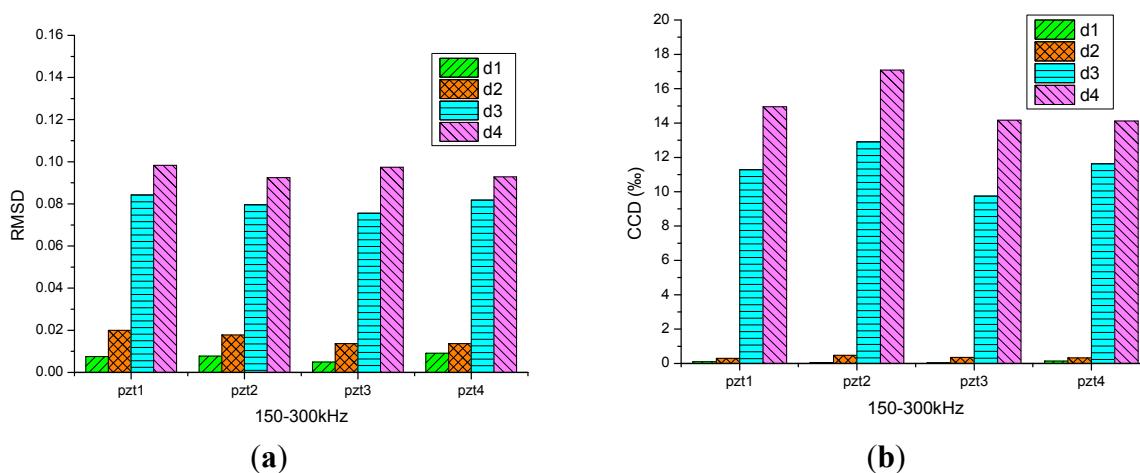
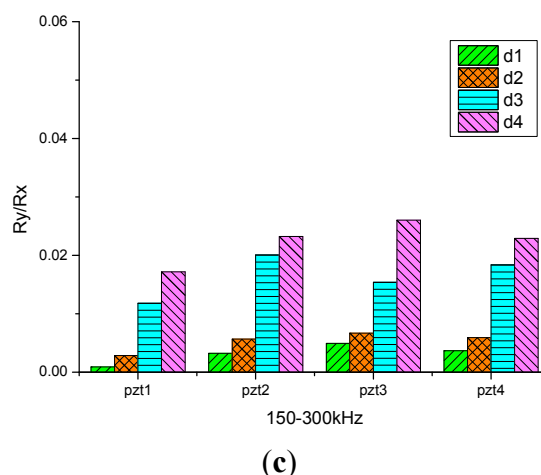
Figure 6. Histogram of the RMSD, CCD and R_y/R_x indices of damage conditions d1–d4.

In the damage analysis of the reinforced concrete slabs, the real part of the impedance curves is used. The frequency range is 150–300 kHz, the RMSD indices and CCD indices of four damage conditions d1, d2, d3, d4 are plotted in histograms in Figure 6a,b. It can be seen from the figure that, along with the increase of the amount of damage, the RMSD indices and CCD indices calculated from the test results of PZT1, PZT2, PZT3 and PZT4 increase, respectively. Because the damage signal of the concrete slabs obtained using the PZT is not sensitive enough, the damage indices of damage conditions d1 and d2 are small. However, when the damage depth of d3 is as deep as 1/2 the thickness of the slab, the damage indices begin to show an obvious growth. Judging from the analysis results, the changes in the amount of damage in reinforced concrete slabs can be monitored by the EMI method.

The new damage index R_y/R_x is used in the analysis, the frequency band is 150–300 kHz, and the index R_y/R_x of four damage conditions d1–d4 is plotted in histogram form as shown in Figure 6c. The result shows that along with the increase of the amount of damage, the indices from test results of PZT1, PZT2, PZT3 and PZT4 will increase, respectively. As to condition d3, the damage index also shows a great increase. In consequence, it is reasonable to judge the amount of damage of reinforced concrete slabs with the new index.

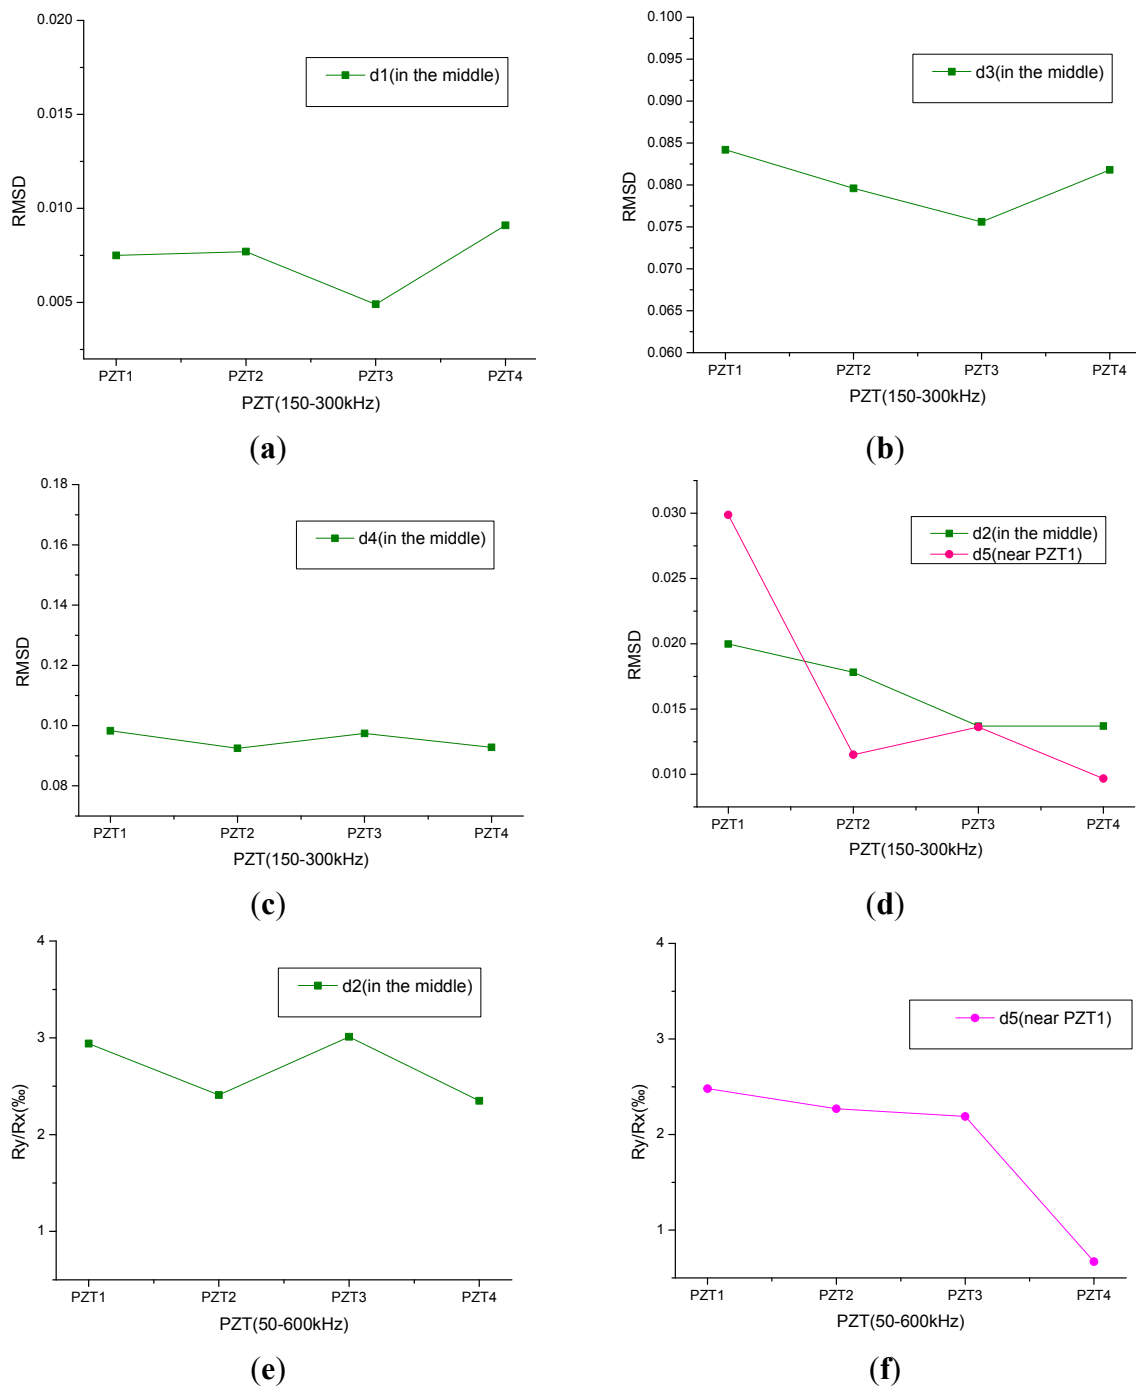
Figure 7. Distribution of damage indices of PZT1-PZT4.

The RMSD index is chosen in the first place, the frequency range is 150–300 kHz, and the indices distribution of damage conditions d1, d3, d4 calculated from PZT1, PZT2, PZT3, PZT4 are plotted in Figure 7a–c. The degrees of the first damage under conditions d2 and the second damage track under conditions d5 are similar, so their distribution is plotted in one figure as shown in Figure 7d. The damages of d1–d4 are in the center of concrete slabs, in the figure green boxes that are basically at the same height, indicating that the four damage indices obtained from the PZT analysis are similar. In Figure 7d, the red dot representing PZT1 is the highest, indicating that there is damage near PZT1.

The new index R_y/R_x is analyzed. The frequency range is 50–600 kHz, and the indices of d2 and d5 from PZT1, PZT2, PZT3, PZT4 are plotted in Figure 7. In Figure 7e, the analysis results obtained by the R_y/R_x index and RMSD index are the same. Figure 7f shows that the damage is far from PZT4, but in the vicinity of PZT1, PZT2, PZT3, and this area can be roughly located as shown in Figure 8.

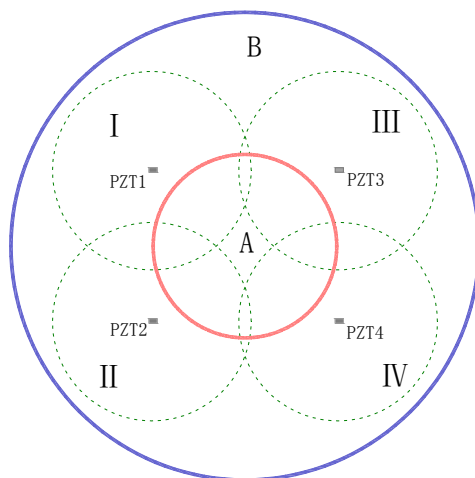
Figure 8. Diagram of the damage areas detected by PZT1-PZT4.

It is supposed that the damage areas detected by PZT1–PZT4 are I–IV, as shown in Figure 8. If the damage index values of the four PZT are similar, the damage is near to all four PZT, that is area A; if the difference of one or two indices is bigger, the damage is out of the range of the four PZT, that is area B. In consequence, the possible areas of damage location can be determined by the indices.

Through comprehensive comparison of the two damage indices, it is preliminarily judged that the damages of d1–d4 are near to the four PZT, *i.e.*, they are in area A, and near the center of area A. The damage under condition d5 is near PZT1, around the overlapping area of area I and area A.
