TECHNICAL REPORT R-60

**A STUDY OF SOME FACTORS AFFECTING
ROLLING-CONTACT FATIGUE LIFE**

By THOMAS L. CARTER

**Lewis Research Center
Cleveland, Ohio**

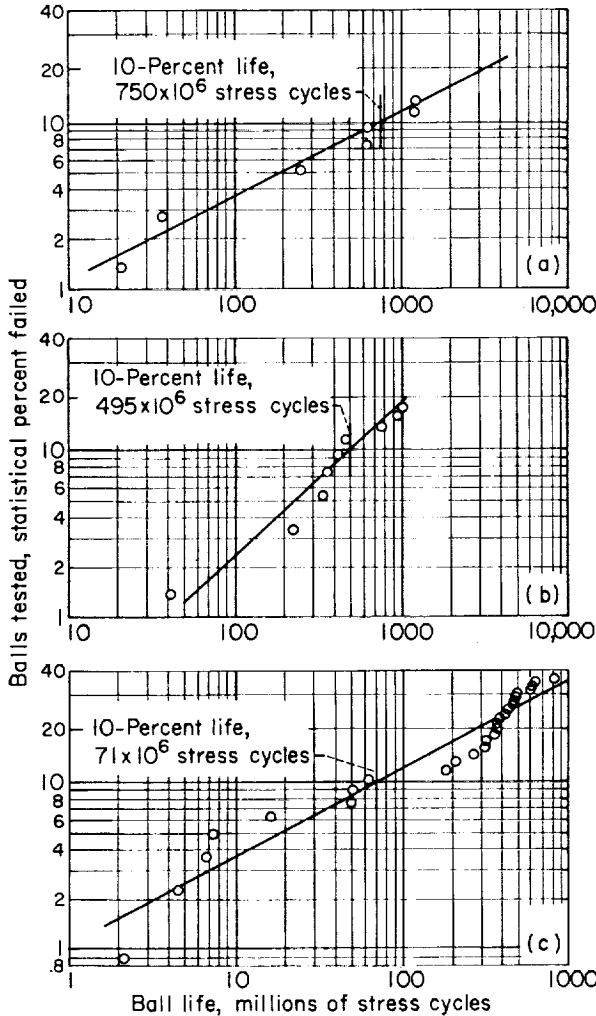
(a) Maximum Hertz stress, 600,000 psi; sample, 50 balls; 7 failures.
 (b) Maximum Hertz stress, 675,000 psi; sample, 50 balls; 9 failures.
 (c) Maximum Hertz stress, 750,000 psi; sample, 74 balls; 27 failures.

Stress-life relation.—The failure lives for the ball data of figure 2 are plotted as a function of stress in figure 4. The slope of this line is the stress-life exponent. A line drawn between the 10-percent lives for the two extreme stress levels gives an exponent (slope) of 10. The 10-percent life for the middle stress level is somewhat higher than this line, but a least-squares line through all the 10-percent lives results only in a shift in position and not in a significant change in slope. The overall value for the three stress levels of figure 4 is 10.4. This compares with the accepted value for full-scale bearings of 9 to 10 given in reference 7.

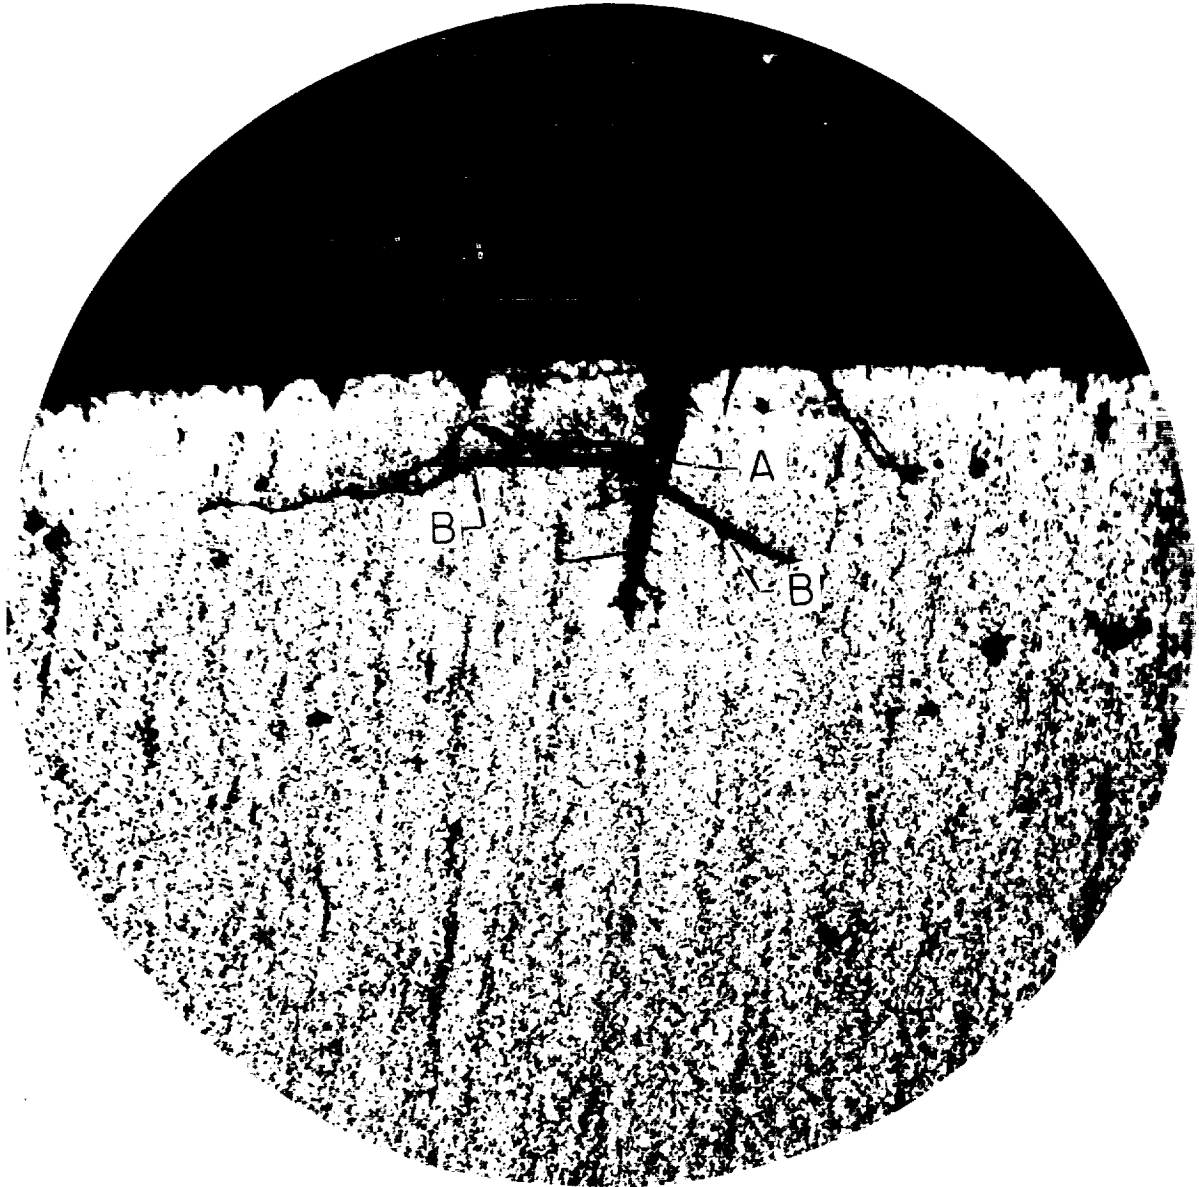
FIGURE 9.—Typical early failure stage in polar area. SAE 52100; X100.

A typical early failure stage in the polar area of concentrated perpendicular fiber is shown in figure 9. Chemical segregation (fiber) is parallel to the high compressive stress. Such structural inhomogeneity can result in changes of elastic modulus or act as a metallurgical stress raiser. It is believed that secondary tensile stresses normal to the fiber were too high and caused the fatigue crack indicated by A in figure 9. Shear cracks progressing from the original fatigue crack are shown by B. If the test were continued, these

would progress to open the characteristic shallow spall failure.

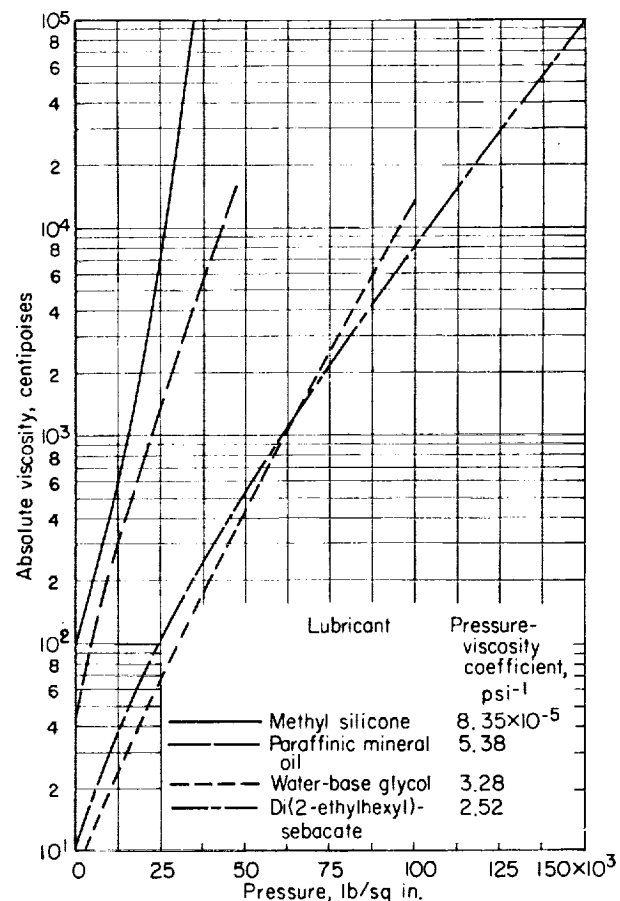
FIGURE 19.—Viscosity as function of pressure for various lubricants (ref. 17). Test temperature, 100° F.

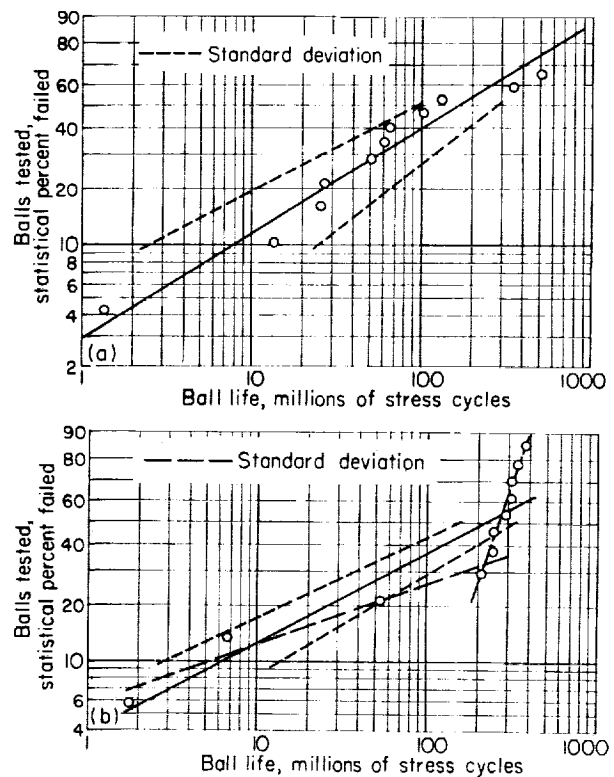
(a) Lubricant, polyalkylene glycol.
(b) Lubricant, 0.2-percent molybdenum disulfide suspension in polyalkylene glycol.

Polyalkylene glycol at 100° F.—The results for the plain polyalkylene glycol at 100° F are shown in figure 23(a); this run was made to establish a base line for comparison with results for a solid-particle suspension in the fluid. Subsurface metallographic appearance was very similar to that observed previously (in this investigation) with other lubricants for AISI M-1 and to that for other materials at 100° F (ref. 15). However, the track surface did not have the characteristic darkening (due to an adherent oxide film) that was characteristic of all previous material-lubricant combinations tested in the spin rig. This could have been because of abrasion or inhibited oxide formations. Since the track did not show signs of appreciable wear, the latter cause appears more logical. Failure appearance and type were the

The abrupt change in slope of the fatigue curve observed in figure 23(b) for the molybdenum

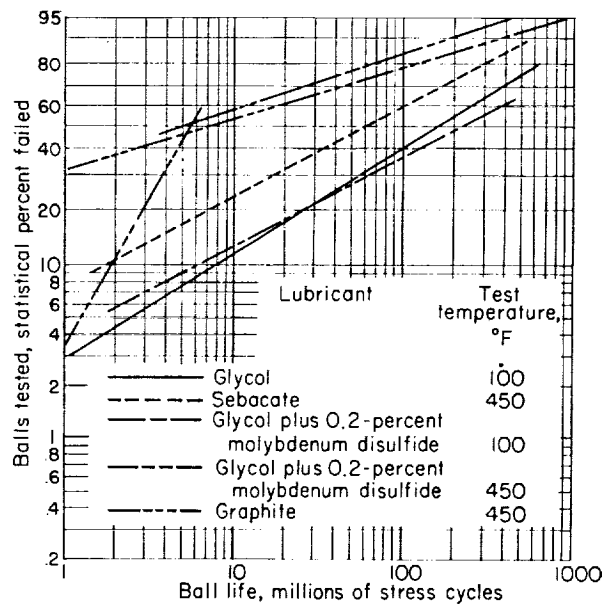
FIGURE 26.—Fatigue life for 1/2-inch AISI M-1 balls with various lubricants. Maximum Hertz compressive stress, 725,000 psi.

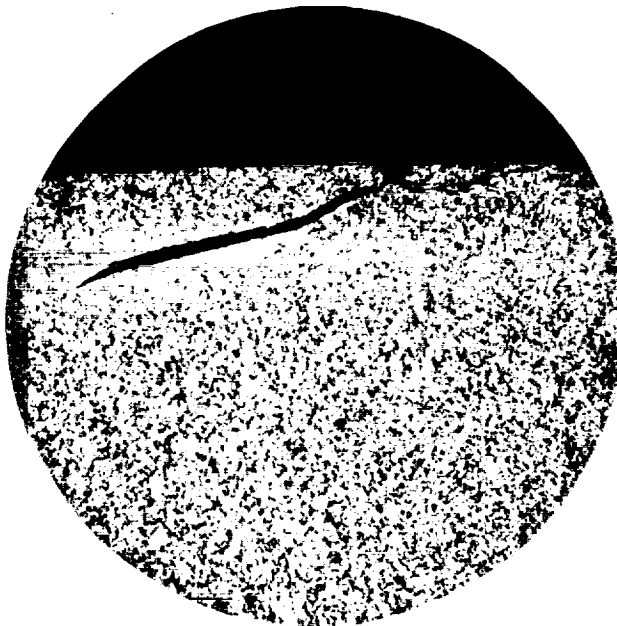
FIGURE 37.—Incompleted fatigue failures showing origin and progression in shear.
