# A Study to Establish Correlation Between Intercolumnar Cracks in Slabs and Off-Center Defects in Hot-Rolled Products

Diptak Bhattacharya · T. K. Roy · Vinay V. Mahashabde

Submitted: 17 September 2015 / in revised form: 11 November 2015 / Published online: 28 December 2015  
© ASM International 2015

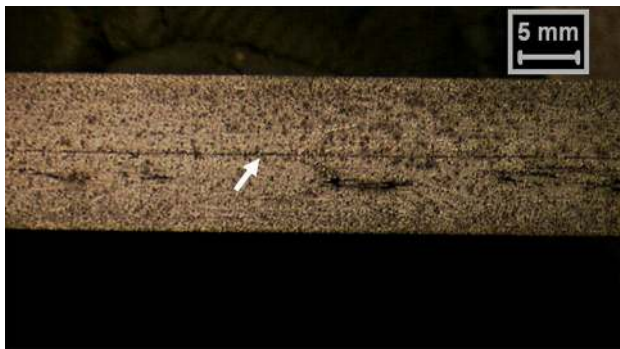
**Fig. 1** Crack-like defect at centerline of hot-rolled product arising due to centerline segregation

Internal quality of hot-rolled sheets or plates is crucial for the sound performance of products during their forming and final application. There have been several instances when delamination or cracks are reported at the mid thickness location of hot-rolled products during forming stage as shown in Fig. 1. Metallographic investigations in most cases reveal a segregation band of manganese sulfide stringers along the centerline of rolled products indicating the defect to have originated from centerline segregation in slab.

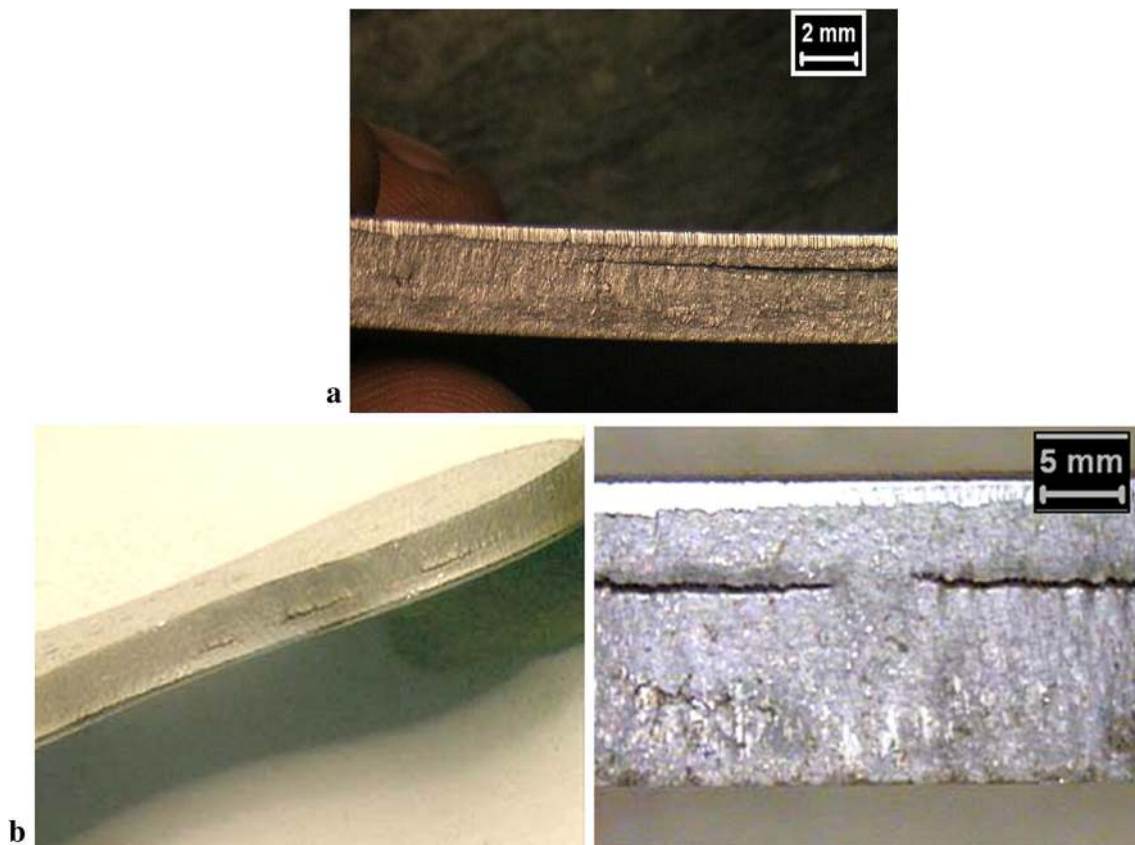
**Fig. 2** Crack-like defect at off-center location of hot-rolled plates observed after forming

During cold-forming operations, some customers of hot-rolled products reported similar delamination or cracking at locations away from the centerline (henceforth, denoted as off-center) as shown in Fig. 2a, b, respectively. Metallographic investigations indicate a segregation line along the off-center crack location similar to that observed to occur on account of centerline segregation in slabs. This may be noted from Fig. 3. Optical microscopy reveals elongated stringers of manganese sulfide in the off-center segregation band as shown in Fig. 4. This clearly suggests that the segregation at the off-center location of the rolled product leads to delamination or cracks during forming operations.

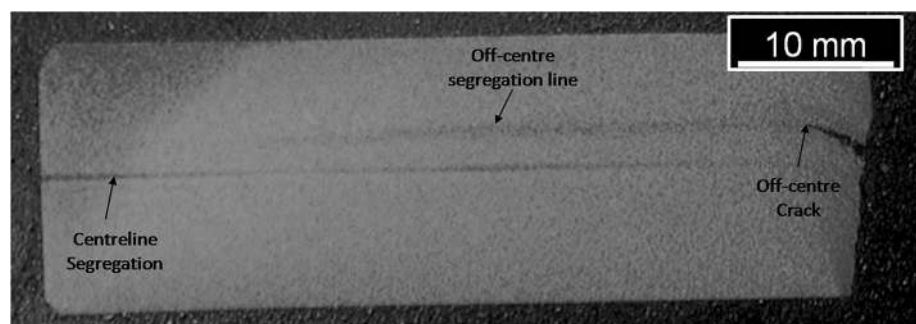
**Fig. 3** Photograph of transverse section of rolled product revealing segregation band along the crack line at off-center location after macroetching (50 vol% HCL)

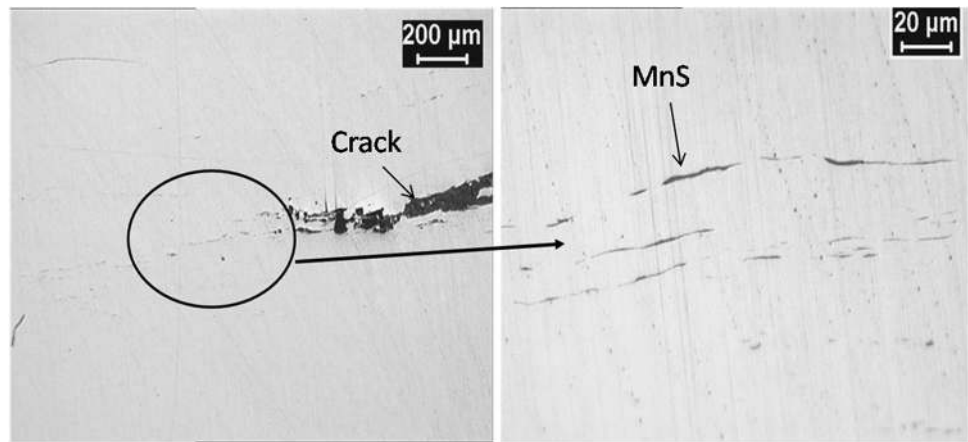
**Fig. 4** Optical micrographs indicating the presence of manganese sulfide stringers at the off-center crack locations

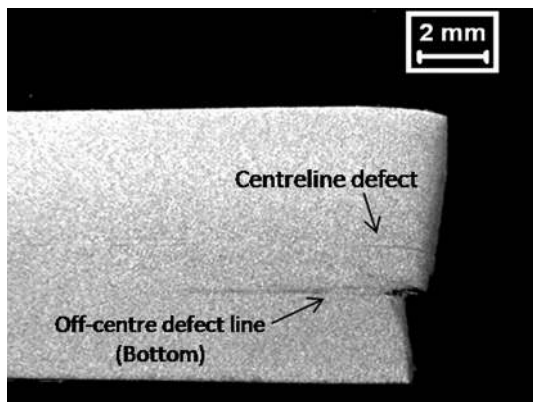
**Fig. 5** Transverse section of macroetched hot-rolled products showing segregation band at centerline and (A) off-center location in one direction (B) off-center location in both directions about the mid thickness plane

The off-center segregation lines may be observed above or below the mid thickness plane of the hot-rolled products or sometimes in both directions, as shown in Fig. 5. Sometimes they are present in addition to centerline segregation. The presence of segregation line at the center of hot-rolled products is a well-studied phenomenon but similar segregation line at off-center locations is not well understood. However, the presence of segregations suggests that the delamination at off-center locations is related to some pre-existing internal defects in the continuously cast slab.

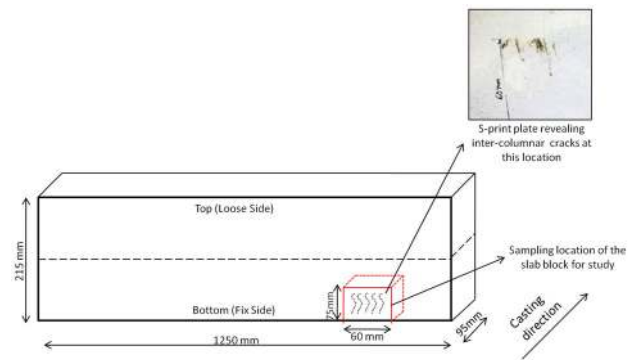
**Fig. 7** Schematic illustration of sampling location of slab block from S-print slab sample

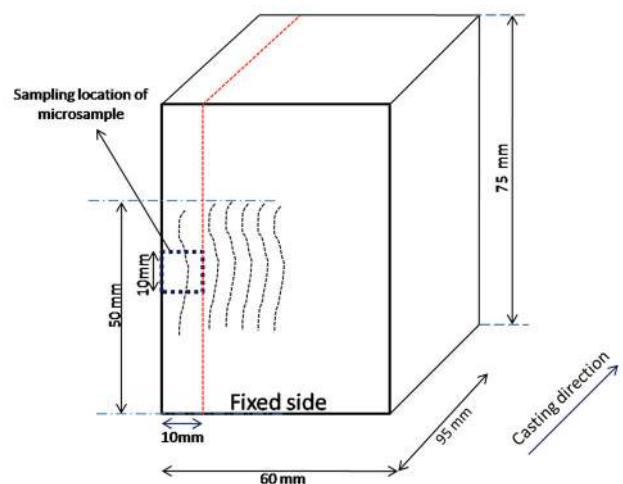
**Fig. 8** Sampling location of microsample from suspected crack portion in the slab block

A microsample of dimension 10 mm × 10 mm × 10 mm was separated from the suspected location of intercolumnar cracks in the slab block. The schematic illustration of its sampling location is represented in Fig. 8. The collected microsample was hot mounted, polished, and observed under optical microscope (Lieca, model: DMRX, Germany) in unetched condition. Following this, studies were made under FE-SEM (Model: Ziess, Vorpommern, Germany) with EDAX and X-ray mapping attachments.

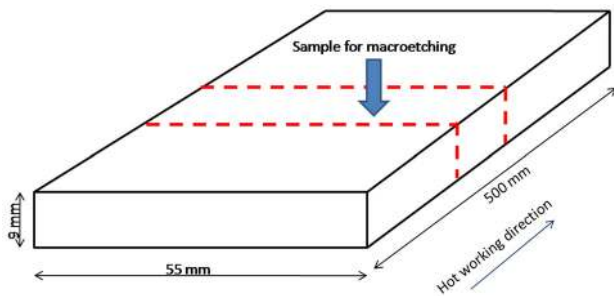
**Fig. 9** Sampling location from hot worked plate of 9-mm thickness

In order to examine its internal quality, a sample was retrieved from the hot worked plate as indicated schematically in Fig. 9 using hydraulic shear machine (Model: HVR 2020). The transverse face of the cut out sample was

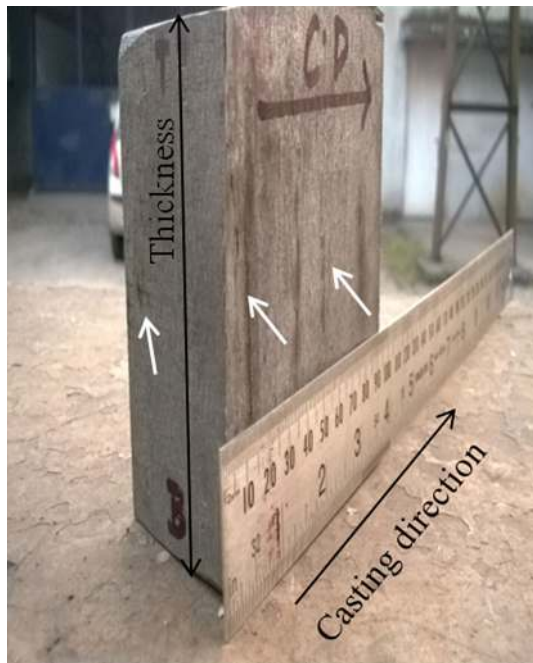
**Fig. 10** Macroetched slab block revealing intercolumnar cracks. (actual photograph)

Macroetching of the slab block revealed the internal cracks from the original slab. These cracks are observed perpendicular to the casting direction and at several locations in the transverse faces of the slab block as shown in Fig. 10. All the cracks are at same distance with respect to the bottom surface of the slab as noted from the schematic diagram of the macroetched slab block in Fig. 11. Since these cracks are generated at the solidification front, the distance ( $'s'$ ) of the cracks from the adjacent slab surface may be employed in solidification equation,  $d = v(s/k)^2$  (where  $s$ -shell thickness (mm);  $k$ -machine constant (mm/min<sup>2</sup>);  $v$ -casting speed (mm/m); and  $d$ -distance from

meniscus (mm)) to roughly estimate the location in the caster where the cracks would have formed. For the slab under study, this distance ( $'d'$ ) is obtained to be 6640 mm (putting  $s = 50$  mm,  $v = 1100$  mm/min, and  $k = 20.35$  mm/m), which corresponds to 9th segment of the caster which was observed with misaligned guide rolls. Misaligned rolls may result in deformation of the solid shell due to bulging of strand between support rolls, imposing strain on the solidification front leading to internal cracks [2]. It may therefore be understood that even the interior of the slab block would contain similar cracks along the plane of cracks revealed on the surface of the slab block.

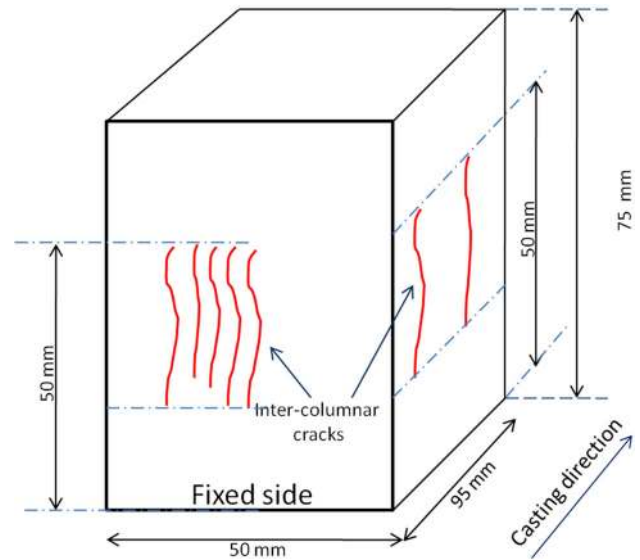
**Fig. 11** Schematic diagram of macroetched slab block

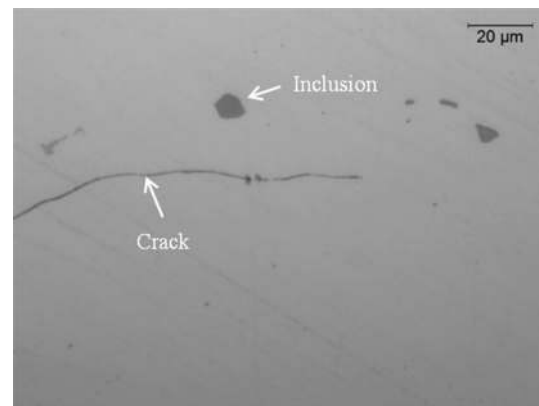
**Fig. 12** Unetched slab sample showing the presence of globular inclusions near the crack (×500 magnification)

The unetched microsample as observed under optical microscope is shown in Fig. 12. It reveals the presence of globular inclusions in the vicinity of an intercolumnar crack. X-ray elemental mapping identifies the globular inclusions to be of manganese sulfide origin as shown in Fig. 13. SEM-EDS line scan analysis was carried out across the crack at multiple locations and the manganese sulfide-type inclusions are indicated inside the crack as well. One such location may be noted from Fig. 14. It may be understood that as intercolumnar cracks formed in the mushy zone during casting, it would have created a suction of solute-rich liquid from the neighboring interdendritic spaces to fill the cracks. This resulted in accumulation of solute elements like sulfur at certain locations inside and in the surroundings of the crack. Consequently, it led to the formation of inclusions observed in association with the intercolumnar cracks.

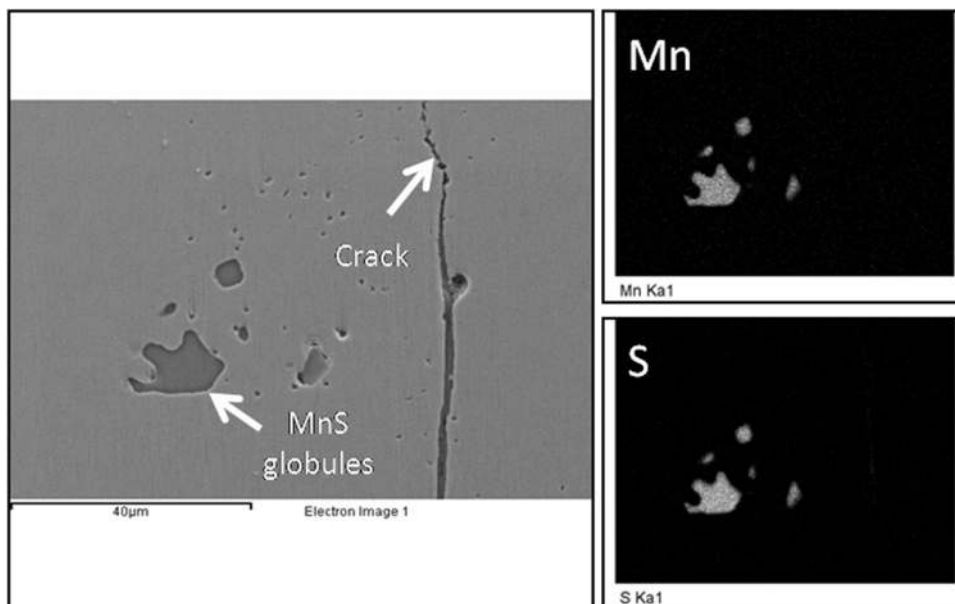
**Fig. 13** X-ray mapping revealing manganese and sulfur in globular inclusion

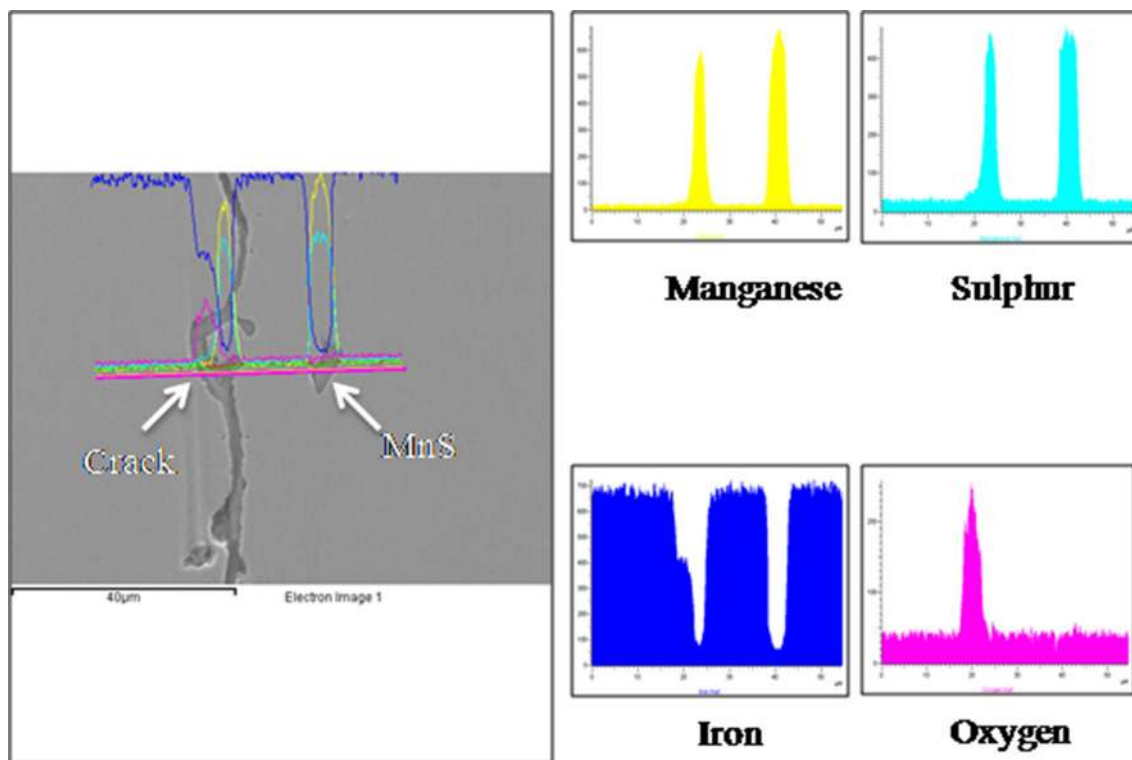
**Fig. 14** EDS line scan across the crack indicating MnS both inside as well as in the vicinity of the intercolumnar crack

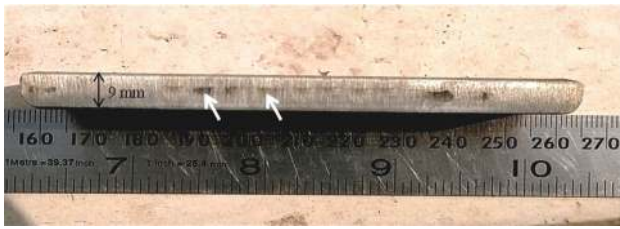
**Fig. 15** Defects in hot worked plate sample arising from intercolumnar cracks in the slab sample

On macroetching, the transverse face of the hot worked plate sample reveals a segregation band (defect line) as shown in Fig. 15. This resembles with observation of centerline segregation in macroetched hot-rolled plate samples. Also, the segregation band is similar to that found associated with off-center crack locations in defect component as shown in Figs. 3 and 4. Optical microscopy in unetched condition reveals plenty of fine stringers at the segregation band location as shown in Fig. 16. Using EDS point analysis, the stringers are confirmed to be of manganese sulfide type as represented in Fig. 17.

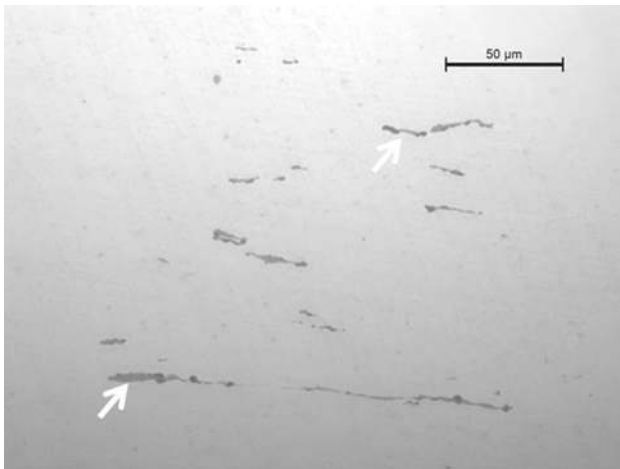
**Fig. 16** Unetched hot worked plate sample showing MnS stringers at the defect location ( $\times 500$  magnification)

The manganese sulfide stringers in the rolled plate originate from the globular sulfide inclusions observed in association with the intercolumnar crack in the slab. The presence of stringers at the defect location in plate suggests that the segregations inside and around the intercolumnar cracks do not disappear on rolling. Rather, they accumulate along some plane in the rolled product, forming a segregation band. The location of this segregation band with respect to the thickness direction of the rolled plate is

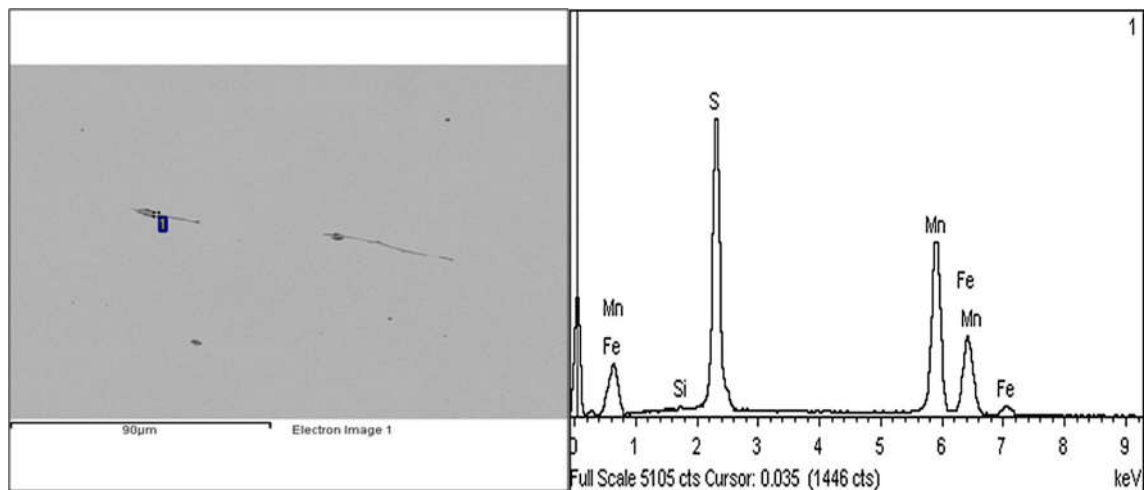
**Fig. 17** EDS analysis confirming the presence of MnS stringers at defect portion in hot worked plate

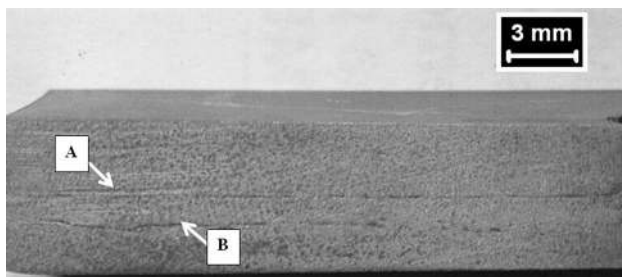
**Fig. 18** Transverse section of rolled plate showing both centerline defect band (A) and off-center defect band (B)

A slab having both centerline segregation and intercolumnar cracks is suspected to create multiple defect bands in the transverse section of the hot-rolled products as shown in Fig. 18. In that case, the segregation band developed due to intercolumnar cracks would be away from the centerline of the hot-rolled product. As there is no facility to experimentally roll full thickness slab samples, investigation of hot-rolled plate samples collected from a rolling mill may validate above hypothesis.
