Presented to the Faculties of the University of Pennsylvania in Partial Fulfillment of the Requirements for the Degree of Master of Science in Historic Preservation 2006.
Advisor: Frank G. Matero

**A TECHNICAL STUDY OF THE MURAL PAINTINGS ON THE INTERIOR
DOME OF THE CAPILLA DE LA VIRGEN DEL ROSARIO,
IGLESIA SAN JOSÉ, SAN JUAN, PUERTO RICO**

This is a technical study of the extant murals of the 17th *Capilla de la Virgen del Rosario* located within Iglesia San José, San Juan, Puerto Rico. The primary objectives of this investigation were to: document existing mural campaigns, establish a chronology of mural painting through analysis of materials and techniques, evaluate the conditions of the paintings and to determine possible deterioration mechanisms, and propose recommendations for their conservation and interpretation. In-situ documentation including color digital photography, extensive field notes, and mapping of visible painting campaigns were conducted. This was followed by a materials analysis of select campaigns' substrate, binders, and pigments. Test methods included gravimetric analysis and XRD of substrate plasters, examination of cross-sections and pigment dispersions,

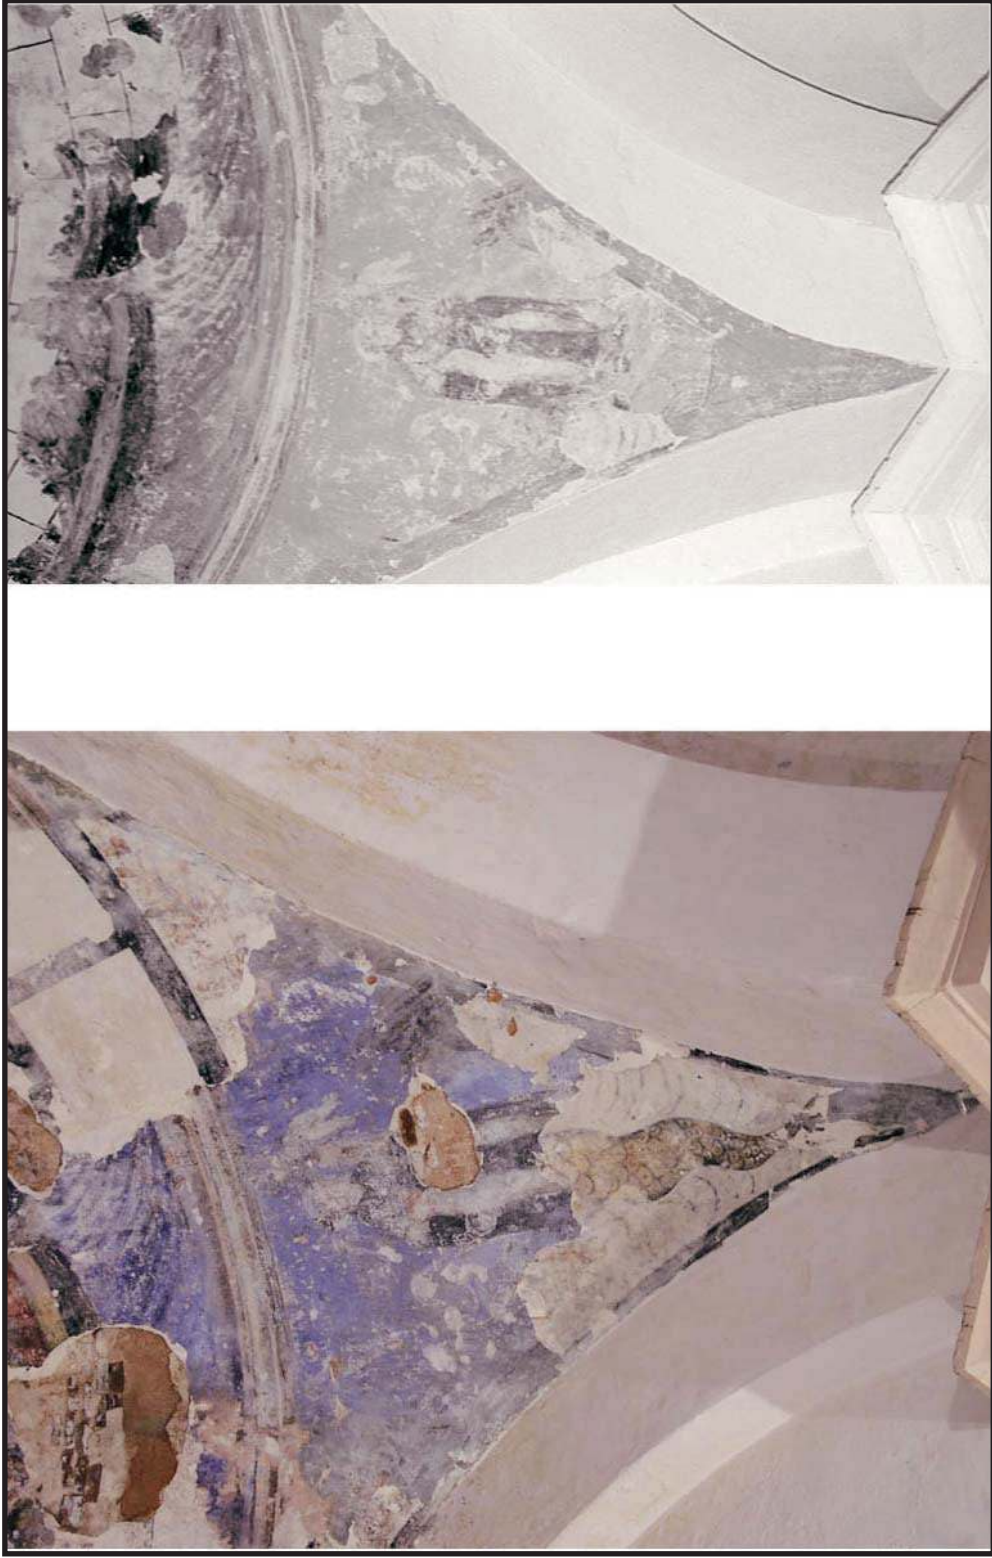
Figure 17: Photographic comparison of Pendentive 1, on the left is a 2004 image and on the right, an image taken in 1981. Note the deterioration in terms of areas of loss and image legibility over a twenty year time span. (Source: Pantel y del Cueto & Associates)

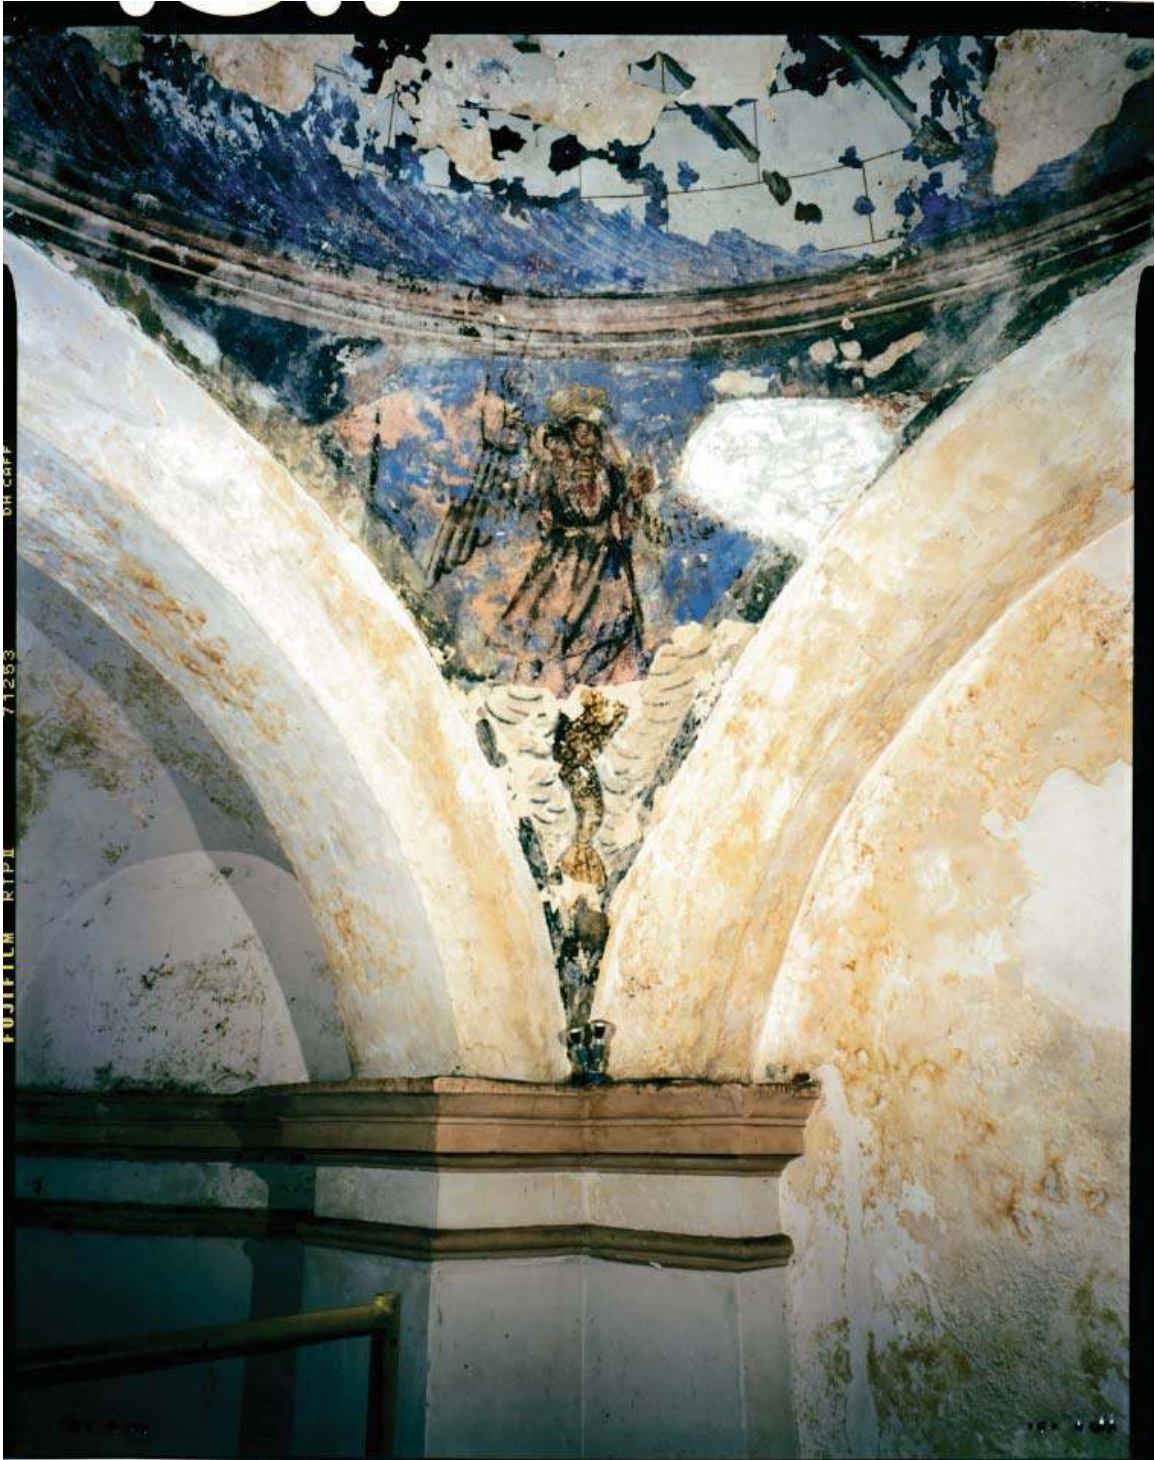
Figure 18: Pendentive 2, southwest corner of Rosario Chapel.
(Source: Joseph Elliott, 2004)

There is a large area of loss down to the original mural Campaign A at the valley point of Pendentive 2 (Figure 18). A 1 ½' x 2' area, along the upper right edge of the pendentive has been patched with repair mortar and remains unpainted. In addition there is a large area of loss measuring 2 ½' x 2 ½', which now exposes the brick dome construction. Due to excessive powdering and binder loss, the earlier Campaign C imagery often shows through making both campaigns nearly illegible. What can currently be seen is a faint image of the Virgin Mary, distinguishable with the aid of a 1982 photograph (Figure 19). The Virgin is depicted wearing a large gold crown and veil, a yellow and red under robe draped by a brilliant blue cloak. She holds the child Jesus in her right proper arm, while the left is extended with her hand closed as if she were holding something no longer visible (Figures 56-58). There is also a dark charcoal gray area in the upper left corner which is similar to the border color on Pendentive 4. The bottom edge of the dome, (framing the top of the pendentives), is defined by the faux cornice from Campaign C, which was not over-painted.

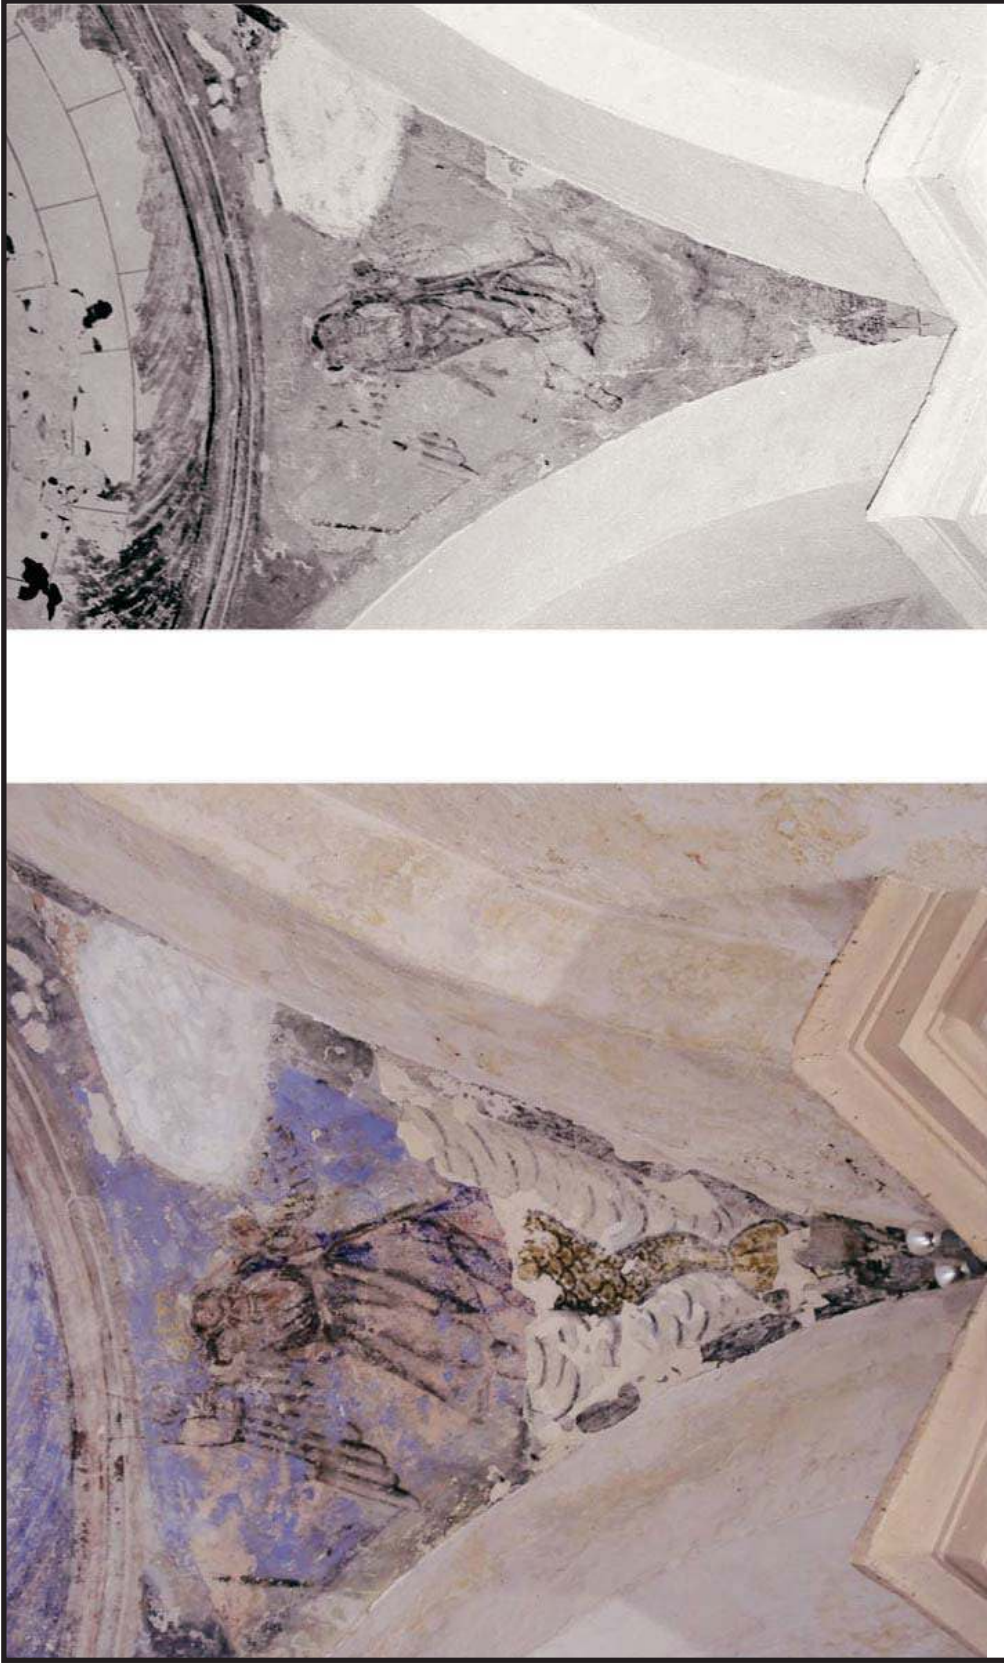
Figure 19: Photographic comparison of Pendantive 2, on the left is a 2004 image and on the right, an image taken in 1981. Note the deterioration in terms of loss and image legibility over a twenty year time span. (Source: Pantel y del Cueto & Associates)

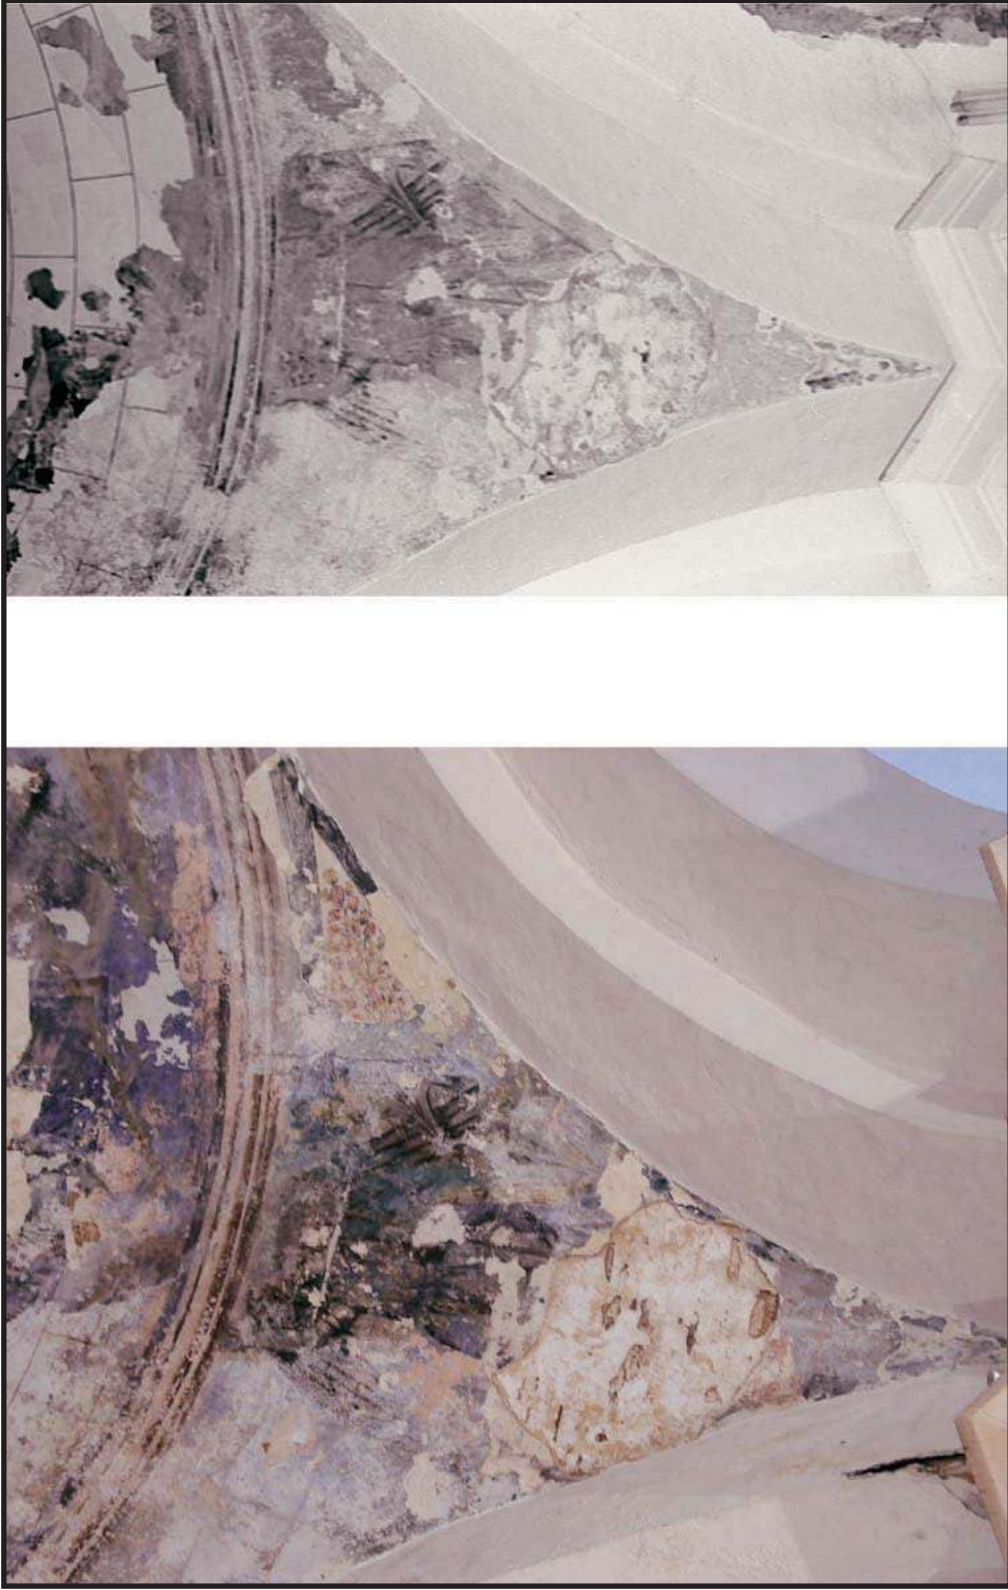
Figure 21: Photographic comparison of Pendentive 3, on the left is a 2004 image and on the right, an image taken in 1981. Note the deterioration in terms of loss and image legibility over a twenty year time span. (Source: Pantel y del Cueto & Associates)

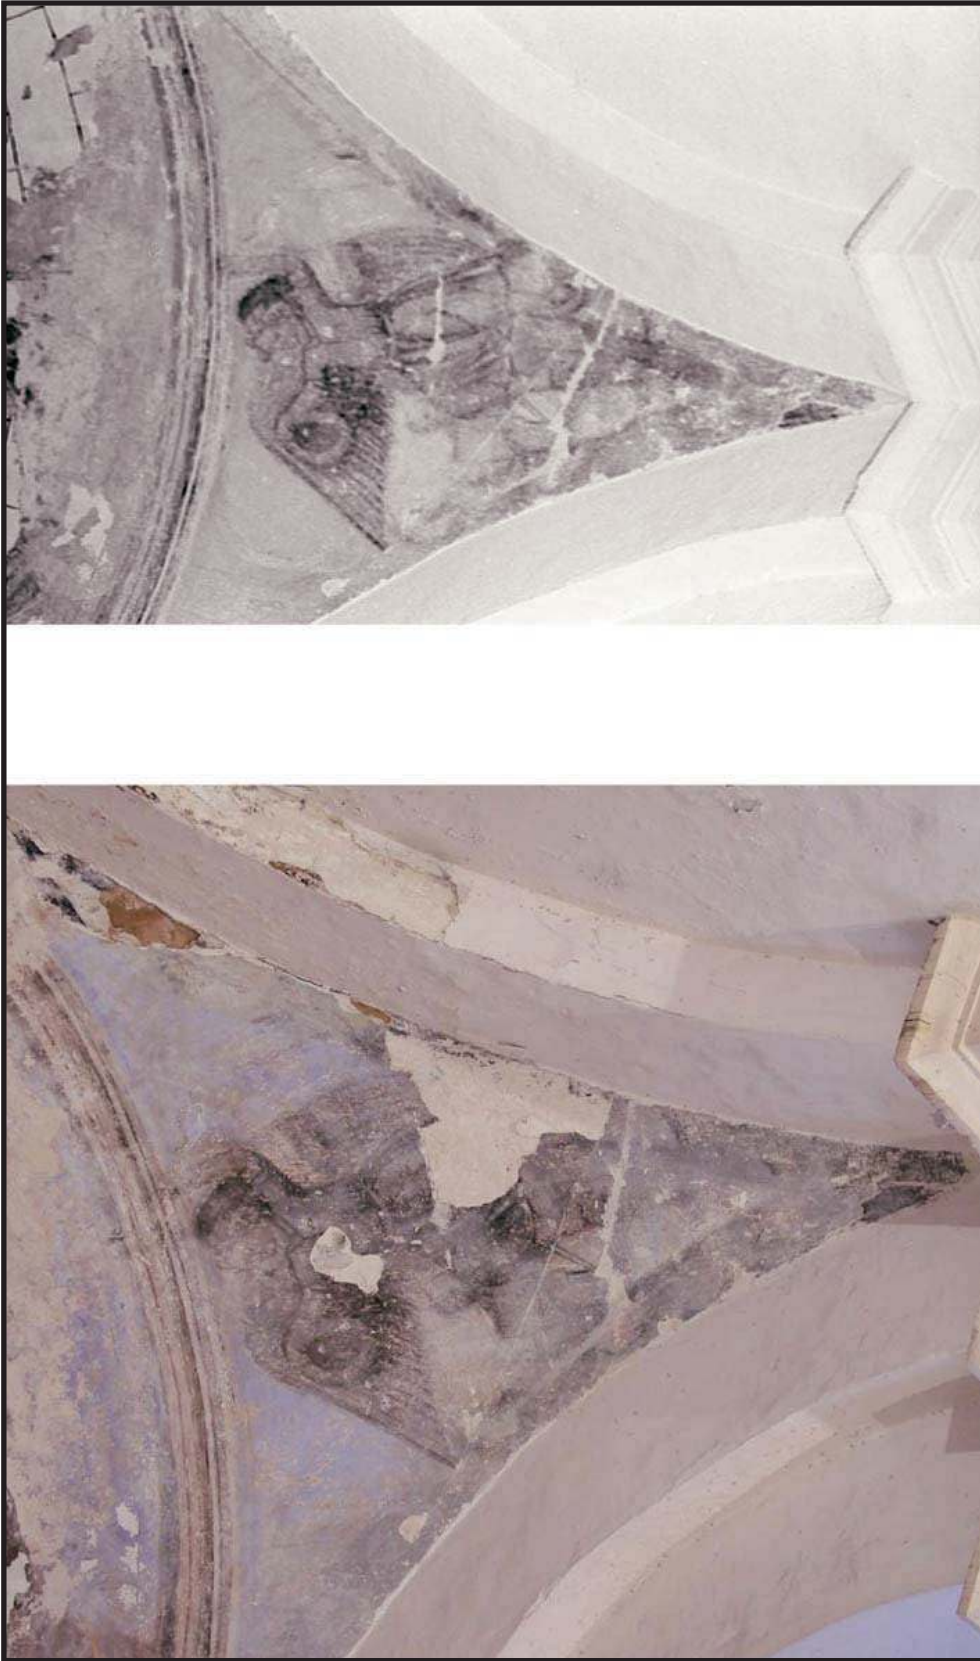
Figure 23: Photographic comparison of Pendentive 4, on the left is a 2004 image and on the right, an image taken in 1981. Note the deterioration in terms of areas of loss and image legibility over a twenty year time span. (Source: Pantel y del Cueto & Associates)

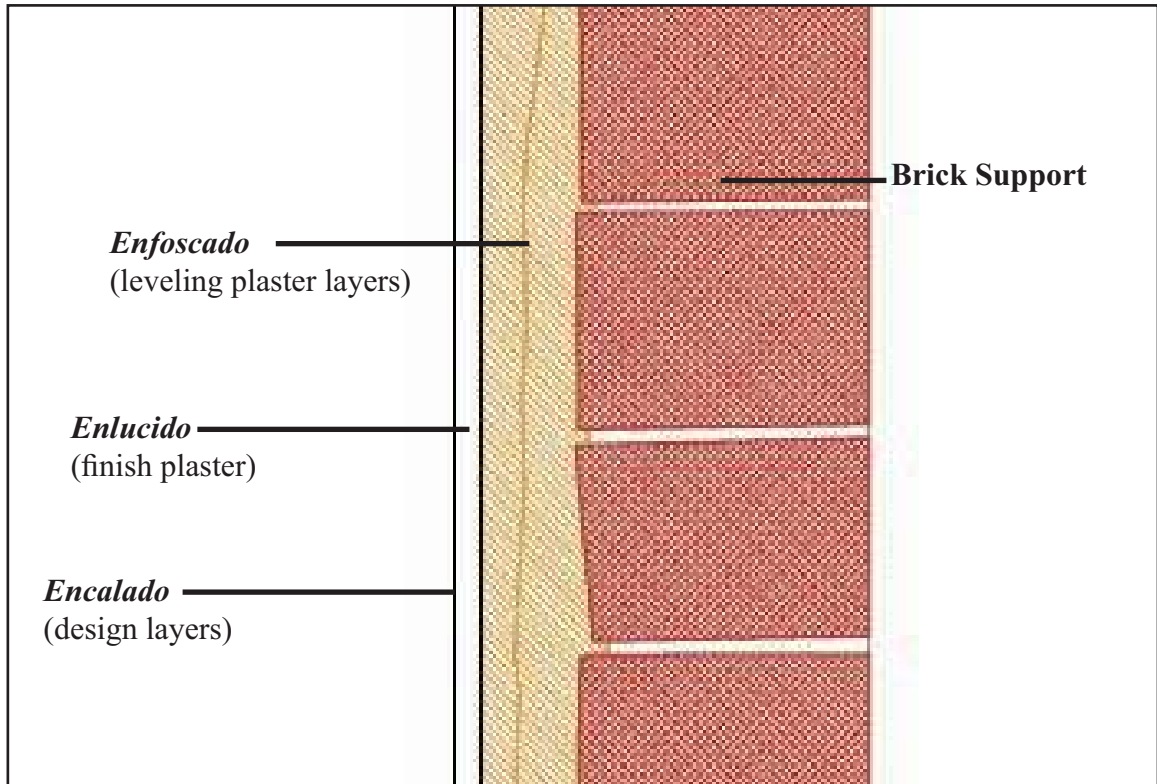
Figure 24: Schematic of masonry support, plaster substrate and design layer sequence composing the Rosario Chapel dome and pendentives.

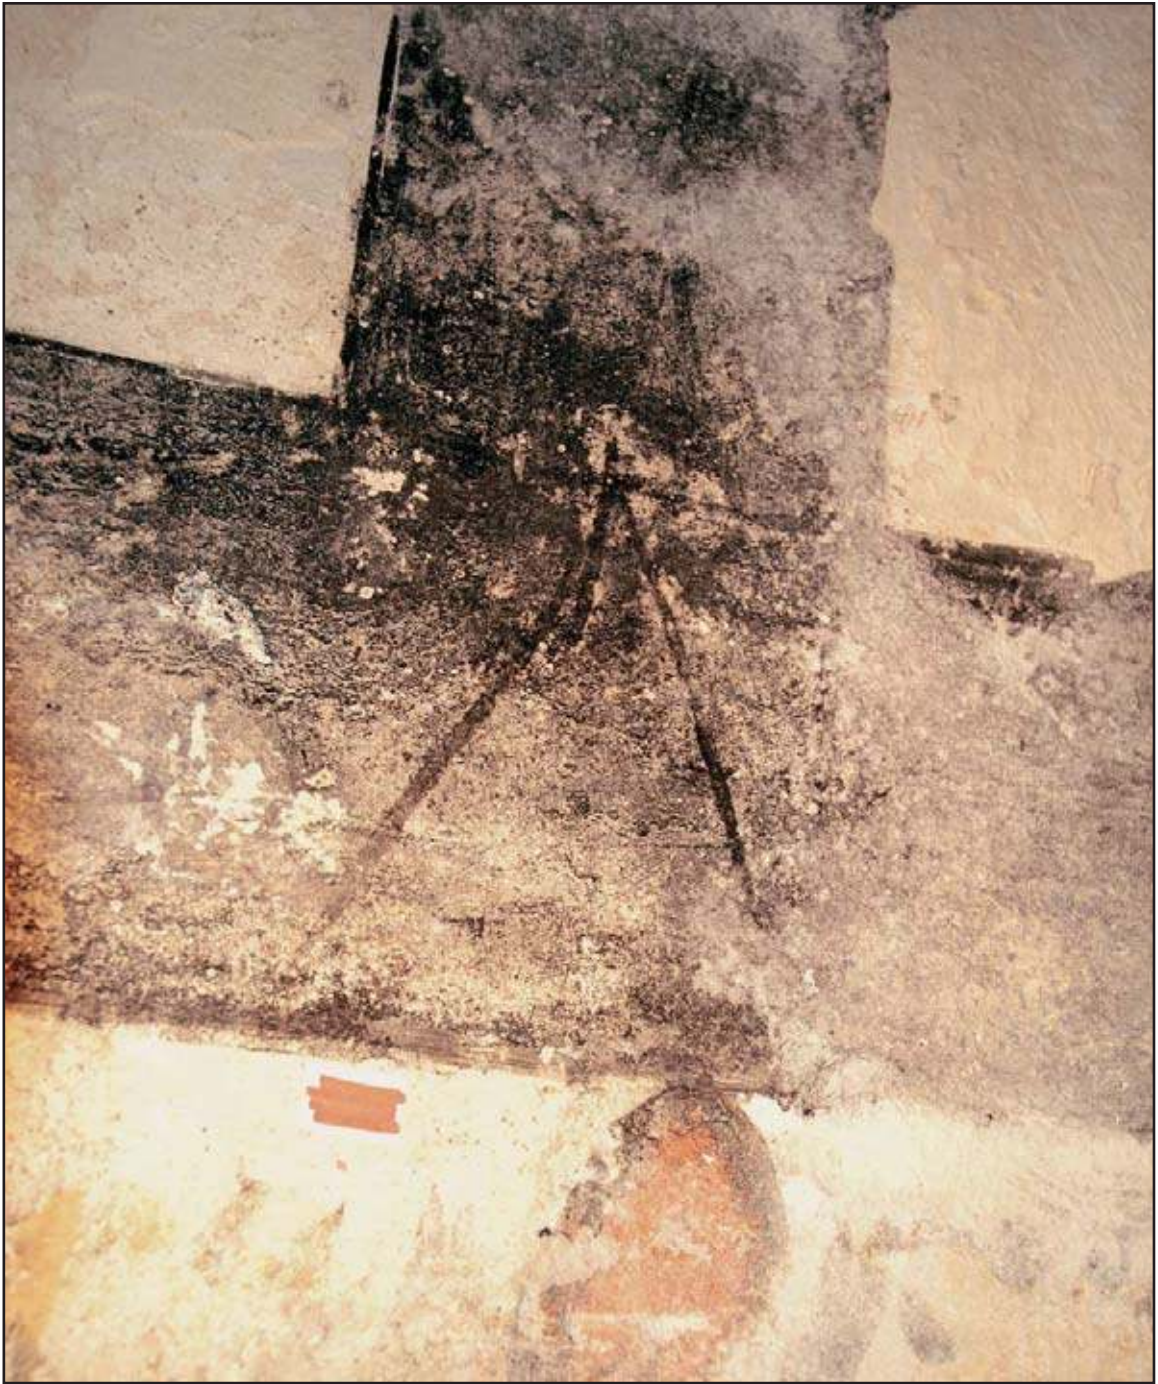
Figure 29: Detail (A6-1) Incised lines used to layout painting, Campaign A
(Source: C. Silva, 2005)

Incised lines and other marks, made while the plaster was still wet, are evident along the banding elements throughout the dome. These incised lines demarcate the width of the thick black banding and mark the center points of the vertical joint lines creating the faux ashlar blocks. Large brush marks, approximately two inches in width are visible within the black bands which were loosely applied within the boundaries of the incised lines and junctions between architectural elements.

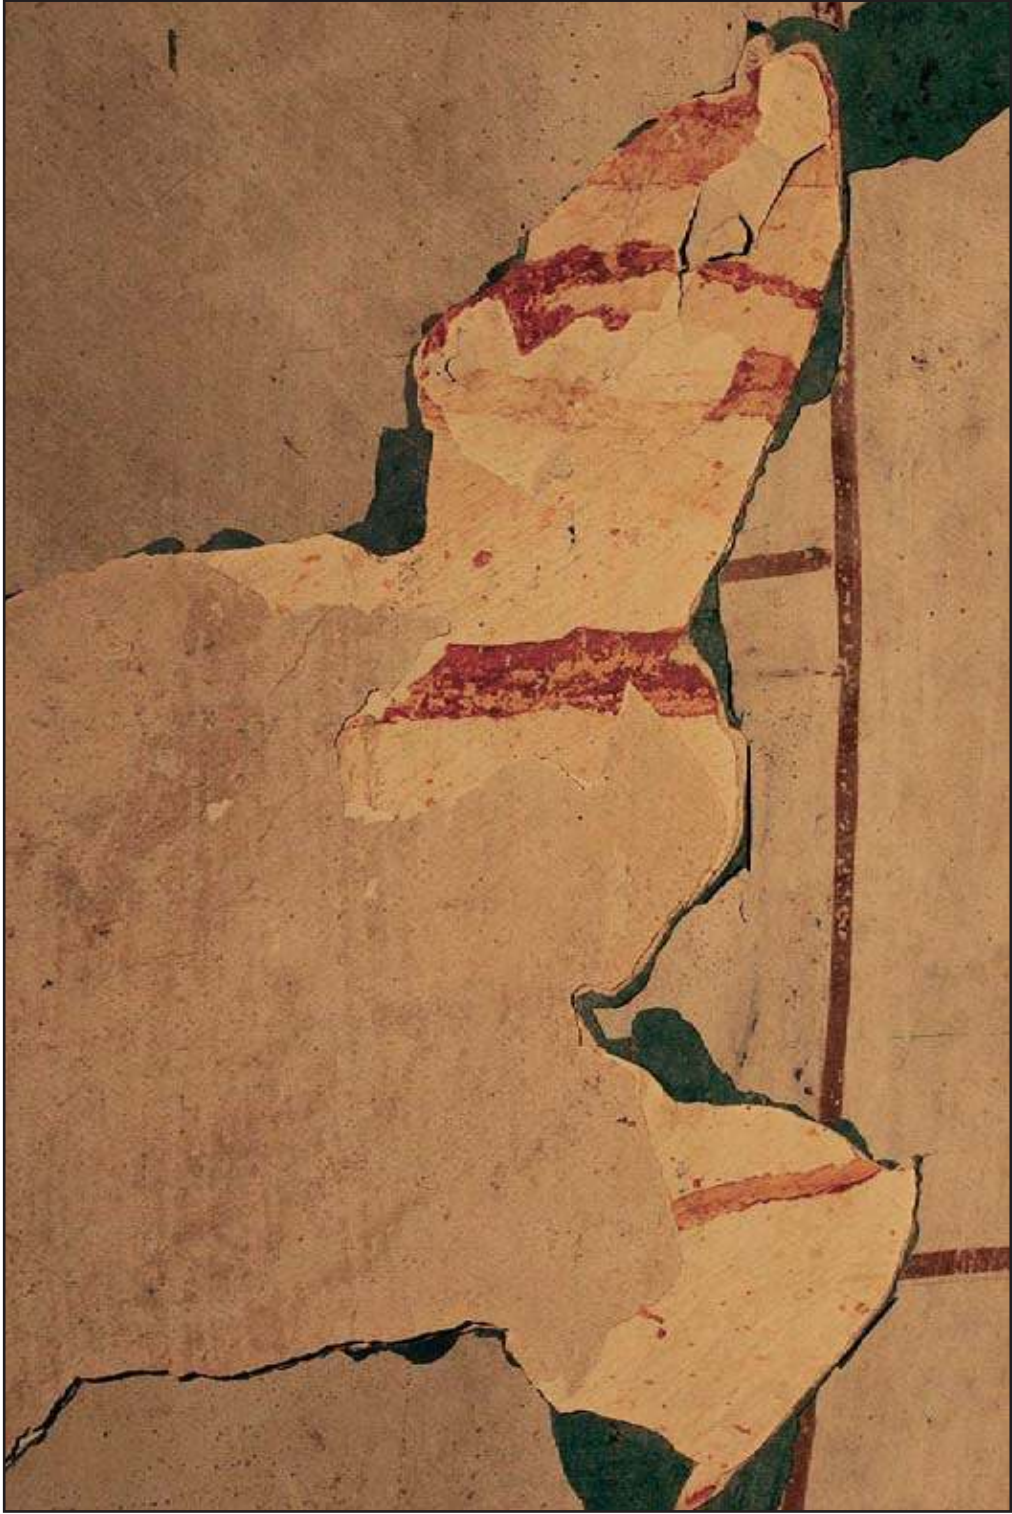
Figure 31: Detail (A6-3). Red marbalizing, Campaign B under later limewashes. (Source: C. Silva, 2006)

Campaign B is the same for the dome, pendentives and arches. A very abstract faux marbleizing technique is executed in red on a white ground, representing veined marble (Figure 31). No other decorative motifs were observed in association with this campaign; however their existence cannot be discounted at this time.

This design layer appears to have been executed in water soluble paint applied to a white lime wash ground. There is no evidence of incised lines, pouncing or under drawing. The red faux marble veins have been applied using loose, freehand strokes with a soft, long haired brush, approximately ½” in diameter pencil brush. There were no lines defining faux ashlar blocks found during site examination.

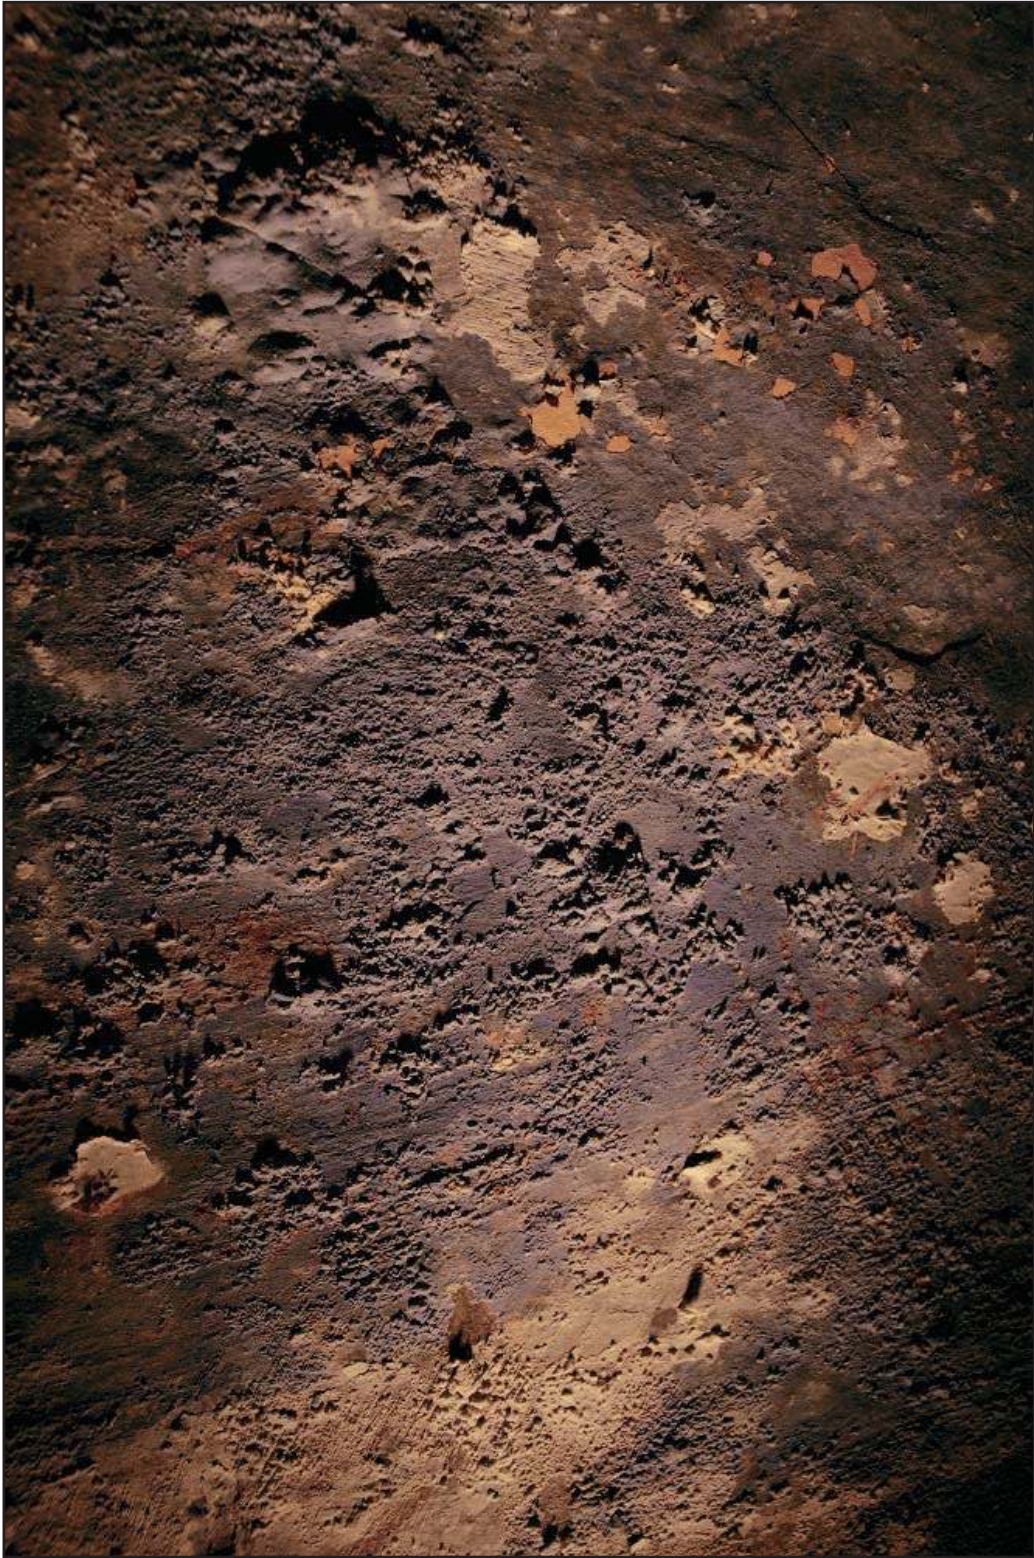
Figure 36: Detail (A6-8) Image of surface conditions: blistering, flaking, and salts. (Source: C. Silva, 2006)

Campaign D is one of the most fragile and incomplete of all the painting campaigns. What remains in most areas are friable fragments depicting partial figures. The surfaces are greatly disrupted by salts, blistering, and flaking, as seen in figure 36. This layer appears to have used an organic binder as a medium which has failed over time.

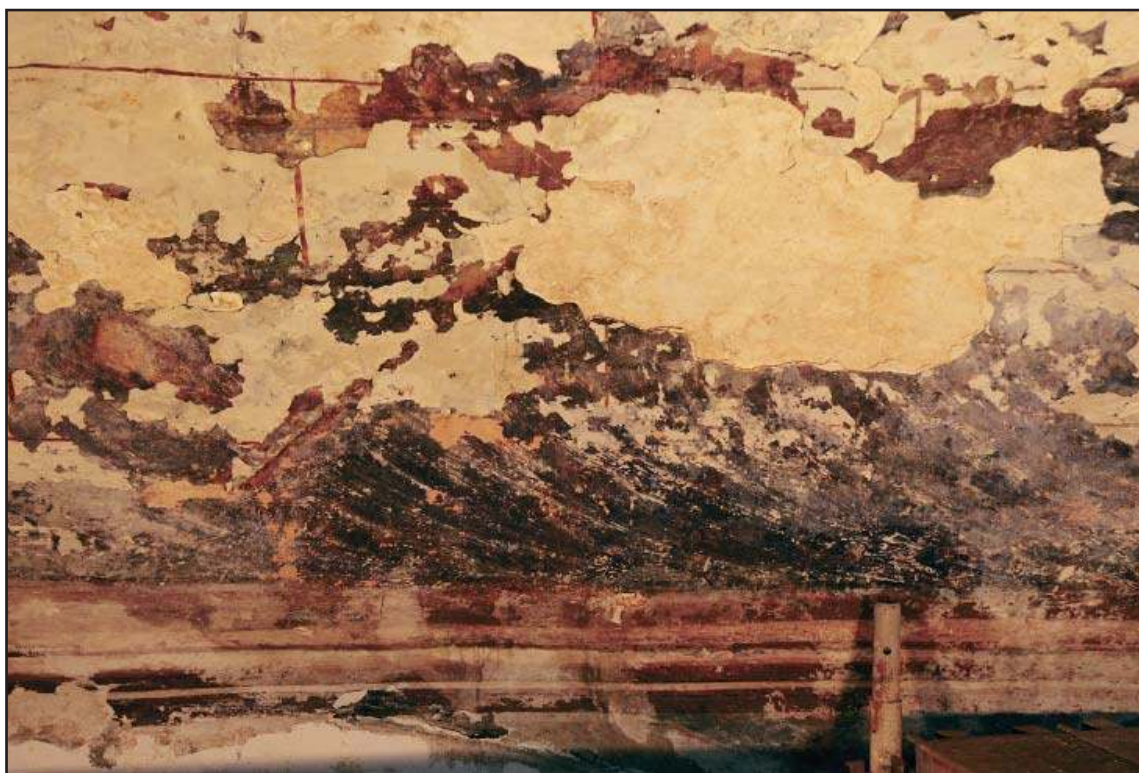
Figure 38: Detail (A6-10) Water motif at the base of the dome, Campaign D (Source: C. Silva, 2006)

This is the most complex composition in the Rosario Chapel, incorporating a figural narrative thought to depict the 1571 Battle of Lepanto. As mentioned earlier, this is an extremely fragmented campaign making legibility difficult. Much of this layer has been lost, over-painted, or has deteriorated to such an extent that earlier layers are now visually dominant. Six small galley ships can be distinguished, each equipped with multiple oars, and a single mast and sail (Map 1). The ships in the foreground measure approximately ten feet long. The bodies of the ships are painted in two to three thick horizontal bands of color (Figure 47). Above the sails fly flags in either red or blue (Figure 37). A wave motif, created by slashing strokes of blues and white (Figure 38), frames the bottom edge of the dome, providing a visual base.

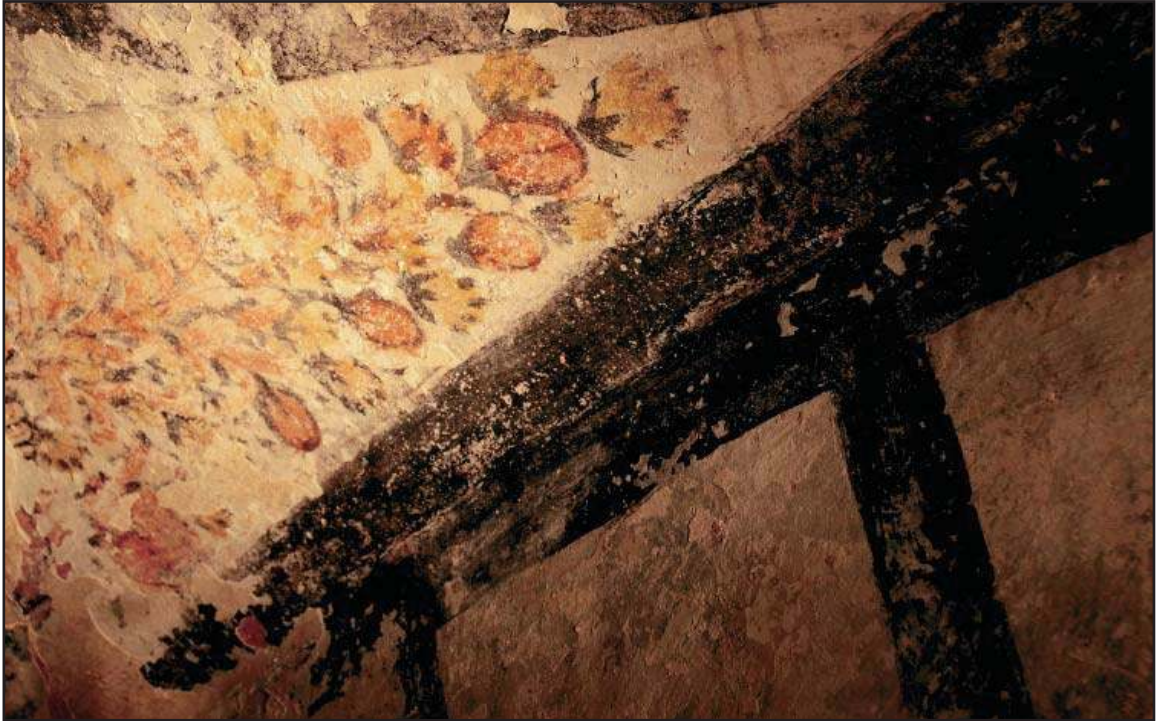
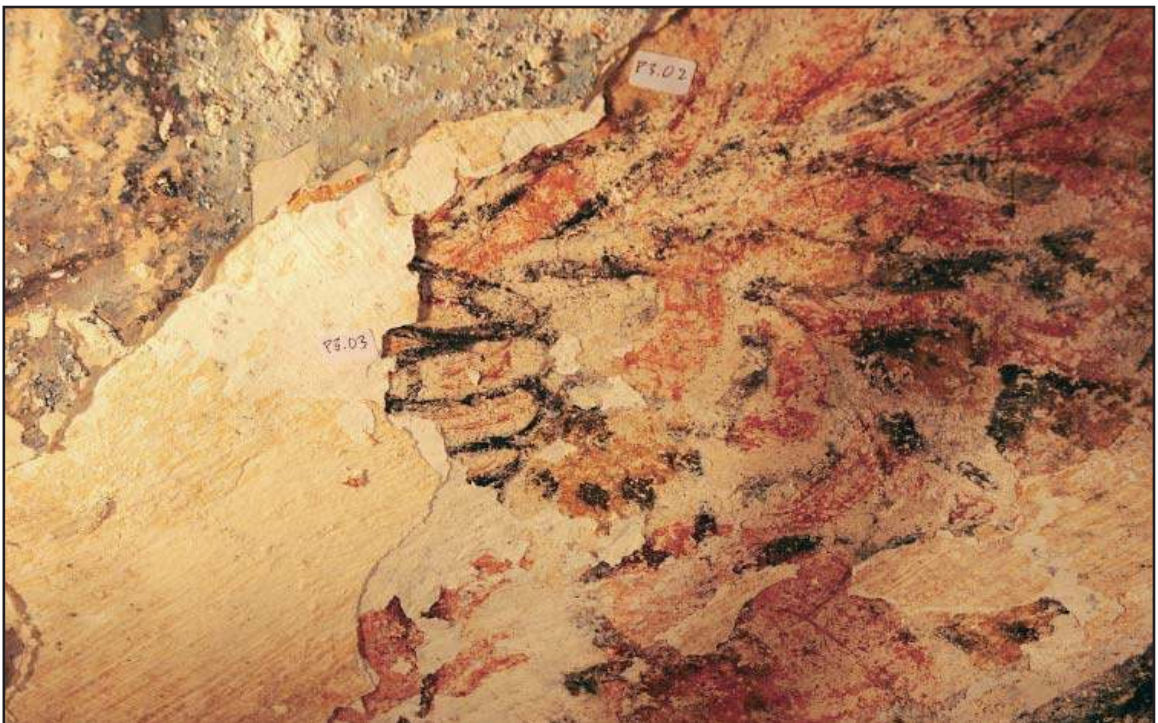
Figure 59: Detail (A8-1). Floral motif with faux voussoirs on the adjacent north arch, Campaign A (Source: C. Silva, 2006)

Figure 60: Detail (A8-2). Detail of a hand holding the floral bouquet, Campaign A (2006)

The bouquet of flowers held in each of the figures' hands was created with very loose, gestural brush work applied in layers of yellow and red describing the buds and flowers and black lines and stippled strokes used to create leaves, stems and other vegetal details (Figures 59-60).

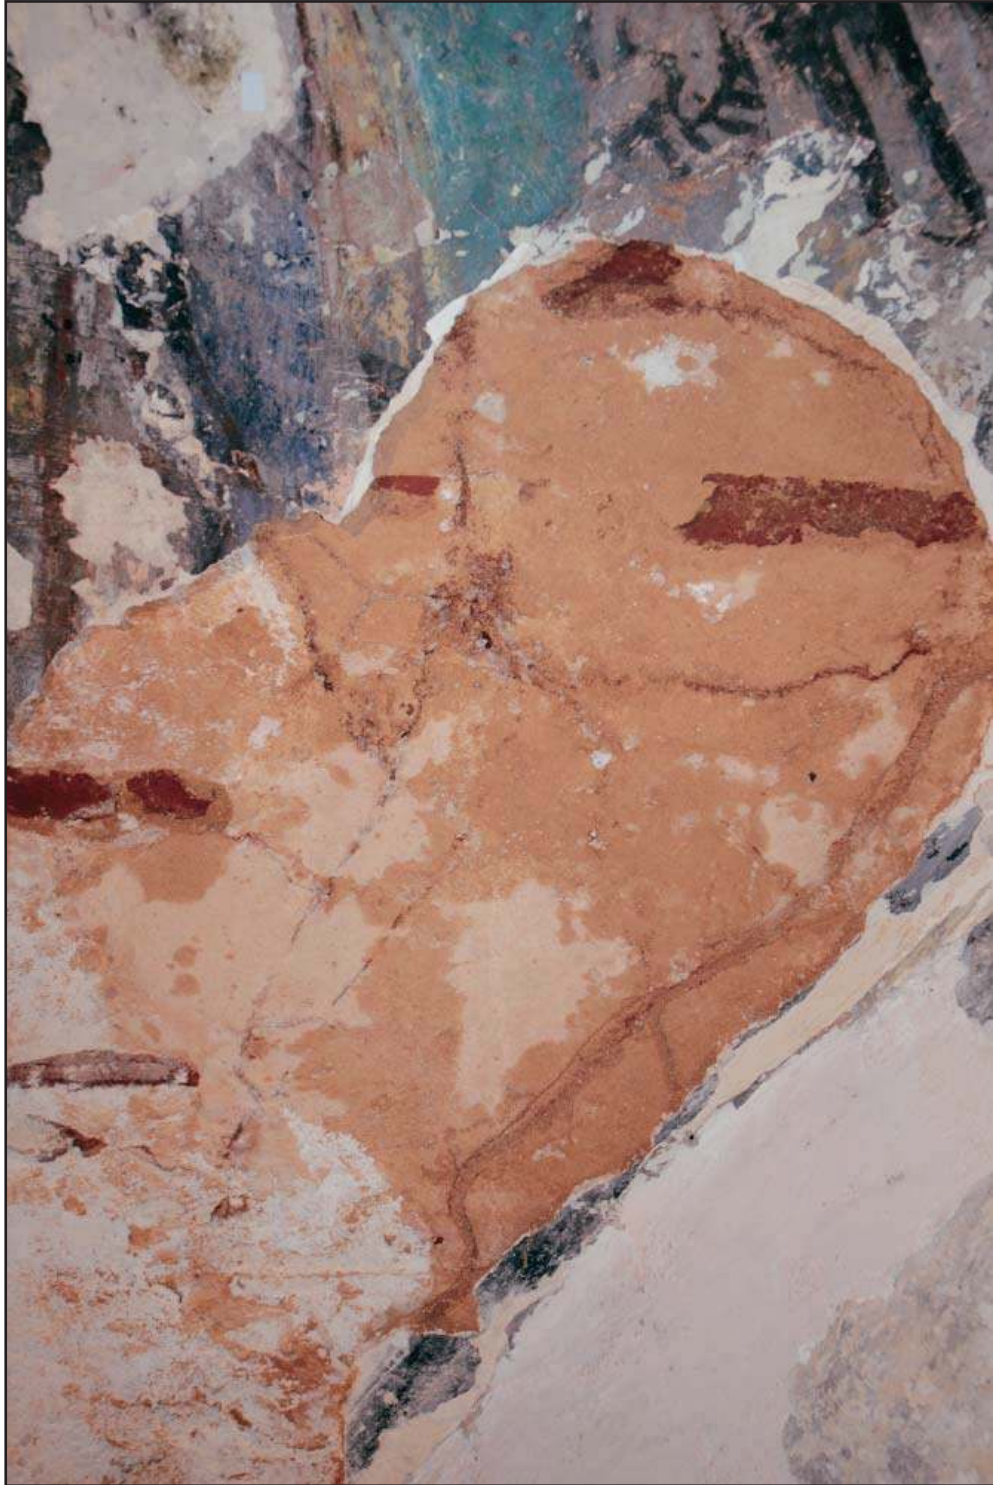
Figure 65: Detail (A8-7) Area of loss with termite tunnels
(Source: C. Silva, 2006)

The subject of this pendentive is a male figure holding a palm frond (Figure 63). He has short cropped hair with head turned in a ¾ view (Map 4 and Figures 61-62). The figure is wearing a simple short sleeved tunic, belted at the waist similar to Pendentive 2 (Figure 64). The collar of this garment has a circular button or fastener at the center of the neckline (Figure 62). A large three foot square area of Pendentive 3 is now lost down to the brick and enfoscado, and the upper right corner has lost all layers except for the first Campaign A (Map 4 and Figure 65).

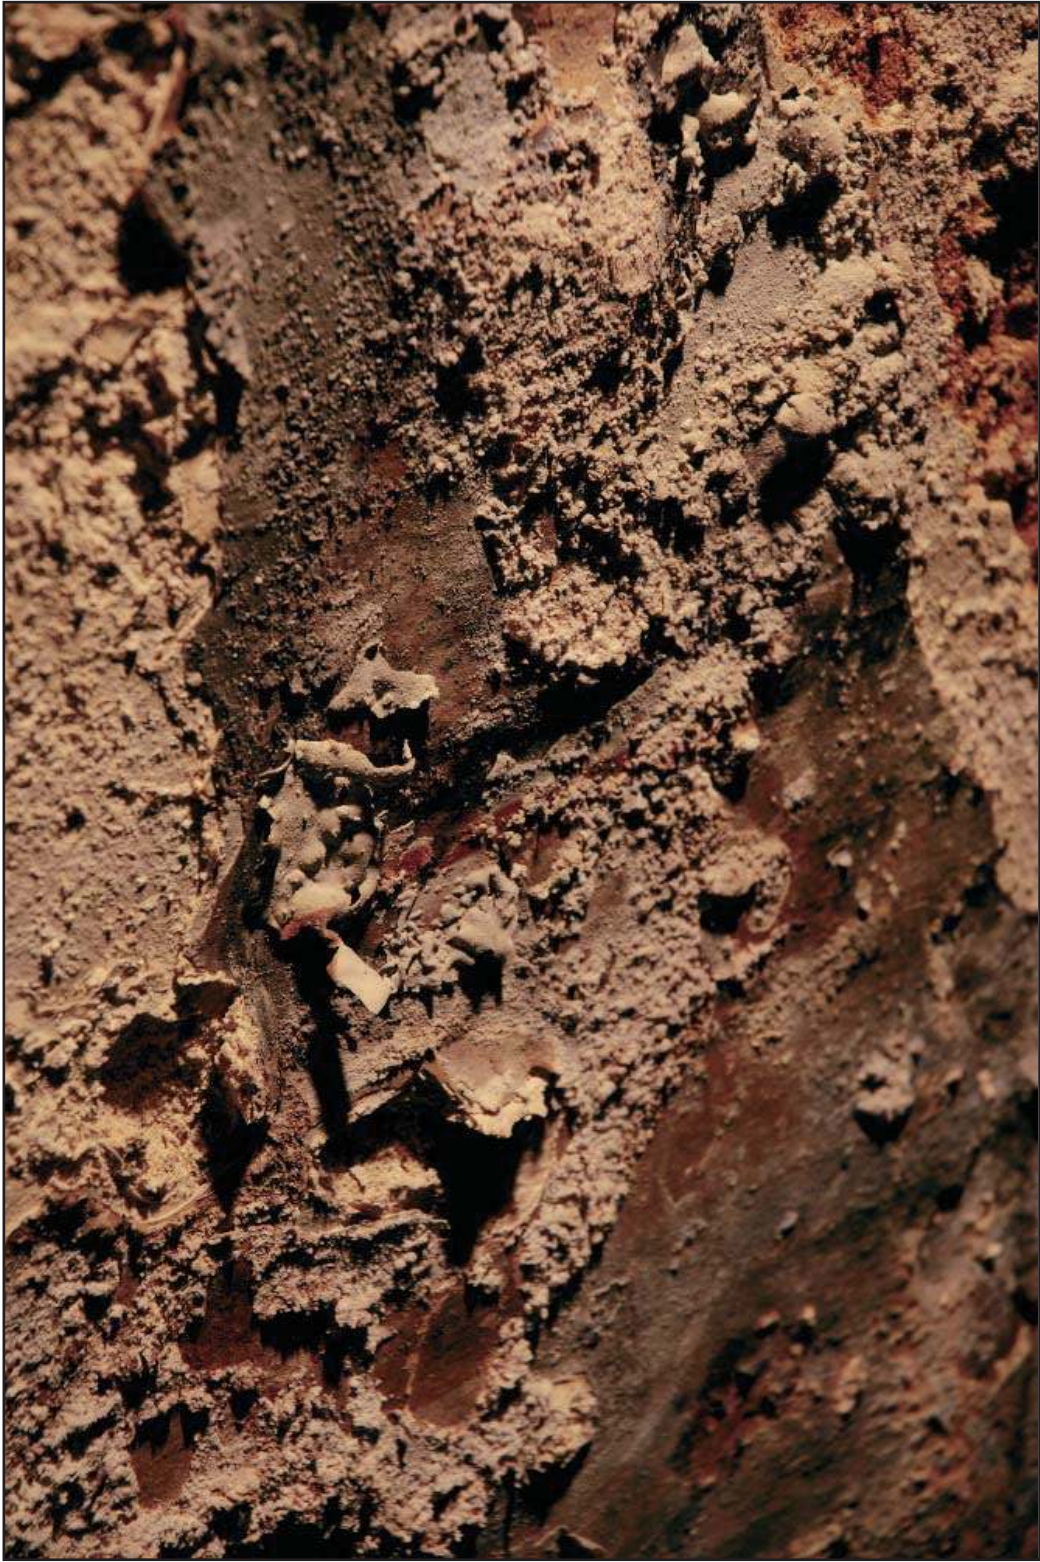
Figure 66: Detail (A8-8) Image of surface conditions: blistering, flaking, and salts (Source: C. Silva, 2006)

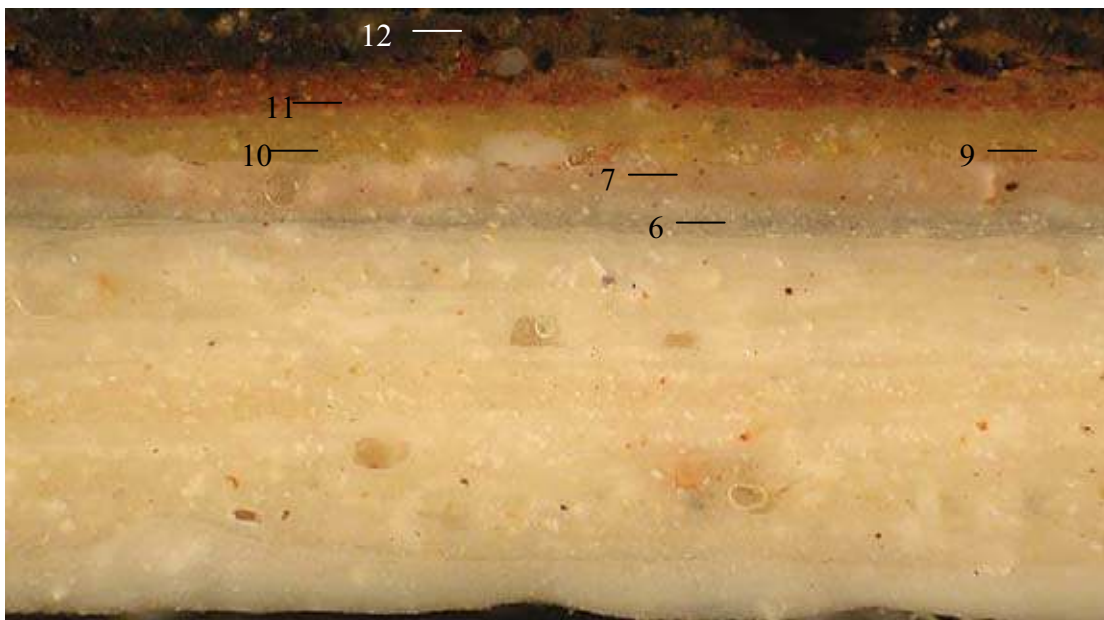
1. Cool White
2. Creamy White
3. Creamy White
4. Creamy White
5. Creamy White
6. Light Gray (C)
7. Peachy-pink (C)
8. Black –not in image (C)
9. Pinkish-Rose (C)
10. Yellow (C)
11. Rust (C)
12. Gray (C)
