Presented to the Faculties of the University of Pennsylvania in Partial Fulfillment of the Requirements for the Degree of Master of Science in Historic Preservation 2006.
Advisor: Frank G. Matero

**A TECHNICAL STUDY OF THE MURAL PAINTINGS ON THE INTERIOR
DOME OF THE CAPILLA DE LA VIRGEN DEL ROSARIO,
IGLESIA SAN JOSÉ, SAN JUAN, PUERTO RICO**

This is a technical study of the extant murals of the 17th *Capilla de la Virgen del Rosario* located within Iglesia San José, San Juan, Puerto Rico. The primary objectives of this investigation were to: document existing mural campaigns, establish a chronology of mural painting through analysis of materials and techniques, evaluate the conditions of the paintings and to determine possible deterioration mechanisms, and propose recommendations for their conservation and interpretation. In-situ documentation including color digital photography, extensive field notes, and mapping of visible painting campaigns were conducted. This was followed by a materials analysis of select campaigns' substrate, binders, and pigments. Test methods included gravimetric analysis and XRD of substrate plasters, examination of cross-sections and pigment dispersions,

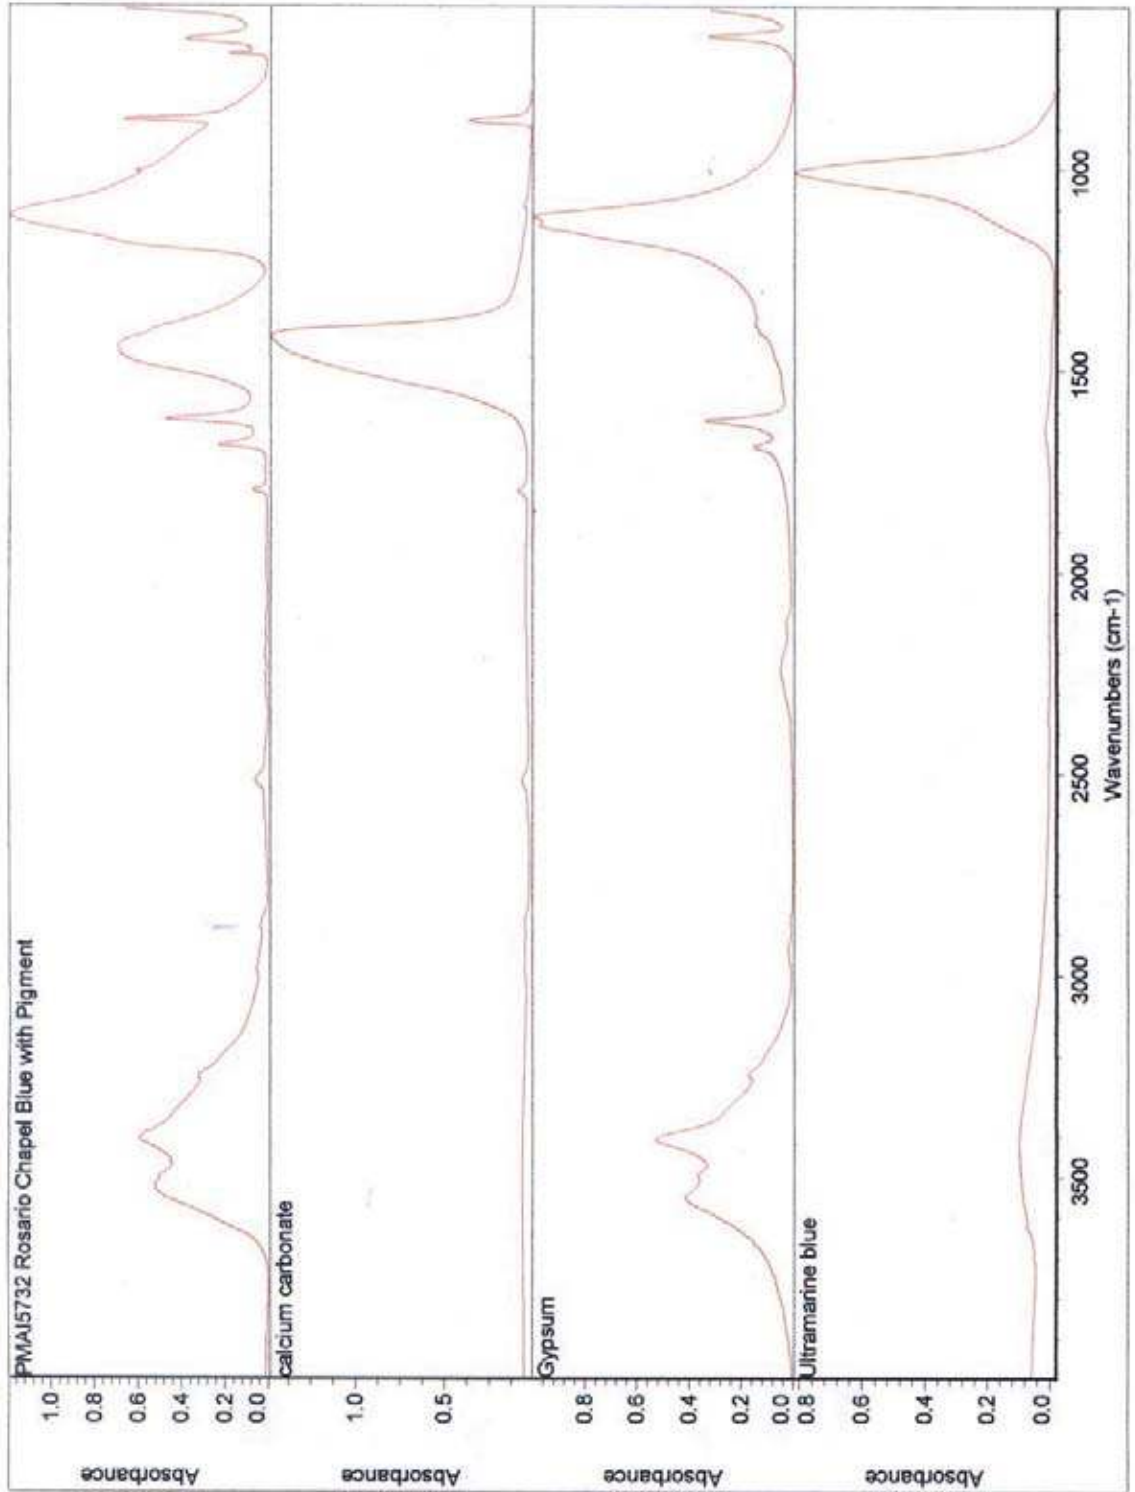
Chart 7: FTIR spectra, sample P1.06, Campaign D blue pigment and binder analysis

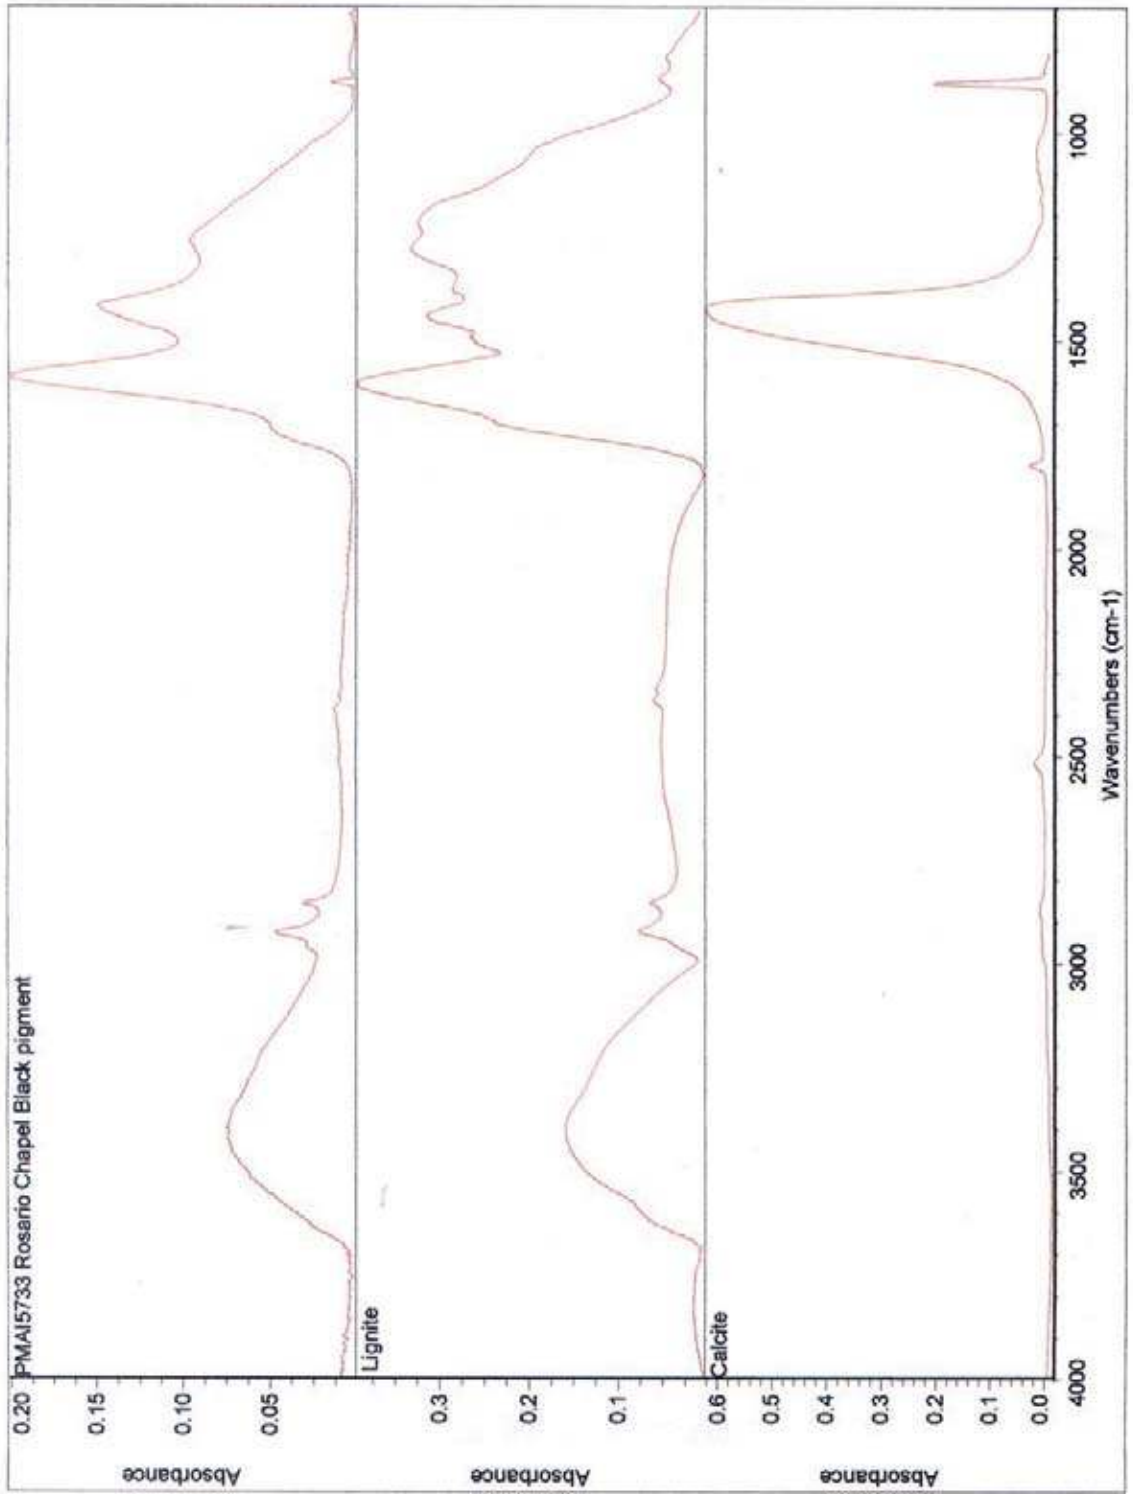
Chart 8: FTIR Spectra, Sample P2.18, Campaign A black pigment and binder analysis

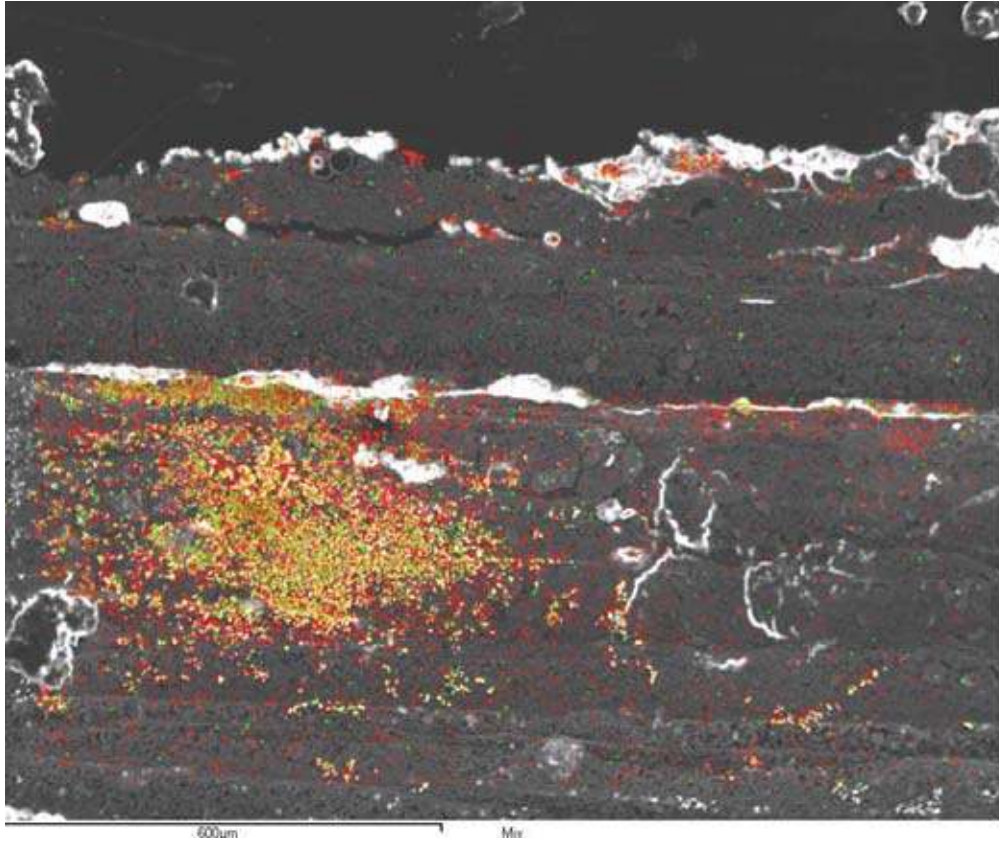
Sample Description: Cross-section from the North Arch
Working Distance: 17mm

Comments: Electron image of Na (green), Cl (yellow), and Fe (red).

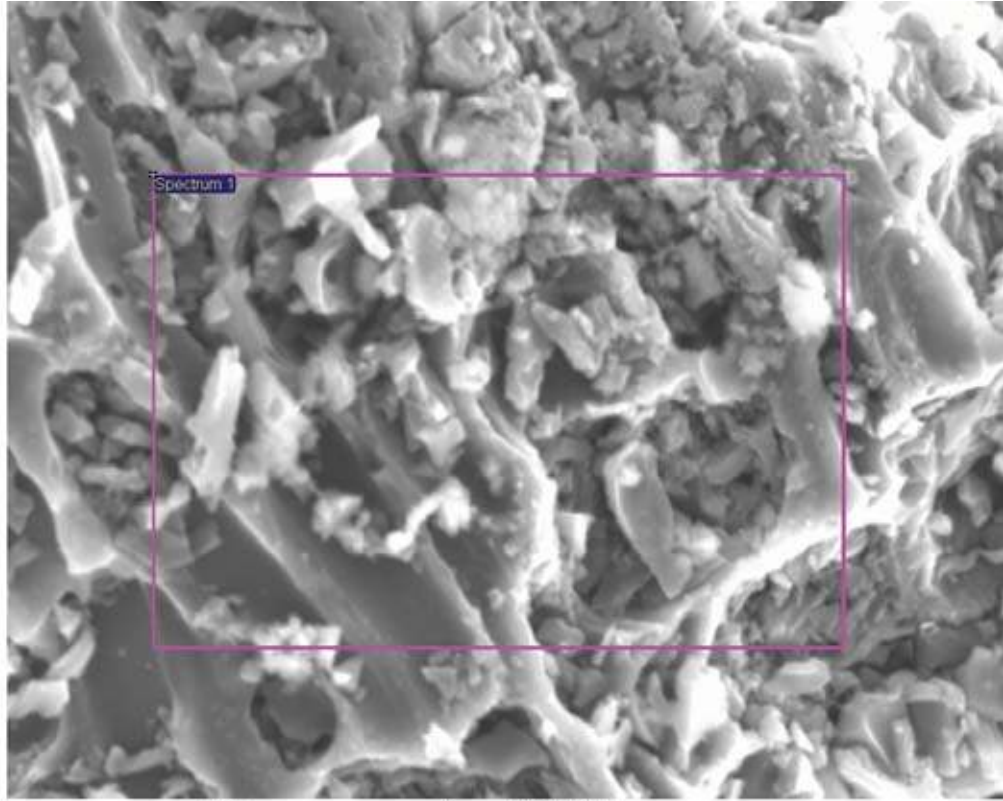
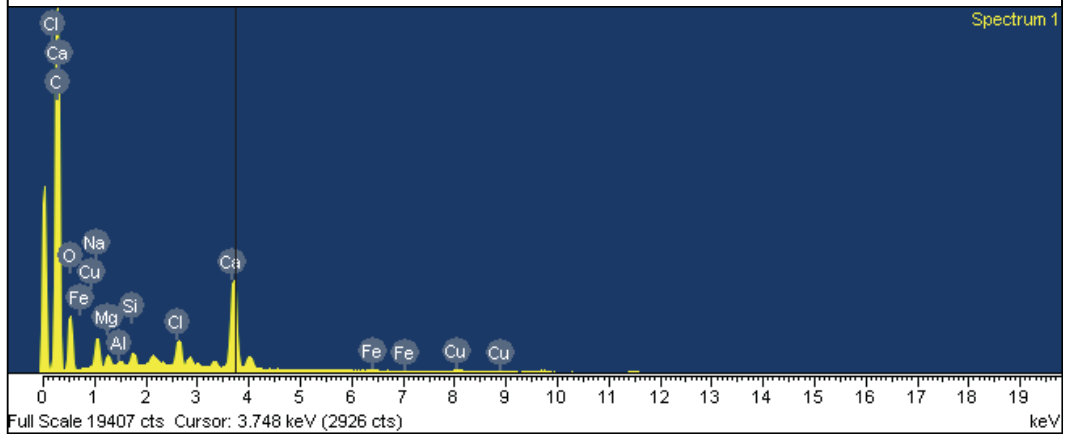
Chart 11: EDS Results, Sample P2.13.2

Sample Description: Black. Campaign (A)
Working Distance: 17mm

Comments: Carbon without phosphorous could be graphite or lamp black. Shiny metallic sheen observed in stereomicroscope suggests graphite.
