A vision-based approach for rolling contact fatigue evaluation in twin-disc tests on a railway wheel steel

Ileana Bodini, Candida Petrogalli, Angelo Mazzù, Simone Pasinetti, Takanori Kato & Taizo Makino

RESEARCH ARTICLE

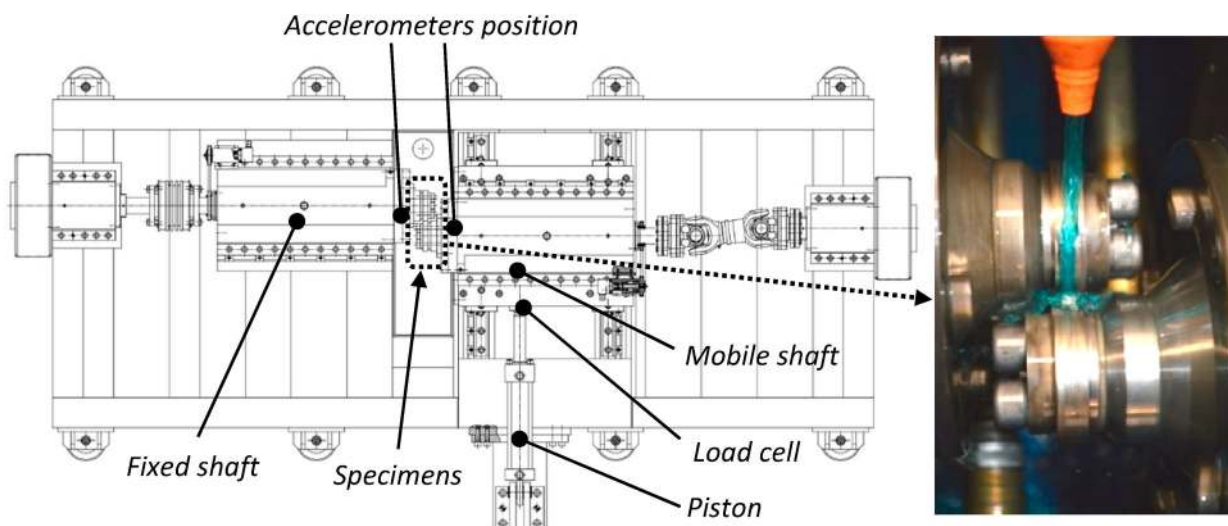
The tests were carried out by means of the twin-disc testing machine shown in Figure 1, whose detailed description is provided in [13].

It is a twin-disc machine where the specimens are fixed to independent shafts. One of them can be displaced orthogonally to the shaft axis by a hydraulic cylinder, which applies the imposed contact load as

Figure 1. Schematic of the twin-disc test bench.

well. The rolling speed of each shaft is measured by encoders, whereas a load cell located at the piston head measures the contact load between specimens.

Two piezo-accelerometers are mounted on the specimen supports: one on the fixed shaft in the vertical direction and the other one on the mobile shaft in the horizontal direction, both normal to the rotation axis. The transducers used are Wilcoxon 736 IEPE accelerometers, with nominal sensitivity $0.98 \text{ V}/(\text{m}/\text{s}^2)$, full scale $5 \text{ m}/\text{s}^2$, linear bandwidth within the range 5–20 kHz. Rolling-sliding tests in dry and wet contact were carried out on specimens in 0.7%C steel with fine pearlite structure, with hardness HV330 (average value of five measurements at random positions, made with a Mitutoyo Vickers hardness tester under a load of 10 N). All tests were conducted with the same maximum contact pressure (0.9 GPa), rolling speed (500 rpm) and sliding/rolling ratio (0.5%). Wet contact was realized by means of a jet of water with the addition of 10% glycol for the prevention of test bench corrosion. In three tests (identified as T1, T2 and T3), dry and wet contact phases of 50,000 cycles each were alternately applied, starting with dry contact. These tests were carried out in the same working condition, in order to ensure a sufficient damage repeatability. In the test identified as T4, 600,000 cycles in dry contact were applied, subsequently wet contact was applied. In the test identified as T5, 10^6 cycles in dry contact were applied, subsequently wet contact was applied. These two tests were carried out without repetitions, in order to explore the trend of the damage occurring when long dry phases are expected. However, regardless of the repetitions, it has to be remarked

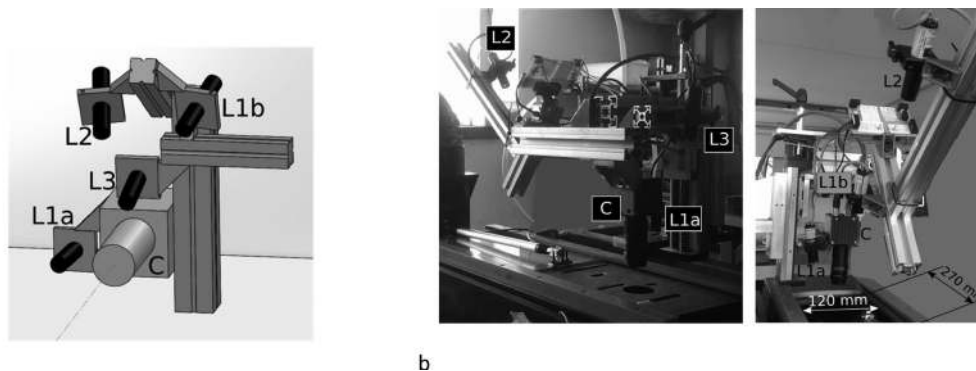
Figure 2(a) shows a schematic of the vision-based measurement system and Figure 2(b) shows the vision-based measurement system integrated with the test bench. The vision system performs measurements on the fixed wheel specimen. With reference to Figure 2, C is a high-speed camera (PROMON 501; AOS Technologies AG), L1a and L1b are two laser pointers suitably defocused to illuminate the specimen surface for 2D analyses. L2 is a dedicated laser stripe, to perform measurements along the radial direction of the specimen (section profile analysis), whereas L3 is a laser stripe for the measurement of the angular position during the tests, allowing for the synchronization between images and angular position. A $f/50 \text{ mm}$ lens is used.

**Figure 2.** Vision system integrated on the RCF test bench.

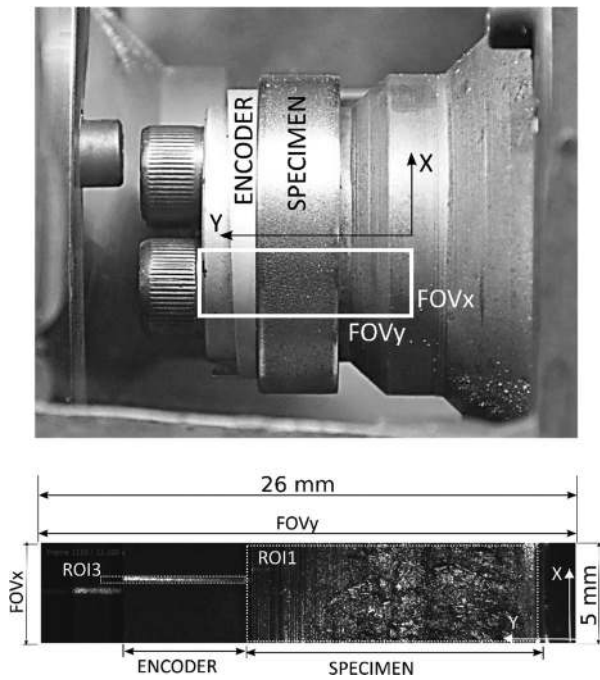
A purposely designed encoder was used to measure the angular position of the rolling specimen. This component, shown in Figure 3, is an axial cam, with an external diameter of 50 mm and internal diameter of 44 mm; the height of the region with the maximum diameter varies linearly along the circumference from 3 to 8 mm. Since the encoder is fixed on a disk screwed onto the specimen, the encoder and the specimen roll coaxially. Every time the specimen is disassembled and reassembled, the zero position of the encoder always coincides with the same portion of the specimen. The camera acquires images with dimensions ($1280 \text{ px} \times 240 \text{ px}$), with a bit depth of 8 bit, and the resulting field of view (FOV) is ($26 \text{ mm} \times 6.5 \text{ mm}$) with spatial resolution equal to $0.021 \text{ mm}/\text{px}$, in both X and Y directions, as defined in Figure 3.

Figure 3. Analogic, linear encoder fixed on a disk coaxially screwed on the specimen. Definition of the X and Y directions.

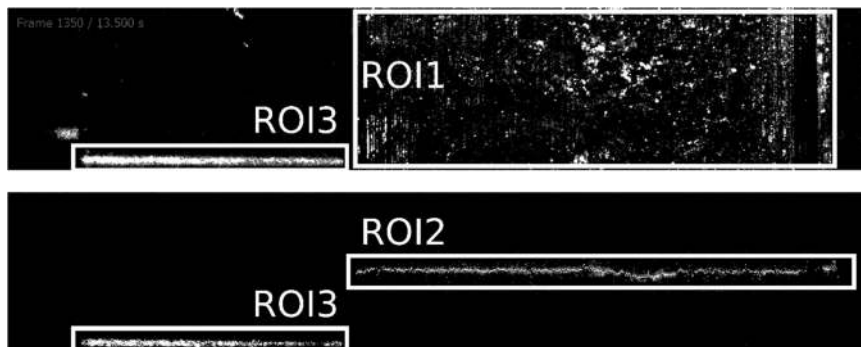
Images of the surface of the specimen undergo simple and fast image processing to quantify surface damage, allowing the definition and assessment of synthetic indexes. Three regions of interest (ROI) were defined, shown in Figure 4. ROI1 includes the surface illuminated by the defocused lasers L1a and L1b; ROI2 includes the region illuminated by laser blade L2; ROI3 includes the region illuminated by laser blade L3.

Figure 4. Definition of the regions of interest (ROI).

Laser L3 projects a stripe on the encoder, and the corresponding acquired image of this projection is shown in Figure 4, completely included in ROI3. While the specimen and the encoder are rolling together, the height of the encoder profile linearly varies; therefore, its measurement in each image allows the determination of the angular position of the specimen. As the L3 laser stripe and the corresponding region of interest on the specimen surface are acquired in the same images, the length of the laser stripe included in the ROI3 allows determining the position on the specimen surface of the image acquired in ROI1 and ROI2.

ROI3 is univocally defined on the image before the image processing starts, so that it only contains the projected laser stripe. The portion of image contained in ROI3 undergoes a thresholding at a level of grey of 62.7: this means that the value of pixels with a grey level lower than 62.7 are put equal to zero and the value of pixels with a grey level >62.7 are put equal to one. This way, the resulting image is binary. Such thresholding was chosen to eliminate the grey levels corresponding to a not damaged surface. Details about this procedure are given in [23]. For each column c of the region of interest ROI3, the row position r_G is calculated through the following equation:

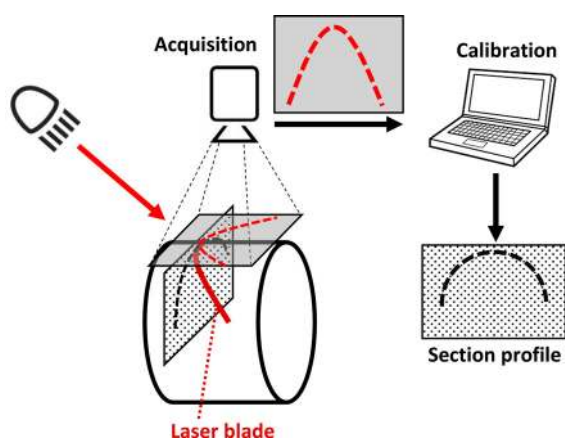
The profile of the contact surface along the radial direction was obtained by elaboration of the laser blade track acquired during the tests, with a precision of 0.018 mm. A scheme of the elaboration procedure is shown in Figure 5: the image of the laser blade, deformed by the surface asperities, is calibrated as detailed in [22] in order to obtain the contact surface profile on a radial plane.

Figure 5. Scheme of laser blade elaboration and section profile reconstruction.

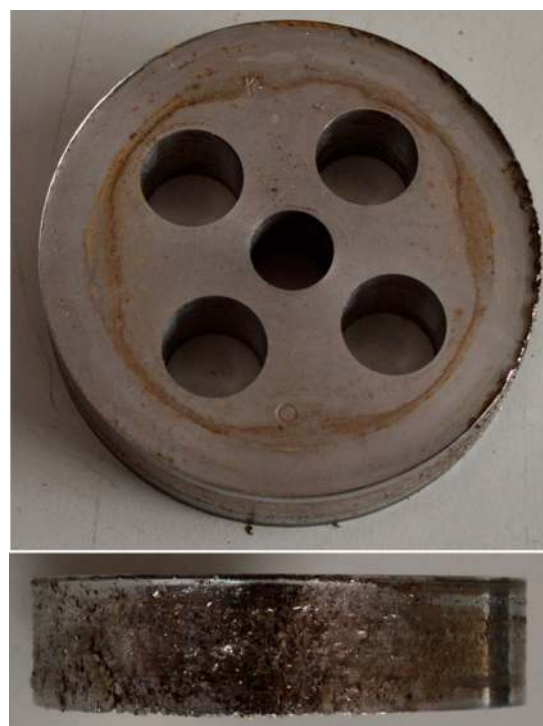
Each test was stopped when the surface was severely damaged; this condition was identified by a significant increment of the vibrations of the mobile mandrel, exceeding 2 m/s^2 . The specimen surface appearance at the end of the test T3 is shown in Figure 6. A marked deformation at the border of the contact surface was clearly visible.

Figure 6. Observed specimen at the end of test T3.

18 mm, exceeding the original specimen width due to the plastic deformation of the contact surface borders in the axial direction, as shown in Figure 6. The latter is shown both as it was obtained and after smoothing by a period 5 moving averaging. On the right of the 2D image, a roughened zone is visible; this zone was detected by the curvature of the laser blade, and the reconstructed profile allowed estimating the depth of the marks, which is about 0.4 mm from peak to valley.

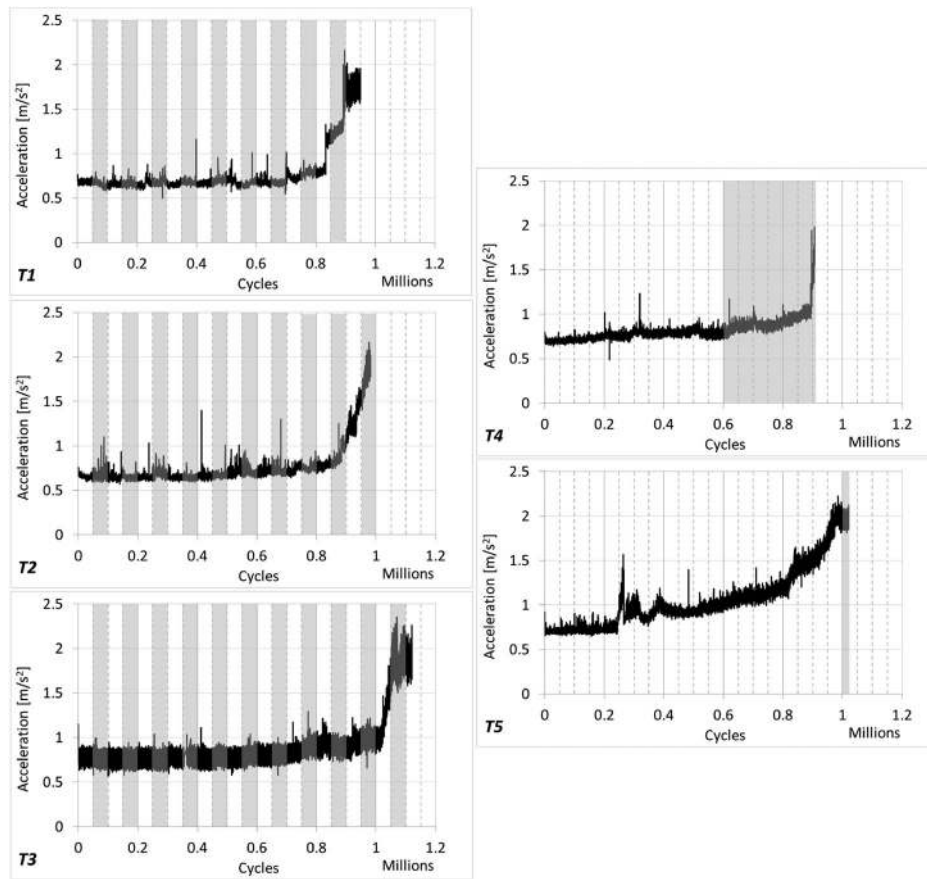
Figure 7 shows the accelerations of the mobile mandrel in the five tests; the grey bands correspond to the phases of wet contact. The acceleration profiles of tests T1, T2 and T3, which were carried out with the alternation of equally lasting dry and wet contact sessions, were characterized by a rather stable band of variation for most of the test duration, until a rapid increment occurred in the final part, clearly related to the occurrence of severe surface damage. Test T4, which was characterized by a long dry session before the application of water, was rather stable for most of the test, but the final raise was even more sudden than in the previous tests. This likely happened because in the final part of the test, once water began to be applied, the mechanism of crack propagation due to the entrapped fluid pressurization started and there were no more dry sessions mitigating it by wear. Test T5, which was characterized by a very long dry session before the application of water, had a very different behaviour: vibrations started to raise progressively but significantly after 200,000 cycles; when water was applied, the sudden increment characterizing the occurrence of severe damage in the previous tests was not observed. This means that severe damage had already occurred in the dry session.

Figure 7. Accelerations of the mobile mandrel during the tests. Grey bands correspond to wet contact sessions.

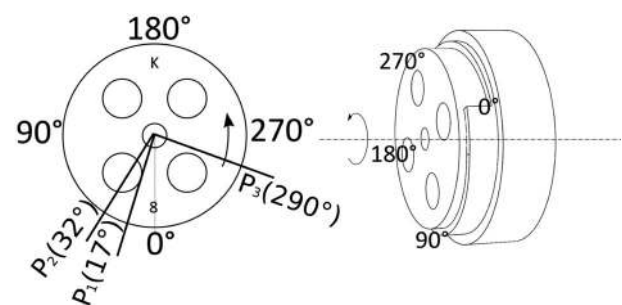
it can work for analysing defects having larger size, e.g. when they are at the stage of pits or spalls. In this paper, the results of the application of this system at the end of the test T5 are presented; these results are representative of the other tests as well. Three positions were chosen on the contact surface, highlighted in Figure 9, in order to show the variability of the damage that can be observed on the surface. The profiles were taken on the contact surface along the axial direction.

Figure 9. Positions of the 3D image elaboration.

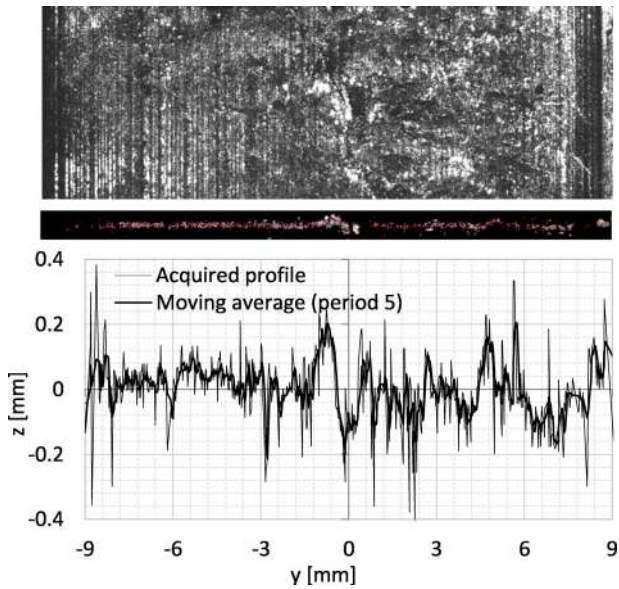
Figure 10 shows the 2D image acquired on the specimen of test T5 in position P_1 , the acquired laser blade and the corresponding reconstructed section profile. Note that the width of the acquired profile is about

Figure 10. Acquired 2D image, acquired laser blade and section profile reconstruction in the position P_1 of the specimen at the end of the test T5.

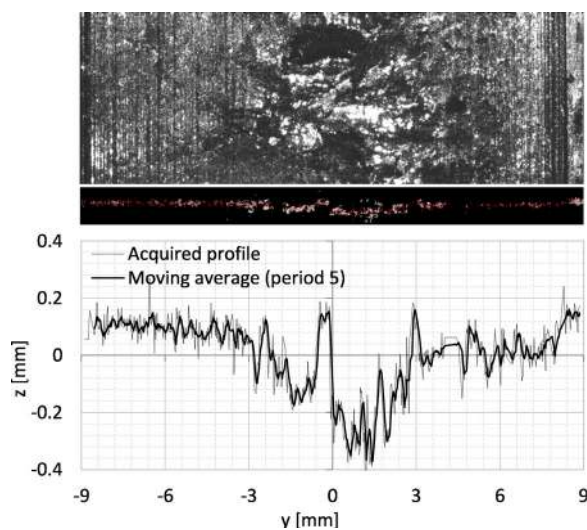
Figure 11 shows the same results for position P_2 . In this case, a localized damage (spall) is visible in the central zone of the contact patch on the 2D image. The section profile analysis detected this spall and allowed estimating its depth as 0.6 mm.

Figure 11. Acquired 2D image, acquired laser blade and section profile reconstruction in the position P_2 of the specimen at the end of the test T5.

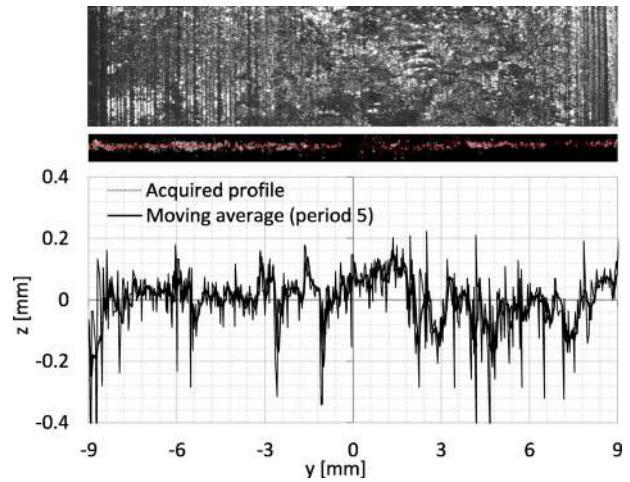
Figure 12. Acquired 2D image, acquired laser blade and section profile reconstruction in the position P_3 of the specimen at the end of the test T5.

Figure 12 shows the profile acquired in position P_3 : similar to position P_1 , the damage was more diffused along the width than it is in position P_2 ; a more perturbed region can be identified on the right side of the surface, with a maximum peak-to-valley distance of about 0.4 mm.

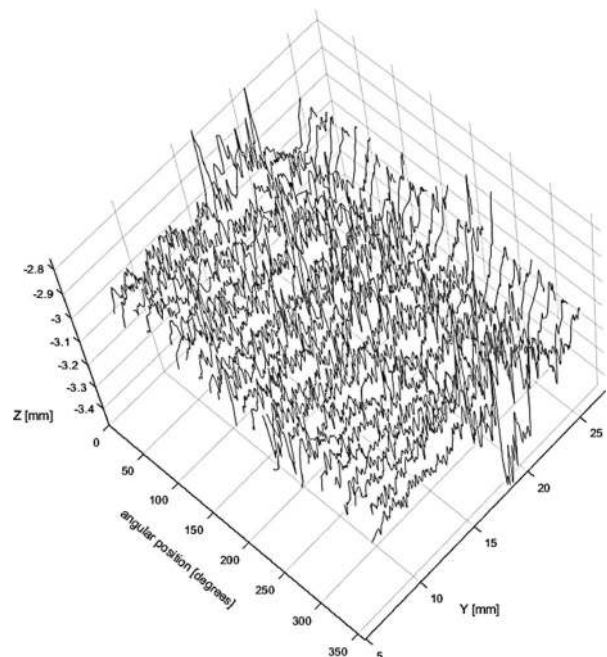
Figure 13 shows the assembly of the acquired profiles along the whole contact surface of the T5 test specimen. This image shows a more damaged strip on the right-hand side of the contact surface, in agreement with the appearance of the acquired images. Despite the fact that this technique still needs refinement, especially in the smoothing and resolution along the angular direction, this image shows the potential of the radial section reconstruction as a tool for contactless 3D surface topology analysis.

Figure 13. Assembly of reconstructed profiles of test T5.
