*International Journal of Pavement Engineering*, 9, October 5, pp. 365-371, 2008-10-01

### **NRCC-50314**

# **Accelerated aging of bituminous sealants: small-kettle aging**

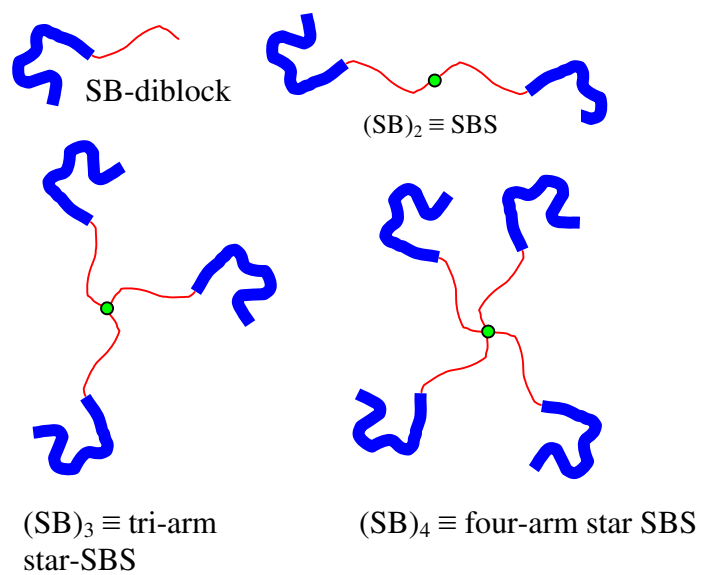
Figure 1. Illustration of the structure of SB-type copolymers.

Bituminous sealants often contain a styrene-butadiene (SB) copolymer (Masson *et al.* 2002). These copolymers contain a polystyrene (PS) and a polybutadiene (PB) block, thus the name SB-diblock. These diblocks can be linked to  $(SB)_n$ , where  $n$  is most often 2 to 4. A most common copolymer is the SBS triblock copolymer, where  $n=2$ ,  $(SB)_2 \equiv SB-BS \equiv SBS$ . With  $n > 2$ , the structure is that of an  $n$ -arm star. Figure 1 provides an illustration of these structures. Given that these polymers have different sizes, they can be separated by GPC.

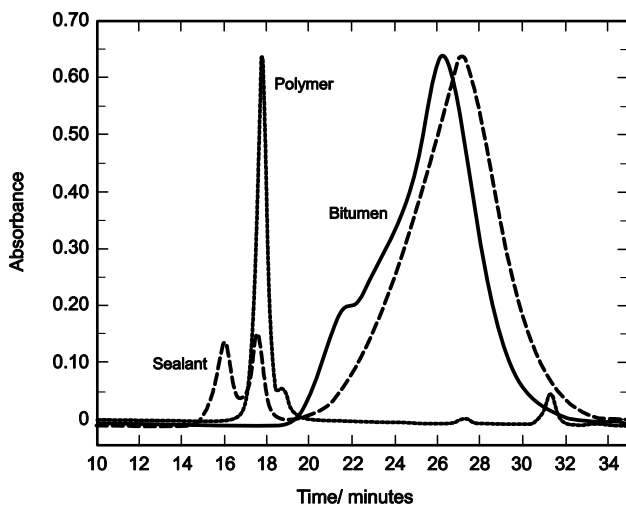
Figure 2. Typical GPC results for bitumen, an SBS copolymer and a sealant. Molecular size and mass increase from right to left.

molecules exit the column first and the smallest molecules exit last. The typical GPC result is an intensity-time plot, the column exit time being inversely proportional to the logarithm of the molecular size. Figure 2 shows results for a bitumen, an SBS copolymer and a bituminous sealant (the raw materials in figure 2 are not those in the sealant). Due to its high molecular mass, from about 1.5 Mg/mol to 100 kg/mol, the copolymer in Figure 2 shows a peak at earlier times than bitumen. A small shoulder on the right side of the SBS (labelled as Polymer) peak shows a residual content of SB diblock. Bitumen, which shows as a broad and intense peak at longer times, has molecular masses of about 300 to 1200 g/mol. Its molecular mass is thus 100 to >1M times lower than that of the copolymer. For the sealant in Figure 2, the GPC results show, from left to right, peaks for (SB)<sub>3</sub>, (SB)<sub>2</sub> and bitumen.

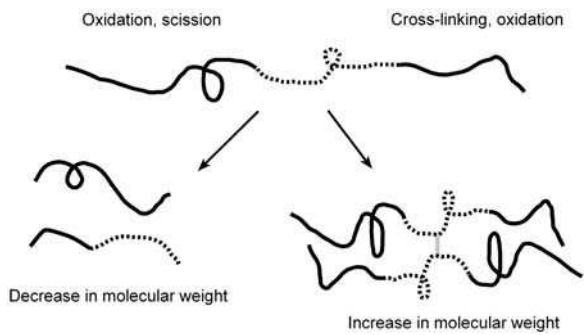
Figure 3. Illustration of the effect of scission and cross-linking on the size of the copolymer.

Given that GPC allows for measuring molecular sizes, the method helps to determine the nature of the aging that affects the copolymer in bituminous sealants. Figure 3 illustrates, for instance, the effect of scission and cross-linking on the size and length of a copolymer chain. Figure 4 shows how these degradation pathways can be differentiated by GPC. Copolymer degradation is first visible as a decrease in the intensity of the main copolymer peak. As the copolymer chains break down into smaller fragments, there is a rise in the background on the right side (low molecular mass side) of the main copolymer peak. When there is cross-linking, the rise in molecular mass is visible as an increase in the background on the left side of the main copolymer peak.

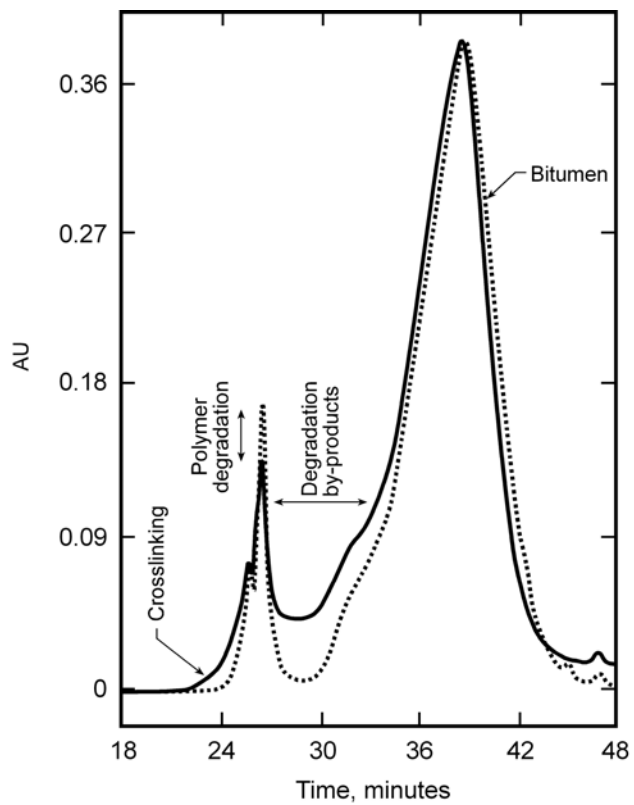
Figure 4. Illustration of the effect of cross-linking and scission on the copolymer on a sealant as obtained by GPC. The sealant is not the same as that in Figure 2, nor as that in later figures.

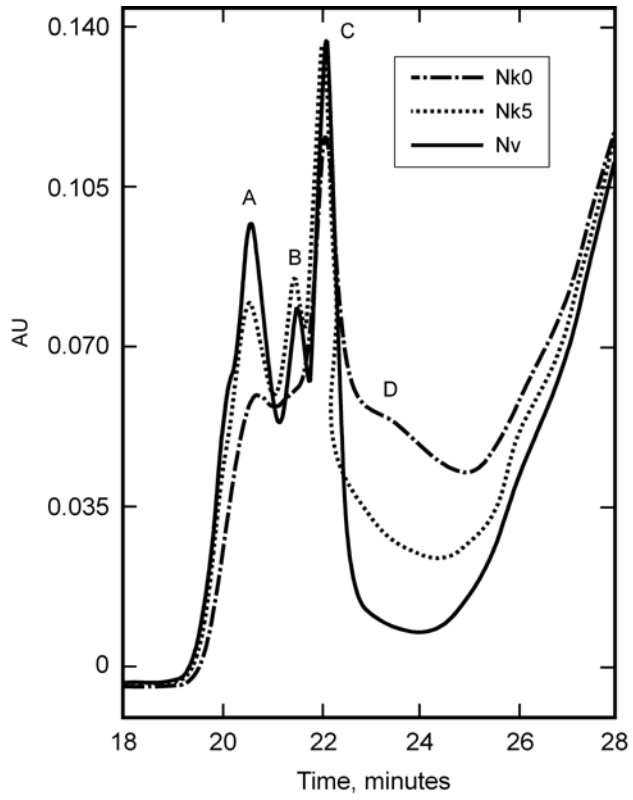
Figure 5. GPC results for sealant N aged in the field.

Figure 5 illustrates the effect of installation on the copolymer in sealant N as obtained by GPC. The bitumen signal, which was not affected by installation, is not shown, and not to overcrowd the view, figure 5 only shows the control (Nv) and two field samples, Nk0 and Nk5. The unaged Nv contained a mixture of three SB copolymers, identified as A, B and C. Each of these copolymers degraded during sealant installation, as seen by the loss of intensities for A, B and C in going from Nv to the Nk samples. The degradation led to shorter copolymer chains that gave rise to an increase in background at D in figure 5. The nature of this field degradation was thus a scission that produced (shorter) polymer chains of lower molecular weight (figure 3). Details of this degradation and its effect on sealant rheology are found elsewhere (Masson *et al.* 2007).

copolymer A, for instance, the change was calculated from  $(I^A_k - I^A_v)/I^A_v \times 100$ , where I is the maximum intensity of the signal at peaks A to D in Figure 5. Figure 6 shows that the concentrations of copolymers A, B and C increased as the installation progressed, which is why figure 6 shows the control sample Nv on the right, at a fictive 6h of installation, and not on the left, prior to the start of installation. The trend for the copolymer degradation by-products (D) is the reverse of those for A, B and C. It decreased throughout the day. As described in detail elsewhere (Masson *et al.* 2007), these results indicate that sealant N was already degraded early in the morning and that throughout the day, as the sealant in the kettle was replenished with fresh and unaged sealant, the overall concentration of degraded sealant in the kettle decreased over the course of installation.

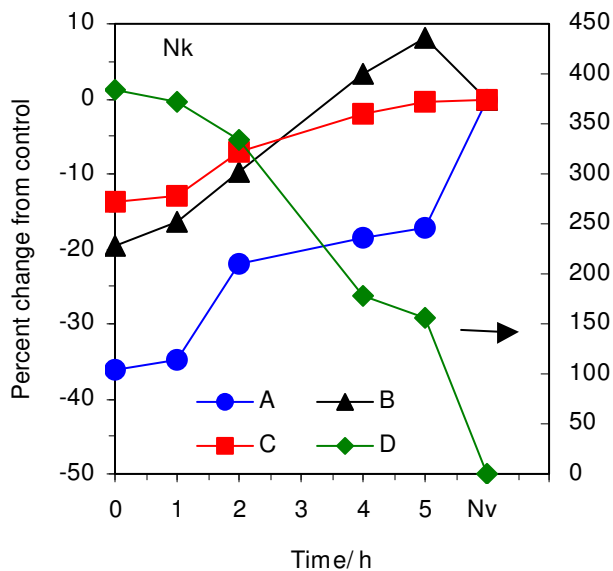
Figure 6. Effect of sealant installation on the GPC polymer peaks in sealant N. The percent change in the background (D) is shown on the right ordinate.

A different perspective on the degradation of sealant N during its installation is provided in figure 6. It shows the percent change of copolymers A to D over time. With

The trend in the degradation of sealant Q in figure 10 is significantly different from that for sealant N in figure 6. Sealant Q degraded while it was heated and applied, whereas sealant N had degraded before it was applied. This highlights the importance of minimizing sealant volume and heating time prior to the start of the crack sealing work.

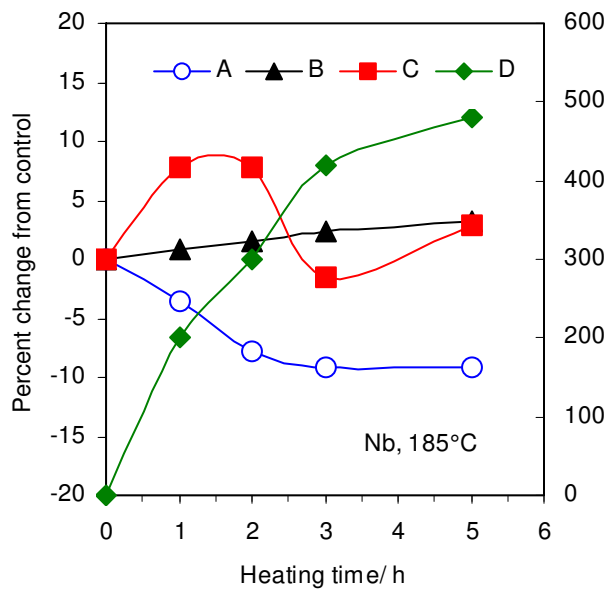
Figure 7. Effect of laboratory heating at 185°C on the GPC polymer peaks in sealant N. The percent change in the background (D) is shown on the right ordinate.

In an attempt to reproduce in the laboratory the effect of field installation, sealant N was first heated in the small kettle for up to 5h at 185°C. This temperature was the lowest suggested application temperature for this sealant and it was close to the average sealant heating temperature measured in the field, 187°C (Masson *et al.* 2005). The effect of the SKA on the sealant copolymers is shown in figure 7 as the percent change over time. Aging caused a 10% decrease in copolymer A, the highest molecular mass copolymer, and an increase in D, the shorter polymer by-products. Aging had little effect on copolymers B, in contrast to field aging. The concentration in copolymer C varies as a result of competing degradation mechanisms, details of which are beyond the scope of this paper. Based on the results for copolymers A and B in figure 7, it may be concluded

that the SKA of sealant N at its lowest suggested application temperature of 185°C led to degradation, but that this degradation was not as extensive as that caused by field installation.

To reflect the extended heating in the field, SKA times at 185°C could be extended beyond the 5h of Figure 7. However, given that SKA is labour intensive, aging beyond 5h renders the method unsuitable for rapid quality control (QC). Sealant N was therefore heated to 200°C, its highest suggested application temperatures (as advocated in ASTM D6690), and to 210°C, the average of the highest measured field application temperatures of 207°C and 214°C (Masson *et al.* 2005). Based on the exponential relationship between temperature and chemical reactions (Atkins 1982), shorter aging times are expected at higher temperatures.

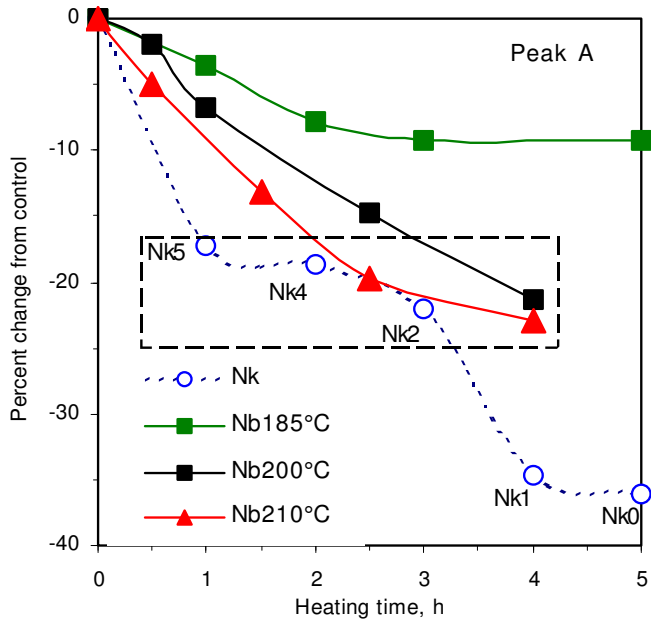
Figure 8. Polymer degradation measured by the decrease in the GPC polymer/bitumen peak ratio.

The effect of SKA at 200°C and 210°C on sealant N is shown in figure 8. The trends for copolymers A, B and C were similar at these temperatures, hence only the changes to copolymer A are shown in Figure 8, along with its change at 185°C. After 3 to 5h at

185°C, 10% of copolymer A had been lost. After 4h at 200°C and 210°C, the loss had exceeded 20%. At shorter times, the loss was faster at 210°C than at 200°C, as expected. Never was the degradation as extensive as that observed for the most degraded field sample, Nk0, with a loss of copolymer A near 35%.

The best correspondence between SKA samples of sealant N and field samples was observed with samples collected midway through installation, when an intermediate level of degraded copolymer was measured. This was the level shown by the SKA sealants heated about 2.5h at 210°C or 4h at 200°C, as indicated by the dotted box in figure 8.

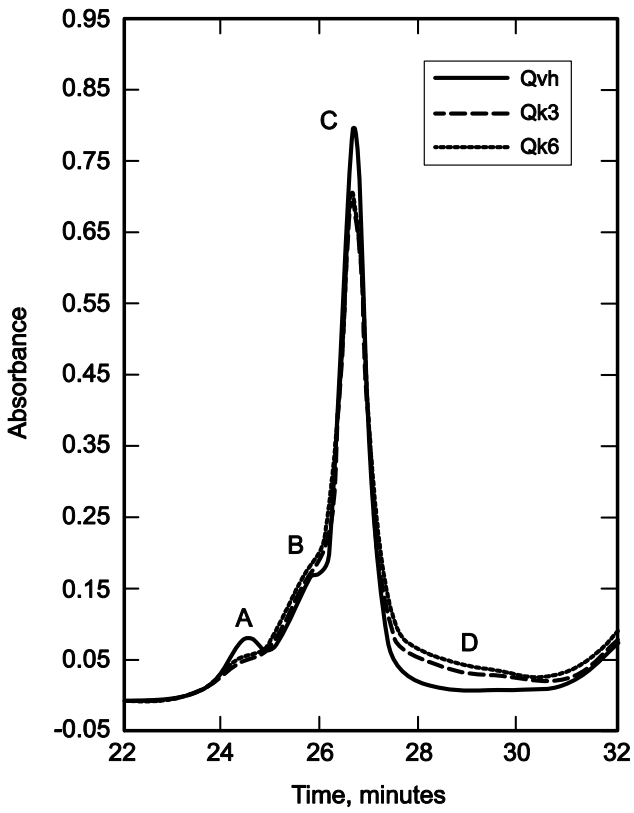
Figure 9. GPC results for the polymer in sealant Q aged in the field. The bitumen portion, unaffected by installation, is not shown.

This sealant had a low volume of reheated material in the kettle when installation began and a short thermal history (table 1). Notwithstanding this careful sealant preparation, the heating of sealant Q in the field also resulted in the application of a sealant with

degraded copolymer (figure 9). The degradation was the greatest for the high molecular mass copolymer A, which levelled after a loss close to 35% (figure 10). The change in copolymer B, which only showed as a shoulder in figure 9, was not tracked. The copolymer with the greatest concentration, copolymer C, showed a loss near 10%. As expected, copolymer degradation led to by-products of low molecular mass that raised the background at D in figure 9.

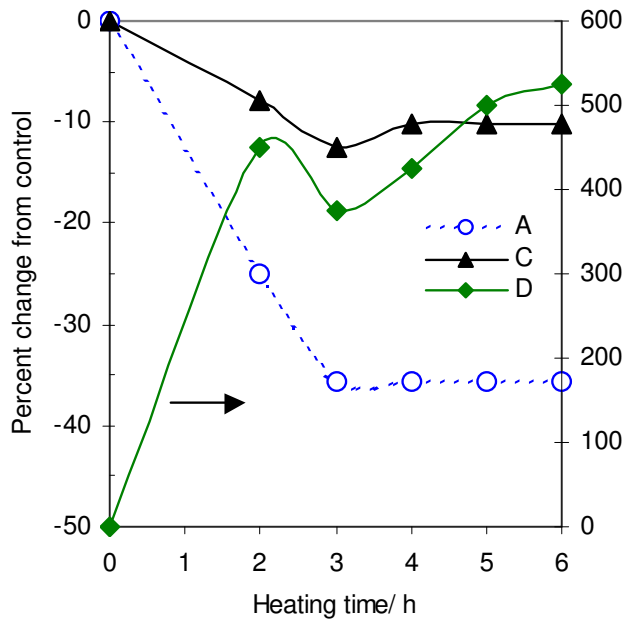
Figure 10. Effect of sealant installation on the polymers in sealant Q. The percent change in the background (D) is shown on the right ordinate.

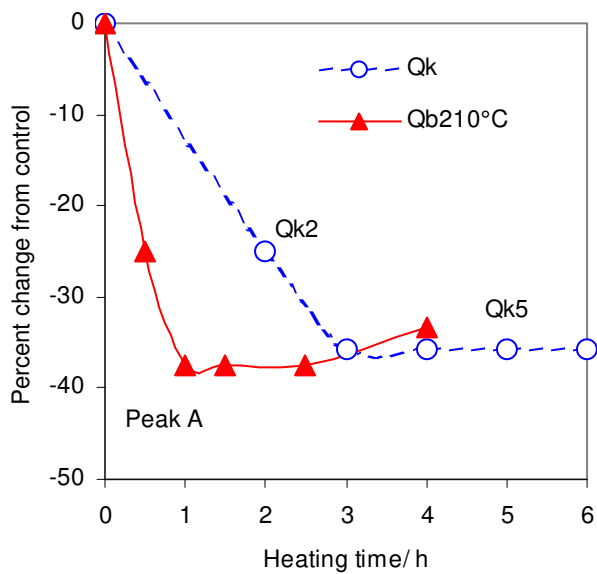
Figure 11. Polymer degradation measured by the decrease in the GPC polymer/bitumen peak ratio in sealant Q.

Given that the field aging of sealant N was suitably and most quickly mimicked at 210°C, sealant Q was also aged at this temperature. The results of SKA on copolymer A in this sealant are shown in figure 11. A similar trend was obtained with copolymer C. The copolymer was quickly degraded to a constant level that matched that for the field samples. One hour at 210°C was sufficient to attain the level obtained after 3 to 6h in the field. SKA was thus a convenient method to accelerate the aging of sealant Q.

As indicated earlier, every 10°C increase in temperature doubles the rate of a chemical reaction (Atkins 1992). This, of course, also affects copolymer degradation. The results in figure 11 are consistent with such acceleration. Based on the time it took for degradation to be completed, 3h in the field and 1h in the laboratory at 210°C, the field application temperature was estimated to be near 190°C, which fits very nicely with the
