Adverse Local Tissue Reaction Arising from Corrosion at the Femoral Neck-Body Junction in a Dual-Taper Stem with a Cobalt-Chromium Modular Neck

H. John Cooper, MD, Robert M. Urban, PhD, Richard L. Wixson, MD, R. Michael Meneghini, MD, and Joshua J. Jacobs, MD

Investigation performed at Rush University Medical Center and Northwestern University Feinberg School of Medicine, Chicago, Illinois, and Indiana University School of Medicine, Indianapolis, Indiana

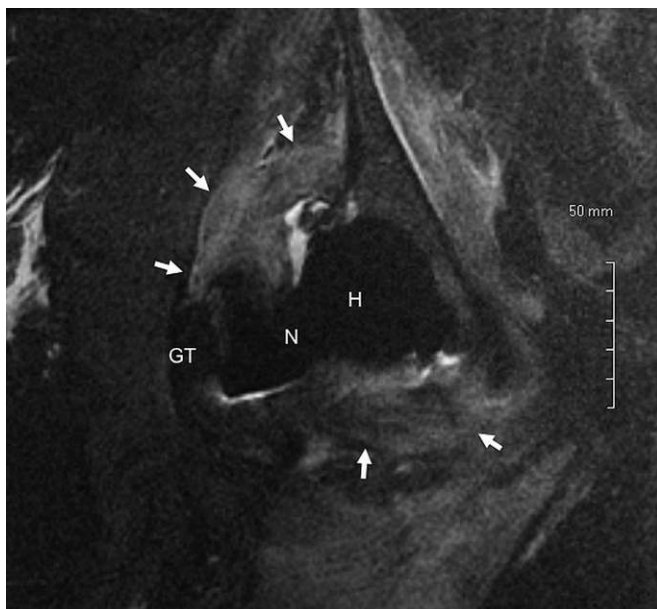
Fig. 1 Coronal short tau inversion recovery (STIR) magnetic resonance image acquired with use of metal artifact reduction sequence (MARS), demonstrating a large pseudotumor (arrows) surrounding the prosthetic hip joint, approximately twenty-one months following total hip arthroplasty (Case 3). As a reference, the greater trochanter (GT), modular prosthetic femoral neck (N), and modular femoral head (H) are labeled. **Fig. 2** Posterior (left) and medial (right) light microscopic images of modular femoral neck that was retrieved after approximately sixteen months in vivo (Case 2). Surface damage, consisting of fretting, corrosion, and black debris, was apparent on all retrieved cobalt-chromium modular femoral neck-body junctions. **Fig. 3** Scanning electron microscope image ($\times 3500$) demonstrating fretting and corrosion (left and center) as well as a thick deposit of fretting-corrosion debris (right) on the lateral aspect of a damaged neck-body junction that had been in vivo for approximately twenty months (Case 1). Similar findings were seen in all ten retrieved implants. **Fig. 4** Scanning electron microscope image ($\times 1500$) of a femoral head-neck junction that had been in vivo for sixteen months, demonstrating marked pitting corrosion of a cobalt-chromium femoral neck that was mated with a ceramic head (Case 6). Femoral head-neck corrosion was found in six of the ten implants analyzed (five with ceramic heads, and one with a metal head).

Serum metal ion levels demonstrated a substantial elevation in serum cobalt, which was elevated to a greater extent than serum chromium; serum titanium levels were generally within the normal reference range of patients with a well-functioning total hip arthroplasty (see Appendix). Radiographs were interpreted as normal in most cases, but one demonstrated subtle scalloping of the bone along the medial femoral neck. MRIs were interpreted as normal in one patient, but the remaining studies demonstrated large fluid collections and/or hypertrophic soft-tissue reactions or pseudotumor formation (Fig. 1).

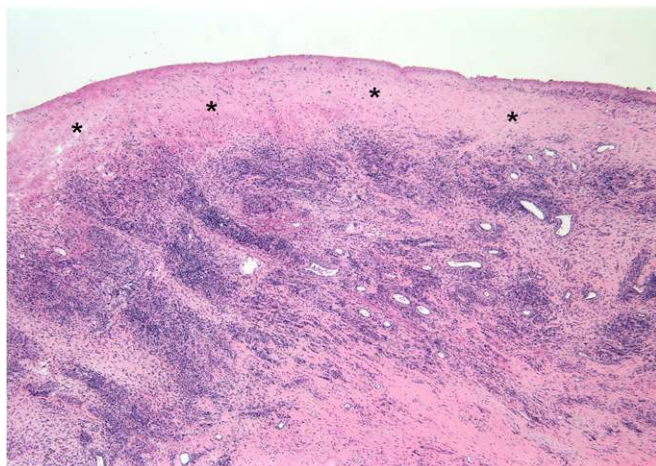
Fig. 5 Histological surgical specimen obtained 12.6 months following hip arthroplasty (Case 4), demonstrating abundant diffuse and perivascular lymphocytes in the joint pseudocapsule. The synovial lining is absent, and a layer of organizing fibrin exudate (*) covers the inner surface of the capsule (hematoxylin and eosin stain, $\times 25$ magnification). **Fig. 6** Histological specimen obtained during revision surgery after 12.5 months in vivo (Case 5). A broad layer of the joint pseudocapsule is necrotic (N) and covered by a surface layer of fibrin (*). Diffuse lymphocytes and a lesser number of eosinophils form a distinct layer (hematoxylin and eosin stain, $\times 25$ magnification).

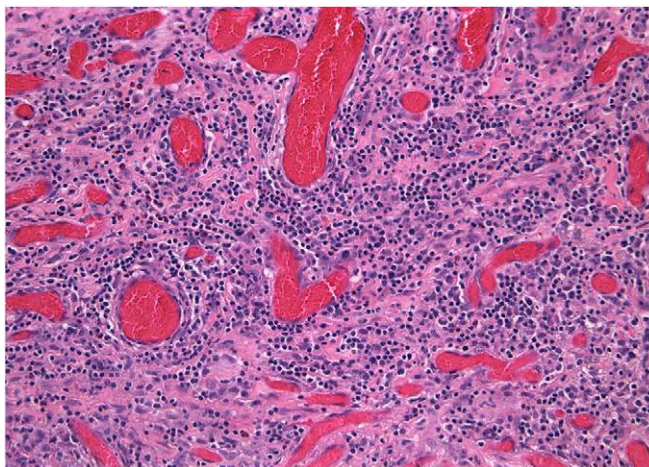
Fig. 7 Histological specimen removed during revision surgery (Case 1). The majority of the specimen was necrotic, but viable areas of pseudocapsule showed chronic inflammation dominated by diffuse lymphocytes and scattered eosinophils (hematoxylin and eosin stain, $\times 200$ magnification).

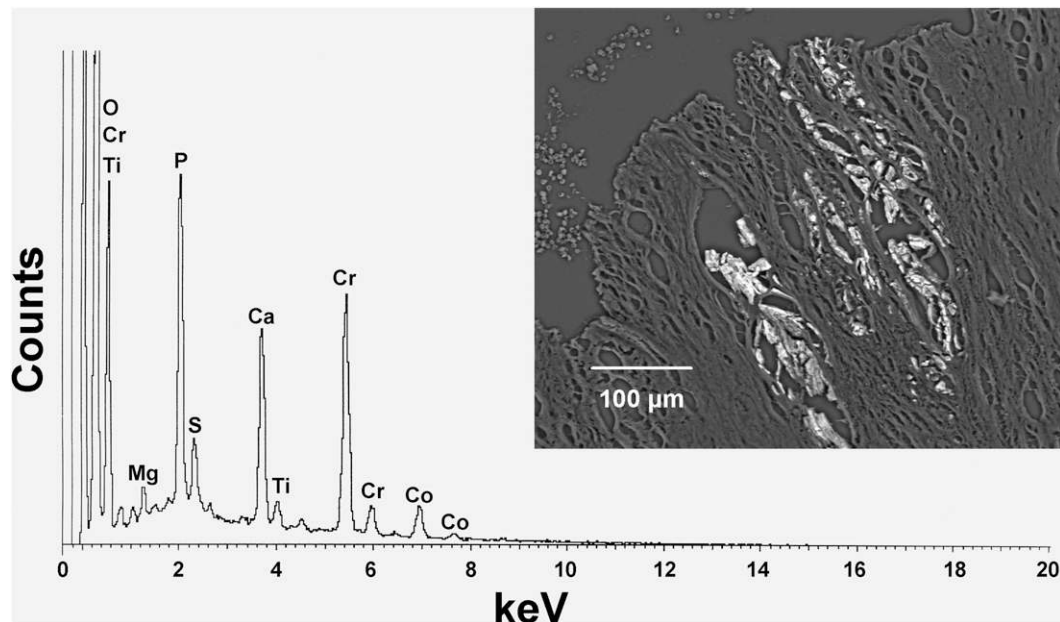
Fig. 8
An energy-dispersive x-ray spectrum (Case 5) reveals the elemental composition of particles rich in chromium (Cr) and consistent with chromium phosphate corrosion product. Traces of cobalt (Co) and titanium (Ti) are also present, the latter suggesting that these particles were generated by corrosion at the junction between the cobalt-chromium modular femoral neck and the titanium alloy stem. The particles (inset) lie in necrotic fibrous tissue of the joint pseudocapsule (backscattered electron micrograph, $\times 200$). O = oxygen, Mg = magnesium, P = phosphorus, S = sulfur, and Ca = calcium.

joint pseudocapsule (Appendix; Fig. 8). Opaque metallic or birefringent polyethylene wear particles in macrophages were only rarely observed in the histological sections. Notably, there were no qualitative or quantitative differences in the appearance of the periprosthetic tissue between patients with elevated or normal inflammatory markers.
