An *In Situ* HVEM Study of Dislocation Generation at AI/SiC Interfaces in Metal Matrix Composites

MARY VOGELSANG, R. J. ARSENAULT, and R. M. FISHER

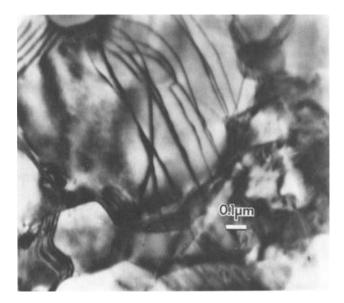
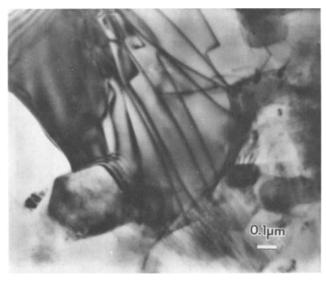
Fig. 4—(a) A foil cut transverse to the whisker axis (5 vol pct SiC). At the beginning of the thermal cycle, 370 K, the dislocations tended to bow away from the two hexagonal SiC whiskers. (b) The dislocations straighten on further heating to 570 K (same area as Fig. 4(a)). (c) Further rearrangement of the dislocations occurred on heating to the annealing temperature of 800 K in the microscope. The dislocations straightened and moved to more equally spaced positions (same area as Figs. 4(a) and 4(b)). (d) During cooling to 570 K the dislocations again began to bow away from the SiC whiskers (same area as Figs. 4(a-c)). (e) On cooling to 360 K, the curvature of the dislocations became pronounced, indicating the operation of a thermal stress; however, the generation of new dislocations did not occur (same area as Figs. 4(a-d)).

The 5 vol pct whisker sample, sectioned transverse to the whiskers so that the hexagonal whiskers are viewed end-on in the microscope, had a small subgrain size, 2.0 μ m, and a high dislocation density, $4 \times 10^{13} \text{ m}^{-2}$, in the subgrains (Figure 4(a)). In this case, on heating the dislocations did not disappear but straightened from an initially bowed configuration and became more regularly spaced: a polygonized configuration. These dislocations did not disappear at high temperatures (Figures 4(b) and 4(c)). On cooling, the dislocations again bowed away from the Al/SiC interface but the density of dislocations did not increase; if anything, the number slightly decreased (Figures 4(d) and 4(e)). Several of the subgrains appeared to change shape during the thermal cycle; however, their boundaries did not move past the surrounding SiC whiskers.

The exception to the generally observed disappearance of dislocations on heating was the 5 vol pct transverse sample for which no satisfactory explanation has been found. A stable polygonized substructure appeared to prevent the disappearance of the dislocations at high temperatures. Backstresses from these dislocations on cooling could have prevented further generation of dislocations in the small subgrains on cooling.
