AN INFORMATIVE CONTENT 3D MODEL FOR THE HALL HOLDING THE RESURRECTION OF CHRIST BY PIERO DELLA FRANCESCA MURAL PAINTING AT SANSEPOLCRO, ITALY

M. Coli¹, A. L. Ciuffreda¹, M. Micheloni^{1,*}

KEY WORDS: HBIM, Piero della Francesca, Sansepolcro, 3D model, cultural heritage, mural painting

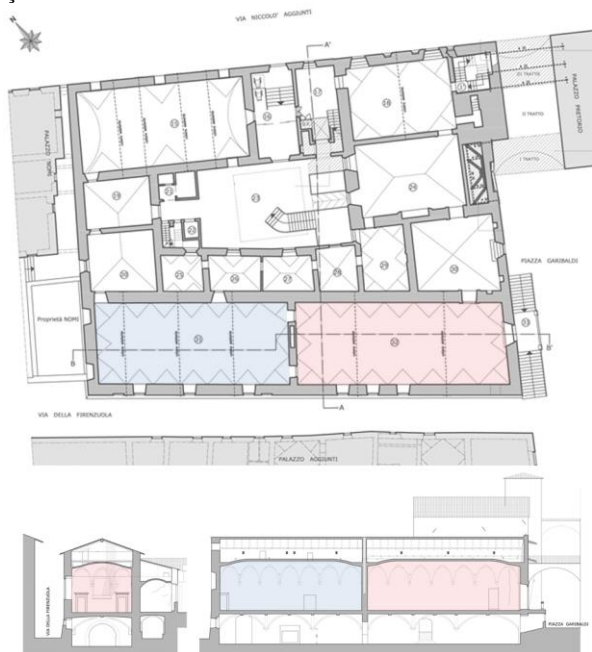
Figure 2. Survey of the Civic Museum of Sansepolcro. In red, the hall of the painting by Piero della Francesca; in blue the hall of Matteo di Giovanni; in the middle the wall that holds the painting. (Survey provided by the Municipality of Sansepolcro).

The building that was originally the Conservatori Palace and holds the painting the Resurrection by Piero della Francesca, today is incorporated in the aggregate building of the Museo Civico di Sansepolcro (Figure 2).

The building currently consists of three levels with a rectangular plan (44 x 9 m) and height of about 14 m. A central wall divides the volume in an almost symmetrical way in two parts with dimensions of about 22 x 9 m.

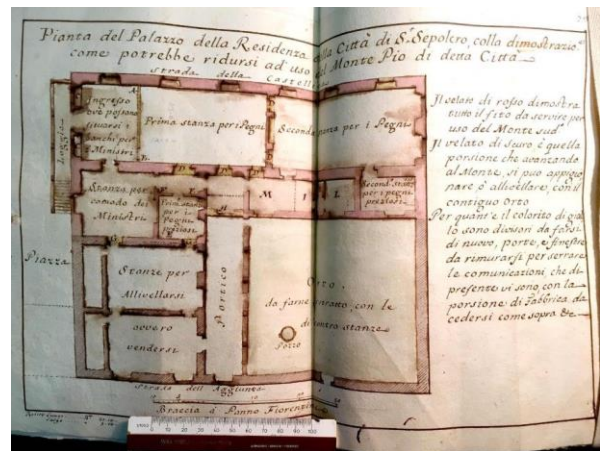
Figure 3. Map of the state of the places and works planned for the settlement of Monte dei Pegni, mid XVIII century (Paola Benigni, in print).

In the XVIII century, the Monte dei Pegni (Figure 3) uses the building. Between the XVIII and XIX centuries in the hall of Piero a false wall was built and three doors were closed in the right wall; two doors on the sides of the painting was opened and closed, while the fireplace was closed.

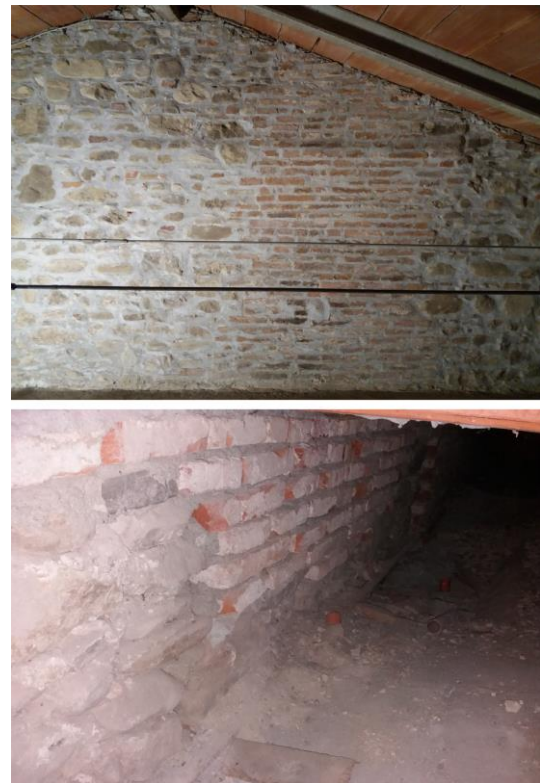
Figure 4. Up: the intermediate wall in the attic where the counter wall supporting the mural painting wall-panel is not present. Down: the counter wall supporting the mural painting wall-panel above the vault but below the attic floor.

Inside this wall, the fireplace and the chimney were made of bricks of 30x15x5 cm, placed by flat, and with mortar of about 1 cm. In the attic is visible the wall that encases the chimney (Figure 4).

The portion of the wall on which the painting stands is made up of a brick wall (thickness 15 cm), laid out flat, 5 cm high and with mortar levels of about 1 cm (Figure 4).

The counter-wall that supports and contains the wall of the painting is made of bricks, (thickness 15 cm) and rises up to the floor of the vaults (Figure 4).

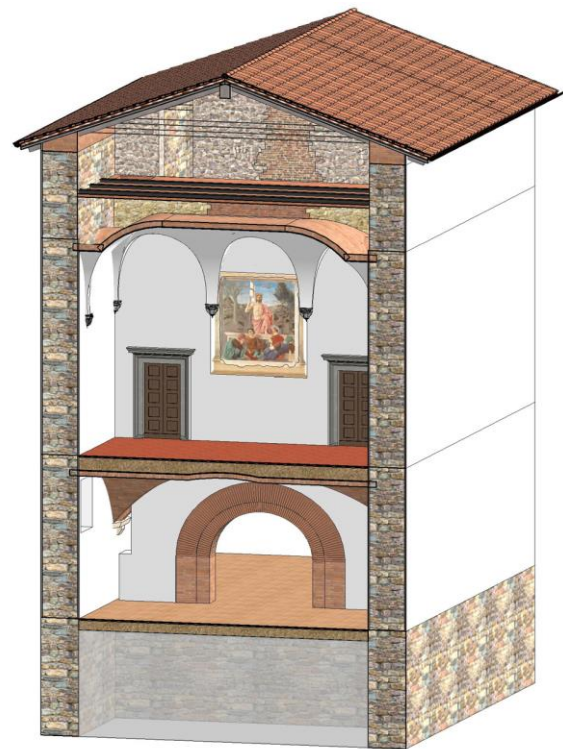
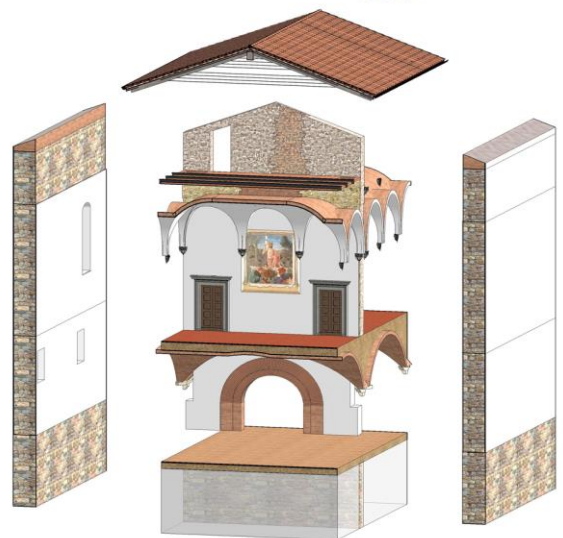
Figure 5. The BIM model. General view.

The operational phase consisted of modelling the case study and creating customized families for entering the data of the surveys carried out. The creation of specific abacus allowed the interrogation of the model (Figure 5).

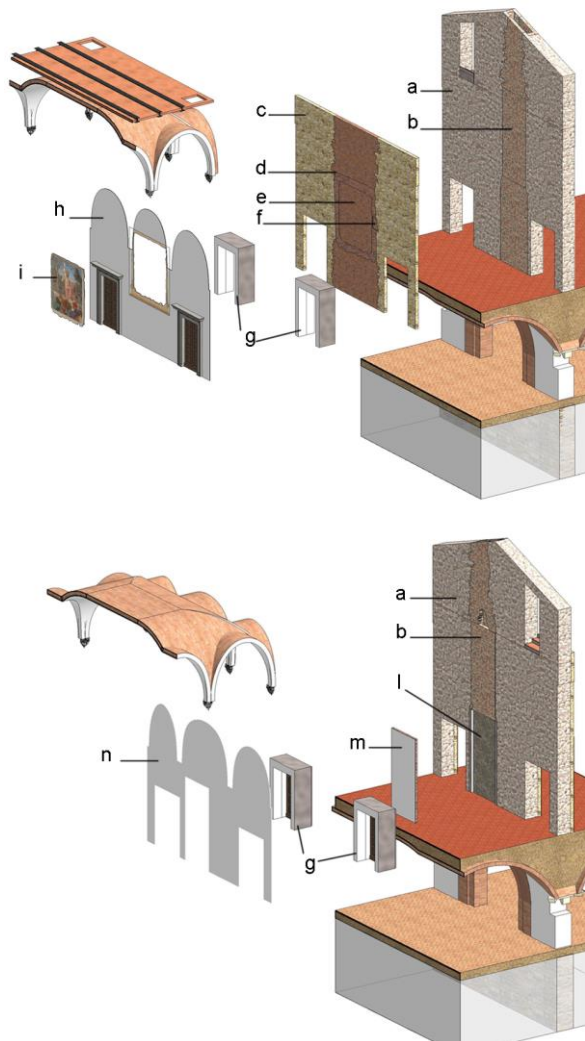
Figure 6. The BIM model. Exploded view: a. the main wall; b. the chimney and the fireplace; c. the counter-wall of the painting; d. the boundary filling of the solid-wall; e. the solid-wall of the painting; f. the support block of the “peduccio”; g. the reinforcement of the two side doors; h. the plaster; i. the painting; l. the incoherent filling of the fireplace; m. the closure at the back of the fireplace; n. the plaster.

The model was subsequently organized through specific views aimed at displaying the different types of information to be highlighted. The BIM model was designed to facilitate the understanding of the wall structure of the painting (Figure 6), to store information found during the diagnostic campaign and during restoration, and to allow easy viewing and consultation.

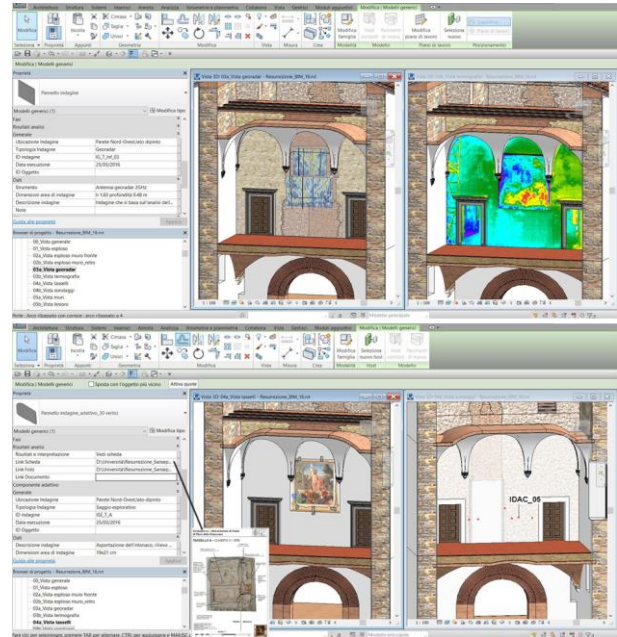
Figure 7. Up: the visualization of georadar and thermography surveys. Down: the visualization of one of the 7 exploratory tests with linked data sheet and of the DAC-tests on the back of the wall with ID label.

The families of the surveys have been associated with parameters that allow to insert information such as the date of execution, the description, the instrument used and the results. It was possible to create parameters to insert links to photos, documents and videos (Figure 7).
