**AN INVESTIGATION
OF ACOUSTIC EMISSION
FROM DEFECT FORMATION
IN STAINLESS STEEL WELD COUPONS**

JANUARY 1969

C. K. Day

Nondestructive Testing Department
Systems and Electronics Division

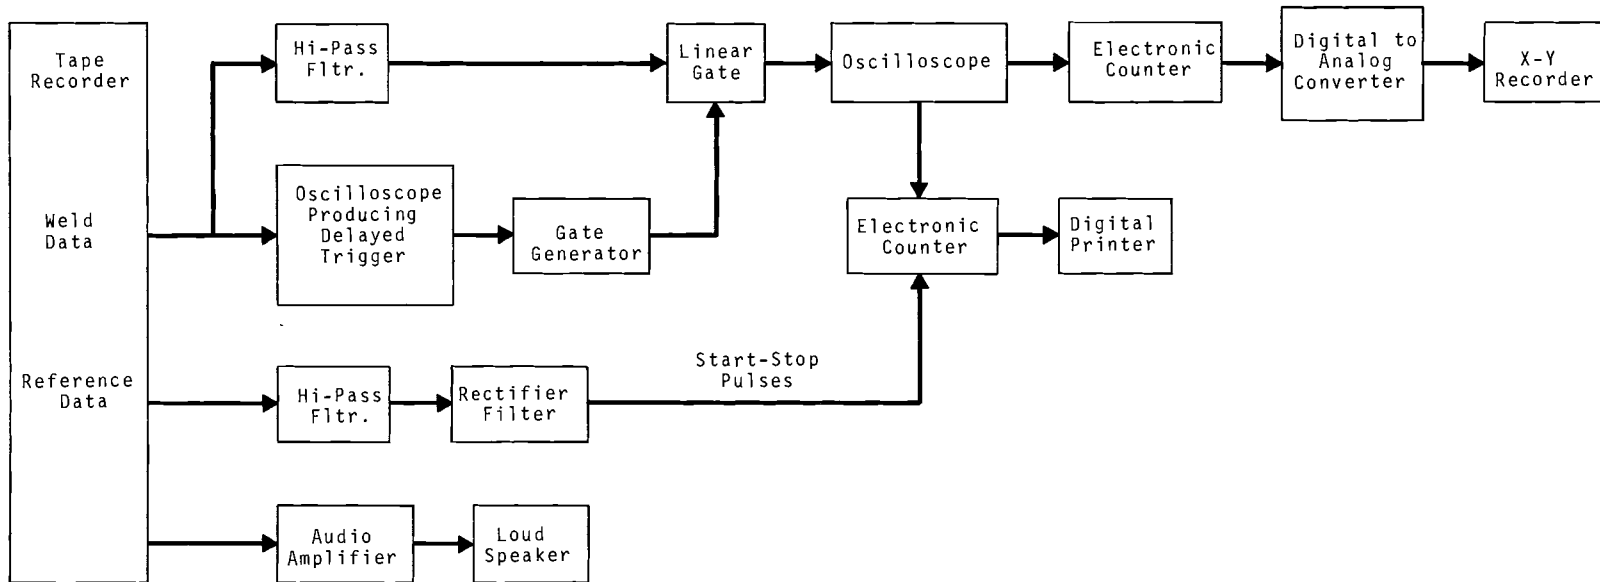
FIGURE 6. Block Diagram of System Used to Analyze Acoustic Emission Data

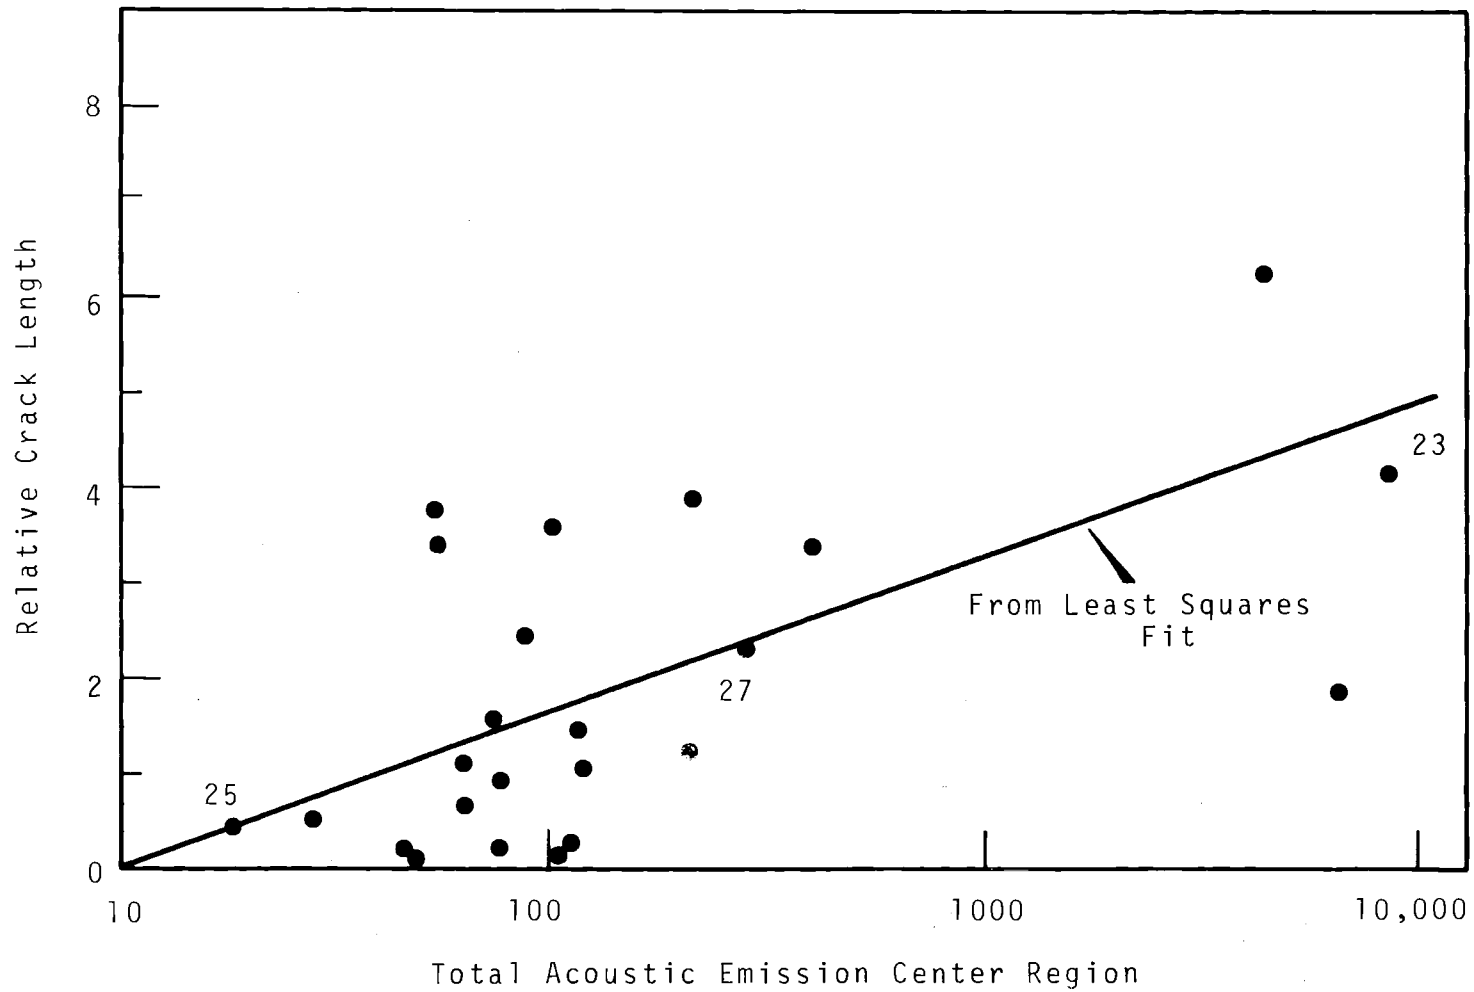
FIGURE 9. Acoustic Emission Versus Crack Length (as Measured from Three Metallographic Sections Each) for the Center Region of 24 Welds. (The Numbered Welds Correspond to those Samples for Which Data Are Shown in Figure 10 and 11.)

As one might expect, a direct correlation between acoustic emission and crack length for the three regions was not obtained, mainly because determining crack length from only three photomicrographs taken out of a two-inch length is a very rough approximation. However, for the center region there were indications that a relationship exists between emission and weld quality. This is plotted in Figure 9 for the 24 usable welds made during the investigation.

When least square fitting and a straight line were assumed, the resulting coefficients produced the line also shown in Figure 9. Additional data from the three welds which lie along this line (25, 27, and 23) are shown in Figure 10. In this figure the amount of acoustic emission produced each second from the weld is plotted against test time. The fact that Weld Number 25 was metallographically one of the best produced is confirmed by the small amount of emission obtained from this specimen. Weld Number 27 was defective because of the addition of a 1/16 in. diameter 1/4 in. long piece of tantalum, and Number 23 was one of the worst welds produced as a result of adding titanium on the third pass.

It should be pointed out that the data presented above are only for the center region and that a good correlation between crack length and acoustic emission for the top and bottom regions was not obtained. For these regions there was even more scattering than that shown in Figure 9.

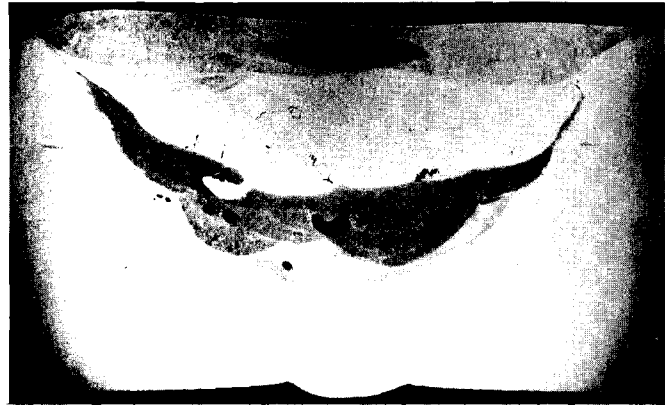
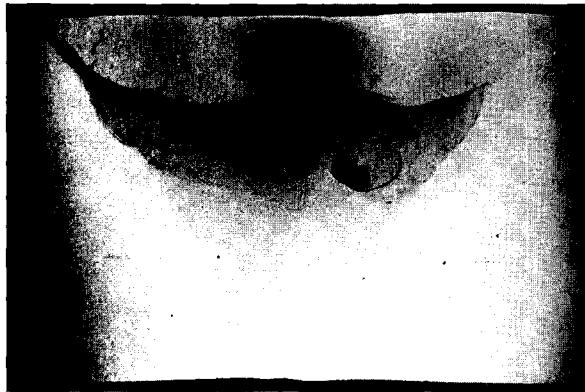
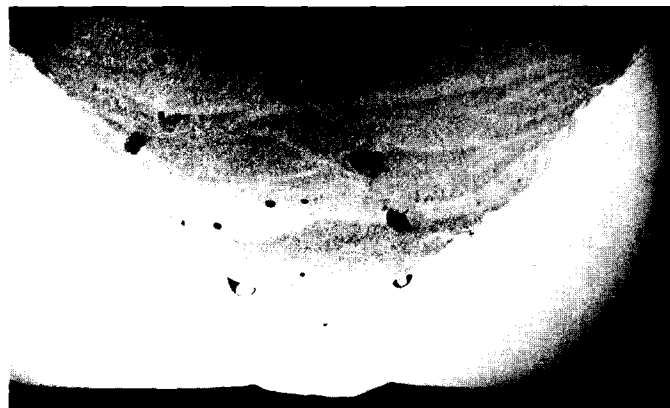
A. Test Weld No. 7
Total Acoustic Emission 426

B. Test Weld No. 9
Total Acoustic Emission 466

C. Test Weld No. 20
Total Acoustic Emission 411

FIGURE 14. Test Welds Containing Porosity. (Large Amounts of Acoustic Emission Were Produced by These Welds.)

Crack formation appeared to be the weld defect causing most of the acoustic emission throughout this study. There were, however, indications that gross porosity formation produced some of the emission since high signal levels were obtained from Samples 7, 9, and 20, shown in Figure 14. These samples contain large amounts of porosity as demonstrated by the radiographs and photomicrographs. However, some cracking accompanied the porosity, and this may have been the source of all emission.

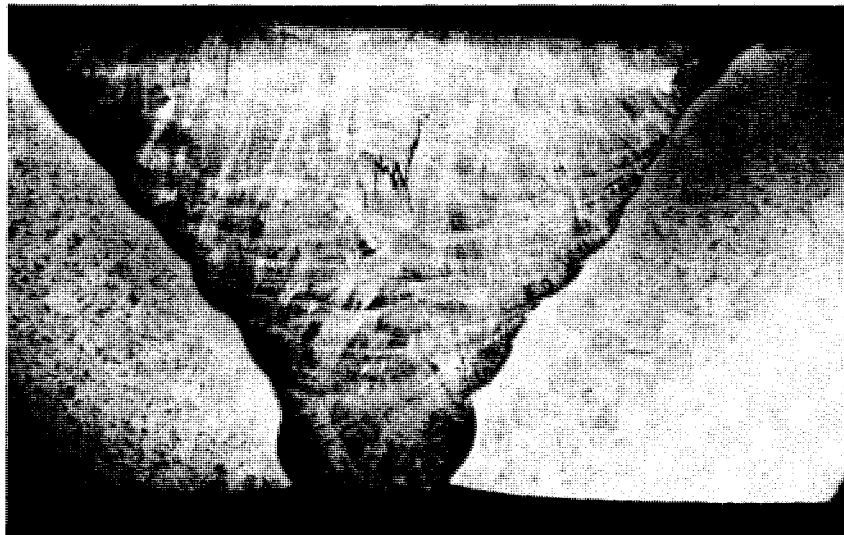
A. Test Weld No. 14
Total Acoustic Emission 10300

B. Test Weld No. 11
Total Acoustic Emission 200

FIGURE 15. Welds Producing Acoustic Emission from Cracks that Were Not Detected by Conventional Radiographic Techniques.

All of the defective welds produced acoustic emission in varying degrees. Two cracked welds produced emission but were not considered as having cracks by radiography. These were Samples 11 and 14 shown in Figure 15. Two hundred signals were produced by Sample 11 while Weld 14 was one of the worst

produced according to acoustic emission with approximately 10,000 signals observed. Photomicrographs of these samples are shown in Figure 15.
