# AN INVESTIGATION OF HISTORIC STRUCTURES OF NOVÁ HORKA CASTLE IN STUDÉNKA (CR)

## Abstract

Baroque castle;  
Building archaeology survey;  
Heating;  
Waste pipes;  
Presentation of cultural heritage.

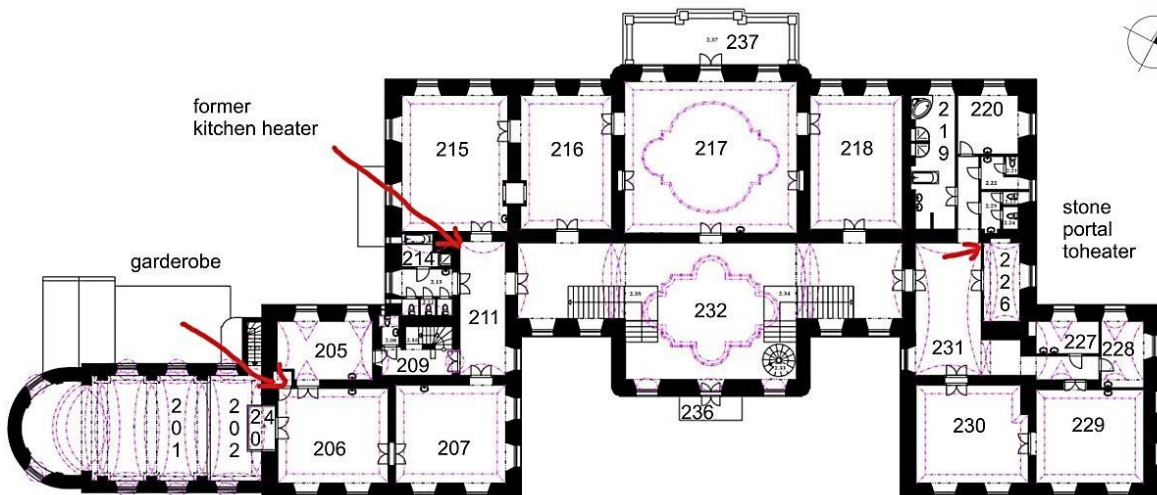
Fig. 2: Nová Horka Castle, plan of the first floor, 2016 (drawn by Oldřich Němec).

The castle was studied with traditional methods of building archelogy survey. The observed floors were inspected and the plans were reviewed and corrected. Then the discoveries (heaters, garderoberes...) were recorded into plans, Fig. 2.

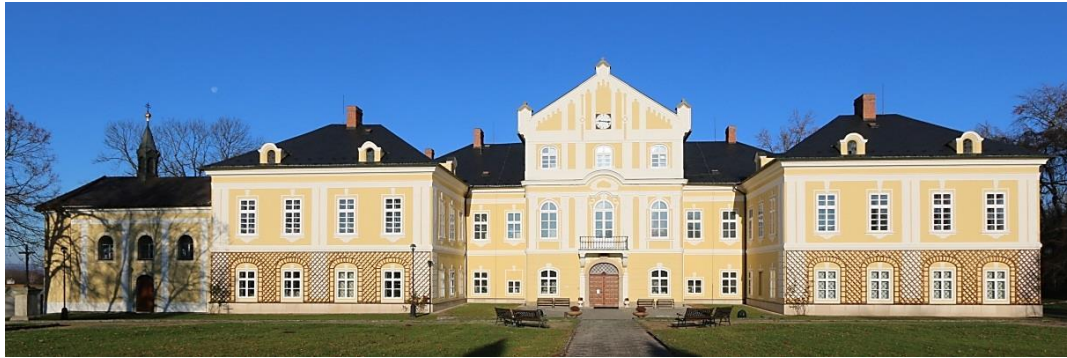
Fig. 4: Nová Horka Castle, 2021 (taken by the author).

Another important member of Vetter von der Lilie family was Karl Josef Franz (10 December 1719 – 27 August 1792). He became an owner of Nová Horka in 1742, [5]. During his time, the castle was rebuilt into a baroque style, Fig. 4.

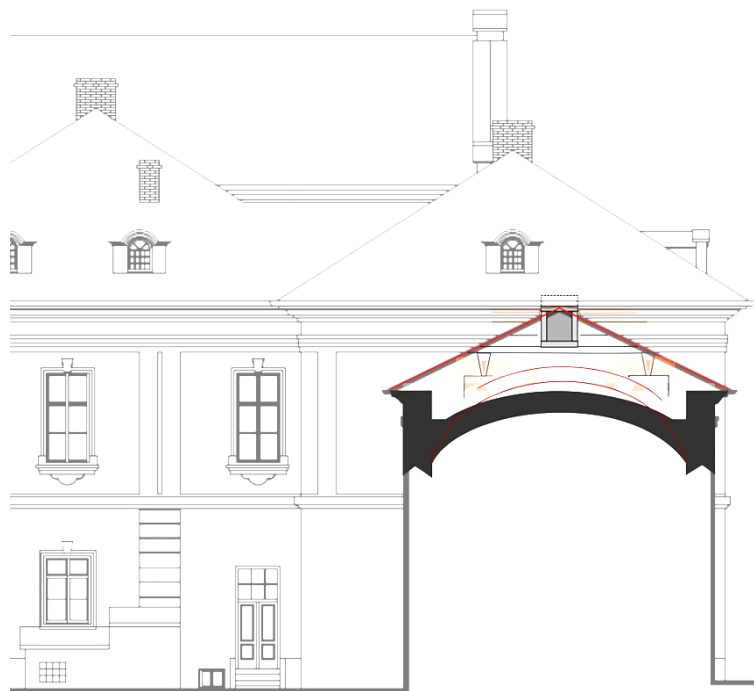
Fig. 6: Nová Horka Castle, southern – western façade with the remnants of the early Baroque windows, 2021 (drawn by A. Knápek).

The Chronicle by Janáček states the castle got the baroque form in the time of Karel Josef count Vetter in 1740s – 1770s. The façade was modified, Fig. 6, then and a *salla terrena* of today's shape was established. The castle got mansard roofs covered with shingles (according to later sources) [6]. Two vedute captured such form of the castle – a detail of the building from the portrait of Karl Josef Vetter from 1792, Fig. 5, and a printing after Kledenský's vedute from 1817, Fig. 5, [10].

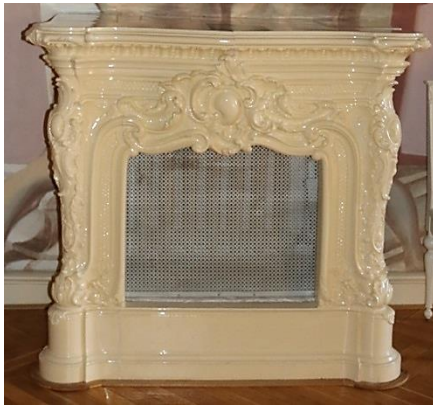
Fig. 7: Nová Horka Castle, fireplace composed of ceramic tiles in *salla terrena*, 2021 (taken by the author).

Visitors of the castle must be attracted by the heater in the *salla terrena*. In the baroque period it undoubtedly was space opened to the garden. In the 19th century it was closed up with windows, the inventory from 1840 describes it as a *Garten Saal* [5]. The former *salla terrena* was heated, or rather kept at a moderate temperature, then. A heater was installed to the southwest wall of the *salla terrena*. In the period of late historicism there were fireplaces as additional heaters in castles commonplace. Additional fireplaces were installed in aristocratic residences mostly at the turn of the 19th and 20th century (stone fireplaces with coat of arms of Stollberg in the castle in Paskov, findings of stone probably fireplace tiling in the castle in Kravaře, ...). The material of the fireplace is unique to the castle in Nová Horka, Fig. 7. Most fireplaces were built of stone or were tiled with stone; the material applied for fireplace heater in Nová Horka was ceramic. The preserved fireplace in *salla terrena* consisted of ceramic tiles. In accordance with historic photographs of the interior, there were more similar ceramic fireplaces in Nová Horka, according to formal signs they came from the latter half of the 19th century, Fig. 7.

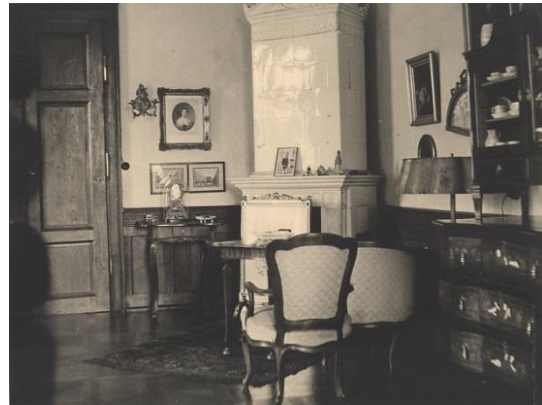
Fig. 8: Nová Horka Castle, fireplace composed of ceramic tiles, photo, 1944 (SOKA Nový Jičín).

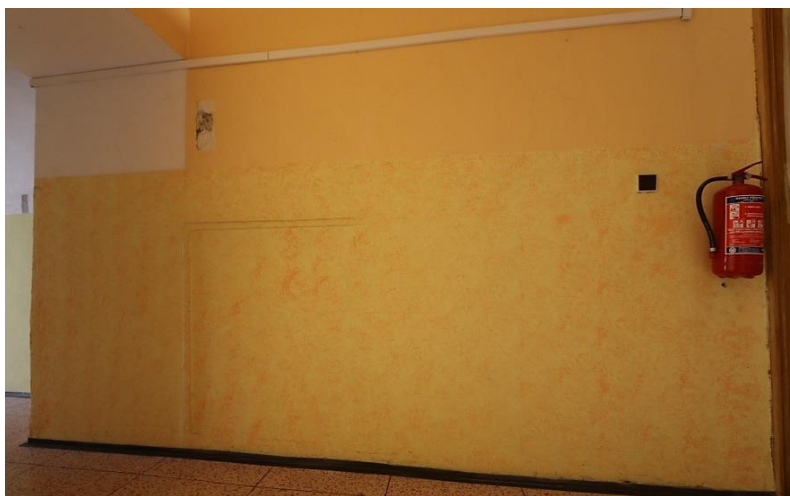
Fig. 9: Nová Horka Castle, corridor N. 211, stone portal to heater, later walled up, photo, 2021 (taken by the author).

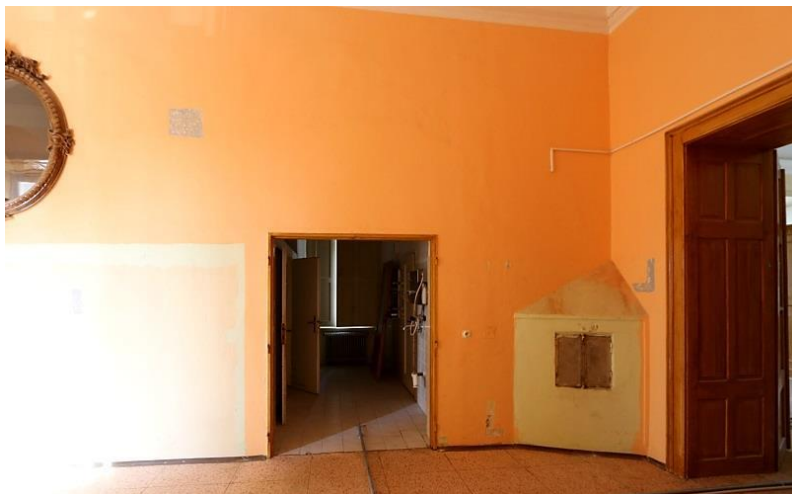
Fig. 10: Nová Horka Castle, corridor N. 231, rebuilt stone portal to the heater, photo, 2021 (taken by the author).

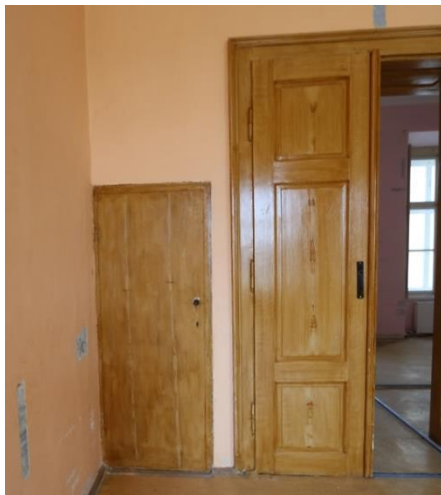
Fig. 12: Nová Horka Castle, room No. 236 with the door leading to the garderobe, photo, 2021 (taken by the author).

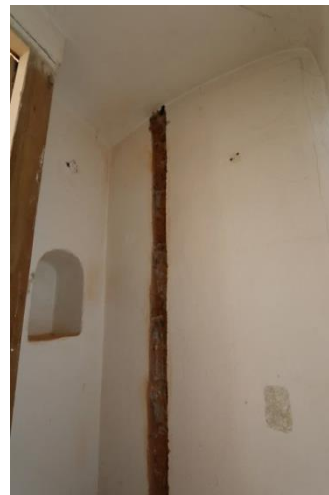
Fig. 13: Nová Horka Castle, rebuilt garderobe with the niche, photo, 2021 (taken by author).
