AN INVESTIGATION OF METALLURGICAL FACTORS
WHICH AFFECT THE FRACTURE TOUGHNESS
OF ULTRA HIGH STRENGTH STEELS

William E. Wood, Earl R. Parker and Victor F. Zackay

May 1973

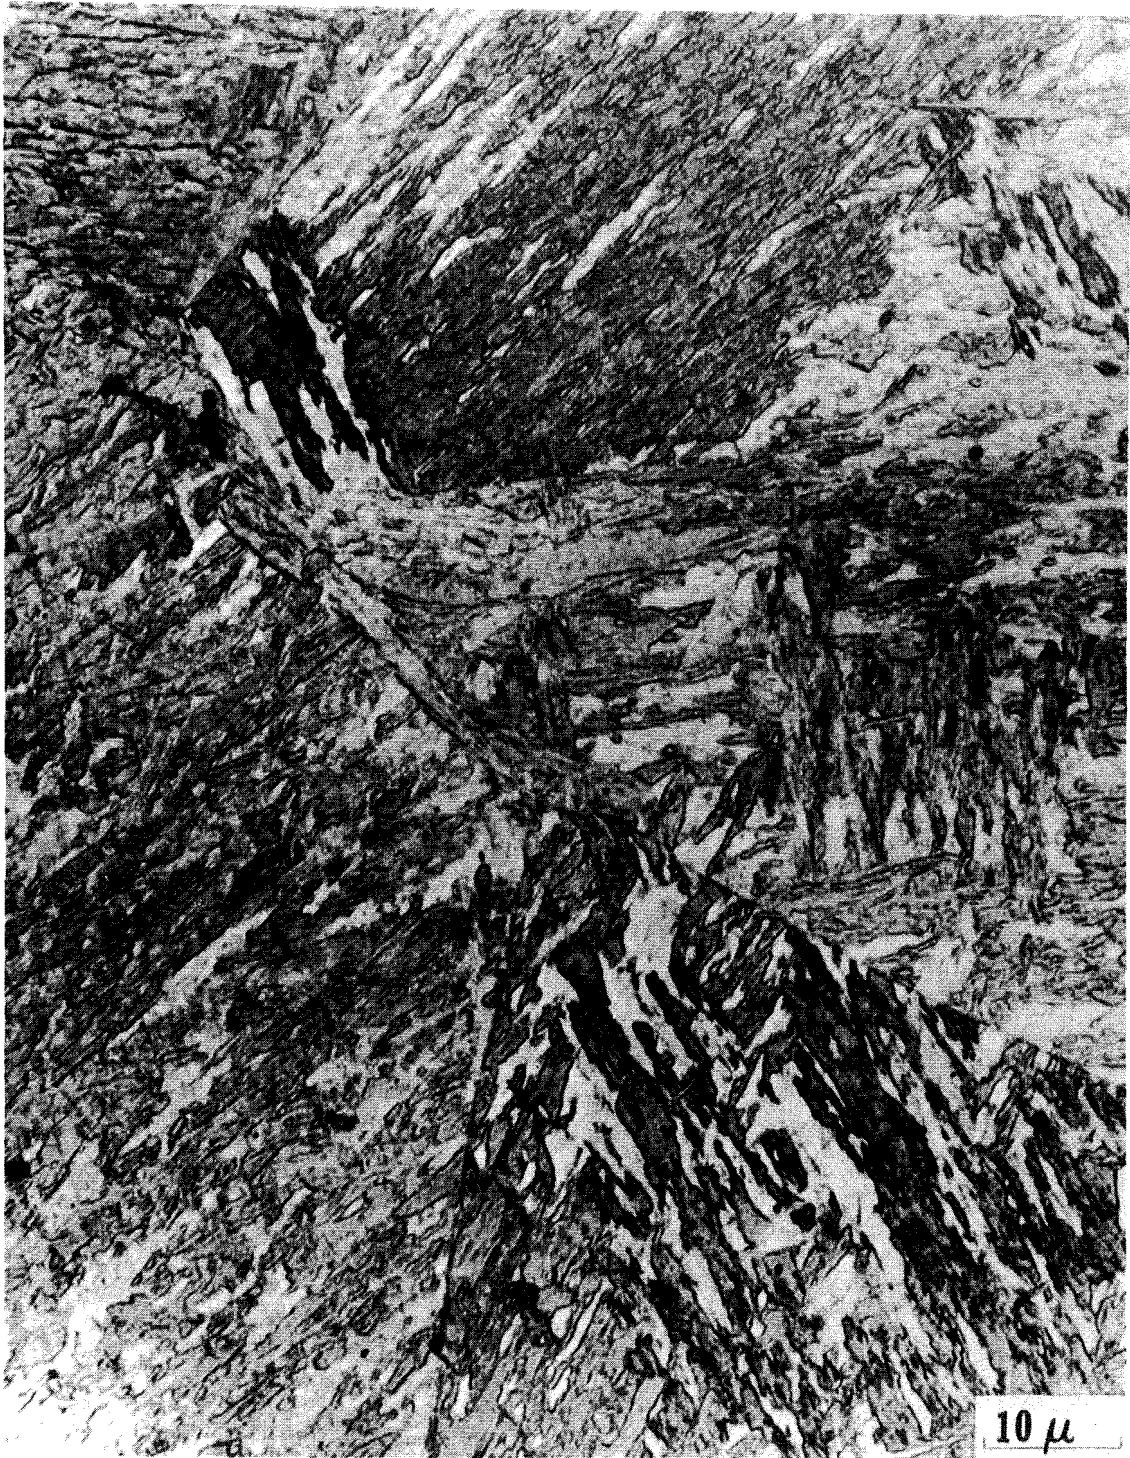
Fig. 33

The as-quenched microstructure for a (1200°C, IBQLN) heat treated section of 4340, 0.027 in. thick is shown in Fig. 33. This structure is fully martensitic without any trace of a decomposition product visible.

4340 (1200, IBQLN) AQ, 0.027 in. thick

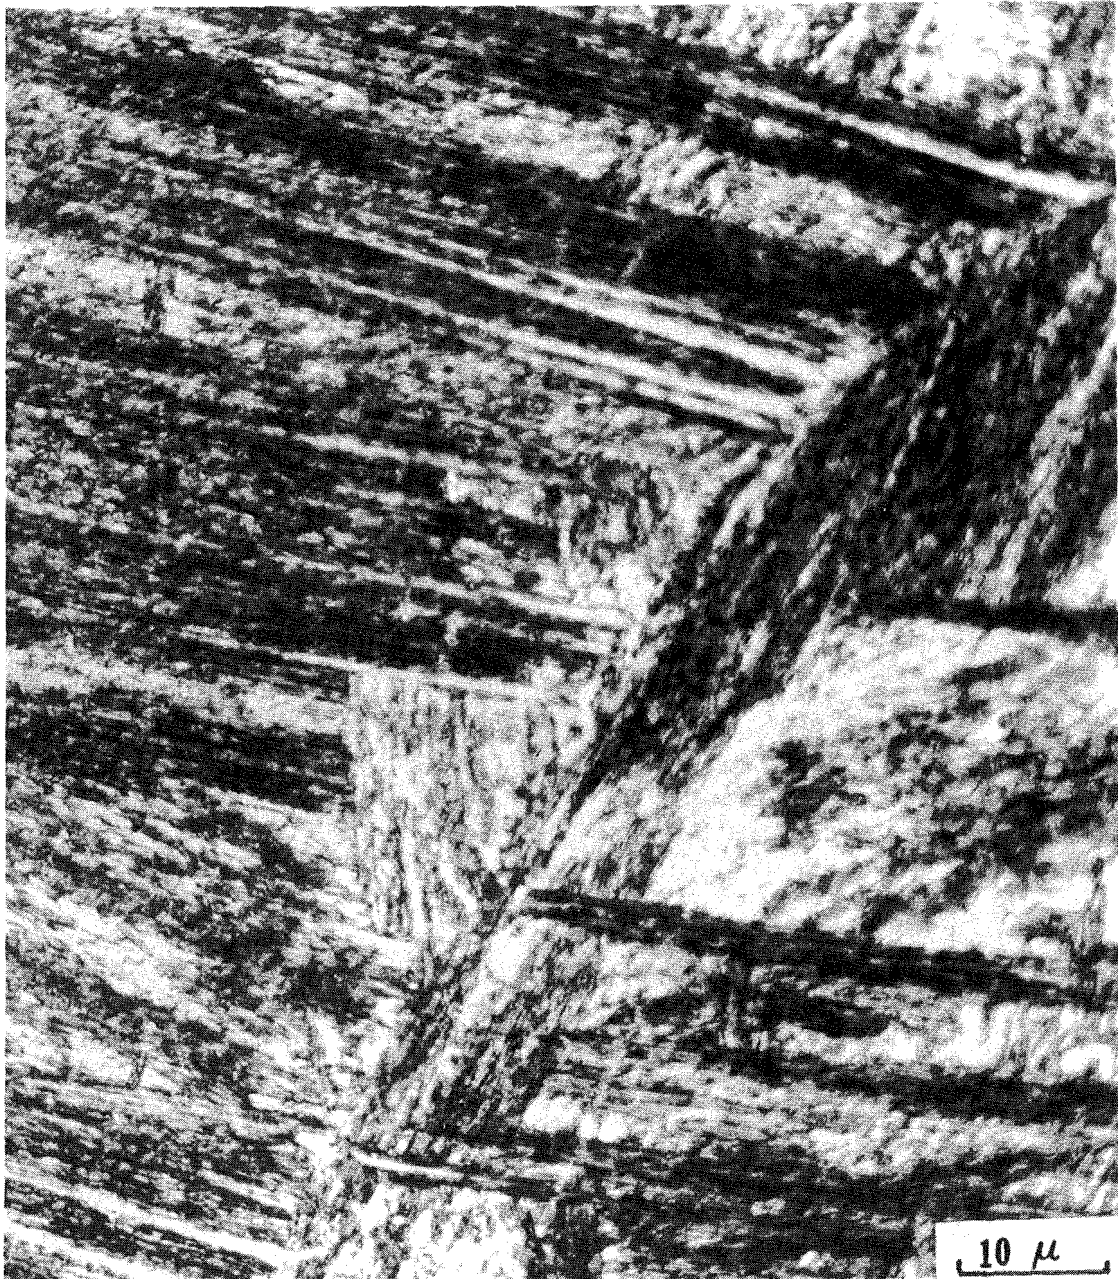
Using a step quench into oil, (1200→870, Oil) does not produce a change in the microstructure. Upper bainite is visible again originating from grain boundaries (Figs. 43 and 44).

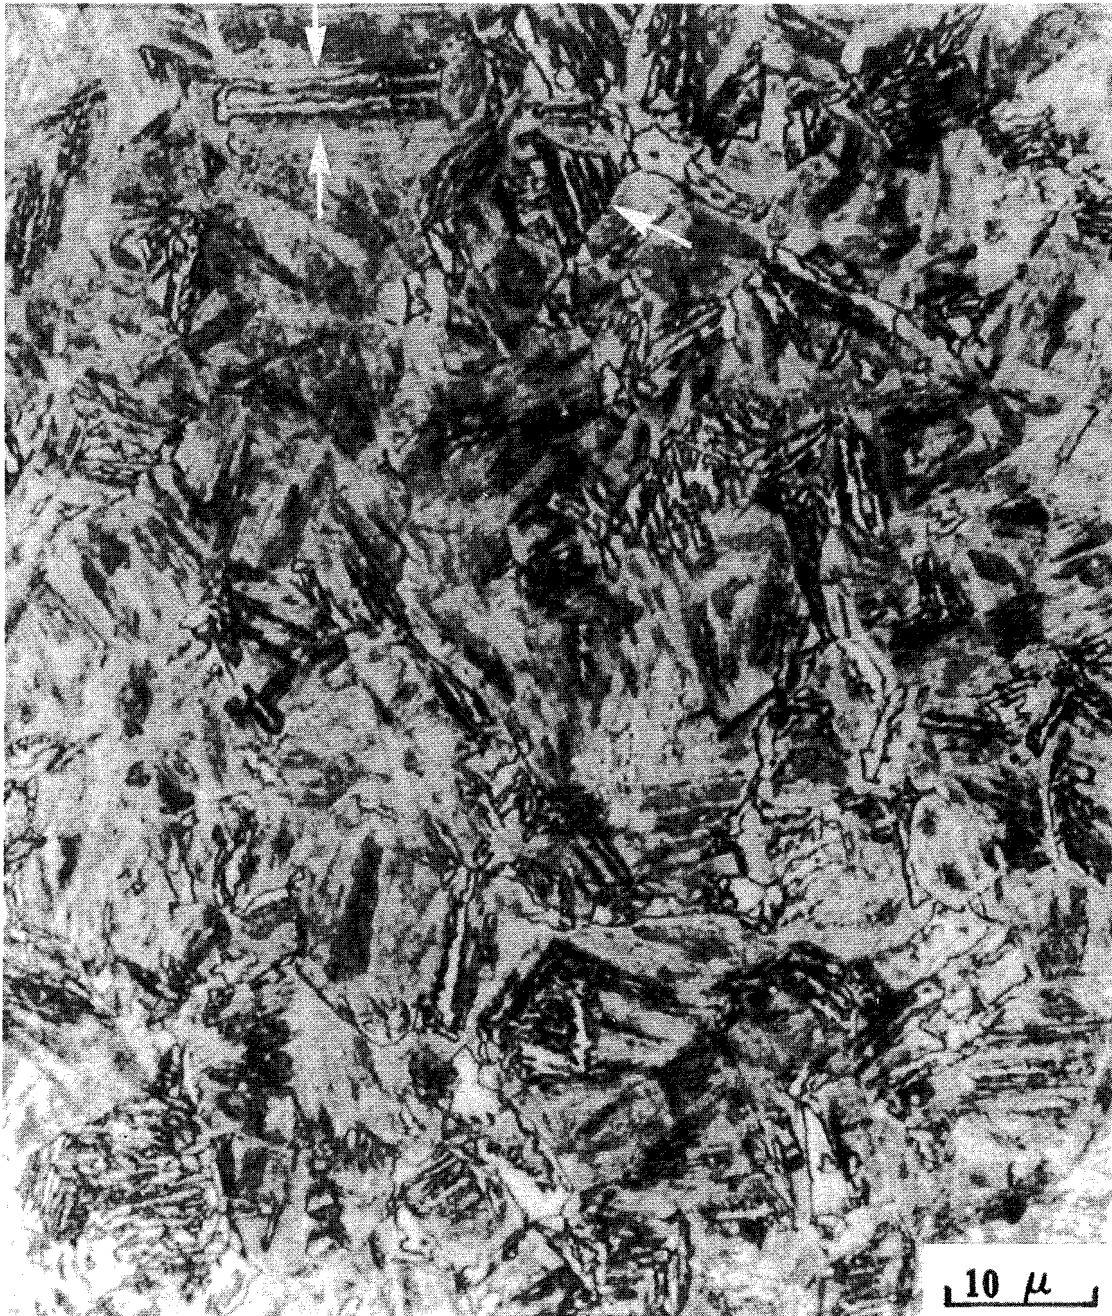
The microstructure which results from the commercial 870°C austenitization followed by an oil quench is shown in Figs. 49 and 50. Figure 50 reveals that this heat treatment results in the formation of ferrite and very coarse upper bainite in which the ferrite laths

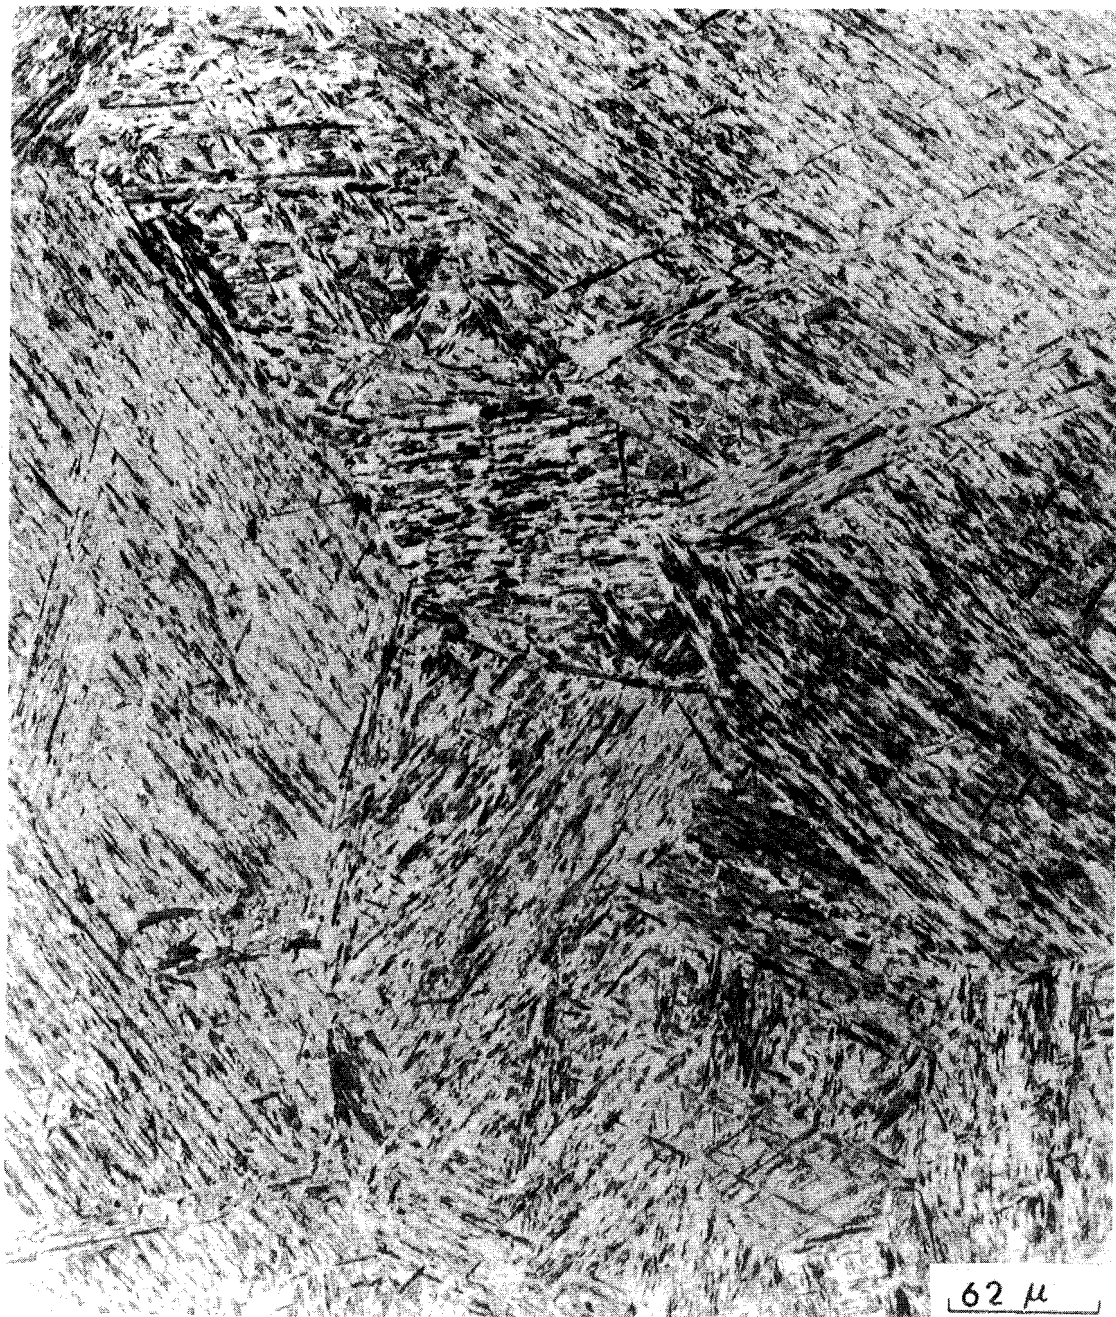
Fig. 51

The microstructure of the (1200, IBQLN) heat treated fracture toughness specimen is very similar to that of alloy 4130. The general appearance of the microstructure of this alloy for this heat treatment is shown in Fig. 51. It is difficult to identify without transmission electron microscopy whether this heat treatment results in a fully martensitic or mixed martensitic and bainitic structure. However, a decomposition product can be seen along the sites of prior austenite grain boundaries. For the (1200, Oil) heat treatment though, there are small regions of upper bainite found occasionally along prior austenite grain boundaries. An interference contrast micrograph (Fig. 52) in which the dark etching region, marked by arrows, can actually be seen to consist of many very finely spaced parallel plates originating from the grain boundary. The long dark etching plates radiating outward from the grain boundaries in the (1200, Oil) heat treatment (Fig. 53) are actually made up of several parallel units characteristic of bainite. Finally, a very fine film of ferrite outlines the grain boundary in Fig. 54 for the (1200, Oil) heat treatment. All the features identified in Figs. 52 through 54 for the (1200, Oil) heat treatment can also be found in the specimen given a (1200 -870, Oil) heat treatment (Fig. 55).
