# ANALYSIS AND CHARACTERISATION OF ADOBE BLOCKS IN JOJUTLA DE JUÁREZ, MÉXICO. SEISMIC VULNERABILITY AND LOSS OF THE EARTHEN ARCHITECTURE AFTER THE 2017 PUEBLA EARTHQUAKE

**KEY WORDS:** Earthen architecture, Seismic vulnerability, Seismic culture, Sieve analysis, Colorimetry

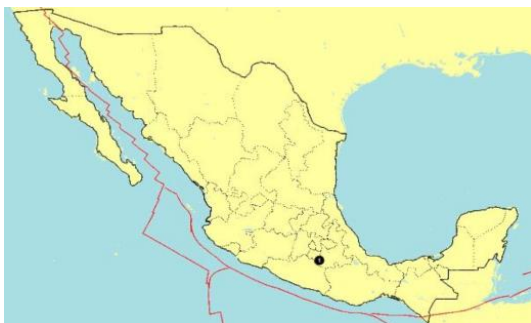
Figure 1. Epicentre of the 2017 Puebla earthquake.

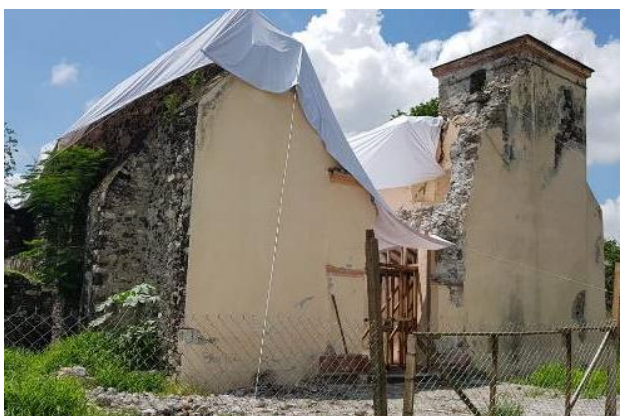
Figure 3. Colonial church damaged by the 2017 Puebla earthquake in Jotutla de Juárez, Morelos. Photo: Adrià Sánchez Calvillo (2018).

Jotutla de Juárez was the most affected locality of the State of Morelos, presenting important structural damages or total collapse in the built heritage, being the traditional earthen buildings, made of adobe bricks, the most vulnerable buildings to seismic efforts. The historic centre of the town was widely damaged, suffering important losses in the built heritage, like the churches and main institutions, as well as the public housing. After the earthquake, México was on the scope of global concern, receiving humanitarian and material aid by many countries and non-governmental organizations. The impact in Jotutla de Juárez was immediate but also prolonged, many families had to live in rescue tents even a year after the catastrophe and the reconstruction of the town has lasted until today.

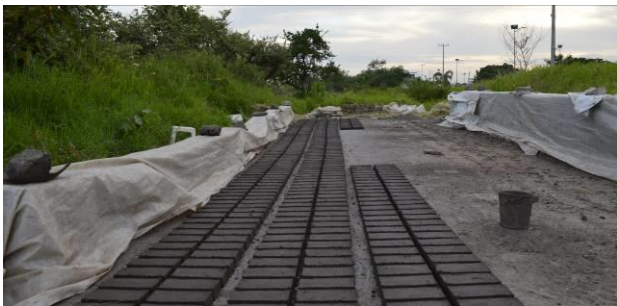
Figure 7. Manufacture area of the ceramic bricks of the region. Photo: Adrià Sánchez Calvillo (2018). © SPOT Image Copyright 2020.

In order to study the seismic disaster affectation on the adobe dwellings of Jojutla de Juárez, several samples were collected to be analysed in the laboratory. Considering the state of the municipality and its population, the sample collection responded to the criteria of taking the maximum amount of material possible before the demolition of the remaining houses. Shortly after the recollection of the specimens, the remaining earthen buildings and structures were demolished, with the consequent disappearance of the vernacular architecture of the town. There also were taken samples of soils of the region, in particular where the material is extracted and adobe bricks and ceramic bricks manufactured.

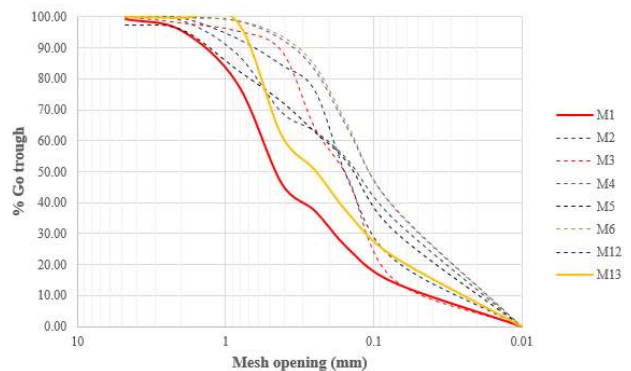
Figure 9. Granulometric curves of the adobes and soils. Continuous line: Natural soils, Discontinuous line: Adobes.

The USCS classification of the material shows relevant information. Samples M1 and M13 correspond to the natural clays from the quarries near Jojutla and are clays of high plasticity. The other samples, corresponding to the adobe blocks of the downtown are either clays of low plasticity or silts (Table 1); also the plasticity graphic shows how the healthy clays of the soil samples are in very different zone of the graphic than the adobe samples. (Figure 9) This demonstrates that the adobes contained other materials probably due to the attempt to stabilise them.

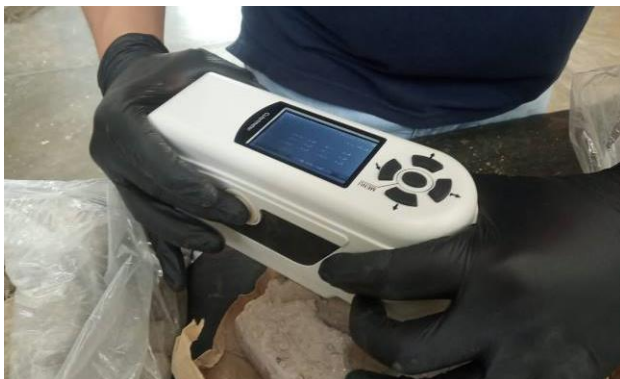
Figure 10. Use of the colorimetry equipment in an adobe sample. Photo: David Preciado Villicaña (2019). © SPOT Image Copyright 2020.

Natural clays of the quarries near Jojutla de Juarez were materials are extracted, were compared by colorimetry tests with the traditional adobe samples which were collected in the town after the earthquake. The results of the colorimetry tests allow us to understand how the natural and artificial aggregates of the adobe bricks change the natural colour of the clay.

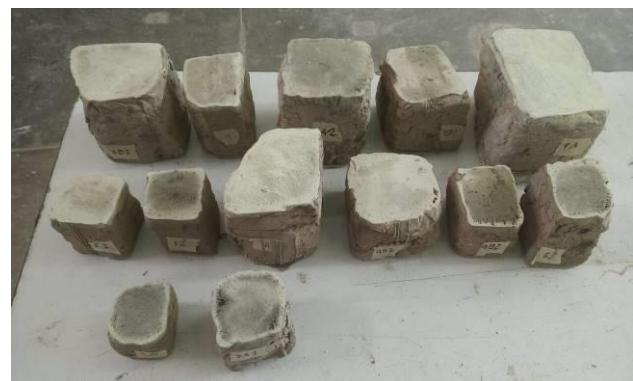
Figure 12. Adobe samples prepared for the compression test. Photo: Adrià Sánchez Calvillo (2019). © SPOT Image Copyright 2020.

One of the main properties to analyse was the compressive strength, in general adobe blocks present lower compression resistances, but with reinforcement and stabilisation strategies these values can increase. Because of the unusual state of the adobes of Jojutla de Juarez, collected after an earthquake, there was necessary to prepare the samples to execute the trial. The samples were carved till obtain the required dimensions, and later cap with sulphur, due to the irregularities presented in their morphology. Once prepared, they were introduced in the Universal Test Machine to test their ultimate resistance to compressive strength. Not all the samples could be used, due to the mentioned irregularities and the unstable state of the fragments.

The results of the Compression strength test were not encouraging, with resistance values between 5-13 Kg/cm<sup>2</sup>, being the average of 7.26 Kg/cm<sup>2</sup>, really low compared to other studies of the adobes of Morelos, which can achieve 16 Kg/cm<sup>2</sup>. (Guerrero Baca, 2019) Other Mexican studies also characterised the compressive resistance of this material, obtaining major values in all the cases (Arroyo Matus et al., 2013; Cruz Farrera, 2018; Ordaz Zapata, 2019).
