Analysis of a Large Rock Slope Failure on the East Wall of the LAB Chrysotile Mine in Canada: Back Analysis, Impact of Water Infilling and Mining Activity — [Source link](#)

Published on: 01 Feb 2017 - Rock Mechanics and Rock Engineering (Springer Vienna)

Analysis of a Large Rock Slope Failure on the East Wall of the LAB Chrysotile Mine in Canada: Back Analysis, Impact of Water Infilling and Mining Activity

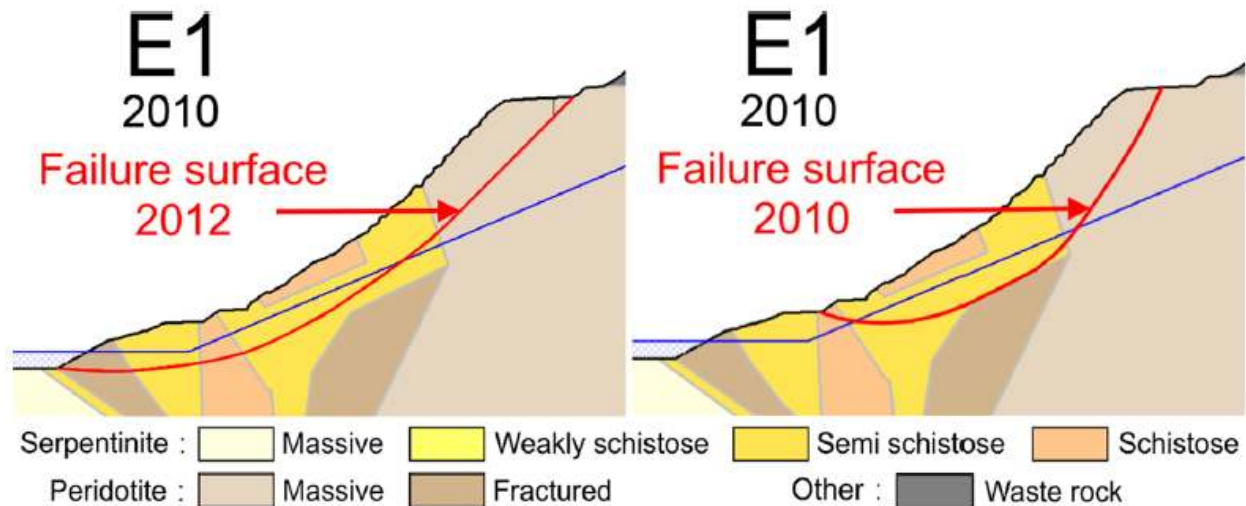
Figure 14. Left failure surface made of an extension of the 2012 failure surface obtained in Sect. 3. Right critical failure surface for the 2010 geometry

At first, the possible extension of the critical failure surface—obtained in Sect. 3 for the 2012 slope profile—up to the toe of the new slope was investigated (Fig. 14 left). Then the model was run to derive the critical failure surface for this new geometry (Fig. 14 right).

The results for the deterministic analysis (both LEA and SSR) are presented in Table 9. The results shown for the 2012 slope geometry are simply the results presented in Sect. 3 for the back analysis. The results presented for the 2010 slope geometry show that a failure surface going through the toe of the slope and then on the critical surface derived in Sect. 3 would result in a FoS above 1.2. A more critical surface can be determined for the water condition that existed in July 2012. The results for both LEA and FESSR analyses both suggest a FoS just above 1.0 for the critical surface. When comparing the slope geometries of 2010 and 2012, the main differences in failure surfaces do not reside in the FoS results but rather in their geometries. On the 2010 slope geometry, the critical failure is daylighting 58 m above the bottom of the pit at an altitude

of 22 m. The critical failure surface is 80 % of the height of the critical failure surface modelled in Sect. 3 for the 2012 slope geometry.

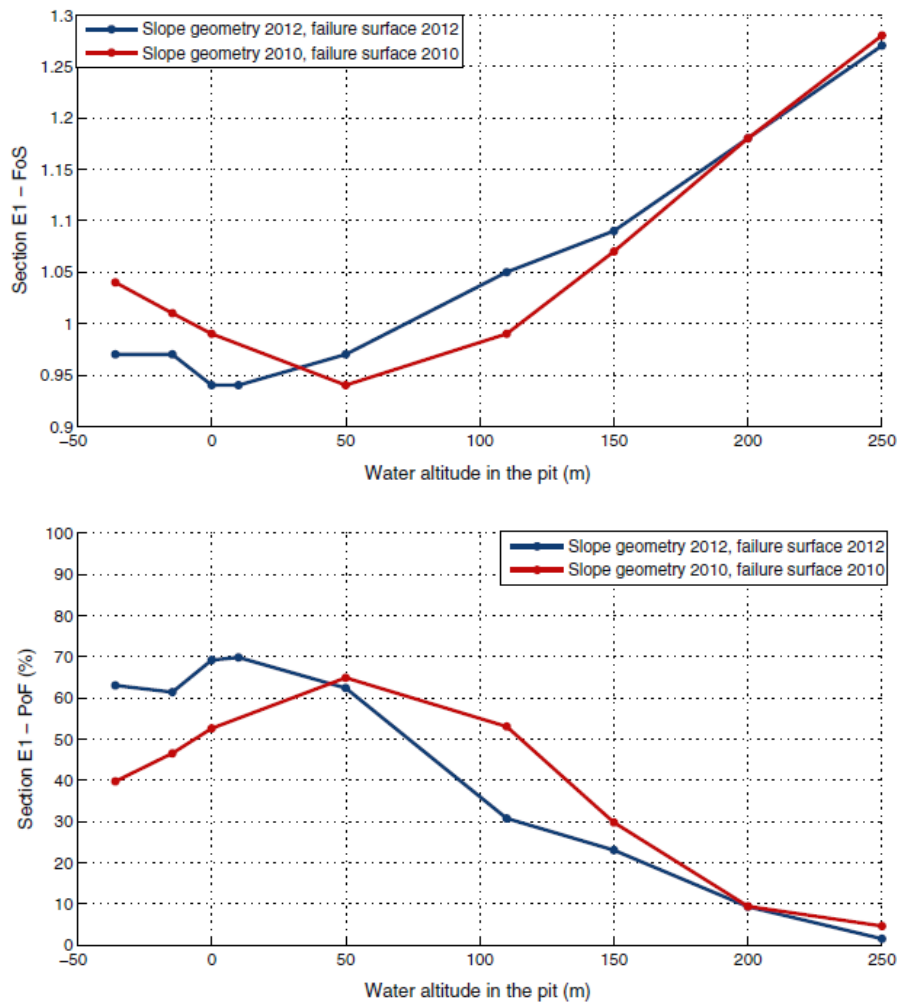
Figure 17. Variation of FoS and PoF with water altitude in the pit using deterministic and probabilistic FE-SSR analyses for section E1 for both 2010 and 2012 slope geometries and failure surfaces

Secondly, deterministic and probabilistic FE-SSR analyses were performed using the software tool RS2. The results are presented in Fig. 17 for both FoS and PoF. Eight additional deterministic and probabilistic FE-SSR models were computed associated with the 2010 slope geometry and its associated critical failure surface. The 2010 slope geometry associated with the extended 2012 failure surface, deemed not critical in the LEA analysis, was not modelled using FE-SSR. The FoS results are comparable with those achieved for the LEA analysis. The PoF results are comparable in trend. Some small variations are observed in the numerical values when compared with the LEA analysis.

Thus, based on LEA and FE-SSR analyses, it appears that a major failure would have occurred on the 2010 geometry (with an abutment). Arguably the failure would have been smaller in size (80 % of the height) and would have happened at a later time (when the water level would have reached an altitude of 50 m). Based on LiDAR monitoring, such a water level in the pit was reached at the end of autumn 2014.
