Analysis of a Large Rock Slope Failure on the East Wall of the LAB Chrysotile Mine in Canada: LiDAR Monitoring and Displacement Analyses — [Source link](#)

Philippe Caudal, Martin Grenon, Dominique Turmel, Jacques Locat

Analysis of a Large Rock Slope Failure on the East Wall of the LAB Chrysotile Mine in Canada: LiDAR Monitoring and Displacement Analysis

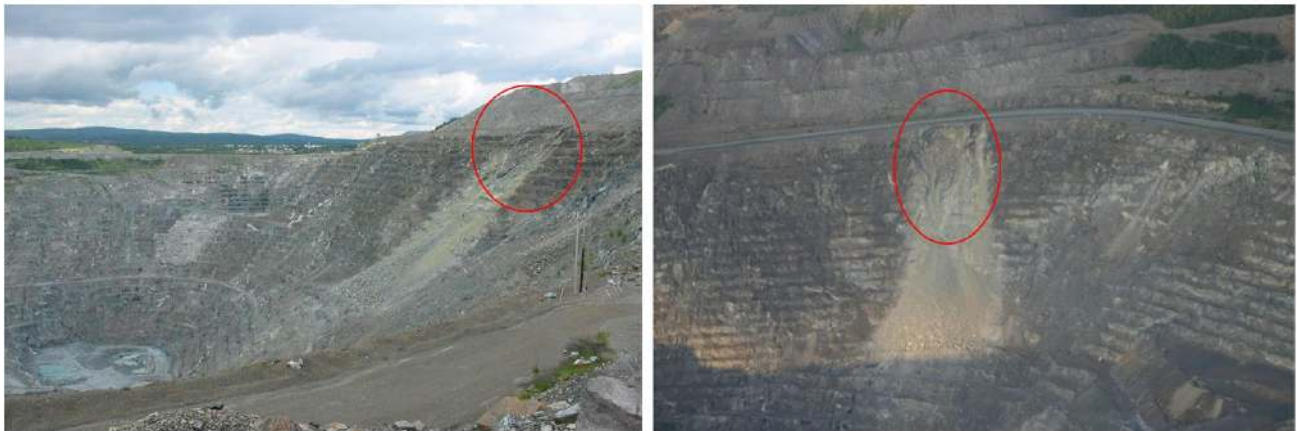
Figure 2. Early signs of failure on the evening of August 11, 2009

The first signs of instability were observed on the ground near the roadway in the fall of 2008. A first slide occurred the night of August 11, 2009. It was 60 m long and 90 m wide. The head of the sliding zone was located less than 6 m from Road 112’s paved shoulder (Fig. 2). Following this failure, monitoring of the sector showed the emergence of open fractures more than 25 mm wide and 0.80 m deep between the failure zone and the southern end of the roadway area. Consequently, while awaiting a new road layout on the West wall of the pit (Fig. 1), the Ministère des Transports du Québec (MTQ) decided to temporarily displace Road 112 on the railway line east of it, so as to move it away from the slide edges (temporary road in Fig. 1). During the week of October 12, 2009, new cracks were observed 500 m south of the location of the August failure;

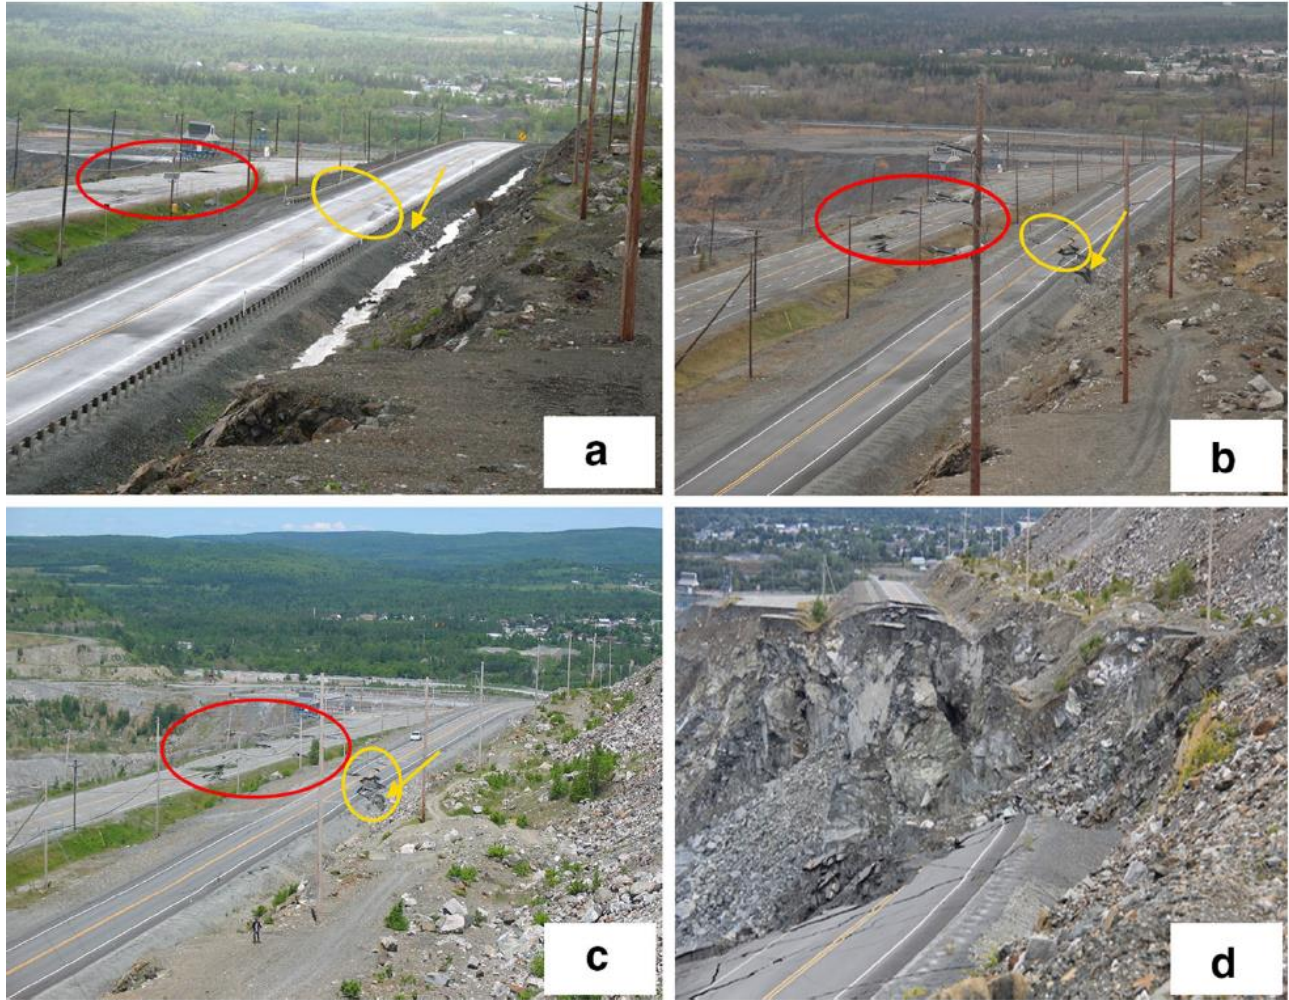
Figure 3. **a** North sector of East wall in May 27, 2011. **b** May 9, 2012. **c** June 14, 2012. **d** July 13, 2012

In 2011, an increase in the crack extensions was observed (circled in red and yellow in Fig. 3a). In May 2011, Road 112 was closed for good. That year also marked the shutdown of the LAB Chrysotile mine. At the same time, termination of water pumping at the pit bottom was confirmed. The cracks observed on the floor of the temporary road increased in the spring of 2012 (circled in red and yellow in Fig. 3b, c); the major slide in the East wall of the main pit occurred on July 12, 2012 (Fig. 3d).

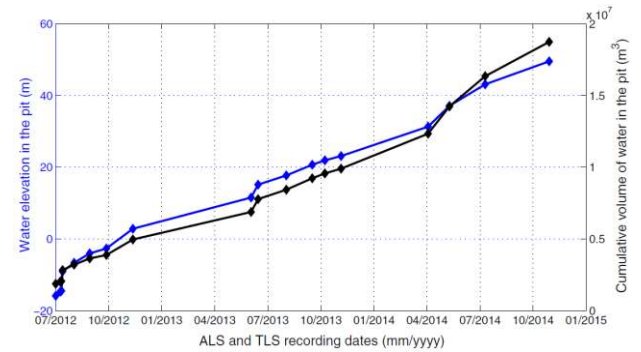
Figure 8. Water surface elevation in the pit obtained with LiDAR survey (blue line) and cumulative volume of water in the pit (black line)

water level at the bottom of the pit was measured as -14.7 m from the DTM obtained on July 11, 2012, the day before the failure of the East wall. The blue curve in Fig. 8 shows the water surface elevation evolution for the monitoring period. The black curve in Fig. 8 represents the volume of water accumulated in the pit, obtained using both pit

volume and water surface elevation. According to the mine restoration plan, the elevation of the lake outlet will be 233 m. This outlet will be created anthropically, and the outlet will reach a river nearby. Assuming that the water table line is at 233 m, the pit should thus be filled by 2035.

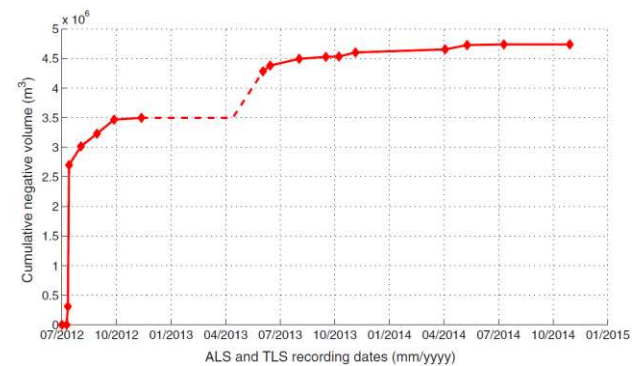
Figure 9. Evolution of the cumulative negative volume during the monitoring period

The first means of quantification used for the sliding on the East wall of LAB Chrysotile mine, is the 3D differential volume quantification. The focus is on the negative volume evolution at the crest of the slope. Figure 9 presents the cumulative negative volume generated in this area. The points on the curve show the results for the cumulative differential volume quantification starting with the DTM recorded on June 29, 2012, and the following DTMs.

Between July 9 and July 11, the sudden increase in the volume was a precursor to the failure that occurred on July 12. The ALS recorded on July 13, 2012, shows that the negative volume suddenly increases from 0.3 hm³ on July 11 to approximately 2.7 hm³ on July 13. The failure continued to be active until its stabilization after November 12, 2012, with a negative volume measured at 3.5 hm³. As no measurement was performed during the 2012–2013 winter and spring periods (dashed line in Fig. 9), the authors reasonably assumed that during the freeze-up period (December 1, 2012, to April 15, 2013), the displacements were negligible, corresponding to a marginal change in differential negative volume. The first

TLS recorded in 2013 was on June 5. The cumulative negative volume increased to 4.3 hm³. The curve seems to taper off after this point, and stabilized at the beginning of the 2013 winter. Few changes were observed during 2014, and the slight increase in negative volume can be explained by washout on the escarpment zone. The curve in Fig. 9 shows that the sliding follows an “active-stable” cycle for the first 2 years of monitoring, likely associated with seasonal temperature changes in the region. This cycle was not observed in the Winter of 2014.

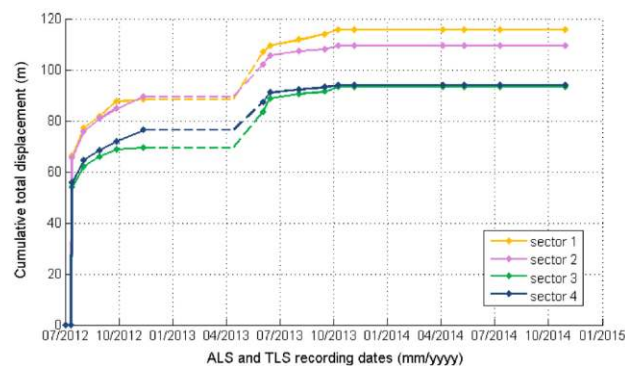
Figure 12. Magnitude of the cumulative displacements along the direction of the average displacement vector for Sectors 1, 2, 3 and 4

The total displacement magnitudes were computed between successive DTMs. These magnitudes were computed based on the vectors introduced in Table 5. Figure 12 presents the total cumulative displacements for the surveyed points for Sectors 1–4 recorded at every LiDAR scan date. The various sectors present some differences in the results. Sector 1 has the largest displacements while Sector 3 features the smallest displacements.

For another look at the computed displacement results, the monitoring period is divided into four periods (Table 6). The first period covers the time around the major failure that occurred on July 12, 2012. The second covers the year 2012 after the July 12 failure. The third covers 2013, and the fourth the year 2014 (note that the dates listed in Table 6 refer to the LiDAR recording dates). For each sector of the East wall, the magnitude is measured consecutively between each period along the survey points. It is important to note that during the Winter and Spring of 2012–2013, no LiDAR survey was performed. This is shown by dashed lines in Fig. 12.

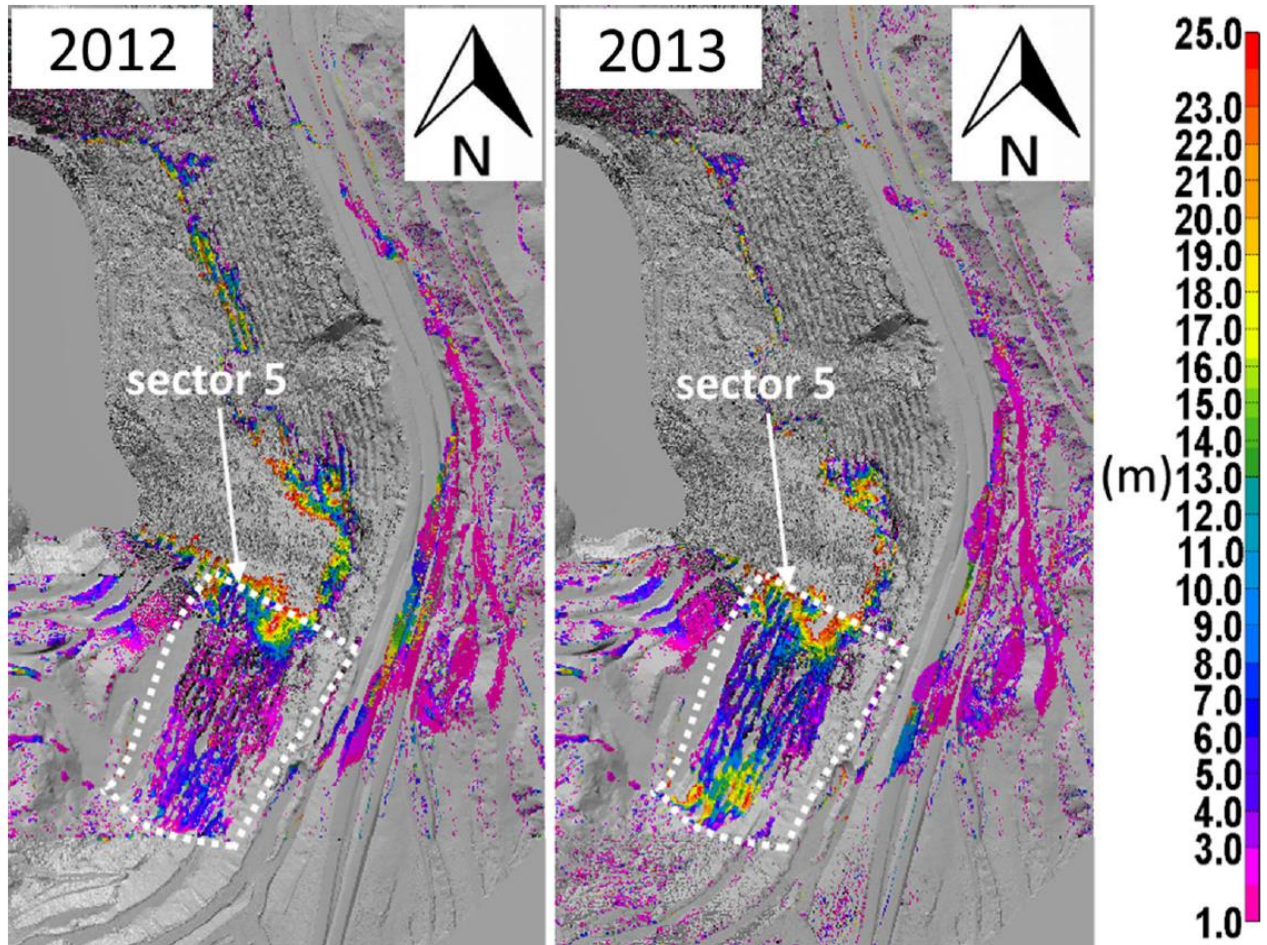
Figure 14. Magnitude of cumulative displacements in Sector 5, during the following two periods: November 22, 2010–July 13, 2012 (2012 map); November 22, 2010–August 5, 2013 (2013 map)
