SERI/TR-351-494

January 1980

The Analysis of Solar Collector Array Systems Using Thermography

Anthony Eden

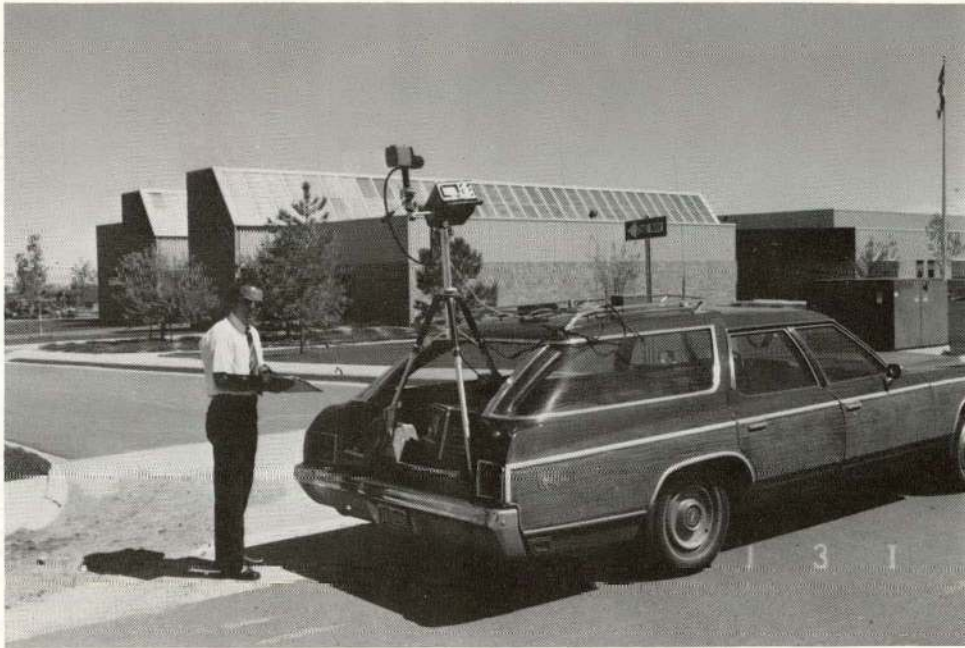
Figure 2-1. Ground-Based Thermographic Equipment

Figure 2-1 shows the ground-based thermographic equipment used in this study in operation. It consists of the camera unit cooled by liquid nitrogen (-200°C) and the cathode-ray tube display unit. Inside the vehicle are the various power supplies plus a larger cathode-ray tube display that repeats the signal from the camera. Using this larger display equipment, one can take photographs for later analysis. Figure 2-2 shows the ground-based equipment and the hand-held unit in operation. The hand-held unit is used throughout the heating, ventilating, and air conditioning (HVAC) industry to detect infiltration or insulation condition in structures and it also displays the temperature distributions that must be observed by an operator and cannot be reproduced. Because the output display from the hand-held unit is not as accurate as that from the ground-based unit, this study will later examine their differences. The hand-held unit, powered by high pressure (35 MPa) argon, is very portable and about the size of a large pair of binoculars. One needs very few instructions to train an operator to use the hand-held unit. The ground-based equipment requires an experienced operator to adjust the image and produce the thermographs.

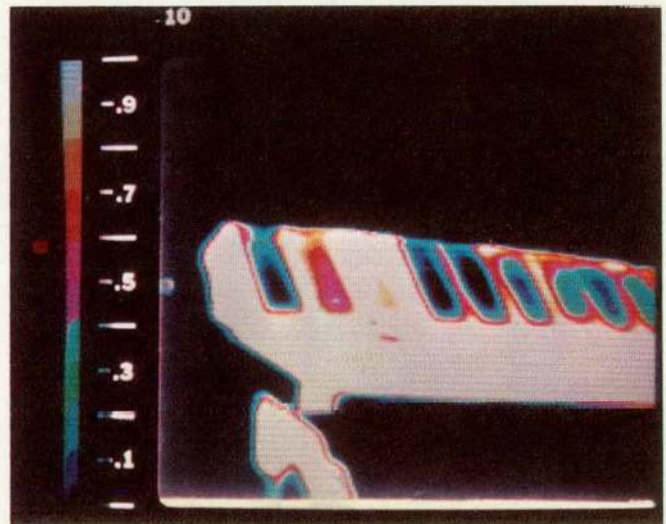
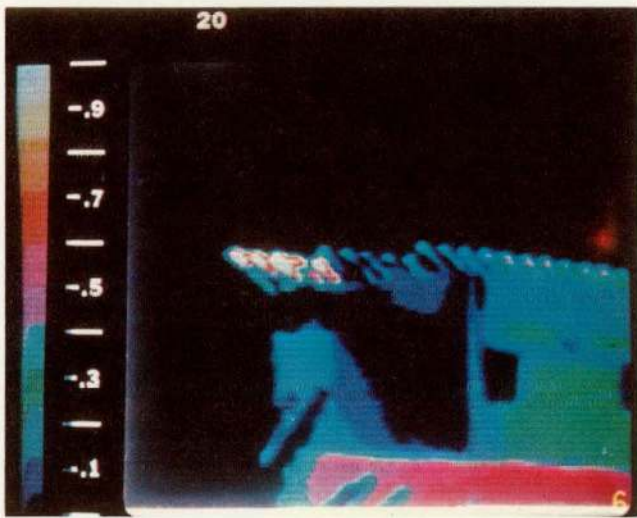
Figure 2-3. Color Thermographs

A typical thermograph (Fig. 2-3) consists of a scale indicator, a reference chart, and a picture of the temperature distribution. These thermographs illustrate the output of the

ground-based unit when a photograph is taken of the image repeater cathode-ray tube. The scale indicator above the picture designates the maximum range of temperature of the thermograph in degrees Celsius. The reference chart to the left of the picture assigns a value to a specific color code. For example, in Fig. 2-3(a), 5 represents 5°C and shows that the range of 0.0-1.0 represents a maximum relative temperature difference of that amount. The other figures show possible scales used during this study. By using the picture of temperature distribution one can compare various temperatures on the surface. Interpretation of the thermograph is relative; however, a calibration of the thermograph may be made if any temperature at one spot on the material is known. Thermographs from the ground-based unit can be made in either black and white or color. Most of the ones in this report were color and reproduced as color (Fig. 2-3) or printed in black and white. The color thermographs show more clearly the various areas of different temperature and prove very valuable in this study. The hand-held unit output was not reproducible; therefore, all comments on its usage will be subjective and taken from notes of the researchers. The view through the hand-held unit resembles a thermograph taken by the ground-based unit with a 10°C scale while slightly out of focus.

The thermographs in Fig. 2-3 illustrate the various temperature distribution patterns caused by flow conditions. Figures 2-3(a) and (c) are examples of thermographs resulting from temperature distributions that match the plumbing configurations of those liquid systems. The two pictures were taken of collector arrays with the panels vertically connected in series and then joined to parallel headers. The normal flow patterns result in absorber surface temperatures increasing from the bottom to the top of each series connection. Then, the temperature distribution is relatively uniform between horizontally adjacent collectors, showing that the flow is apparently balanced throughout the plumbing systems. Figures 2-3(d) and (e) display flow imbalances or air blockages in a liquid system; the very hot collectors blocked by air entrapment show up as brightly radiating surfaces within the arrays. In fact, these hot collectors were completely inactive. All these cases will be discussed in Sec. 4.0 and Sec. 5.0.

The thermograph of the roof array of Solar House I showed only slight temperature differences on the 5°C scale. The collectors shown in Fig. 4-3(a) and Fig. 2-3(a) are this array, and these figures reveal no significant problems. The flow appeared balanced and evenly distributed for such a plumbing system. The ground array was the first evacuated tube system examined with the thermographic equipment and showed very little information [Fig. 4-3(b)]. This type of collector, it appeared, would not be easy to analyze with either the ground-based or hand-held units. An experiment was conducted with the cooperation of the laboratory personnel to shut down the middle module of the ground array, which was done without the research team knowing which module had been turned off. When the sensors on these collectors' surfaces showed a temperature difference of 30°C between the operating and nonoperating modules, the ground-based unit detected a 10°C difference on the glass surface. The hand-held unit also detected the shut-down module when its glass surface temperature difference reached 10°C, demonstrating the capability of the hand-held unit to detect differences of 10°C or greater. The research team concluded that the roof array was functioning normally and that evacuated tube collector arrays were difficult to analyze because of the nature of the vacuum barrier between the glass and absorber surfaces.

After repairs were accomplished, another group of thermographs was taken. Figures 4-7(c) and 2-3(d) show the air blockage that occurred on the roof array after restart in the afternoon, and cleared by normal use of the bleed air valves on the roof. Figure 4-7(d) illustrates what normally flowing collectors look like on the 20°C scale. The ground array, which had been operating as expected during this period, began to display an air blockage [see Fig. 4-8(b)], caused by a blocked air vent valve on this particular cluster and cleared while being observed with the thermographic equipment. Both air blockages were also detected with the hand-held unit.

From the location high above the arrays, thermographs such as Figs. 5-8(b) and (c), and Fig. 2-3(f) were shot, showing the temperature differences across the large arrays in sufficient detail so that the researchers could locate overheating or other problems. Figure 2-3(f) shows the left array from a position in front of the right one and the progression of temperature increase from left to right. The storage tank at this time was 80°C and the collector inlet fluid temperature was 74°C . The temperature distribution conformed to the plumbing system configuration of direct return from left to right. The other thermographs in Fig. 5-8(b) and (c) were taken from other perspectives in front of the collectors during the afternoon when the storage tank temperature was 83°C and the collector inlet fluid temperature was 79°C . The three broken collectors discovered from the bucket truck can be seen in Fig. 5-8(c). That the glazings on these three collectors were broken could have been discovered by a rooftop inspection, but the broken glazings were not mentioned during the initial interview. The 5°C to 10°C scale used for these thermographs illustrates that there are no significant problems with either of the two groups of collectors other than the broken glazings. To confirm this finding, the researchers climbed onto the roof and examined the first few rows in each group and took thermographs such as Fig. 5-8(a). There were no large problems with temperature distribution, flow imbalances, or air blockages. The researchers also concluded that a bucket truck may not be necessary when investigating a large group of collector arrays that has an excessible, flat roof.

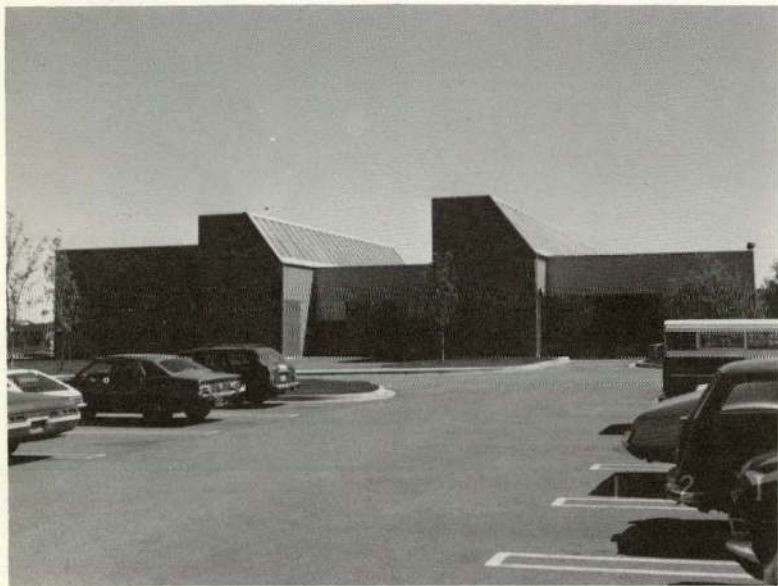
Figure 4-1. Elementary School

The research team first visited an elementary school in Aurora, Colo. (See Fig. 4-1(a)). The operator described the system, which consisted of 166 m² of single-glazed, selectively coated, flat-plate collectors. The collectors were supplying thermal energy to a 105,000-l storage tank that was used in parallel with a heat pump and for service hot water. The collector arrays were plumbed in series-parallel combinations and each array had its own plumbing system. During the interview, the operator discussed the problems with operation of this system, including controlling the collectors and the system. The location of the collector sensor appeared to cause operational difficulties. The data instrumentation system was not completely installed. The weather was clear and warm with calm winds.

The thermographs of Yale Elementary School were the first taken of such a large array system. Those shown in Figs. 4-1(b), (c), and (d) display the temperature distribution across the front and rear arrays. Figure 4-1(b) is the rear, (c) and (d) are the front, left to right. These thermographs illustrate a temperature distribution indicating a balanced flow in the plumbing system with no blocked collectors or loops. The progression across the arrays was as expected for a series-parallel plumbing system. The very small differences that appeared on the 5° C scale were considered insignificant. The hand-held unit displayed no temperature differences. Thermographs were taken with the storage tank at 53° C in the morning and 56° C in the afternoon. All thermographs illustrated the same conditions as Fig. 4-1. The researchers concluded that this collector array did not have any major problems detectable by thermography.

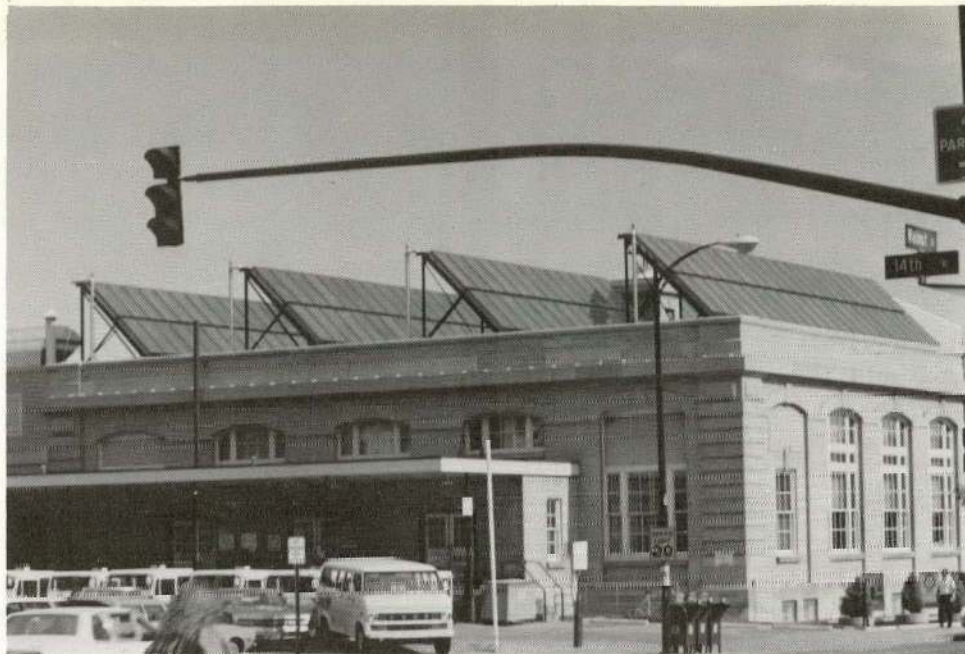
(a)

The initial thermographs of the roof array [Fig. 4-7(b)] show a slight temperature difference across that array with one collector being approximately 2°C hotter than the others. This temperature distribution had never occurred during any of the other studies done of this particular array [4]. Also, this thermograph was not immediately compared with the one from the ground array [Fig. 4-8(c)] for a reference temperature difference. The next ground-based thermographs showed the ground array operating with a relatively

Figure 4-7. USAFA STH Roof Array

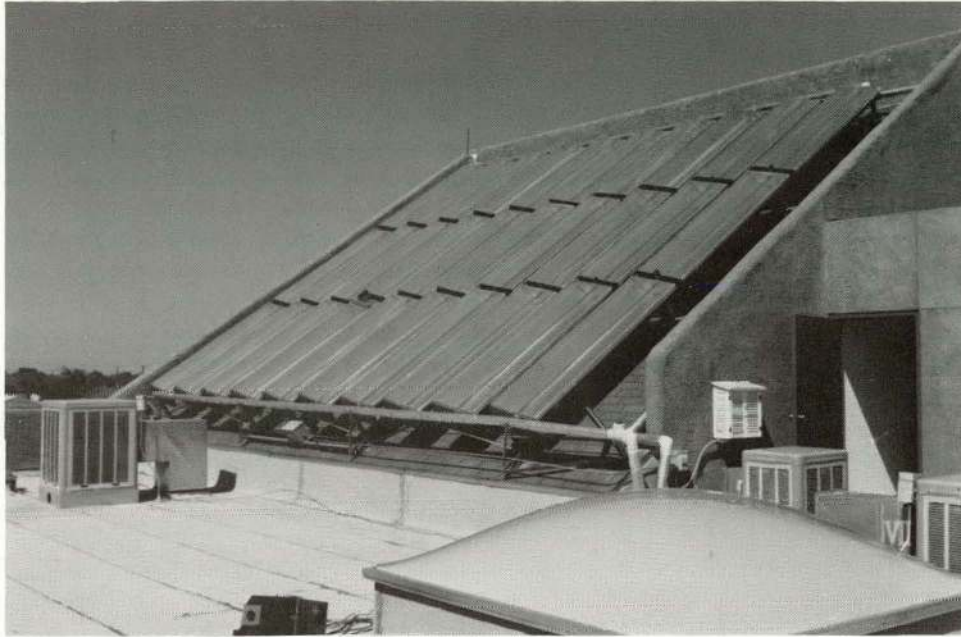
Figure 5-1. Burns and Peters Building

The researchers viewed the roof mounted collector system from the roof itself, as shown in Fig. 5-1(a). The collector tubes proved to be evasive targets. Imperfect characteristics of the compound parabolic concentrator caused glare around many tubes, which was minimized by moving the thermography equipment to new locations. The first thermographs show these tubes and how they appeared when viewed in close proximity [see Figs. 5-1(b) and (c)]. The progression of hotter temperatures from bottom to top matched the expected distribution in the series-connected collectors with parallel headers. The thermographs showed that this system appeared to be operating with no significant flow problems or blockages.

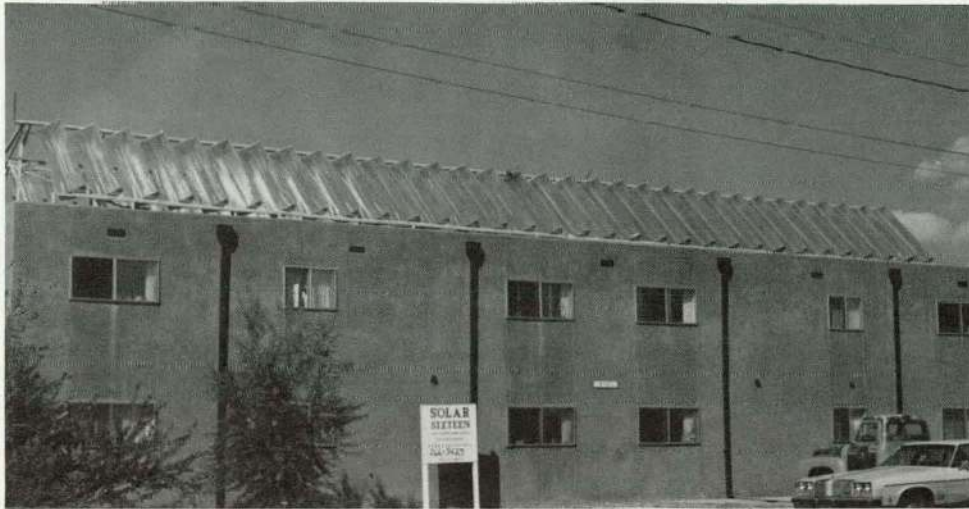
Figure 5-2. Solar Sixteen Apartment House

Solar Sixteen was another project with the CPC collectors mounted on its roof. The collector system, with an area of 87 m^2 , was used to heat the apartments and their domestic hot water. The research team did not obtain direct access to this structure, nor did they gather data on its performance because no maintenance personnel were present. However, the team viewed the system from the street, as shown in Fig. 5-2(a). The weather was the same as for the previous site, since these sites were within two blocks of each other. The thermographs shown in Figs. 5-2(b) and (c) display the same type of information as that from the previous site, but from a farther distance. No conclusions could be drawn from these thermographs because of a lack of information about system performance and flow through the collectors. Because the compound parabolic concentrators were not optimally focused, the glare from the tubes was once again a problem. The ability of the tracking controller to maintain alignment is displayed by the angle difference between the collectors in Fig. 5-1(a), taken in the morning, and those in Fig. 5-2(a), taken in the afternoon.

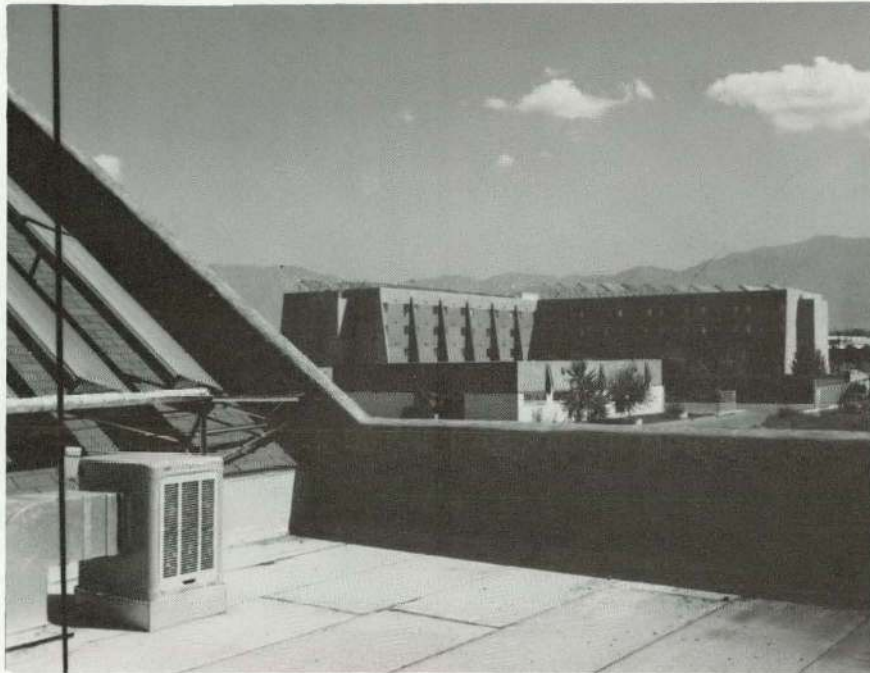
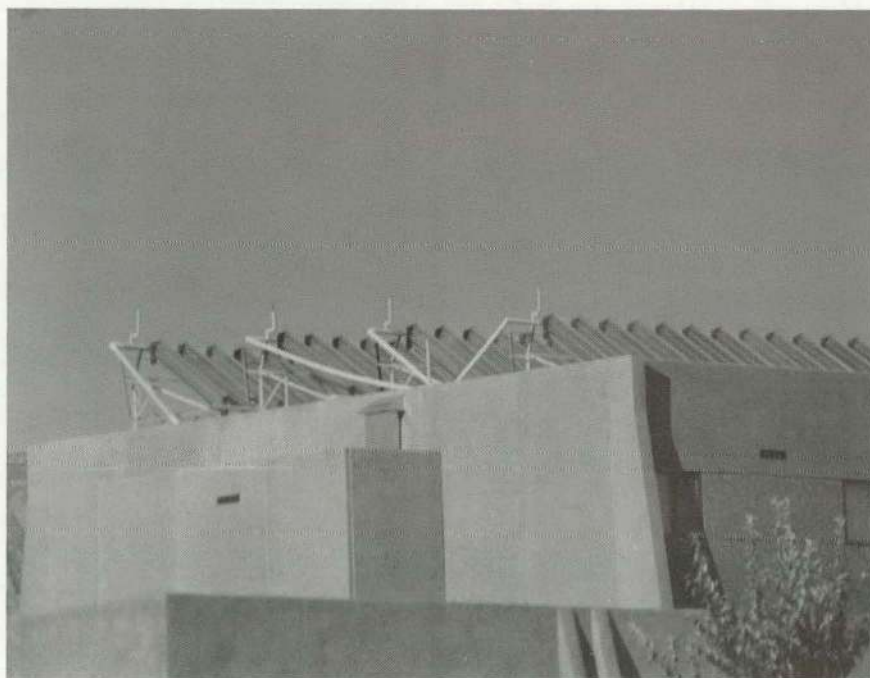
Figure 5-3. Solar Villa Apartment House

While on the roof of the Burns & Peters Building, the research team viewed the Solar Villa Apartment House from the perspective shown in Fig. 5-3(a). This collector system, the third visited in Albuquerque that used the AWSI collectors, had 930 m² of collectors plumbed in parallel rows supplying hot water to a 215,460-l storage tank that, in turn, was used to heat the large apartment building. Three rows of this system, 153 collectors, were dedicated to the domestic hot water system and were operative when the research team visited the site. Another view from the street halfway to the Solar Villa [Fig. 5-3(b)] shows the collectors in their "parked" position just before sunset. The weather for this study was again clear and warm with a slight breeze.

While the research team was preparing to move over to Solar Sixteen and Solar Villa from Burns & Peters' roof, the thermographic equipment was aimed at the system on Solar Villa. The ground-based equipment showed what appeared to be hot collectors in the third row on the roof. This was the first time such a long shot has been attempted during this research study and the display was interesting, but dismissed as glare. Since the tubes located on Burns & Peters' roof were such difficult targets, the researchers felt that the distance to the Solar Villa roof would make any thermographs obtained invalid. After moving to the street between the structures and waiting for the collectors to be turned toward the west by the tracking system in the later afternoon, the researchers took the pictures shown as Fig. 5-4(c) originally in black and white, and Fig. 2-3(e) originally in color. Again, the third row showed up as significantly hotter than its neighbors. This thermograph is very important because of the distance involved and the apparent magnitude of the difference between collector arrays. Figure 5-4(c) displays the details that can be seen through a hand-held unit and Fig. 2-3(e), the details from the ground-based unit using color. Skeptical of the thermographs from this distance, the researchers decided to visit the roof of Solar Villa.

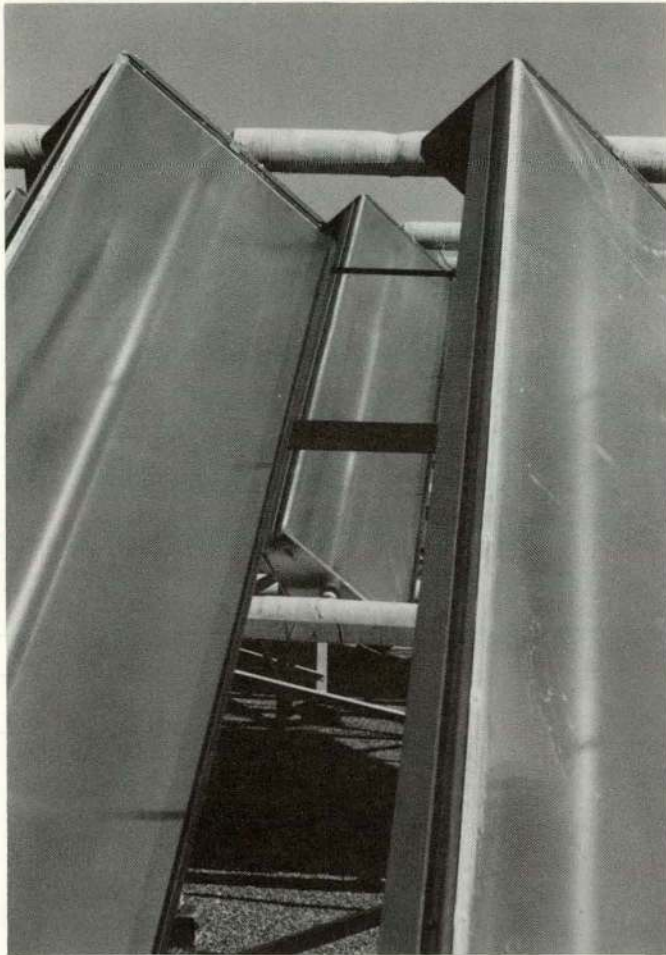
Figure 5-4. Solar Villa Collectors

From a viewing angle such as Fig. 5-4(a), thermographs were taken showing temperature distributions as Figs. 5-4(b) in color, and (d) in black and white. These indicate that the third row in the collector array was very hot. The 50°C scale thermographs show a great difference between the second row in the foreground and the third row in the background. A small temperature probe was inserted under the insulation at strategic locations and measured a temperature of 75°C into the supply headers of the first row and an output of 82°C to the return header. The second row had 67°C input and 74°C output. The third row, suspected of being badly blocked, showed 61°C input and over 93°C output. The rows consisted of 55, 55, and 43 collectors, respectively, all assigned to supplying domestic hot water. Water hammer was apparent in the third row as well as air bubble sounds through the plumbing. A chattering air vent valve was discovered at the far end of the array. The mechanical engineer explicated that the third row of 43 collectors was added to the system to boost the domestic hot water thermal energy. The original pump had been left in the system. Since this system was a drain-down type, the farthest air vent valve from the pump, located in the third row, had to be closed by system pressure once the water was reloaded each morning into the collectors. Apparently, the pressure was now not high enough to keep this valve closed, and it leaked water onto the roof. The partially open valve also allowed air into the partly filled third row; this air then blocked the flow through some of the collectors, which overheated and boiled most of the remaining water, resulting in a blocked array of 43 collectors and an undetected problem within the large system of collectors. Figure 5-4(d) shows what would have appeared in a hand-held unit if it, too, were used. The researchers concluded that the thermographic equipment can be used to examine CPC collectors and can detect blocked collector arrays from long distances with even small targets such as CPC collector tubes.

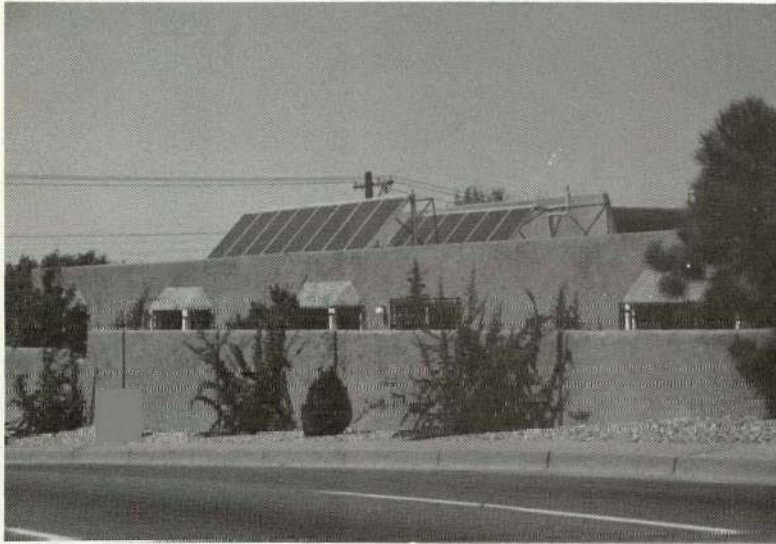
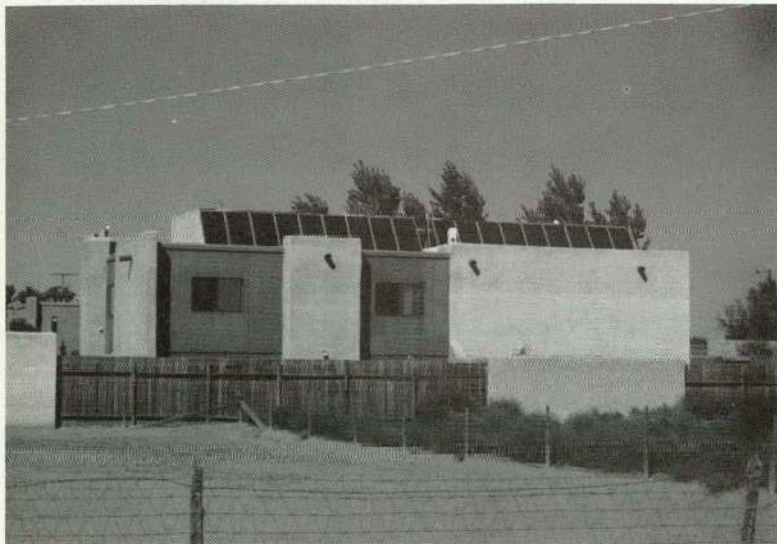
Figure 5-5. Homes by Marilyn

The other home by Marilyn that was analyzed was located at 1016 Guadalupe Del Prado, Albuquerque. A working crew was repairing a leak in the system when the researchers arrived, but the collectors were turned on after the workmen finished. The collector system shown in Fig. 5-5(c) consisted of 18 collectors for each of the two connected townhouses. The area for each system was 33 m^2 , and the collected energy was used to heat a 3,780- ℓ storage tank for each dwelling. The same heating system was used on this structure as the previous one. Again, the weather was clear, warm, and slightly breezy. Figure 5-5(d) shows one collector system running, while the other was shut down because the occupant of the townhouse was on an extended vacation. On the 5°C scale thermograph, the operating system showed no significant problems with temperature distribution, flow patterns, or air blockages. The simple system of parallel collectors in parallel arrays proved effective in maintaining even flow and collector temperatures.

This site did prove unique in one important aspect. The research team revisited this building that night and checked the system for thermosyphoning, which was very evident after sunset during cool night conditions. The first collector adjacent to the two-story (7.6 m) plumbing supply riser was 5°C hotter than the others in that array, illustrating that hot water was circulating up that pipe at night and radiating energy through the first collector. An interview with the designer disclosed that no check-valve was installed on that branch of the plumbing system.

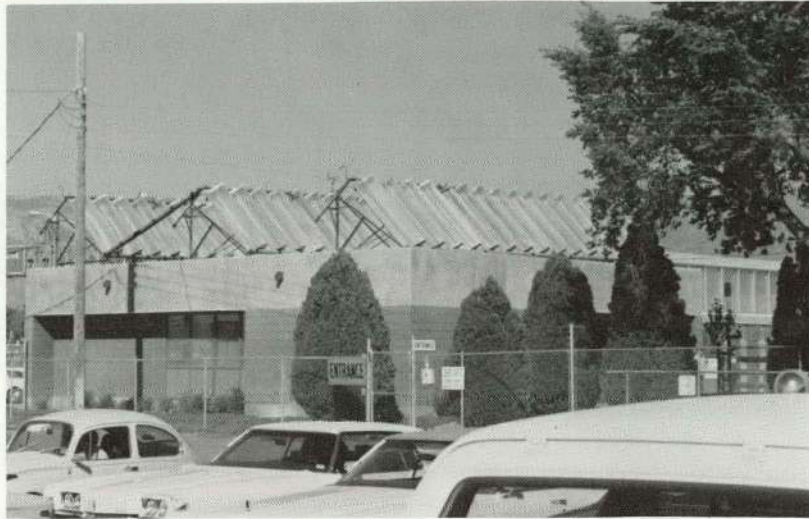
Figure 5-6. Animal Control Center

The collector system was viewed from the adjacent parking lot as shown in Fig. 5-6(a). The thermographs [Figs. 5-6(b) and (c)] showed some slight temperature variation between arrays; the front one (c) was the coolest and the rear one (b), the warmest. Some glare showed up in the rear array because of the sun's angle for that time of day when the collectors could be viewed from this location. The parallel collectors in parallel ar-

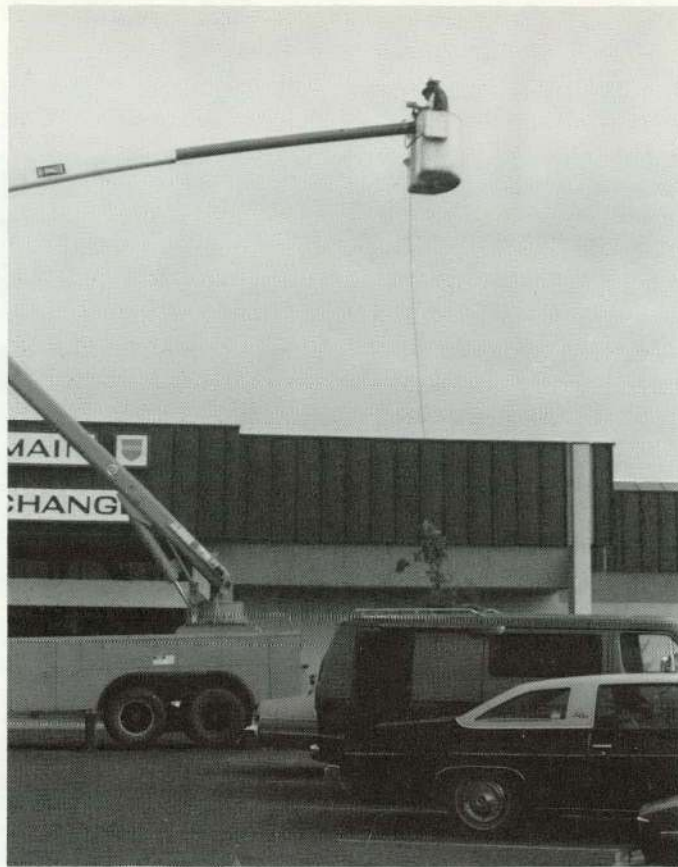
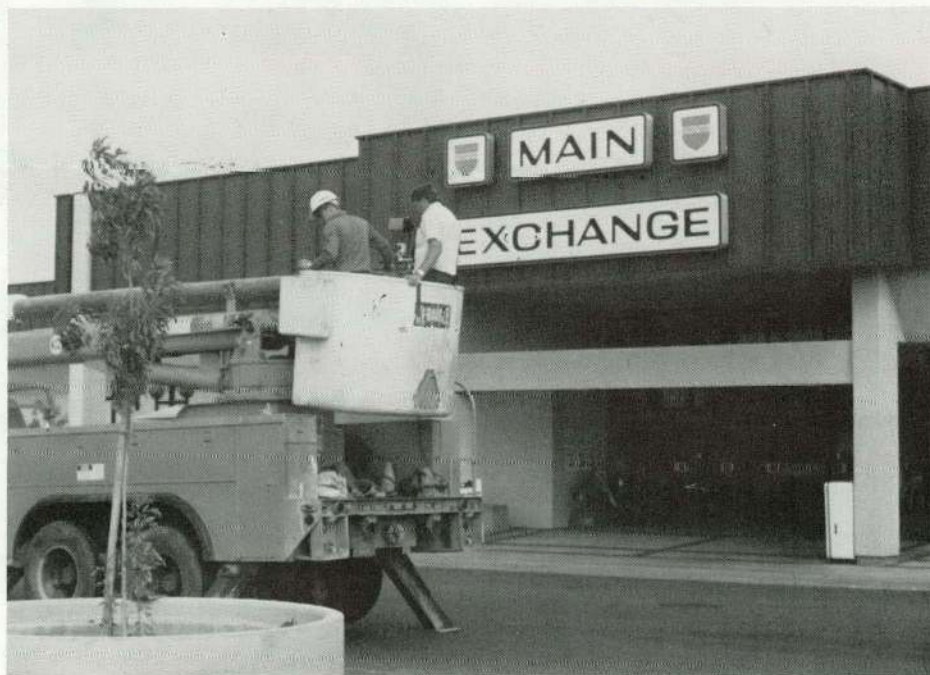
Figure 5-7. KAFB Exchange Equipment Setup

The equipment setup used at this site is unique. The researchers felt it was necessary to view the entire array at once. A bucket truck with an operator was obtained from the base civil engineering squadron and is shown in Fig. 5-7(b), and taken up to a position high above the array in front of the Base Exchange, allowing thermographs to be taken from an overall point of view as is shown in Fig. 5-7(a). The thermographs had to be carefully obtained to avoid glare when the sun finally broke through the clouds.
