Webb, G., Vardanega, P. J., Fidler, P., & Middleton, C. (2014). Analysis of structural health monitoring data from Hammersmith Flyover. *Journal of Bridge Engineering*, 19(6), [05014003]. [https://doi.org/10.1061/\(ASCE\)BE.1943-5592.0000587](https://doi.org/10.1061/(ASCE)BE.1943-5592.0000587)

Analysis of Structural Health Monitoring Data from Hammersmith Flyover

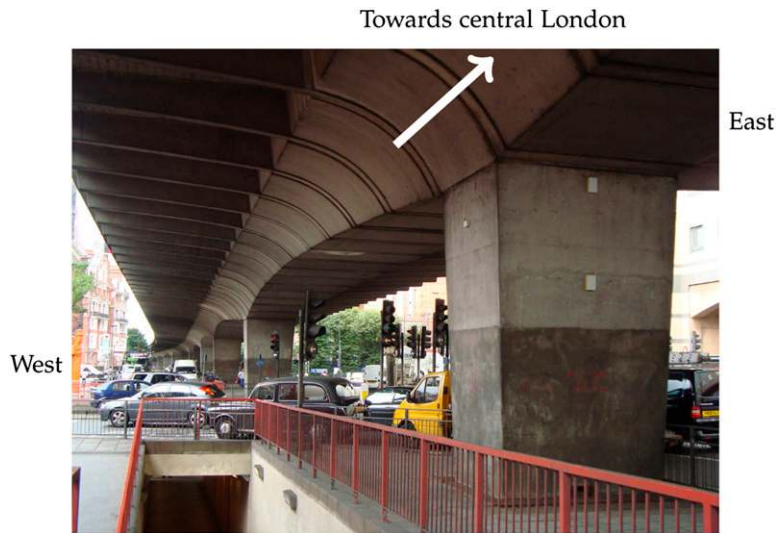
Fig. 1. The Hammersmith Flyover (image courtesy of Dr. Peter Bennett, taken August 26, 2009)

This paper discusses the collection and interpretation of data from two independent SHM systems installed on the Hammersmith Flyover in London, United Kingdom (Fig. 1). The original design of

Constructed in the early 1960s, the Hammersmith Flyover carries four lanes of a strategic road transport artery, the A4 trunk road, into London from the west. It is a 622-m-long, 16-span, partially bonded, posttensioned, segmental, cellular concrete bridge supported on RC piers. The flyover has roller bearings at the base of each pier, is restrained against longitudinal movement at each abutment, and has a single expansion joint toward the center of the bridge.

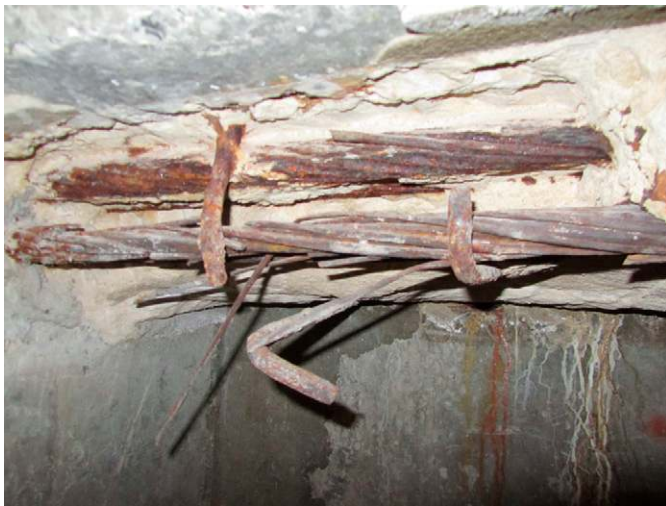
Fig. 2. Corrosion of prestressing tendons (image by authors, taken May 14, 2012)

In recent years, concerns have arisen about the condition and live load capacity of the flyover, primarily as a result of observed corrosion of the prestressing tendons, which has been accelerated by the application of deicing salts during winter and the failure of the waterproofing system. Although corrosion had been a concern for many years, recent intrusive inspections found it to be far more severe than had been expected (Fig. 2). A second concern was the performance of the roller bearings (photographed in Fig. 3) and

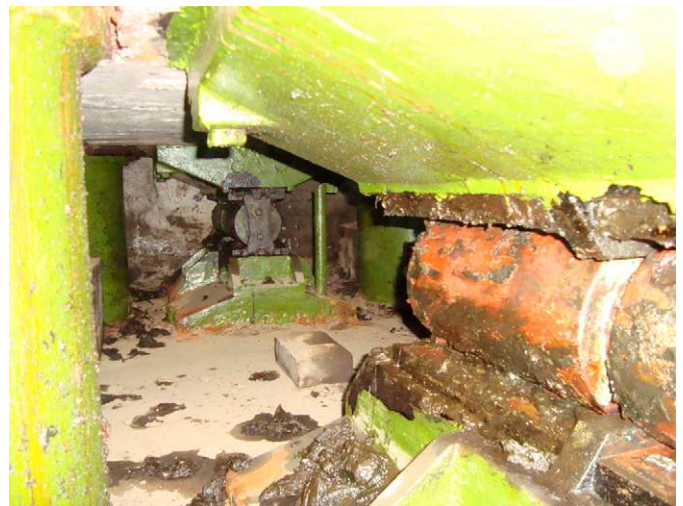
Fig. 3. Roller bearings supporting a bridge pier (image courtesy of Dr. Peter Bennett, taken September 22, 2009)

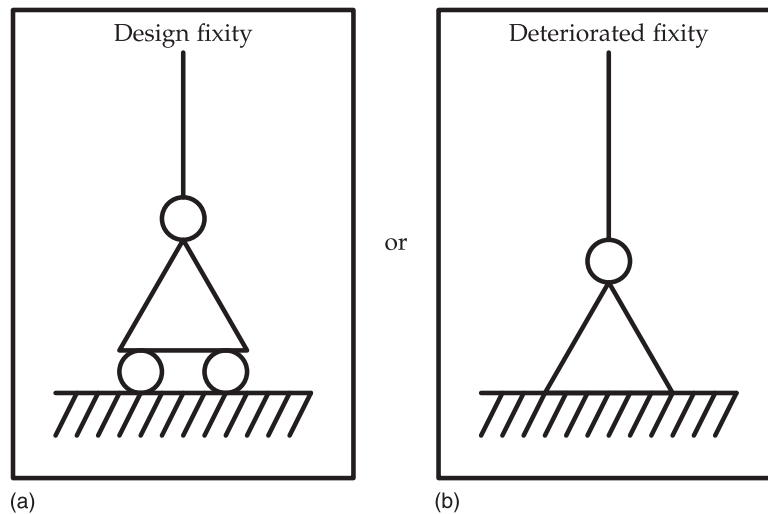
Fig. 4. (a) Symbolic representation of fixity of bridge roller bearing as designed and (b) possible actual operational fixity in the deteriorated state

whether deterioration was resulting in a restraint against expansion as symbolized in the schematic in Fig. 4. Thermal movement is accommodated by roller bearings at the base of each pier. Restraint in the bearings due to corrosion would induce additional bending moments in the piers and deck, potentially causing an opening of the joints between segments and exacerbating the stress levels in the corroded prestressing tendons.

allowing unrestrained longitudinal movement, as symbolized by the design fixity shown in Fig. 4. Displacement at the bases of the piers is predominantly caused by uniform temperature increases, with the other loading scenarios considered having a much smaller effect. This suggests that plotting displacement of the base of the piers against temperature should show a good correlation if the bearings are functioning correctly.

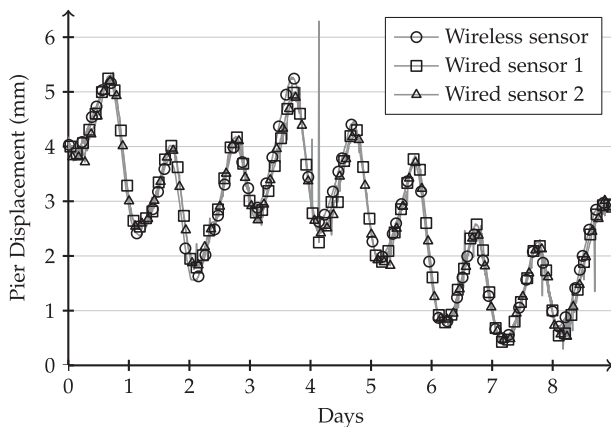
Fig. 7. Comparison of data from commercial wired and research wireless monitoring systems (start date March 22, 2012)

An analysis of some of the commercial sensor data is presented later in this paper. The only data from the Research System used in the analysis presented here are those obtained from the displacement gauges at the base of the piers, which enabled comparison between the data obtained from the commercial wired and research wireless SHM systems. Fig. 7 shows that the commercial and research

systems both provided very similar readings for displacement at the base of the piers.

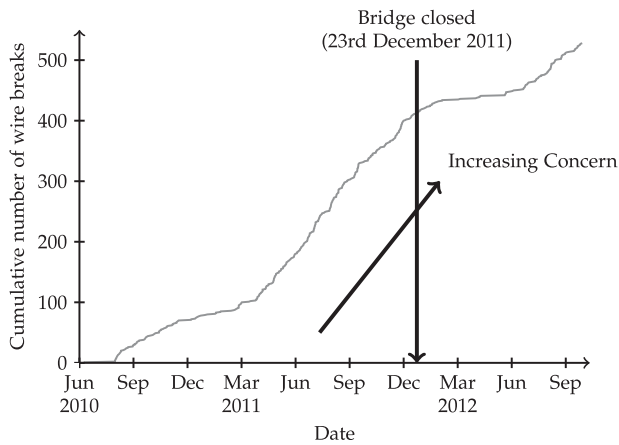
Fig. 8. Cumulative wire breaks in all spans (2010–2012)

The commercial AE system was installed with the aim of detecting wire breaks in the prestressing tendons in the deck box section. Fig. 8 shows a cumulative plot of the number of wire breaks detected throughout the whole bridge by the AE system over approximately 2 years. Investigations following from the results of the AE monitoring led to the closure of the bridge for emergency repairs on December 23, 2011. It might be expected that losses of prestressing force would result in a change in longitudinal strain in the bridge deck. The installed monitoring systems included a limited number of gauges at critical sections measuring longitudinal strain in the deck, and a study was undertaken by the University of Cambridge research team to determine what magnitude of strain is caused by different levels of prestress loss, although it was anticipated that these strains would be very small.

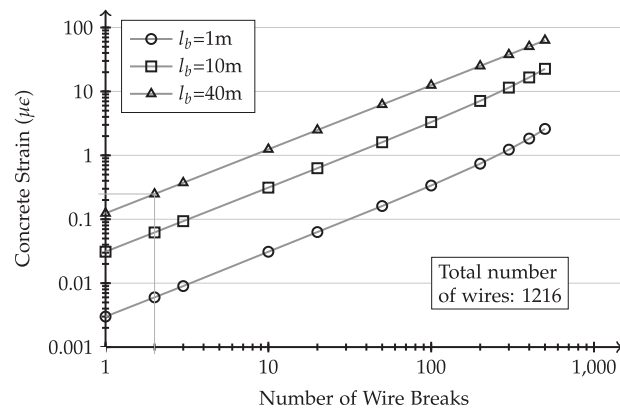
Fig. 10. Calculation of concrete strain variation versus number of wire breaks (assuming unbonded tendons)

The plot in Fig. 10 assumes that all wire breaks occur in different wires and at the same location along the beam; however, this is unlikely to be manifested in practice in the field. It is thus necessary to consider how subsequent breaks affect a tendon that already contains wire breaks at other locations. When a wire break occurs, the tension in that individual wire is assumed to reduce to zero over the effective break length, meaning it cannot break again within that region. If another wire break is detected in the same area of the tendon, it must therefore be a different wire. If, instead, the next wire break occurs farther away, it could be in any wire, including the already broken wire, because a wire break is assumed to not affect the wire outside the effective break length. In this case, the effect on the whole tendon will be the same as a single wire break with an increased effective break length.

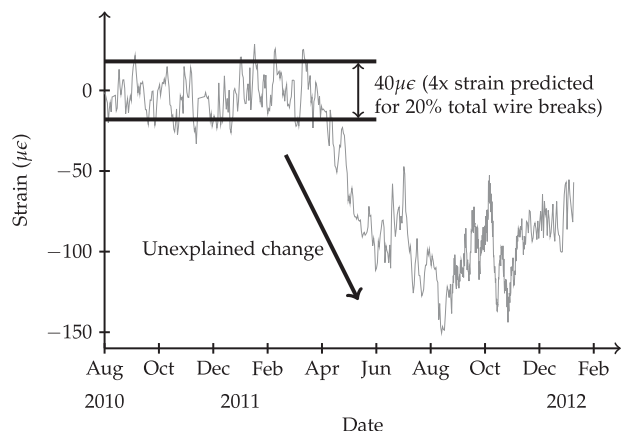
Fig. 11. Measured longitudinal strain at midspan of a typical span (2010–2012)

The Commercial System includes a single longitudinal strain gauge at the midspan of three of the deck spans of the flyover. Fig. 11 shows a plot of longitudinal strain of a typical span measured at midspan. The recorded number of wire breaks of 1% of the tendon cross section over a 2-year period would result in a predicted strain change of $0.2 \mu\epsilon$, which cannot be detected with any confidence

given that there is a general background variation of approximately $40 \mu\epsilon$ in the readings, almost four times the predicted strain change expected for a loss of 20% of the prestressing wires. A large, unexplained shift in strain of approximately $100 \mu\epsilon$ in the concrete deck was detected during April and May 2011 (Fig. 11). A number of the other strain gauges, displacement transducers, and inclinometers also displayed a significant change at the same time, for which there does not appear to be an obvious physical explanation. This suggests that it is probably not a problem with any individual sensors; however, without further data from an independent monitoring system there is no way of verifying the cause. Unfortunately, the Research System was not functioning during this time and therefore no alternative data are available. However, even if this unexplained jump was not present, it would still not be possible to distinguish any small strain changes caused by prestress loss from the noise present in the data.

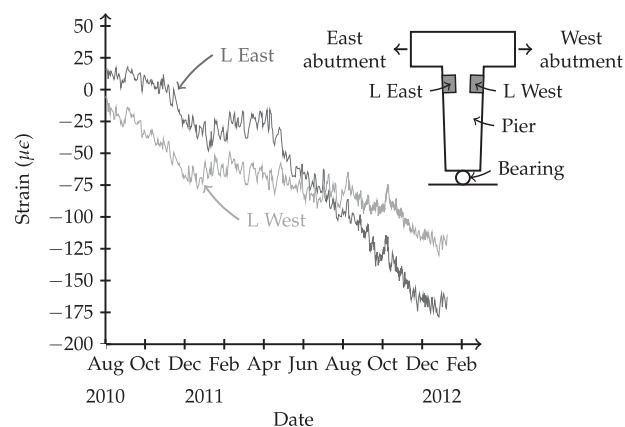
Fig. 12. Measured vertical strain in pier L (2010–2012)

Fig. 12 shows a plot of the vertical strain measured on the walls of a typical pier. The expected cyclic nature of the yearly variation due to temperature is not visible in the readings. Instead, there appears to be a long-term trend of increasing compressive strain. Because there is only a single strain sensor in each measuring location, it is impossible to verify whether the readings are valid or whether they are caused by drift of the monitoring system.

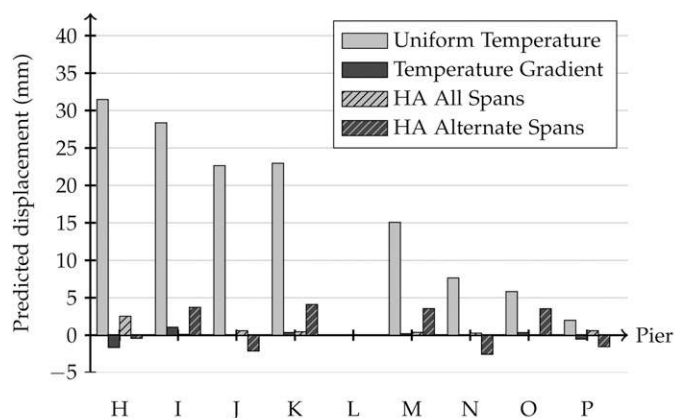
(a) All bearings free

(b) One bearing pinned (at pier L), others free

Fig. 13. Predicted displacements for various load cases: (a) all bearings free; (b) one bearing pinned (at pier L), others free (HA loading is defined in Table 1)

Fig. 13(a) shows the predicted displacements for each pier for each of these load cases when all bearings are functioning correctly

Subsequently, the analyses were repeated with the support at one pier (pier L) assumed fixed to prevent any longitudinal displacement, simulating a corroded and jammed bearing. In Fig. 13(b), it can be seen that, with the exception of pier L, the predicted displacements of the piers are very similar to those shown in Fig. 13(a) (the undamaged scenario). Repeating the aforementioned analysis with any other pier assumed fixed results in a similar outcome. This means that deterioration of one of the bridge's bearings is not expected to significantly alter the displacements measured at the other piers. This should make it possible to determine the state of any bearing if the correlation between temperature and movement is no longer present.

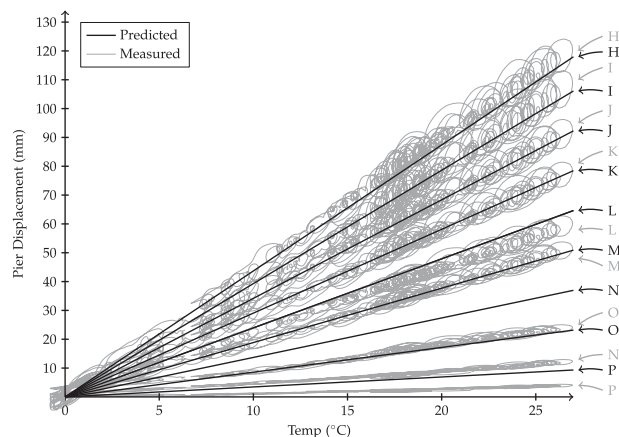
Fig. 14. Predicted and measured longitudinal displacement versus temperature plots for piers H to P

Fig. 14 shows plots of both predicted and measured values of horizontal displacement against temperature for the bases of the piers in the eastern half of the bridge. The predicted displacements are based on the assumption that all bearings were working and unrestrained. Because the zero offset for pier displacement is arbitrary, the plots have been shifted vertically such that they all pass through the origin. This allows for easy comparison of the gradients.

For each pier, there appears to be a good linear relationship, suggesting that pier displacements are caused predominantly by temperature changes, as expected. A hysteresis effect can be seen, caused by the thermal mass of the bridge taking time to react to temperature changes. The actual measured displacements of seven of the piers (H, I, J, K, L, M and O) compare very well with the predictions, whereas piers N and P do not. Although these two piers move with temperature variations, they do not move to the same extent as would be expected from the modeling predictions. This implies that the bearings for these piers behave as if partially restrained and do not allow completely free longitudinal movement. No access to pier P was available to the authors; however, inspection of the bearings at pier N revealed the cause at that location. In each bearing pit, in addition to the bearings supporting the pier, there are also four steel plinths designed to prevent catastrophic damage occurring if any of the bearings were to fail by only allowing the pier to drop by a few millimeters. During construction, metal shim plates were inserted between the top of the plinths and the base of each pier to maintain a gap of approximately 13 mm (Rawlinson and Stott
