**NASA Technical Memorandum 81403**

**ANALYSIS OF WEAR DEBRIS FROM  
FULL-SCALE BEARING FATIGUE  
TESTS USING THE FERROGRAPH**

William R. Jones, Jr. and Stuart H. Loewenthal  
Lewis Research Center  
Cleveland, Ohio

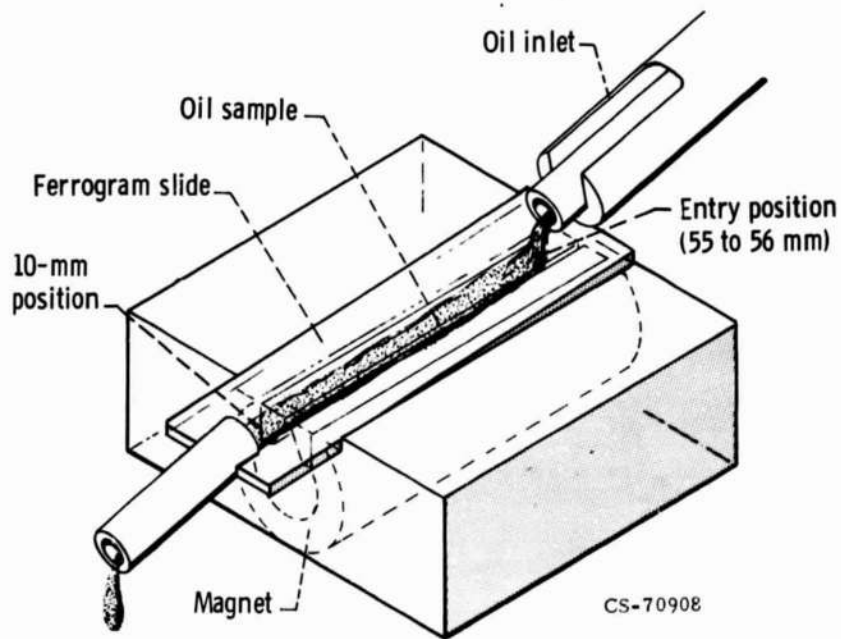
Figure 4. - Ferrograph analyzer.

The Ferrograph (refs. 2 to 4) was used to magnetically precipitate wear particles from the used oil onto a specially prepared glass slide. The oil sample was heated to 70° C for a minimum of 10 minutes and then shaken vigorously. A mixture of  $3 \times 10^{-6}$  cubic meter (3 ml) of used oil and  $1 \times 10^{-6}$  cubic meter (1 ml) of solvent is then prepared. This mixture is slowly pumped over the slide as shown in figure 4. A solvent wash and fixing cycle follows which removes residual oil and permanently attaches the particles to the slide. The resulting slide with its associated particles is called a Ferrogram.

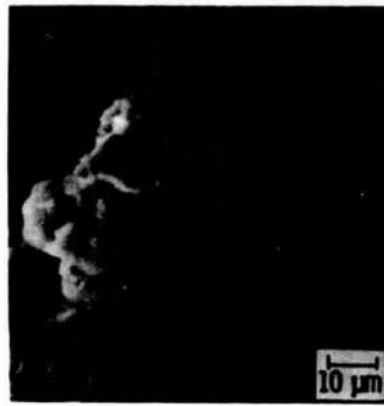
(a) STRING OF WEAR PARTICLES AND 8 micrometer DIAMETER SPHERE FROM 530-hour SAMPLE.

(b) AREA (a) AT HIGHER MAGNIFICATION.

(c) X-RAY ENERGY MAPS OF (b) FOR IRON.

Figure 6. - Scanning electron micrographs.

Normal rubbing wear particles. - Normal rubbing wear particles (ref. 10) are observed in almost all oil samples from lubrication systems. This study was no exception as most samples yielded at least a few such particles. Typically, these particles are small asymmetrical metallic flakes (<15 μm in major dimension and <1 μm thick). They are produced anytime that sliding wear takes place. Electron micrographs of some normal rubbing wear particles appear in figures 6(a) and (b). An X-ray energy map for iron appears in figure 6(c) and indicates that most of the particles are predominately iron.

Spherical particles. - Microspheres (1- to 10-  $\mu$  diam) were observed in many samples. An 8-micrometer sphere is shown in figure 6(a). Although most of the spheres appeared metallic when observed in the bichromatic microscope, an X-ray energy analysis indicated that there were two types present. These types are illustrated in figure 7 where two different 4-micrometer-diameter spheres are shown. An iron X-ray energy map for the sphere of figure 7(a) appears in figure 7(b). This is the normal iron map one would obtain from a solid iron or steel microscope. However, the 4-micrometer-diameter sphere of figure 7(c) indicates a much lower concentration of iron. This type of sphere may contain a large amount of organic material (ref. 14) or may be a compound of iron (an inclusion) (ref. 15) or perhaps even be hollow (ref. 16). Although an analysis of all the spheres observed during this study was not possible, measurements on a number of Ferrograms indicated about half of them contained a high concentration of iron and the remaining half a much lower concentration.

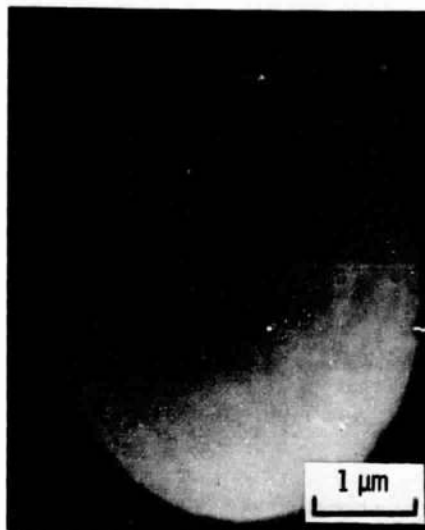
Figure 7. - Scanning electron micrographs of two spherical particles (a) and (c) and their corresponding iron X-ray energy maps (b) and (d). 530-Hour sample.

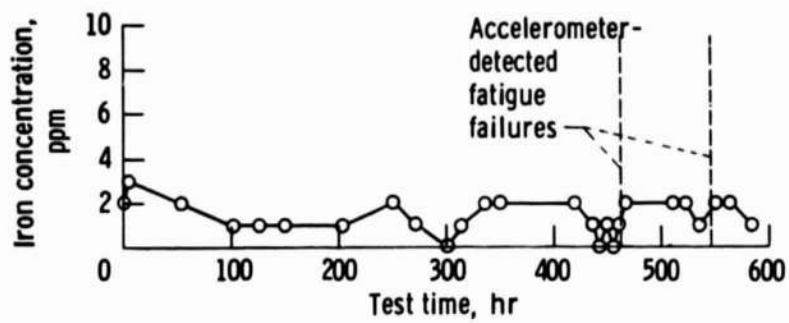
Figure 10. - Iron concentration in oil in ppm as function of time from spectrographic oil analysis (SOAP).

One other parameter was studied for possible failure correlation. This parameter was the change in concentration of iron in the oil samples measured by ordinary spectrographic analysis (SOAP). Measurements were only made on selected oil samples from test startup to 566 hours, thus encompassing the first two fatigue failures. The iron concentration in parts per million appears as a function of test time in figure 10. Rather low values were observed (0 to 3 ppm), and there was no correlation with the two failures.
