# Axial Compression Tests on Corroded Reinforced Concrete Columns Consolidated with Fibre Reinforced Polymers

Professional paper

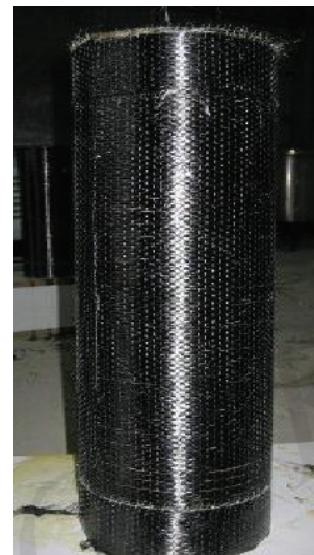
Before manufacture, the selected steel tube was cut into the needed lengths keeping the sections of the two ends smooth. Two pieces of steel cover plates, which were larger than the section of the corresponding test specimen, were then cut same as the cover plates of the test specimen. Every test specimen had a corresponding cover plate. One end of the steel tube was then welded with the cover plate; the other end of the steel tube was also welded after concrete pouring. The geometric centres of the cover plate and the steel tube were aligned during welding. As concrete would contract during maintenance, the surface of concrete should be higher than the section of the steel tube during pouring, and polished and levelled after hardening. Self-mixing concrete was used. For electrochemical corrosion, the pouring of the test specimen was conducted twice. The first time, the short column body was poured, followed by seven days of maintenance. After the form was removed, it was naturally maintained for one month. After the concrete strength had fully developed, the electrochemical corrosion experiment on longitudinal reinforcement and hoop reinforcement was carried out, respectively. The second time the pouring of the ground beam was performed after the reinforcement of the column body had corroded. After that, the concrete was maintained using the natural maintenance method. The surface of steel tube was pasted with fibre cloth after 28 days of maintenance, as shown in Fig. 1.

Fig. 1 – Fibre cloth covered reinforced concrete column

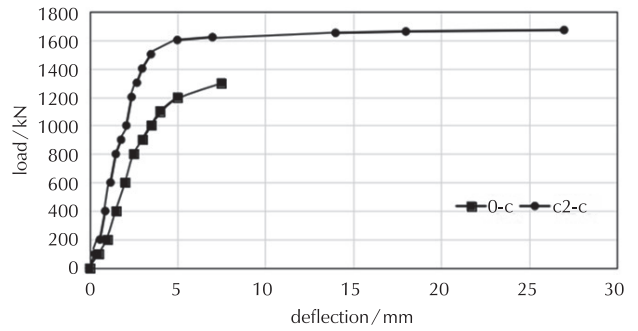
Fig. 2 shows the load-intra-column lateral deflection curves of test specimens 0-c and C2-c. The lateral deflection generated by fibre reinforcement composite material and steel tube concrete composite middle long column test specimen C2-c at the beginning of load-bearing developed slowly due to the initial defects of the test specimen; the load-intra-column lateral reflection curve was almost linear; this stage was called the elastic working stage. When the load of the test column reached 70 % of the ultimate load, the load-intra-column lateral deflection curve began to develop deviating from a straight line. Moreover, the slope of the curve gradually increased; this stage was called the elastic-plastic working stage. When the load exceeded 70 % and became close to the ultimate load, the curve tended to be stable and the development of the load-intra-column deflection accelerated. Eventually when the load reached the ultimate value, the test specimen failed due to the excessively large lateral deformation.

Fig. 2 – Load-intra-column lateral deflection curves

Fig. 2 suggests that, compared to ordinary steel tube concrete middle long column, the elastic working range of fibre reinforced composite material and steel tube concrete composite middle long column was larger; the slope of the load-intra-column lateral deflection curve was larger in the elastic stage; in the entire loading process, the test specimen with certain deflection had higher load; therefore, the load increased, *i.e.*, the bending rigidity significantly increased. In addition, larger lateral deflection deformation produced in the composite middle long column before the load reached its ultimate value; the deformation developed quickly, and the curve became much gentler when the test specimen was close to failure. This indicated that the lateral restraint effect of fibre cloth improved the bearing capacity and ductility of the component. Fig. 3 suggests that, compared to the load-average longitudinal strain curve of the short column test specimen, the longitudinal strain of fibre reinforced composite material and steel tube concrete composite middle long test specimen developed faster under the effect of initial defects in the elastic-plastic stage, exceeding the load-average longitudinal strain curve; the bearing capacity and ultimate deformation ability of the test specimen were significantly improved.

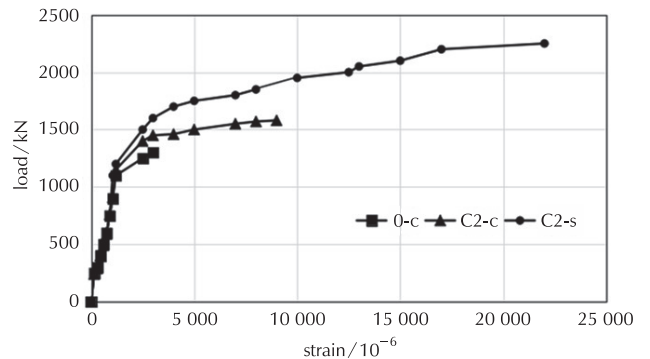
Average longitudinal strain, *i.e.*, longitudinal deformation rate, refers to the ratio of the longitudinal compression deformation of the test specimen to the initial length of the test specimen. Fig. 3 shows the load-average longitudinal strain curves of test specimens C2-s, C2-c, and 0-c. For the fibre reinforced composite material and steel tube concrete composite middle long column test specimen, the longitudinal strains of all measuring points were closely under the same grade of load at the initial stage. With the increase in load, the longitudinal strains of all measuring

Fig. 3 – Load-average radial strain curves

points demonstrated a difference, and the curve began to develop deviating from a straight line, under the same grade of load under the influence of factors such as initial defect and accidental eccentricity. When the load reached ultimate value, the average longitudinal strain increased sharply until the test specimen failed due to the excessively large lateral deformation.
