SLAC-PUB-4546
March 1988
(A)
SLAC-PUB--4546

BREAKDOWN PHENOMENA IN HIGH POWER KLYSTRONS*

A. E. VLIKES, M. A. ALLEN, R. S. CALLIN, W. R. FOWKES,
E. W. HOYT, J. V. LEBACQZ, T. G. LEE
Stanford Linear Accelerator Center
Stanford University, Stanford, California 94305

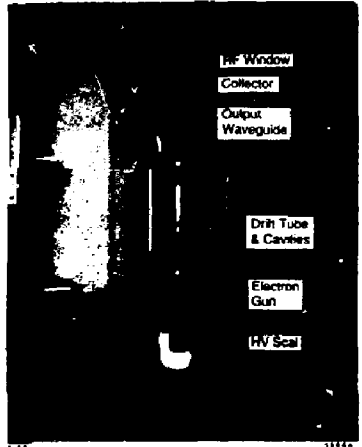
A klystron consists of several key components and regions which are subject to high levels of electrical stress. Figure 1 shows one of our latest production klystrons. It operates at a beam voltage of 350 kV and delivers 67 MW RF power. Its operating frequency is 2.856 GHz. The regions where breakdown phenomena have been a problem in this tube are the gun area, the ceramic window area and the output cavity area.

Fig. 1. The 67 MW production klystron.

The cavity and drift tube region serve to convert the unmodulated electron beam from the gun to a sharply bunched beam modulated at the input driving frequency. Each of the resonant cavities develop RF voltages across the cavity gaps (see Fig. 1). Beginning with the input cavity, which develops an RF voltage of approximately 2.5 kV, each of the succeeding cavities develop a higher and higher voltage due to the increasing RF beam

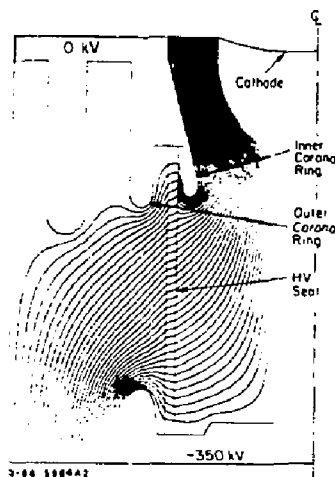
The geometry of the gun is shown in Fig. 2. The cathode and its support structure is located at the far right of the figure. The inner and outer anode corona rings are also shown with the ceramic seal sandwiched between them. An external cathode corona shield is also located at the base of the seal. To the right of the ceramic seal is the oil bath. The oil is tested to withstand an electric field strength of 150 kV/cm. The separation between the outer anode corona ring and the ceramic seal is 1.02 cm, and the separation between the inner anode corona ring and the seal is 0.32 cm. The location of the punctures was always at about the height of the outer anode corona ring. There was also evidence of arcing activity on the vacuum side of the seal opposite the inner corona ring but this did not appear correlated with the puncture sites.

Fig. 2. Gun field profile with original geometry.

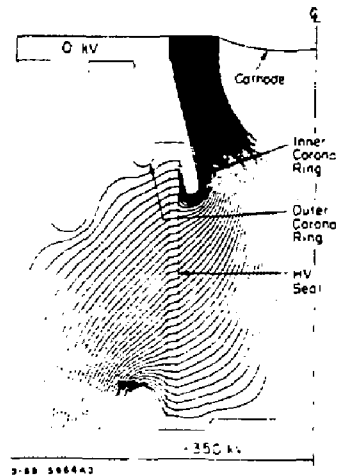
a large accumulation of charge to build up within the ceramic and then bleed off slowly through the length of the ceramic or arc to the closest metallic surface. These metallic surfaces are the inner or outer corona rings. If this mechanism is correct then a solution to our puncture problems would be to shorten the outer corona ring. Any arcing that could take place would then only be to the inner corona ring. We therefore reduced the outer corona ring by 2.5 cm. Figure 3 shows the new design. After testing several klystrons to determine that no negative effects to the general performance resulted this change became the new design for all klystrons. Fifteen months and 125 klystrons later no klystron with this new design has had a punctured high voltage seal.

Fig. 3. Gun field profile with modified outer anode corona ring.

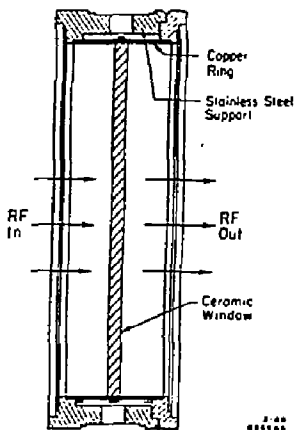
In high power klystrons, the RF ceramic windows are prone to several different types of breakdown phenomena because of the high levels of RF power they must transmit. Because of their susceptibility to failure, many studies and tests have been performed to ensure a window design with a high probability of long life. The ceramic window assembly is shown in Fig. 4. One may classify the main breakdown phenomena into three categories:

Fig. 4. Output ceramic window assembly.

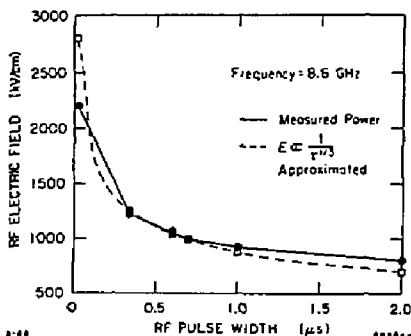
A plot of the results of the SL-3 measurements showing the importance of pulse width in standing off high electric field gradients is seen in Fig. 5.

Fig. 5. Electric fields in the output gap of SL-3.

We see that for the first tube types operating at 2.856 GHz, no output gap breakdown is found for pulse widths of a few μ sec. For tube type SL-3, we see that, because of the higher RF frequency (8.568 GHz) and smaller dimensions, the peak fields in the output gap become much higher for lower output RF power. An interesting point is that output gap breakdown for the SL-3 was observed for an output power of 15 MW for pulse widths > 0.7 μ sec and at 17 MW for pulse widths > 0.6 μ sec, indicating the pulse width dependence of breakdown.

In collaboration with Lawrence Livermore National Laboratory (LLNL) this tube type, SL-3, was also run using their induction linac as a high energy, high current source. We were able to measure output power levels corresponding to fields of 2.2 MV/cm for pulse widths of ≈ 30 nsec. No breakdown was observed.
