CHAPTER 364

BREAKWATER DAMAGE IN OKUSHIRI PORT DUE TO THE HOKKAIDO NANSEI-OKI EARTHQUAKE TSUNAMI

Abstract

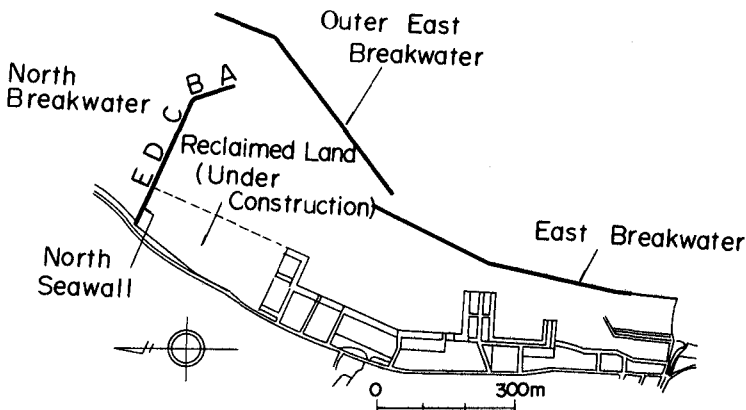
Figure 2. Breakwaters in Okushiri Port

Okushiri Port on the eastern side of Okushiri Island is the only port of the island, and includes the ferry terminal to mainland Hokkaido. Figure 2 shows the breakwaters and port facilities in Okushiri port. The outer east breakwater and the east breakwater are the main barriers against wind waves. The opening between the outer east breakwater and the north breakwater is used for the main waterway, and a narrow opening between the outer east breakwater and the east breakwater is also used for a waterway for small craft.

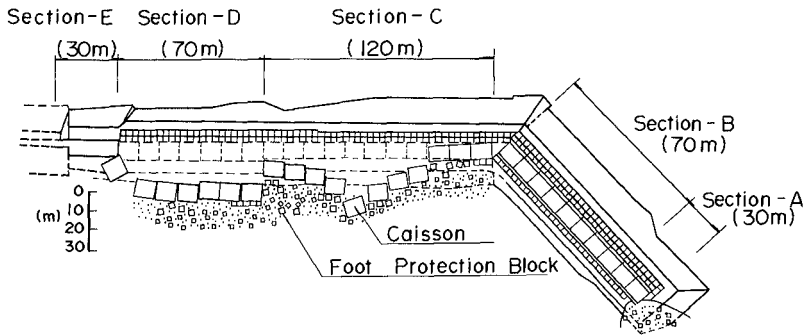
Figure 3. Caisson Sliding at the North Breakwater

Figure 3 shows the damage pattern of the north breakwater. Sections A, B, C, and D are caisson-type composite breakwaters, and section E is a concrete block type. According to the eyewitnesses, the tsunami waves propagated parallel to the shore line and attacked vertically against sections, C, D, and E of the north breakwater. In contrast, caissons slid little in sections A and B near the head of the breakwater.

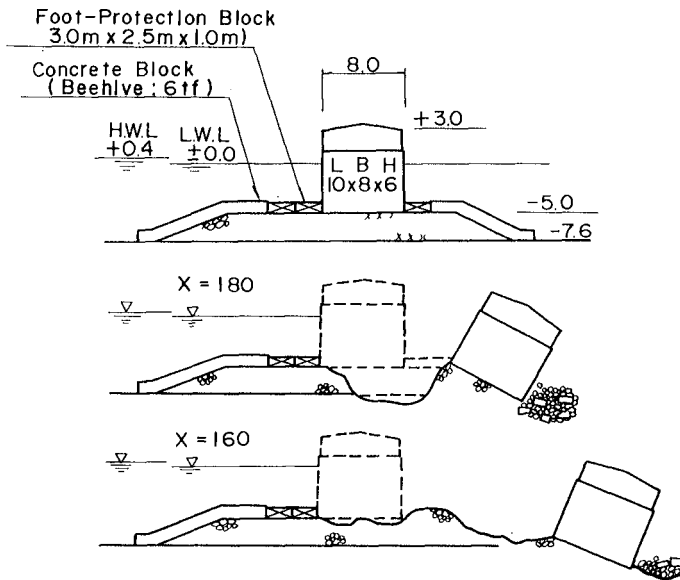
Figure 4. Damage Patterns of Section C of the North Breakwater

Figure 4 (upper diagram) shows a standard cross section of section C. The depth was 7.6m and the caisson was settled at a depth of 5.0m. Figure 4 (lower diagrams) shows typical damage patterns. At the position of X=180 m, the caissons slid 20m and pushed foot-protection blocks (3.0m long, 2.5m wide and 1.0m thick) and concrete blocks (6tf beehive). The scouring of rubble stones (30~300kg)

progressed along with the action of tsunami waves even after the caissons had slid, and mound rubble collected at $X = 160$ m.

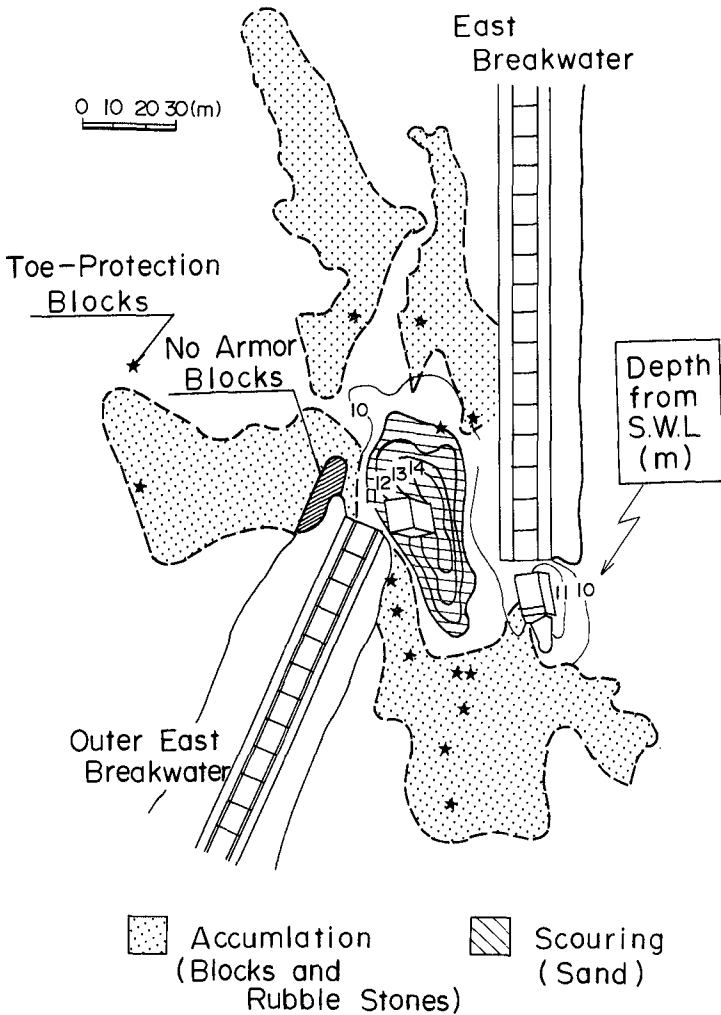
Figure 5. Scouring at the Narrow Opening

Figure 5 shows the scouring at the narrow opening between the east and the outer east breakwaters. The width of the opening is 35m and the depth was 10m. Rubble mounds of both breakwaters were covered by concrete blocks (1 tf beehive) and foot-protection blocks (1.5m wide, 2.5m long and 1.5m thick). These armor

blocks were moved and scattered as shown in Fig. 5. The maximum scouring depth was 4 m from the original sea bed, and the head caissons at both breakwaters collapsed.

At the flow rate $U_0=196$ cm/s (7.6 m/s in prototype), the first tsunami wave scoured most of rubble stones around the head caissons, and the head caissons of both breakwaters tilted due to the scouring of the rubble mound. In the outer east breakwater, the damage progressed further to the head caisson failure by the second tsunami wave. The maximum flow rate at the failure was recorded to be 2.3 m/s (8.9 m/s in prototype). Photo 1 shows the damaged caisson and mound of the outer east breakwater after the experiment. The prototype damage around the breakwater heads as shown in Fig. 5 was successfully reproduced by these model tests.

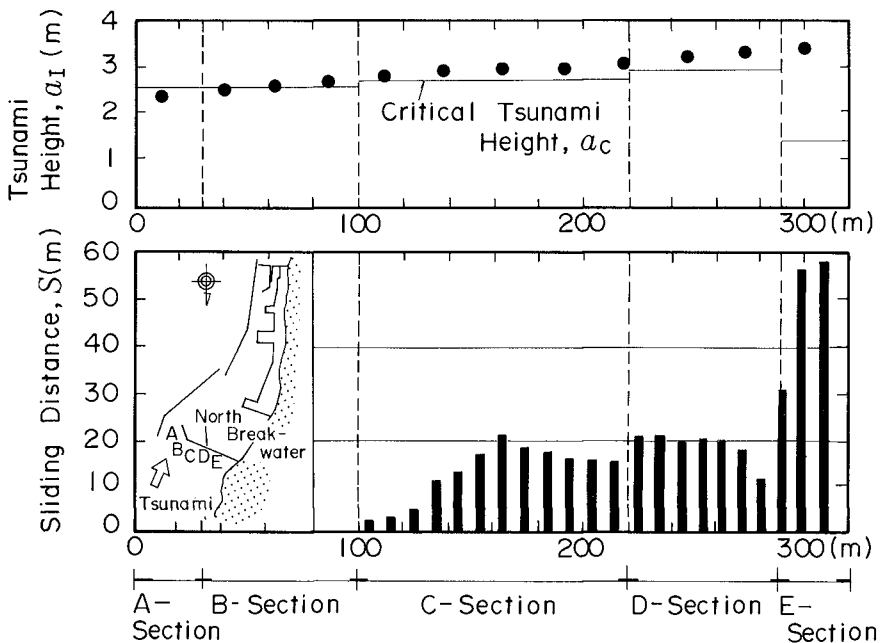
Figure 6. Tsunami Heights and Sliding Distances of the North Breakwater

The lower part of Fig.6 shows the sliding distance S of each section in the north breakwater. The upright structures of Section E (seawalls for reclaimed land) were heavily damaged, because the sand fillings were not completed when the tsunami struck. Other sections were caisson breakwaters with depths of 5~11 m, and widths of 7.5~9.0 m.

The upper part of Fig.6 shows the critical tsunami heights a_c (horizontal lines) calculated by Tanimoto's formula, and the incident tsunami heights a_I (solid circles) estimated by 3-D numerical simulations. The sliding distances S increase when $a_I \geq a_c$, which confirms the applicability of Tanimoto's formula for prototype failures.

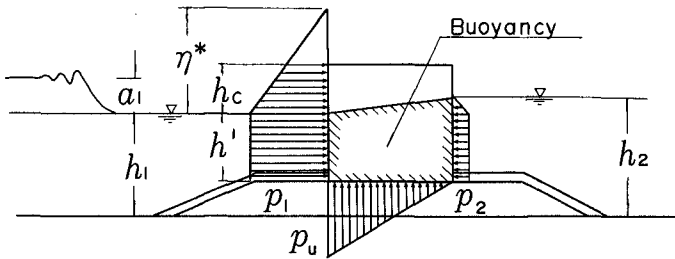
Figure 7. Tsunami Wave Pressure Distribution

Tanimoto (1983) proposed tsunami wave pressure distributions (Fig.7). The pressure intensity under the still water level p_1 and the crest tsunami height η^* can be calculated as follows:

$$p_1 = 2.2w_0a_I \quad \text{-----(1)}$$

$$\eta^* = 3.0a_I \quad \text{-----(2)}$$

where a_I is the incident tsunami height and w_0 is the unit weight of water. h_1 and h_2 are the depth at the offshore side and the harbor side, respectively.

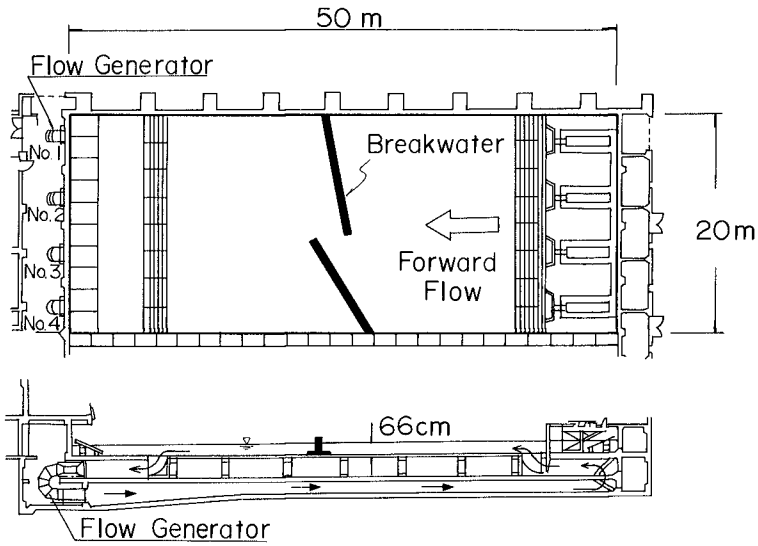
Figure 8. 3-D Basin with Flow Generators

Large-scale hydraulic model tests with a scale of 1/15 were also made in the 3-D basin (50 m long, 20 m wide and 3.5 m deep) at the Port and Harbour Research Institute (Fig.8). Four axial flow pumps were installed in the basin so that tsunami waves could be reproduced by the action of the flow. By changing the rotation direction and cycles of the axial pumps, the flow direction and speed could be changed according to the analog signals.

Tsunami waves were simulated by generating oscillatory flows with the observed tsunami period of 10 minutes (prototype scale). The forward direction is defined as flow coming into the harbor. The flow speed was monitored at the center of the opening (Fig. 8) with a 2-D electromagnetic flow meter at the depth of 10 cm above the still water level. The peak flow speed of the tsunami (U_0) was defined as the square root of each flow components. The water level was also measured at the same point by a wave gauge.

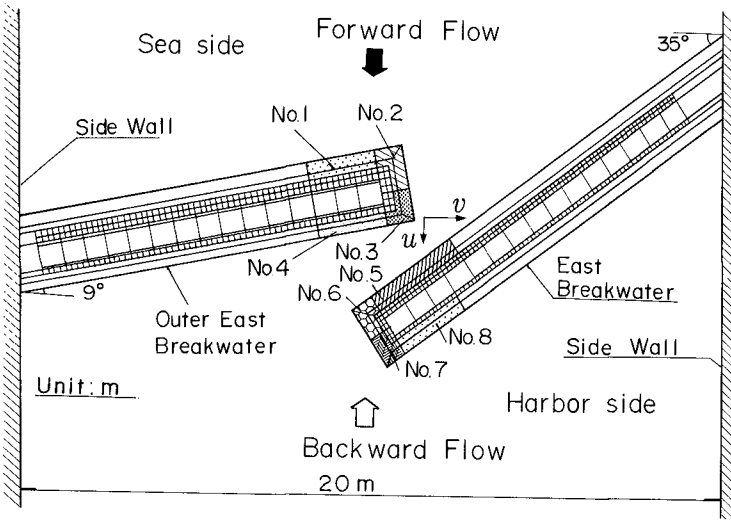
Figure 9. Breakwater Model in the 3-D Basin

The breakwater models were placed in the center of the basin (Fig.9). The scourings of rubble mounds and successive caisson failures at the narrow opening were reproduced. The depth was 66cm, the average depth of this area considering the tidal conditions. The upright section of breakwaters were made of reinforced concrete box (66.7cm long, 56.7cm wide and 73.3cm high) and their weights were adjusted by the filling materials. Concrete blocks (296gf beehive) and foot protection blocks (10cm wide, 16.7cm long and 6.7cm thick) were produced to scale. To facilitate the observations, concrete blocks were classified into four areas (Fig.9) and painted different colors.

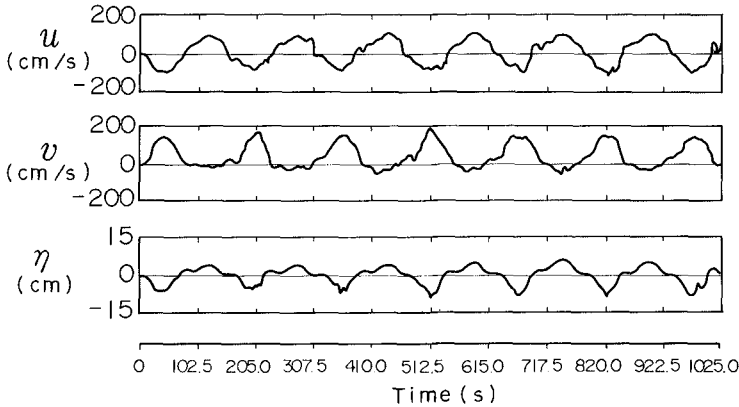
Figure 10. Flow and Water Level at the Center of Opening

Five kinds of tsunami flow with different peak speeds ($U_0 = 112, 151, 169, 180$ and 196 cm/s) were used for stability tests. How many tsunami waves attacked this area is not clear, but at least three waves are certain to have covered this area from information given by witnesses. In this experiment, tsunami waves corresponding to a duration of 6.5 times as long as the wave period were created to observe the displacement of the armor blocks and caissons. Figure 10 shows the flow and water level changes at $U_0 = 196$ cm/s.

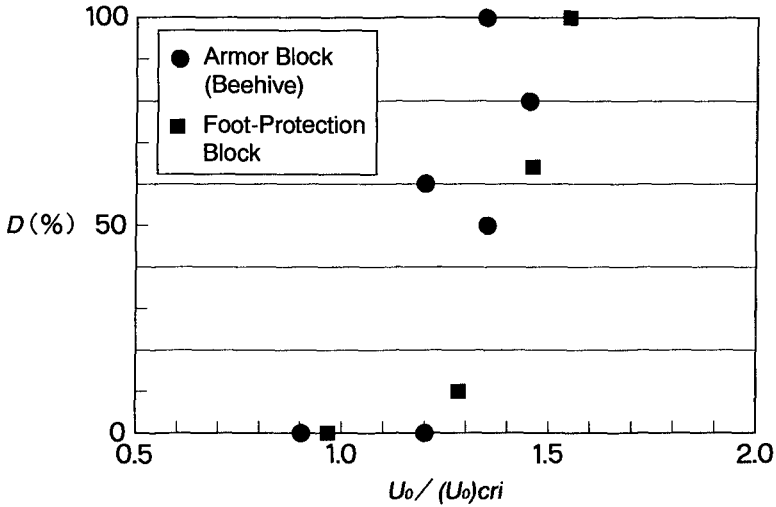
Figure 11. Damage Ratios of Armor Blocks and Foot-Protection Blocks

In the 3-D model test for breakwater heads, damage ratios were also observed for each tsunami flows. Figure 11 shows the damage ratio of beehive and foot-protection blocks for $U_0=151, 169, 180$ and 196 cm/s. The critical flow speed $(U_0)_{cri}$ is calculated from Eq.(3) for beehive ($\gamma = 1.2$) and foot-protection block ($\gamma = 0.65$). Damage starts from $U_0/(U_0)_{cri} = 1.0$, and therefore the applicability of these coefficients is proved.

Tsuruya et. al. (1994) recommended that the Isbash parameter γ for beehive blocks should be 1.2 in the actual settled condition, and 0.967 for individual blocks separately settled on the sea bottom. Kimura(1995) proposed that $\gamma=0.6\sim 0.7$ can be used based on the previous tsunami damage for foot-protection blocks.
