Bridge Piers with Structural Fuses and Bi-Steel Columns. I: Experimental Testing

Samer El-Bahey¹ and Michel Bruneau, F.ASCE²

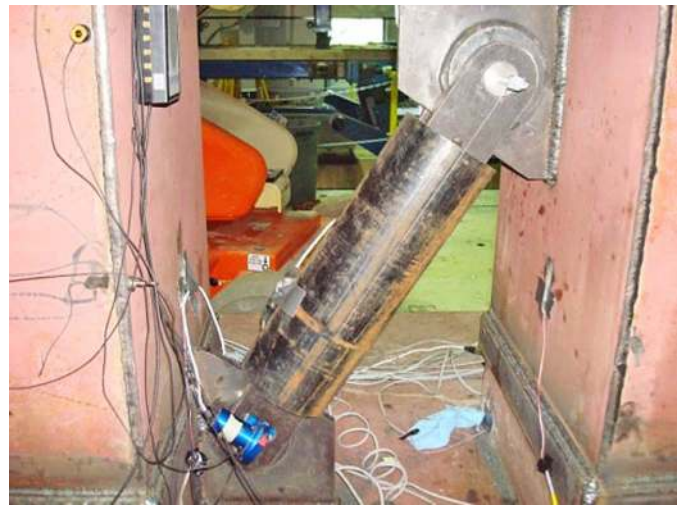
Fig. 4. BRB used in specimen (S2-1)

For the second specimen (with BRBs as structural fuses between the columns), six BRBs having specified yield strength of 533 kN and $\sigma_y = 355$ MPa, and a core length of 300 mm and total BRB length of 600 mm were also designed to meet the structural fuse concept described previously. A typical BRB is shown in Fig. 4. Pin-ended connections were used to eliminate moment and shear at the connection points and to allow rotation of the BRBs during specimen sway.

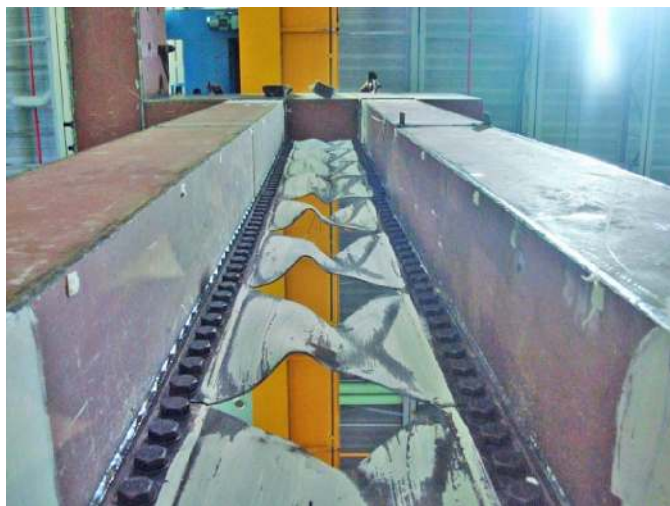
Fig. 7. SPSL's yielding at 1.6% drift

Testing restarted by repeating the cycles at a displacement of 75 mm (1.1% drift). At 112.5 mm displacement (1.6% drift), minor signs of yielding of the lower-west column were observed. At that drift, it was determined that the part of the experiment intended to illustrate the structural fuse concept had been completed because a further increase in displacement would have resulted in the columns yielding. Fig. 7 shows the links at this stage of the test.

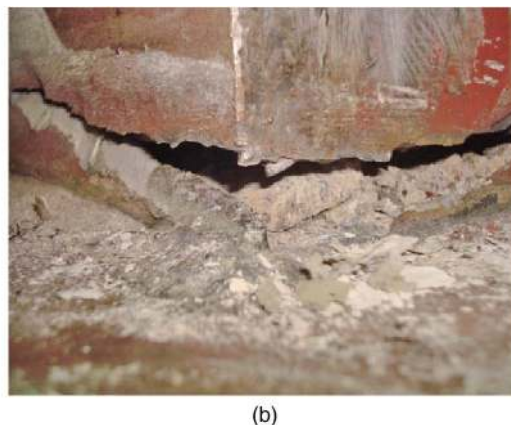
Fig. 8. (a) Local buckling of west column 2.2% drift; (b) fracture at 2.7% drift

Nevertheless, testing continued for the specific purpose of observing the ultimate behavior of the bi-steel columns in this particular application. Local buckling at the west side of the lower-west column started to appear at 150 mm displacement (2.2% drift) as shown in Fig. 8(a), while fracture started to occur at the same drift level at the east side of the column and propagated rapidly.

The column was completely fractured along its west side as shown in Fig. 8(b) at 187.5 mm displacement (2.7% drift), and the load dropped from 700 kN to 420 kN at that point.

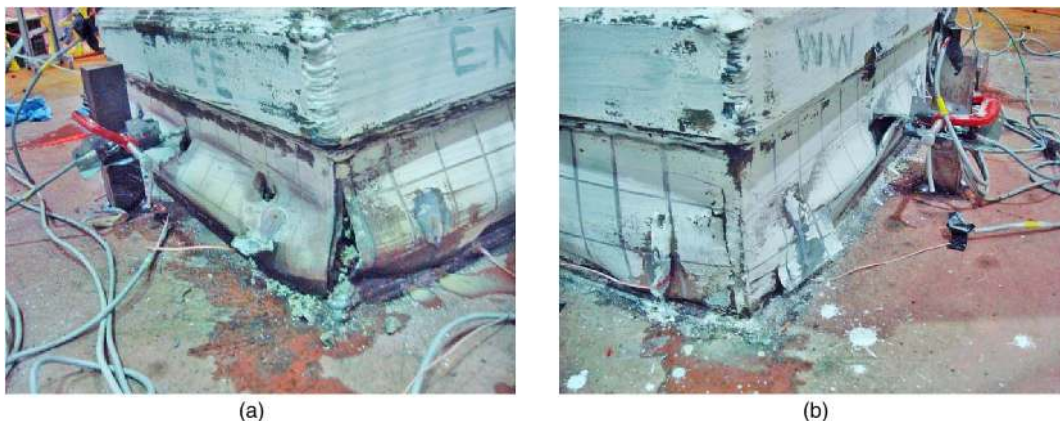
Fig. 10. (a) Damage at east column at 3.62% drift; (b) damage at west column at 4.35% drift

Testing continued to 175 mm displacement (2.5% drift), at which the lateral load resisted by the specimen dropped 44% from 711 kN to 400 kN. As testing continued, to better understand the progression of the failure mechanism (and because the specimen had a nonnegligible residual strength), the crack propagated across the south side of the east column, and the east column was totally damaged at this stage.

It was not deemed beneficial to cycle further beyond that point, but the west column was still intact, having suffered only from local buckling. So it was decided to apply one more half cycle up to a displacement that would make the west column totally fails. The fractured column would be in compression during that half cycle, making that last stage of testing possible. At 175 mm displacement (2.5% drift), a minor crack started to appear at the northwest corner of the bottom-west column. The crack started to grow and propagate as displacement was increased in the same direction. At the same time, the east column was suffering major damage at 200 mm displacement (2.9% drift). At 225 mm displacement (3.26% drift), the crack at the northwest corner of the west column propagated, and concrete started spalling from the southeast corner of the east column. At 250 mm displacement (3.62% drift), the applied load started to drop gradually as shown on the hysteretic curve, and the existing crack on the west face of the west column further propagated. At the same time, another large crack developed at the northeast corner of the bottom-east column, and concrete rubble started to escape from the crack opening as shown in Fig. 10(a). At 300 mm displacement (4.35% drift), the west column had developed 600 mm long cracking along its base and had extensive local buckling, and concrete rubble started escaping from the northwest corner crack as shown in Fig. 10(b). Testing was then terminated at that stage.

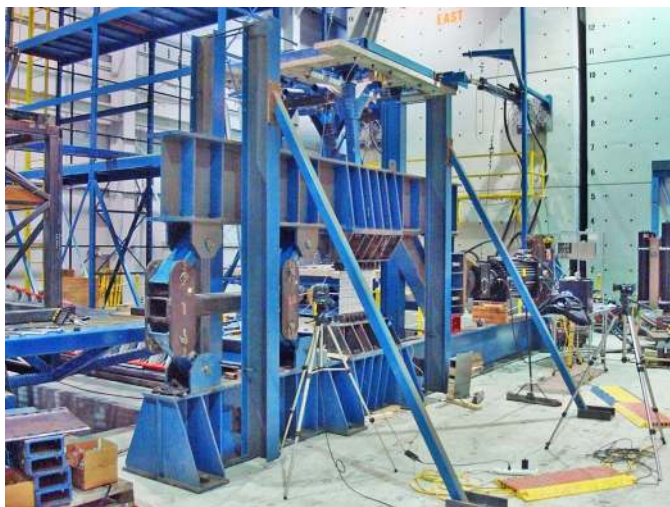
Fig. 12. Pentograph system

The test setup shown in Fig. 12 was originally designed by Berman and Bruneau (2005). The setup is a pantograph that was designed to apply a shear force on short-length specimens. The pantograph functions to prevent the rotation of the loading beam while allowing the link to deform unrestrained in the axial and horizontal directions, preventing the introduction of axial load in the link when deformed in shear and flexure. The loading protocol used for testing the SPSLs was the one specified by the 2005 AISC seismic provisions for eccentrically braced frames (EBFs). Hysteretic behavior of both restrained and unrestrained links are shown in Figs. 13(a) and 14(a), respectively. A comparison of the results obtained accompanied by an analytical investigation is presented in the companion paper (El-Bahey and Bruneau 2011).

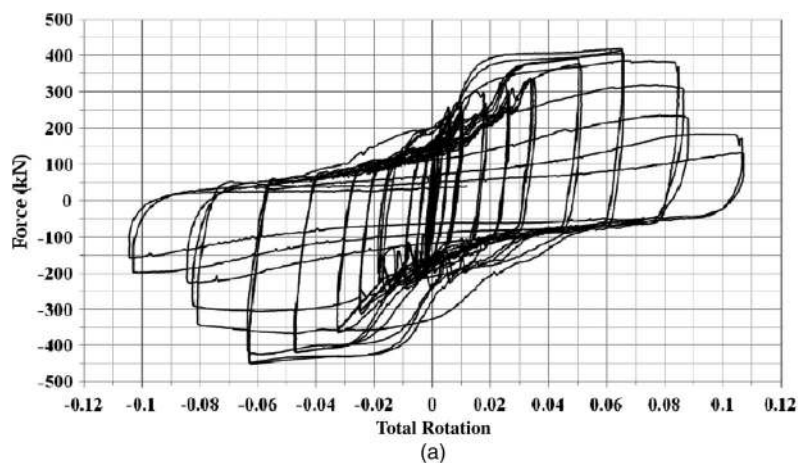
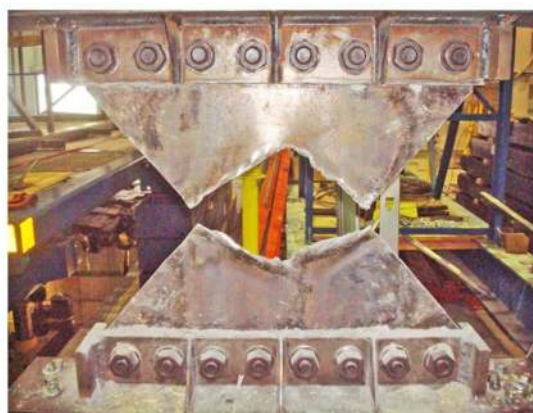
Fig. 13. (a) Link shear versus total rotation hysteretic curve for restrained specimen; (b) link condition after testing

Specimens restrained against out-of-plane buckling using the fiber-reinforced plastic (FRP) panels almost observed the same trend of behavior during testing. For illustration, a brief description of the test performed on the SPSL presented in Fig. 13(a) is presented. At $\gamma_{tot} = 0.002$ rad, and loss of stiffness was observed in the hysteretic curves at a shear force of 150 kN. Yielding started to occur at a total rotation of 0.015 rad and a shear force of 250 kN. No buckling was observed in the wedge parts because they were designed to remain elastic (observed after removal of the FRP panels at test termination), and consequently no significant loss in strength occurred at repetitive cycles for the same rotation level. This was attributed to the fact that the middle part was the only part yielding in the specimen and was designed to yield in pure shear. At a rotation level of 0.08 rad, a drop in strength from 400 kN to 380 kN was observed; this was attributed to a fracture that might have started to propagate somehow in the middle part of the link, but this could not be confirmed or seen at that time because of the presence of the restraints. This was approximately a 20% loss in strength from the maximum strength reached, and, by definition, the specimen was deemed to have failed in performance. However, testing continued until the specimen totally fractured. Loss of strength continued at the same rotation level for every cycle performed because of the propagation of the anticipated crack. A significant loss in strength was then observed at a rotation level of 0.1 rad, and the strength dropped to almost zero. At that point, testing was terminated, and the restraints were removed to investigate the link condition at the end of the test. Fig. 13(b) shows the specimen condition after removal of the restraints.

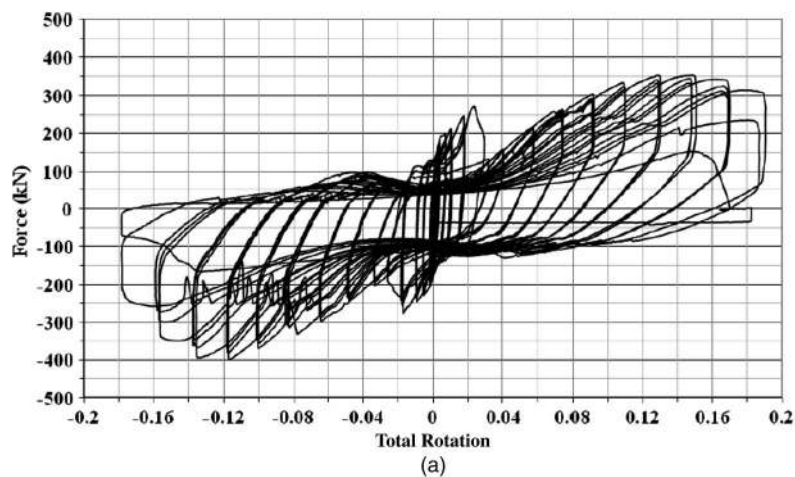
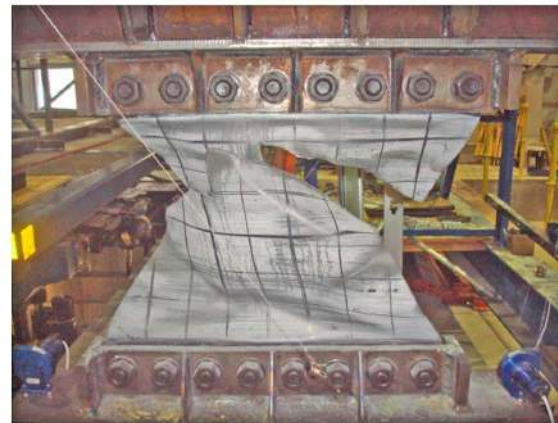
Fig. 14. (a) Link shear versus total rotation hysteretic curve for unrestrained specimen; (b) link condition after testing

Specimens unrestrained against out-of-plane buckling also observed similar behavior during testing. Again, a brief description of the hysteretic behavior shown in Fig. 14(a) is presented. At $\gamma_{tot} = 0.002$ rad, a loss of stiffness was observed in the hysteretic curves at a shear force of 150 kN. At a rotation level of 0.02 rad, a sudden drop in strength was observed and was attributed to the initiation of buckling that occurred in the middle part of the specimen. Up to that point, the specimen was assumed to be yielding in shear (similar to the restrained specimens); this is because of the fact that no signs of buckling were observed in the specimen from which no tension field action is assumed to develop. Because of the unavoidable geometric imperfections, buckling started to initiate in the plate, and significant strength loss was observed. The specimen then started to pick up strength gradually at each incremental cycle. Significant pinching in the hysteretic curves is also observed and expected as the plate stretches and relaxes. A strength reduction is

also observed at each rotation level for the repetitive cycles. Progression of buckling for successive rotation levels was observed. At a rotation level of 0.13 rad, a crack at the upper-east corner of the wedge part initiated and propagated at incremental rotation levels, no significant strength loss was observed in the hysteretic curve. As the crack propagated, gradual softening in the hysteretic curve was observed in both directions. Another crack initiated in the upper-west corner at a rotation level of 0.15 rad. At that point the cracks propagated rapidly, and a significant loss in strength from 350 kN to 250 kN was observed in the negative side of the curve at a rotation level of 0.16 rad; that is approximately a 30% loss in strength. At the same rotation level at repetitive cycles, the specimen totally fractured, and the strength dropped to zero as shown in Fig. 14(b).
