Building Collapse in Nigeria: the Trend of Casualties the Last Decade (2000 -2010)

Dr Anthony Nkem Ede

Department of Civil Engineering, Covenant University, PMB 1023 Ota, Ogun State - Nigeria.

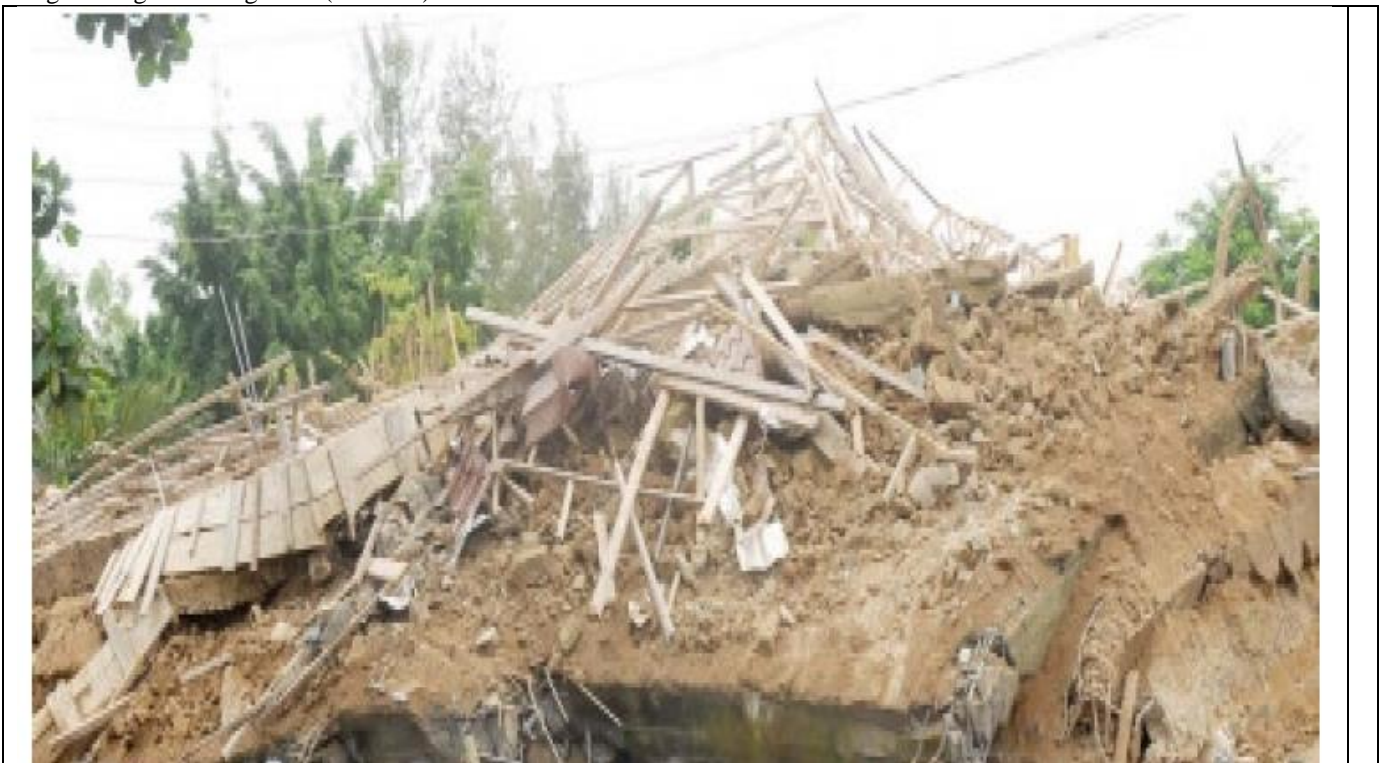
Most of the facts high-lightened above were confirmed by one of the most recent collapse verified in Abuja. On the 11th of August 2010, thirteen people died in a building, which collapsed at Ikole Street, Abuja (figure 1), while about 35 persons are believed to be trapped in the debris while 10 persons were rescued (Bukola, A. 2010). This was the third collapse case in the city since the beginning of the year. The three storey building, a hotel, has been under construction since 2001 and was later marked for demolition by the Federal Capital Development Authority (FCDA) because the owner added an extra floor thereby making it a four-storey building as against the specified three-storey building. When the agency discovered this, the developer was issued a "stop work" order on the 12th of December 2009.

Fig. 1. Catastrophic collapse at Ikole Street, Abuja of 11th August 2010 (courtesy TheNationonline)

The agency enforced the mechanical removal of the additional floor and subjected the entire structure to Schmidt Hammer and Structural Integrity Tests on the 29th July 2010 and the structure failed the tests. All the occupants were asked to move out of the building while legal backing for the demolition was sought but never obtained till the collapse. As some people illegally made the uncompleted structure their sleeping place at night, they became the victims of the collapse. The causes of the deaths verified in

this collapse include among other things greed (the owner had the courage to seek redress from court against the demolition), non compliance with building rules and regulations, disturbance of the structural equilibrium during the removal of the illegal fourth floor, exposure of construction materials to deterioration (due to the infiltration of water and steel corrosion over the past 9 years in which the structure was under construction) low quality materials, use of quacks and unskilled personal, disobedience and
