Bypassing of Dredged Littoral Muddy Sediments Using a Thin Layer Dispersal Technique

Terry Healy[†], Ashish Mehta[‡], Hugo Rodriguez[‡], and Fengming Tian[†]

HEALY, T.; MEHTA, A.; RODRIGUEZ, H., and TIAN, F., 1999. Bypassing of Dredged Littoral Muddy Sediments Using a Thin Layer Dispersal Technique. *Journal of Coastal Research*, 15(4), 1119–1131. Royal Palm Beach (Florida), ISSN 0749-0208.

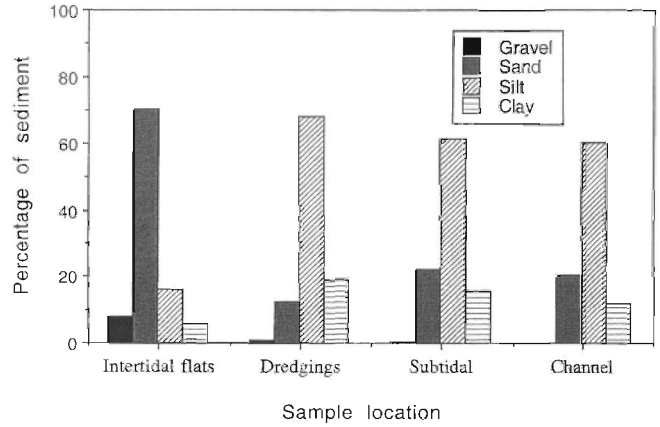
Figure 2. Texture of sediments in the navigation channel and surrounding littoral environment (from HULL, 1996).

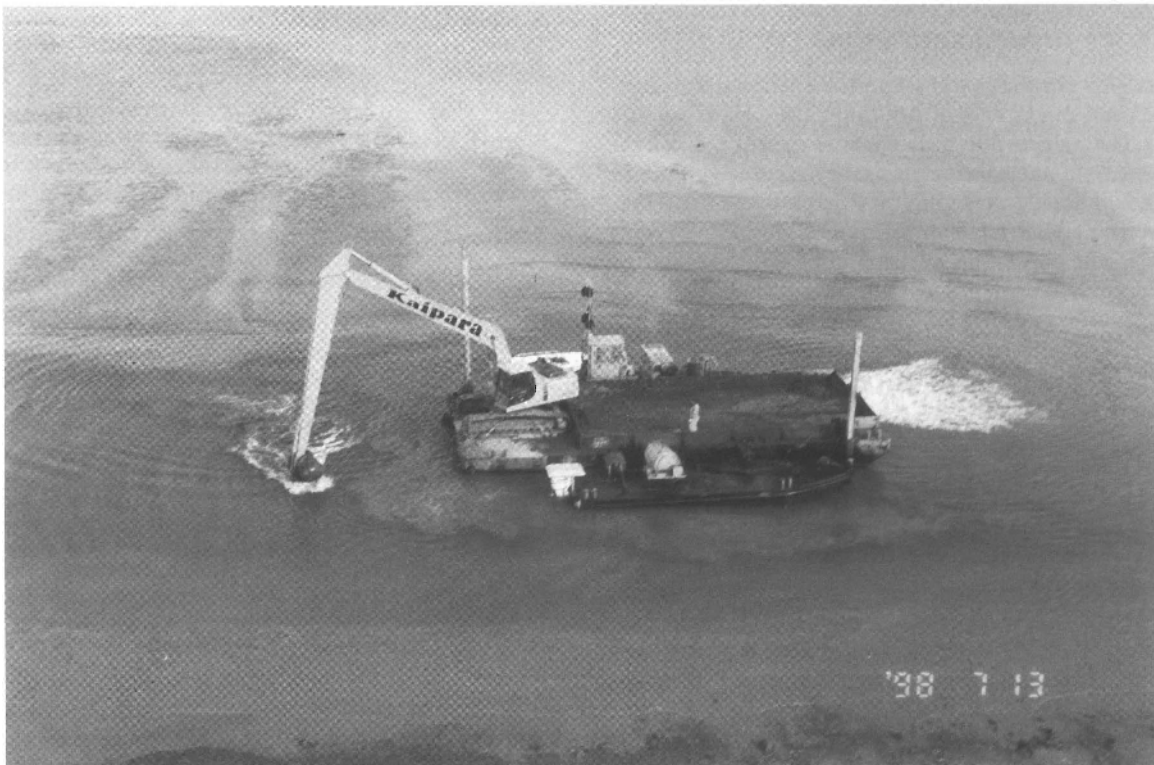
Figure 3. The dredging of muddy sediments from the marina approach channel using a digger mounted on a barge.

mulation of muddy sediment deposited in the channel was dredged using a digger mounted on a barge (Figure 3), and side-casted into a mound of muddy material about 50 m broad and 0.5 m high alongside the channel. Monitoring of the side-casted dredgings was carried out over the next year (HULL, 1996), but unfortunately some of the muddy material became transported back into the channel by the reverse littoral drift processes.

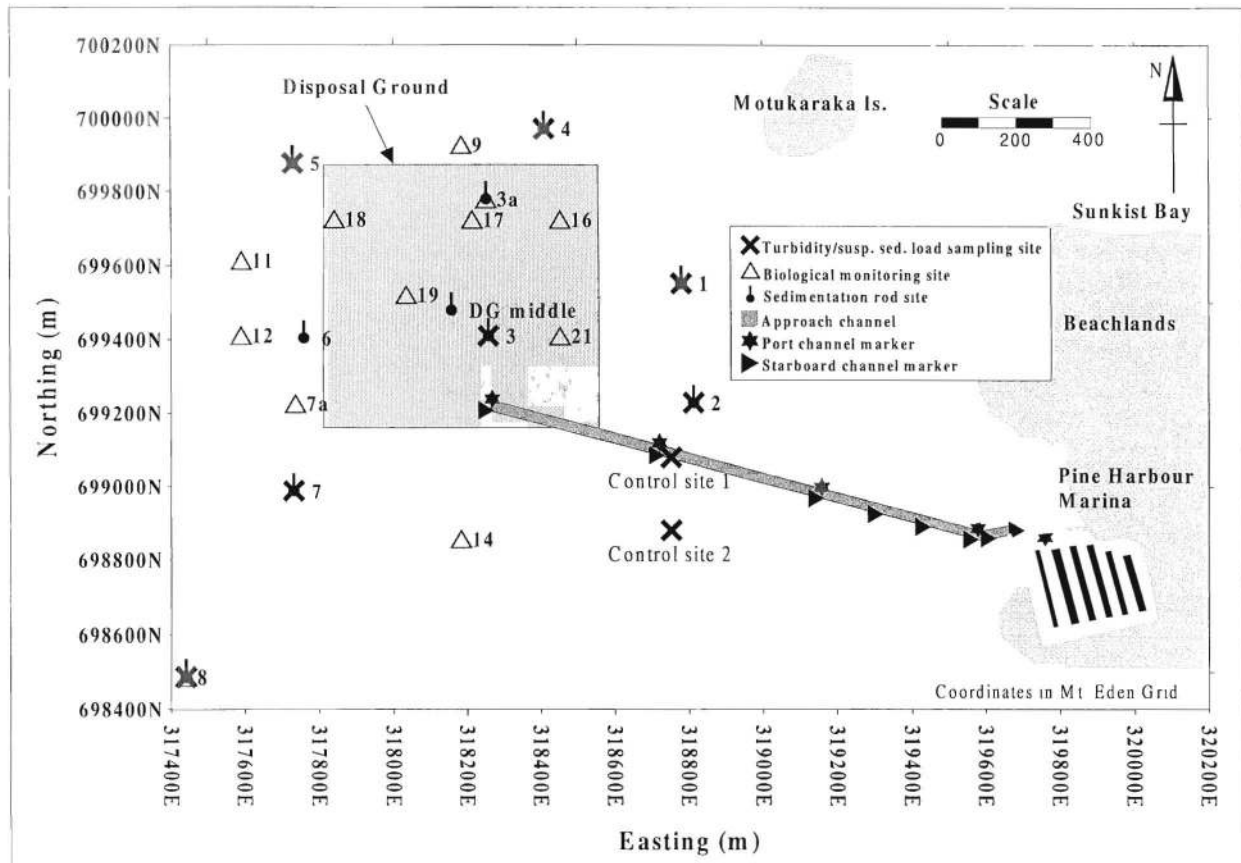
Figure 4. Pine Harbour Marina maintenance dredging and disposal monitoring sites.

barge was required for another contract. The monitoring program envisaged a “before dredging, during dredging and after dredging” set of surveys for bathymetry, side-scan sonar, and benthic ecology. In the event, due to inclement weather, only the ‘before’ and ‘after’ monitoring for bathymetric, side-scan, and ecological surveys were carried out. Notably however these surveys were able to be carried out immediately after the cessation of dredging so that maximal effect of those activities on the environment were able to be measured. Monitoring sites are illustrated in Figure 4.

Fortnightly monitoring runs were required and were carried out on 05 September, 19 September, and 03 October 1997 at the sites given in Figure 4. Samples were collected as 3 replicates at mid water depth, on the ebb tide, and notes were taken on the wind and wave conditions at time of sampling. Results of the turbidity and suspended sediment load

Sedimentation rods were placed on the sea floor (Figure 4) to check the variation of the sea floor sediment elevation as an indicator of sediment transport over the sea floor. If the deposited sediment were to migrate onshore as a cohesive mass (MATHEW and BABA, 1996), for example, then evidence of transport across the sea floor would likely be registered on the sedimentation rods. The rods were emplaced by SCUBA divers and revisited on 19 September and 06 October 1997.

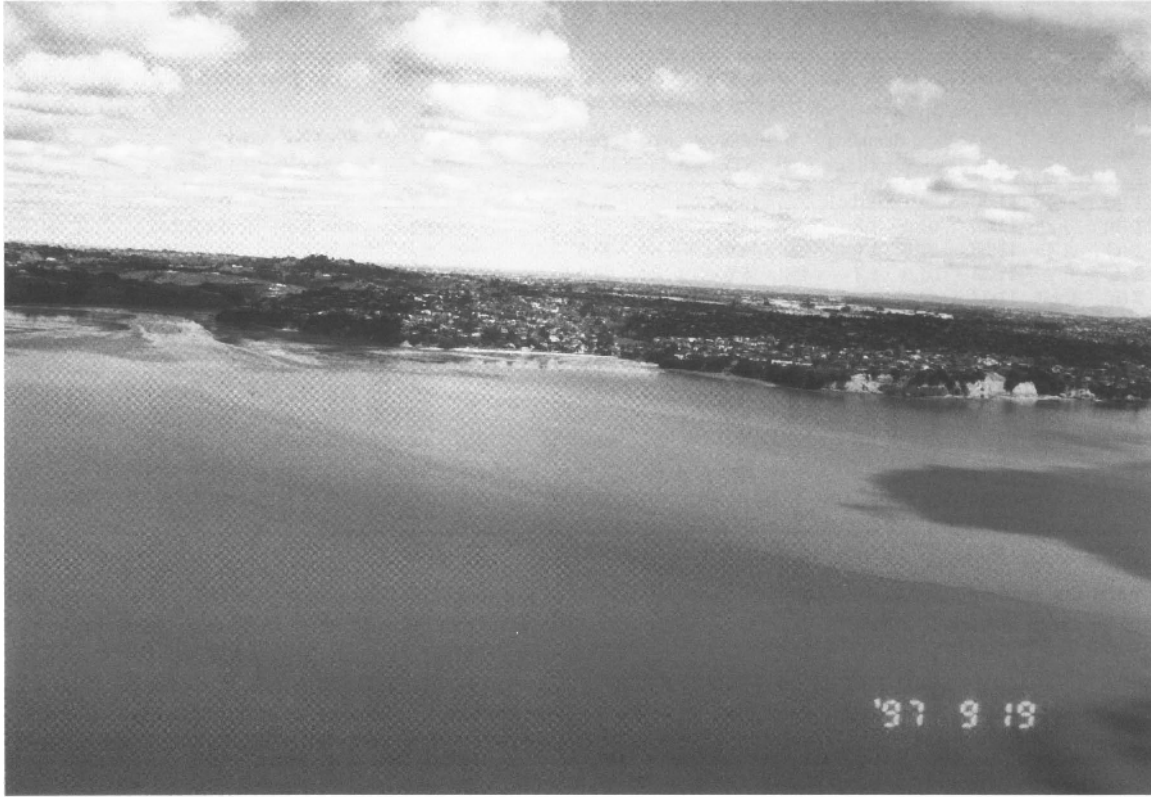
Figure 5. Turbid plume due to natural catchment discharge of high natural suspended sediment loads from the adjacent Turanga catchment.

the catchment. Suspended sediment load in the channel and control site were all close to 30 mg/l (turbidity ~ 5 NTU). But remarkable was the suspended sediment load of 140 mg/l (turbidity—61 NTU) in surface waters at site 8, representing the natural discharge from the Turanga catchment. This is an order of magnitude greater than levels measured in the direct dredging plume as represented by the site 2 values above. The Turanga catchment discharge plume is identified in the photo records for that day (Figure 5).

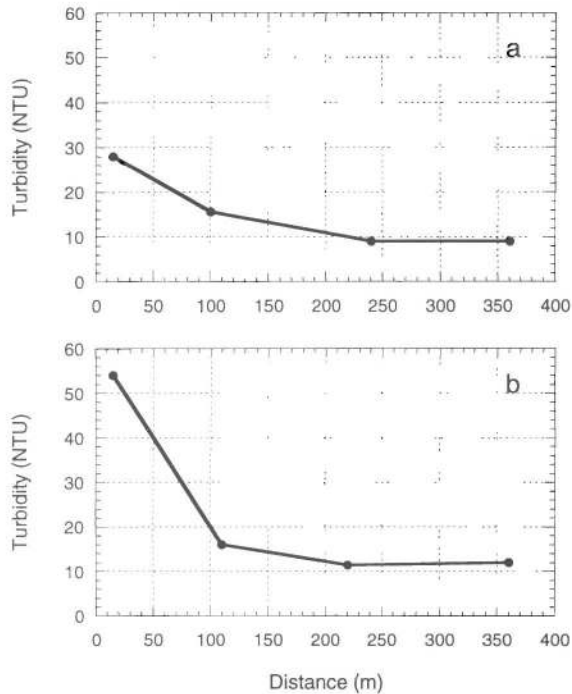
Figure 6. Turbidity of the surface water (0.2 m from the water surface) at different distances behind the barge during the spoil disposal monitoring days of: (a) 05 September 1997 and (b) 19 September 1997. The width of the plume was about 10–15 m and the background turbidity was ~ 4 NTU.

The results show that close to the barge as it is discharging sediment the NTU values are expectedly high at 25–30 NTU, which would have been associated with a suspended sedi-

ment load of about 50–70 mg/l in the trailing plume. But at distances greater than about 250 m from the barge the water turbidity reduced to levels close to background (~ 9 NTU), suggesting that the duration of the turbid plume during the disposal operation was just a few minutes (5–15), which is consistent with observations on muddy dredge spoil disposal in Poverty Bay (KENSINGTON, 1990; SANDER, 1993; WOOD, 1994).

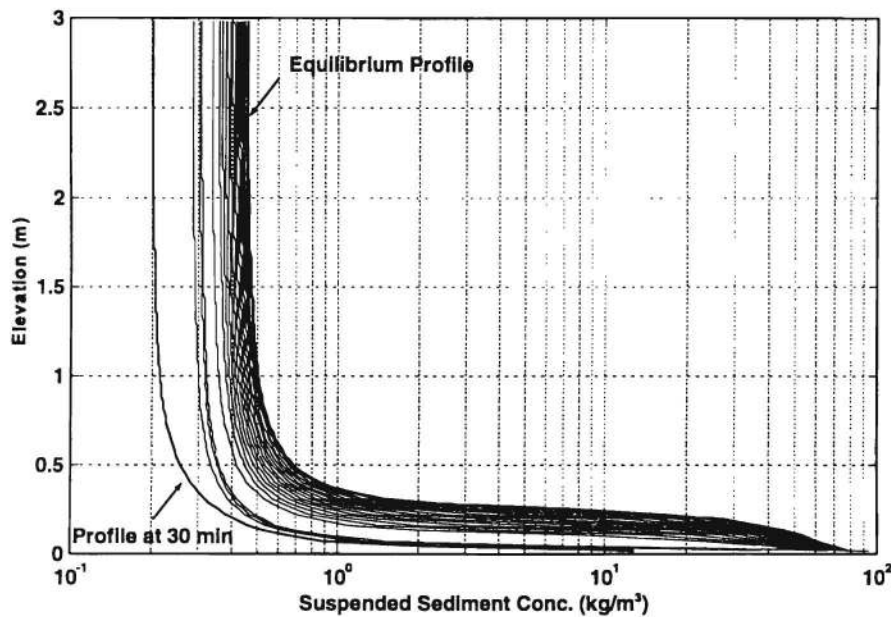
Figure 7. Time evolution of suspended sediment concentration profile over natural bed at the disposal site. Profiles are every 30 min starting with initiation of 1 m wave action over the bed. The water column is assumed to be initially free of suspension.

Results from running the model showed that in the pre-disposal condition, bottom mud was easily resuspended (Figure 7) and generated a surficial (equilibrium) concentration of 0.45 kg/m^3 (450 mg/l). The predicted concentration after disposal (Figure 8) was found to be 0.43 kg/m^3 (430 mg/l). These concentrations are sensitive to the erosion threshold of mud and are upper limits—the respective mean values being about $\frac{1}{3}$ of these, *i.e.*, ~ 150 and ~ 143 mg/l, which is closely similar to values actually measured in waters discharging from the adjacent catchment on 03 October 1997. Irrespective of the actual magnitudes, the simulations indicate that the erodibility of bottom sediment in the disposal area, which seems naturally high, is unlikely to change measurably as a result of disposal of the muddy dredgings.

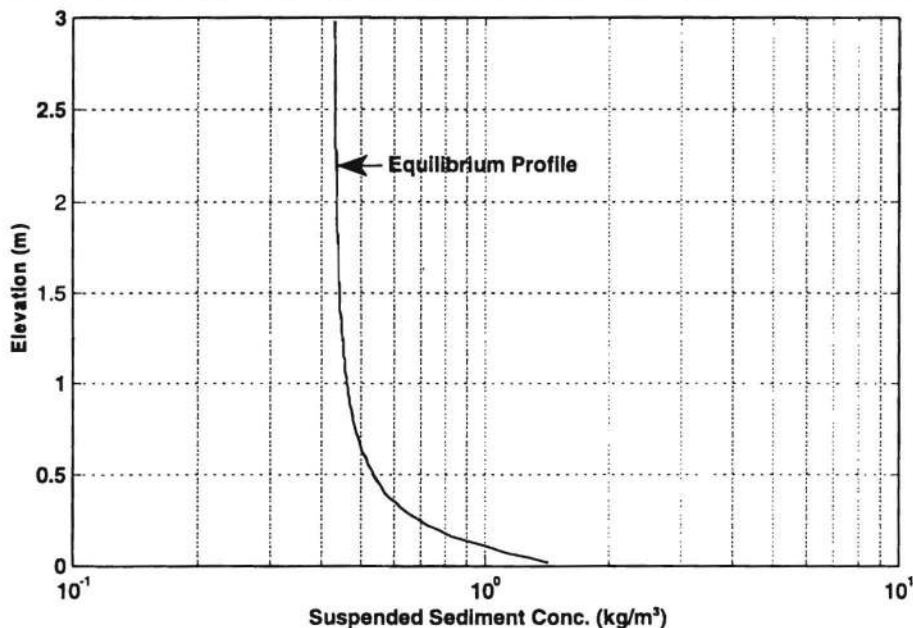
Figure 8. Equilibrium profile of suspended sediment concentration under 1 m waves at the disposal site after dredged material disposal. Profiles evolving with time have been omitted.

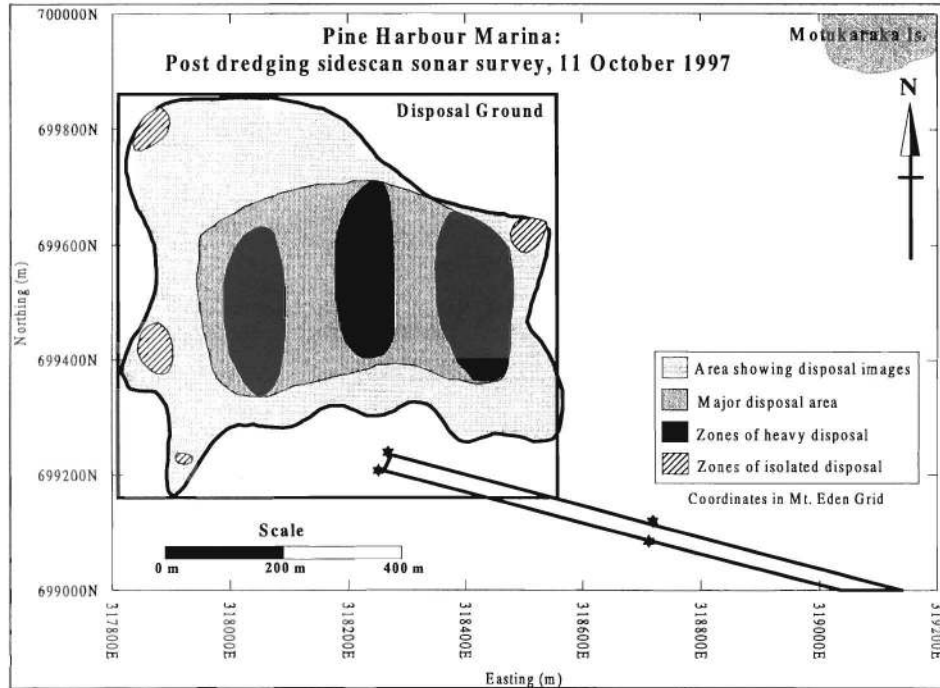
Figure 11. Interpretation of sea bed patterns from the post-disposal side-scan sonar survey of the disposal ground.

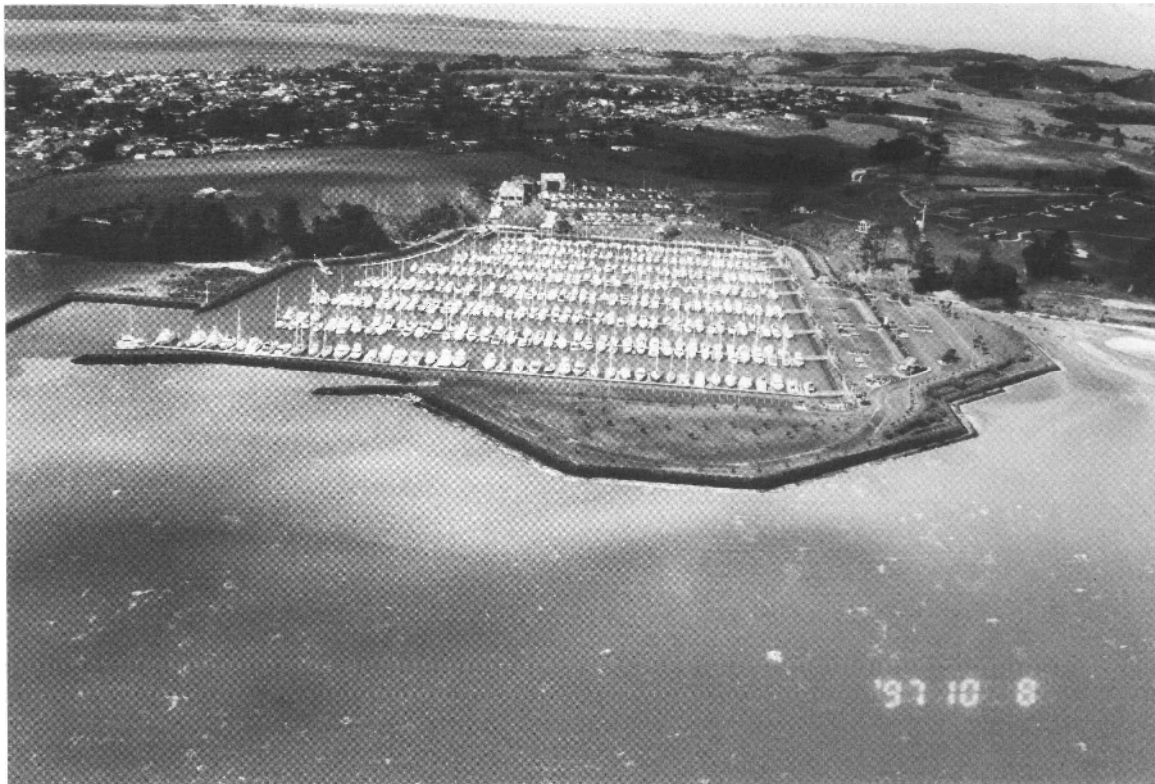
Figure 13. Turbidity and high suspended load from the estuarine turbid fringe and from the stream adjacent (to the right) of the marina flowing under the influence of southwesterly winds into the marina approach channel, where muddy deposition occurs. Such "natural" turbidity is higher than measured at the monitoring sites related to the dredging.

At times of the monitoring runs, high angle oblique air photos were taken to provide a visual record of conditions at the time of monitoring. These clearly show that the surrounding catchments and the wave agitated estuarine turbid fringe provide much greater generation of turbid water with higher suspended sediment loads which impact over much larger areas of the embayment than the dredging and disposal activity (Figure 13).
