Carbon fiber-reinforced epoxy filament-wound composite laminates exposed to hygrothermal conditioning

Abstract This study focuses on the evaluation of the effect of hygrothermal conditioning on tensile, compressive, in-plane and interlaminar shear properties, and also on the viscoelastic characteristics of carbon fiber/epoxy laminates. Flat unidirectional laminates were manufactured by dry filament winding and cured under hot compression. The laminates were later exposed to hygrothermal conditioning in a chamber, following the recommendations of ASTM D5229M. All composite coupons were tested before and after conditioning. An analytical Fickian model was used to fit experimental data, showing very good estimates. Shear strength and modulus reduced to about 30 and 38 %, respectively. All specimens presented acceptable failure modes; shear specimens failed at the gage section with delaminations and fiber/matrix debonding, whereas short beam specimens failed via delaminations at the specimen mid-plane. Moisture penetration through the carbon/epoxy surface lead to interfacial debonding and matrix plasticization. Puck's failure envelope accurately predicted failure under compressive and

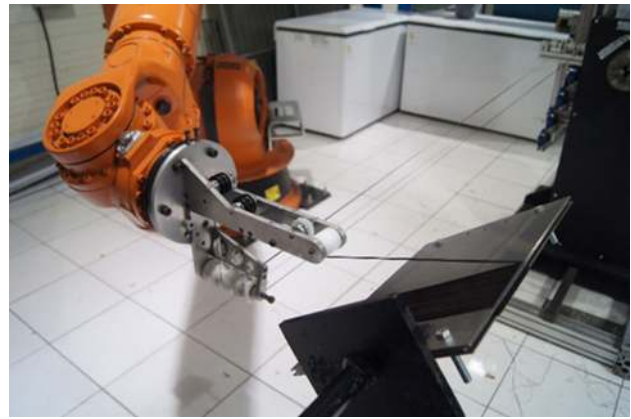
Fig. 1 Manufacturing of a flat unidirectional laminate by filament winding

Carbon fiber/epoxy prepreg tow (towpreg) from TCR Composites, with Toray T700-12 K-50C carbon fiber and UF3369 epoxy resin system, was used in this work. The flat laminates were manufactured using a rectangular stainless steel mandrel ($327 \times 228 \times 12 \text{ mm}^3$) and a KUKA robot KR 140 L100 with control and peripheral devices from MFTech, with an achievable tolerance in the winding angle lower than 0.5 %. Hoop flat laminates were produced on the designed mandrel, as presented in Fig. 1. Two simultaneous rovings (towpregs) were used to produce the laminates. The towpregs were then wound onto the mandrel. After winding, a polyester-based shrink tape was used to wrap and help consolidating the laminate during the

curing process that followed. The tape begins to shrink around 70 °C and reaches a maximum shrink force at 150 °C. This aids ply compaction and the elimination of voids, yielding a resin-rich part surface.

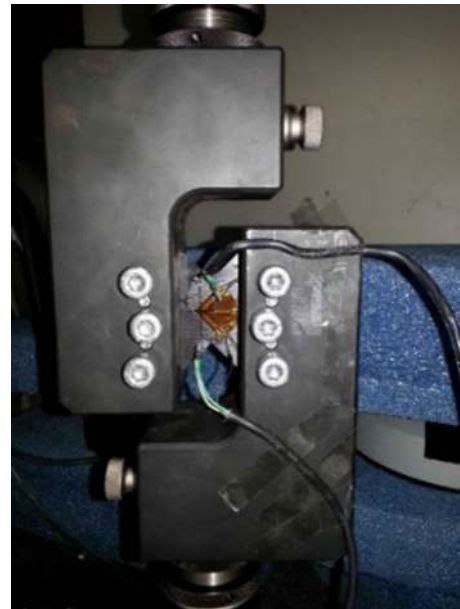
Fig. 2 V-notched shear test with a bonded rosette

- **In-plane shear** The V-notched rail shear method (ASTM D7078-12) test was chosen. The specimen (dimensions: $76 \times 56 \times 2.8 \text{ mm}^3$) was centrally V-notched on both sides. The notch angle is 90° and the radius is 1.3 mm. Cross-head speed was 1.5 mm/min and the shear modulus was determined on six samples using a strain gage rosette aligned at $\pm 45^\circ$ at the mid-section of the sample (as seen in Fig. 2).

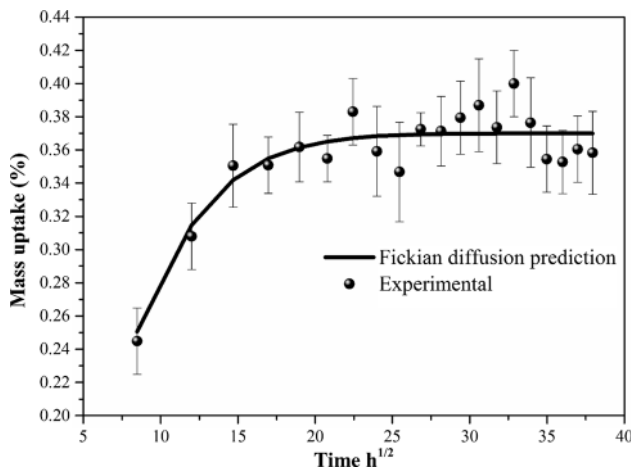
Figure 3 presents the mass uptake for the 0° unidirectional carbon fiber/epoxy coupons (average of five coupons) after hygrothermal conditioning. Water uptake is influenced by (i) the hydrophilic character of the matrix and fibers, (ii) fiber/matrix adhesion, (iii) micro-cracks, and (iv) voids. The resin network controls water uptake and, in turn, the absorption of water influences the network. Formation of voids and micro-cracks is induced by water absorption, becoming more important as the saturation level increases [13].

Fig. 3 Mass gain obtained from experimental measurements and Fickian diffusion prediction

Hot/wet environment accelerates the deterioration process of an epoxy-based composite. Reproducibility of the experimental data is well predicted by the Fickian model, both experimental and analytical data being representative in terms of water content of the material. The initial stage till pseudo-equilibrium is typical of a thermally activated Fickian response, whereas, at longer times, the uptake occurs at a lower rate mainly due to a combination of mechanisms such as relaxation of the glassy epoxy network, filling of micro-voids, and debonded zones with water by wicking [19]. Thus, moisture absorption is expected to take place via diffusion.

Kinetics of the diffusion process depends on temperature and relative moisture absorption. The higher the relative moisture absorption, the greater the absorption rate. Water saturation ($\approx 0.37\%$) reached at around 30 days, and maximum mass uptake, about 0.40% , was noticed after 42 days of conditioning, both are typical of epoxy resins. Moreover, mass uptake values were relatively low compared to literature data for the same matrix and fiber [8, 12, 13, 20], which can be justified by the high fiber volumetric fraction and good compaction of the layers.

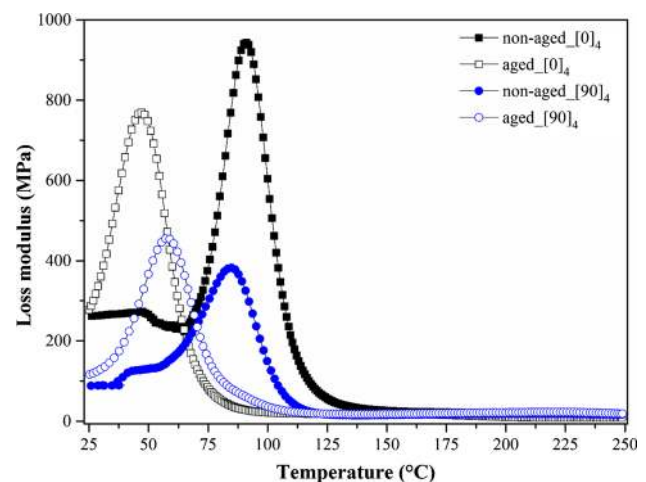
The loss modulus (E'') is related to energy dissipation in the material, and composites with poor interfacial bonding are prone to dissipate more energy. Some specimens presented a more flattened loss peak, where the hygrothermally conditioned specimens had lower loss modulus, as seen in Fig. 5. Analysis of the curves shows that the behavior was more affected by fiber orientation than by weathering, and the specimens with fibers at 0° presented much higher peaks. For the 90° specimens, the aged laminate dissipated slightly less energy. This can be attributed

Fig. 5 Loss modulus of the unconditioned and weathered composites

to the inhibition of relaxation processes in the composites, decreasing mobility at the fiber/matrix interface.

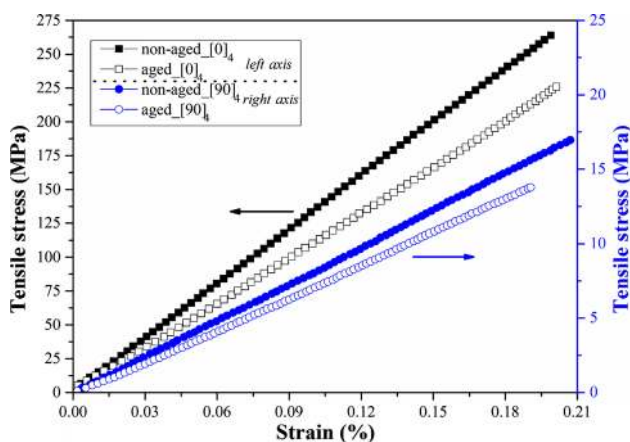
Stress versus strain data for the tensile testing of non-aged and aged composites are shown in Fig. 9. The final properties may be summarized as follows: (i) Non-aged: $E_{1,t} = 129.8 \pm 5.6$ GPa and $E_{2,t} = 9.1 \pm 0.5$ GPa, and

Fig. 9 Stress × strain profile plots for all coupons measured by longitudinal and transversal analogical extensometers

(ii) Aged: $E_{1,t} = 119.7 \pm 4.1$ GPa and $E_{2,t} = 6.3 \pm 0.8$ GPa. A more significant drop in E_2 may be justified considering that this property is more influenced by the characteristics of the matrix, which is more severely affected under hygrothermal aging.

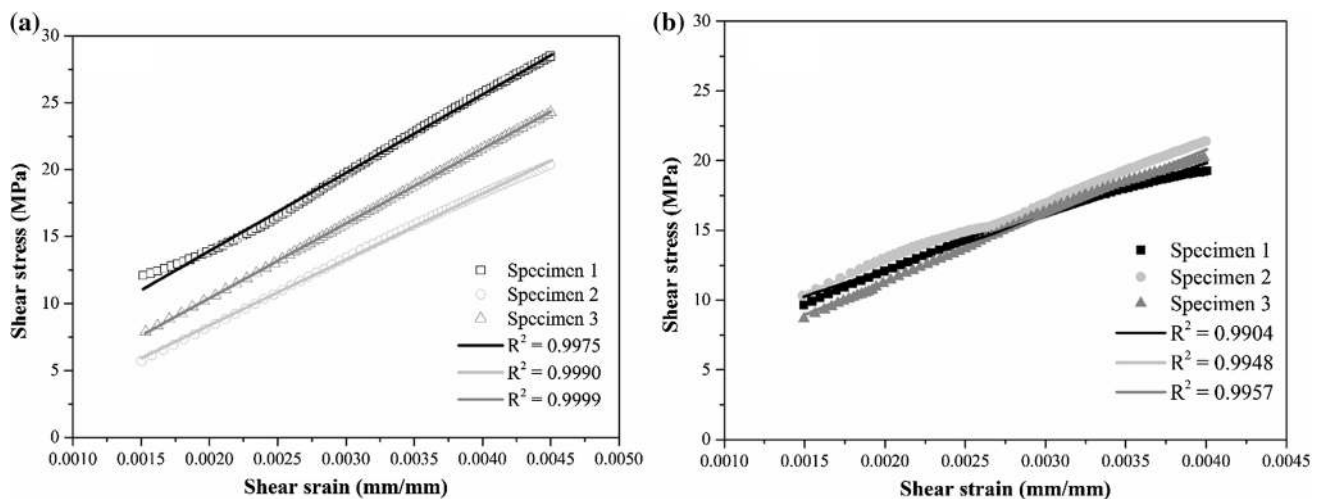
The shear stress \times strain profile curves are presented in Fig. 14. For both non-conditioned (Fig. 14a) and conditioned (Fig. 14b) specimens, the curve profiles were very linear, with $R^2 > 0.99$ for all specimens. Shear modulus reduced after aging, from $G_{12} = 5.44 \pm 0.48$ GPa to $G_{12} = 3.89 \pm 0.19$ GPa.

Fig. 14 Shear stress \times strain curves for non-aged **a** and aged **b** specimens for the determination of shear modulus

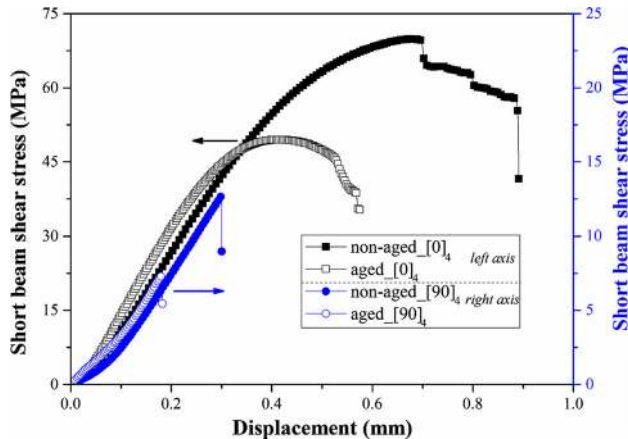
Short beam strength (SBS) results are shown in Fig. 16. SBS values for 0° samples were 69.9 ± 1.1 and 49.5 ± 1.3 MPa for non-aged and aged, respectively. For transversally aligned fibers, SBS reduced from 12.6 ± 0.6 to 7.4 ± 0.7 MPa for non-aged and aged laminates, respectively. Short beam is one of the most recommended tests to investigate fiber/matrix interface and, from these results, it is clear that aging damages the interface, reducing interfacial strength in about 41 and 70 % for non-aged $[0]_4$ and non-aged $[90]_4$, respectively.

Fig. 16 Short beam shear stress versus displacement for all family of laminates studied

Typical load versus displacement curves suggest that the 0° coupons failed by shear, presenting a non-linear behavior followed by discontinuities along the test, typical of delaminations and interlaminar fractures. On the other hand, the 90° samples presented a more linear behavior with brittle fracture, suggesting a strong influence of tensile load in the test. As in Almeida Jr. et al. [24], the SBS is strongly dependent on fiber orientation and it decreases from 0° to 90° .

Even though shear is the dominant loading in this test, the internal stress state is complex and a variety of failure modes can occur, such as interlaminar shear, micro-buckling, flexure, tension, compression, or their combination. In this test, the maximum shear stress occurs in a region where other stresses might also exist [25] and stress distribution may be distorted, with peak stresses taking place close to the loading points, even if the
