CASE STUDY: STABILISATION OF A RAPIDLY ERODING POINT USING AN INSITU-FILLED GEOTEXTILE CONTAINER GROYNE FIELD

Bobbie Corbett¹, Nicholas Wellwood², David Shing³ and Leslie Angus Jackson⁴

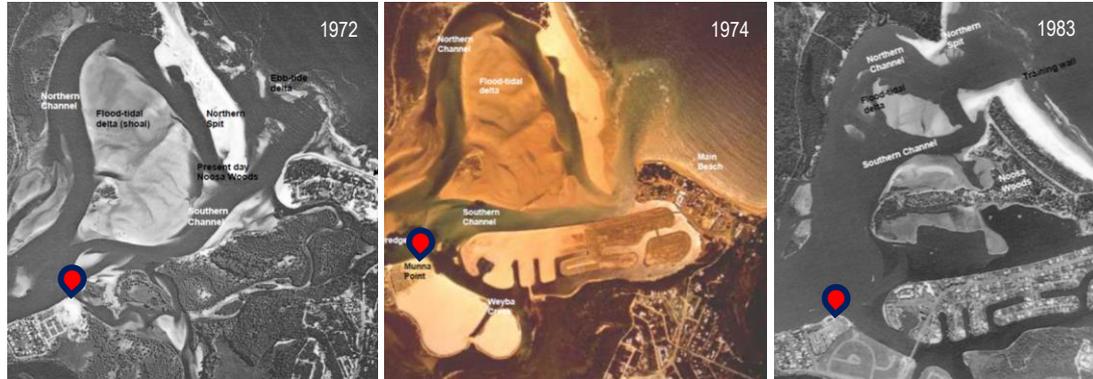
Figure 2. Historical Aerial Photographs from 1972, 1974 & 1983

The site was reclaimed as part of a major development in 1974 and the relocation of the river mouth and reclamation of Noosa River Spit to protect this development was subsequently undertaken in 1978 (Corbett & Tomlinson, 2010 and Chamberlain et al, 2010). The Noosa River Holiday Park was established in 1983 (Figure 2).

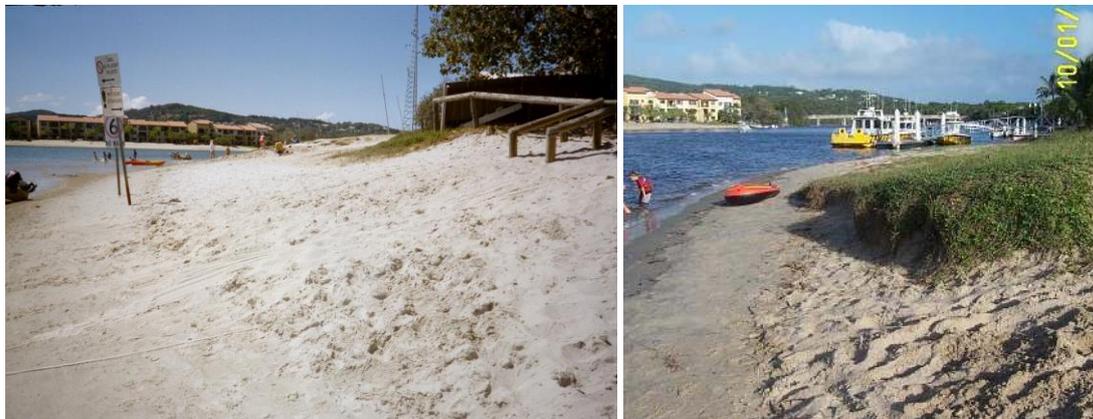
Erosion of Munna Point beaches was first observed in 1988. This was managed through bi-annual maintenance nourishment with volumes up to 5,000m³. Nourishment longevity was reported to be typically less than 6 months, resulting in high maintenance costs (Figure 3). Nourishment volumes were reduced since 2001 and ultimately suspended in 2010 due to high long-term costs.

Figure 3. Performance of Nourishment (left: post-nourishment Sept 2004; right: Jan 2006)

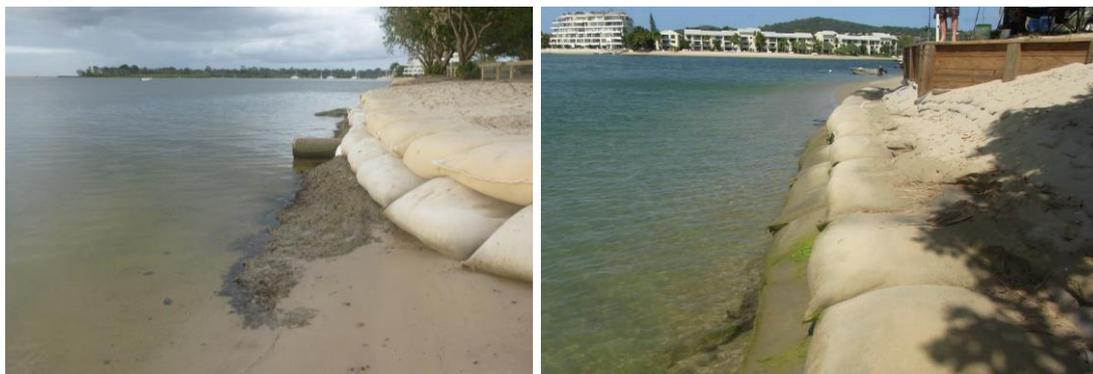
Nourishment was suspended, but erosion continued. In 2013, infrastructure was threatened and an emergency seawall approximately 1.5m in height was constructed using 0.75m³ sand-filled geotextile containers (Figure 4).

Figure 4. Emergency Seawall

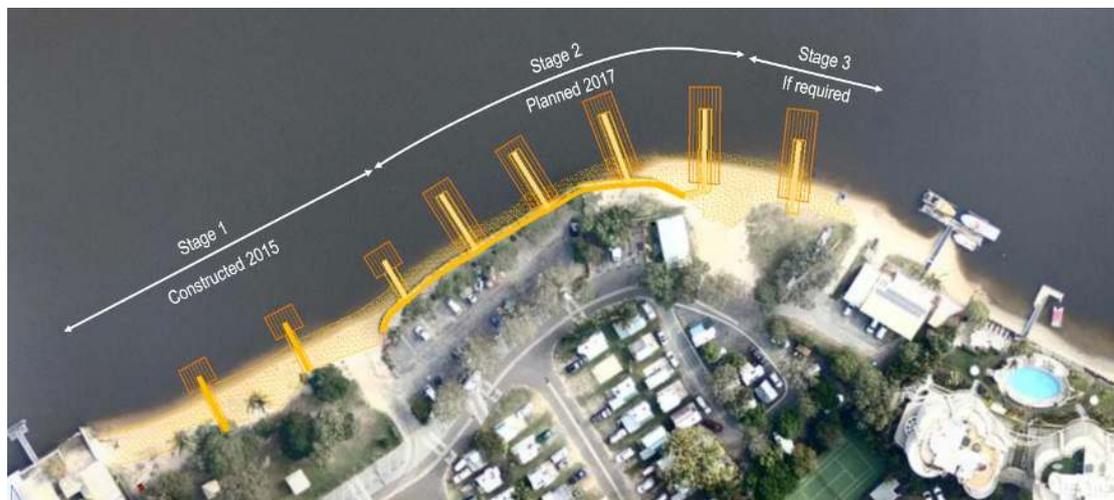
As such, beach nourishment was proposed with construction of a groyne field to stabilize the beach profile and extend the longevity of the placed nourishment. The groyne field included up to 8 groynes some 13 - 20m in length (Figure 5).

Figure 5. Design Concept

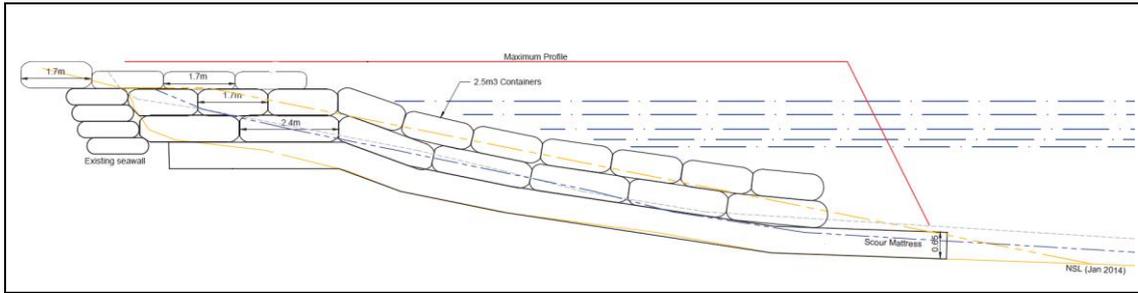
To minimise the visual impact of structures on the foreshore and retain the recreational amenity and accessibility of the beach, the structures were designed to be low-crested and constructed using softer, safer and more user-friendly sand-filled geotextile containers (Figure 15). Both 0.75m³ and 2.5m³ containers were utilized and all containers were fabricated using a non-woven needle punched composite geotextile for maximum durability (Heerten et al. 2001). Due to the proximity of the main channel and the high degree of natural variability of the Noosa River, a custom sand-filled scour mattress was specified to protect the toe of the structure and ensure that the structure remained robust and effective throughout its life.

Figure 6. Typical Groyne Profile adjacent to seawall

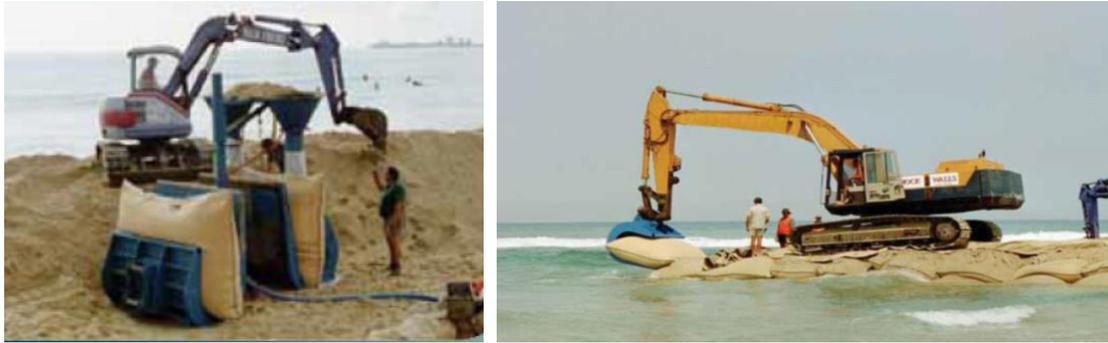
Traditionally in Australia, sand-filled geotextile containers of this size are filled in a hopper and placed with a large excavator from shore (Figure 7) (Restall et al, 2001). This construction method would have been difficult for this design as the lower crest and length of the groyne would have required a reach beyond that of excavators typically used, even at low tides.

Figure 7. Traditional Method of Filling Sand-Filled Geotextile Containers

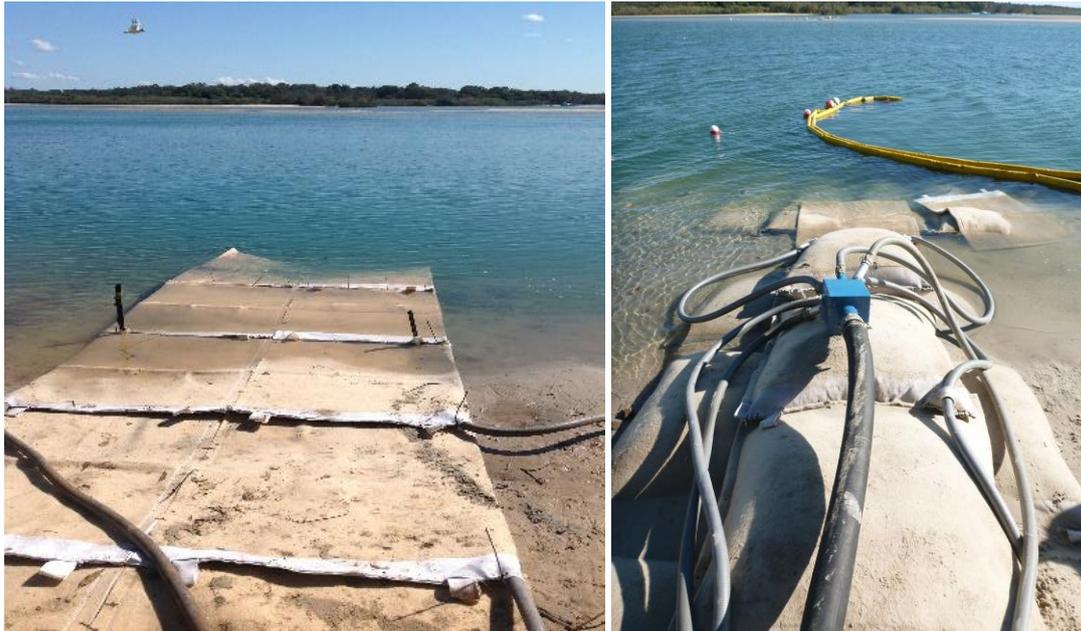
Construction of the first stage was undertaken in August 2015. The construction methodology involved the placing of pre-fabricated and pre-connected containers in the correct position and alignment with in-situ filling of both geotextile containers and scour mattresses using a small 6/4" dredge with a splitter box (Figure 8). This technique is more typical for larger mega-containers and its innovative application to the custom scour mattresses and smaller containers proved to be very successful provided containers were manipulated during the filling process to ensure adequate container shape and interlocking.

Figure 8. Novel Method of Filling Sand-Filled Geotextile Containers In-Situ

The same methodology was utilized for above water and underwater construction. As the depths were typically reasonably shallow, the need for commercial divers was limited to the closing of deeper ports of the scour mattress. This also resulted in cost savings compared with typical underwater construction activities.

An 8t excavator assisted with the loading and setout of the scour mattresses as well as manipulation of upper containers during filling as required. The minimal use of heavy construction equipment resulted in a safer and quieter work site which was of great benefit to the continued operation of the Noosa River Holiday Park.

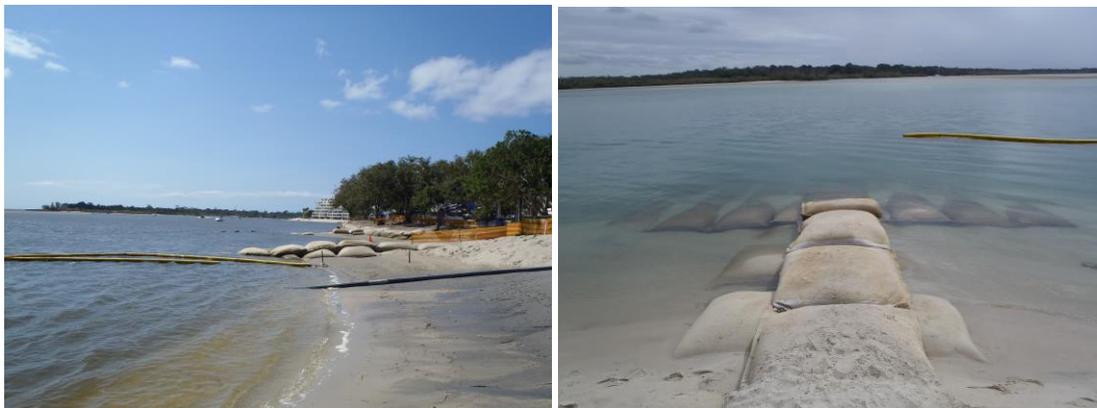
The completed works were successfully completed (Figure 9) and were relatively low profile even prior to nourishment resulting in burial of the works.

Figure 9. Completed Stage 1 Groyne

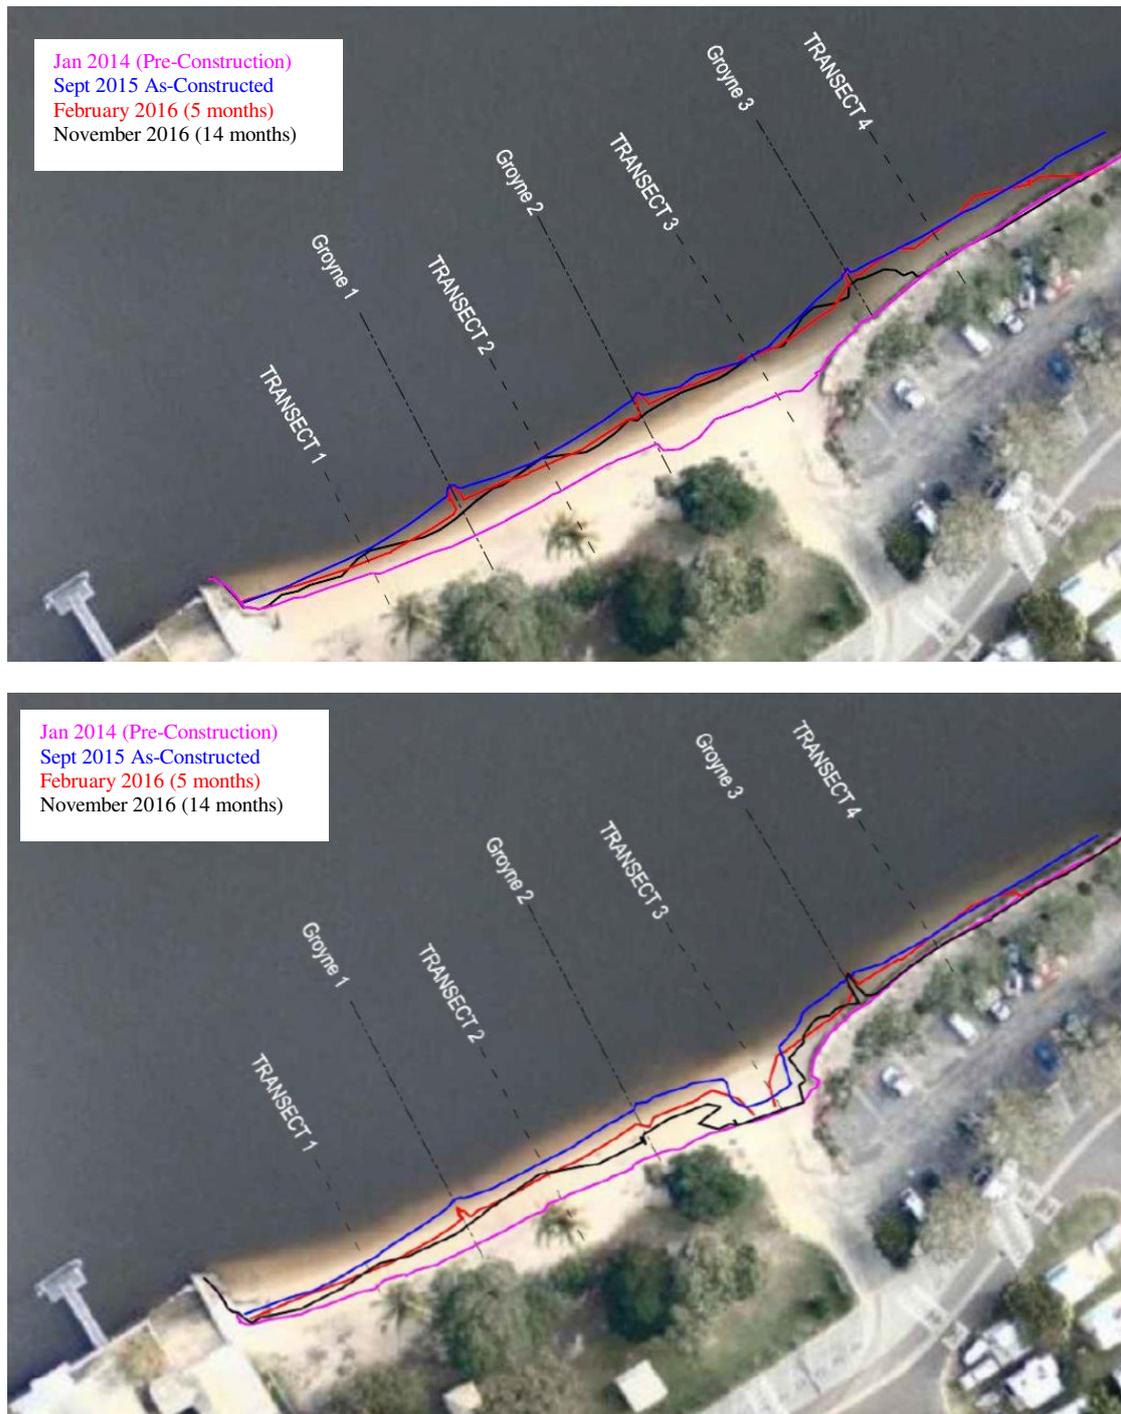
Review of survey data within the footprint of the Stage 1 works over a 14 month period (Figure 10 and Figure 11) indicates that the mid to high tide beach is 3 – 4m wider and the whole profile is 9 – 12m³/m larger than the pre-construction condition. The intertidal nourished profile experienced some minor reprofiling as expected (<1m³/m change) in the first 5 months but has since remained essentially stable. Observed widening of the profile below low tide could be the result of natural processes or the migration of nourishment downstream of the groyne field (which was not stabilized).

The planform shape of the beach is generally consistent with bi-directional sediment transport and a nett upstream (Westerly) sediment transport direction. The observable “groyne effect” is limited by the bi-directional nature of the sediment transport, the relatively narrow design beach width and the low-crested nature of the groynes which allow overpassing. At the groynes themselves, this is

Figure 10. Monitoring Survey showing Transect Location and Planform Shape of the Beach at Mid Tide (top) and High Tide (bottom)

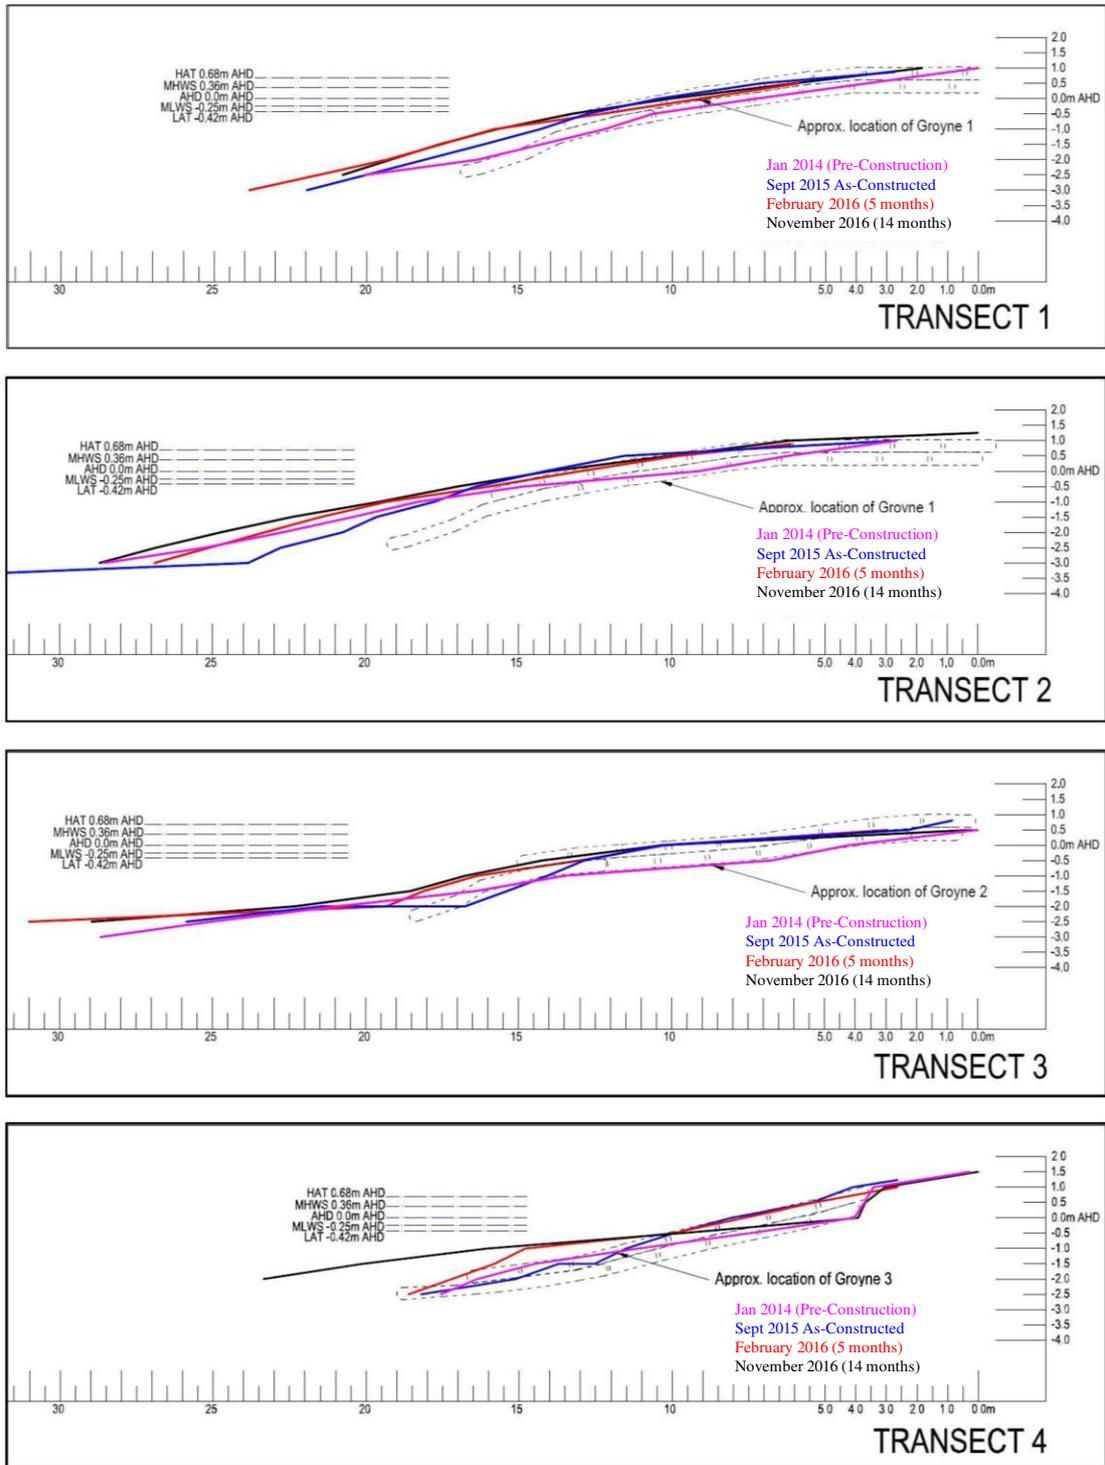
Figure 11. Comparison of Monitoring Surveys showing Beach Profiles at Relevant Transects. Location of Transects shown in Figure 10.

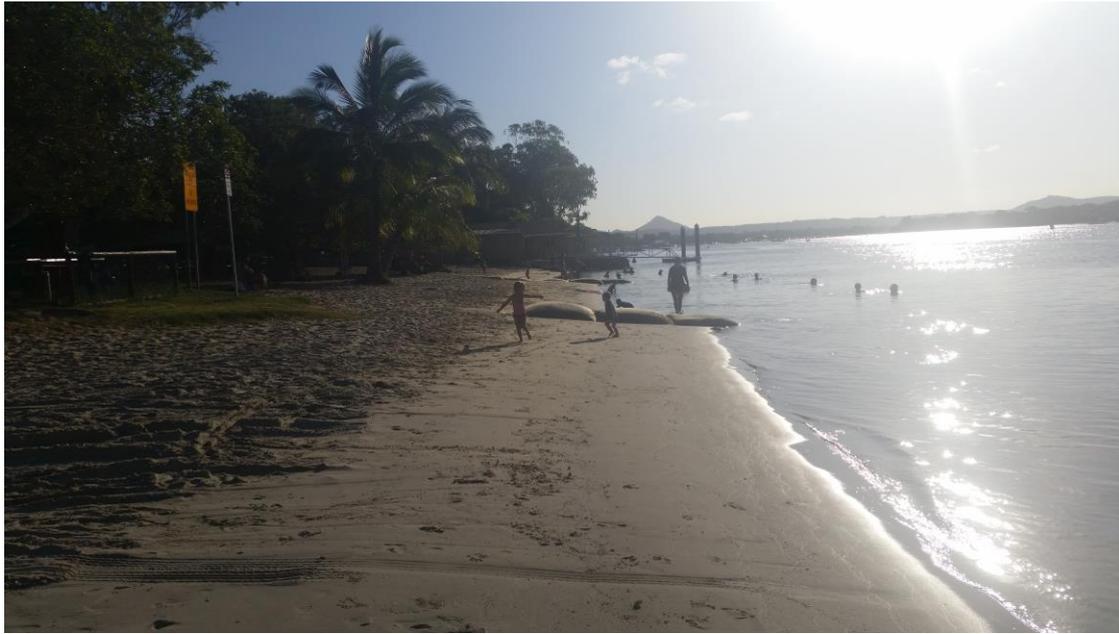
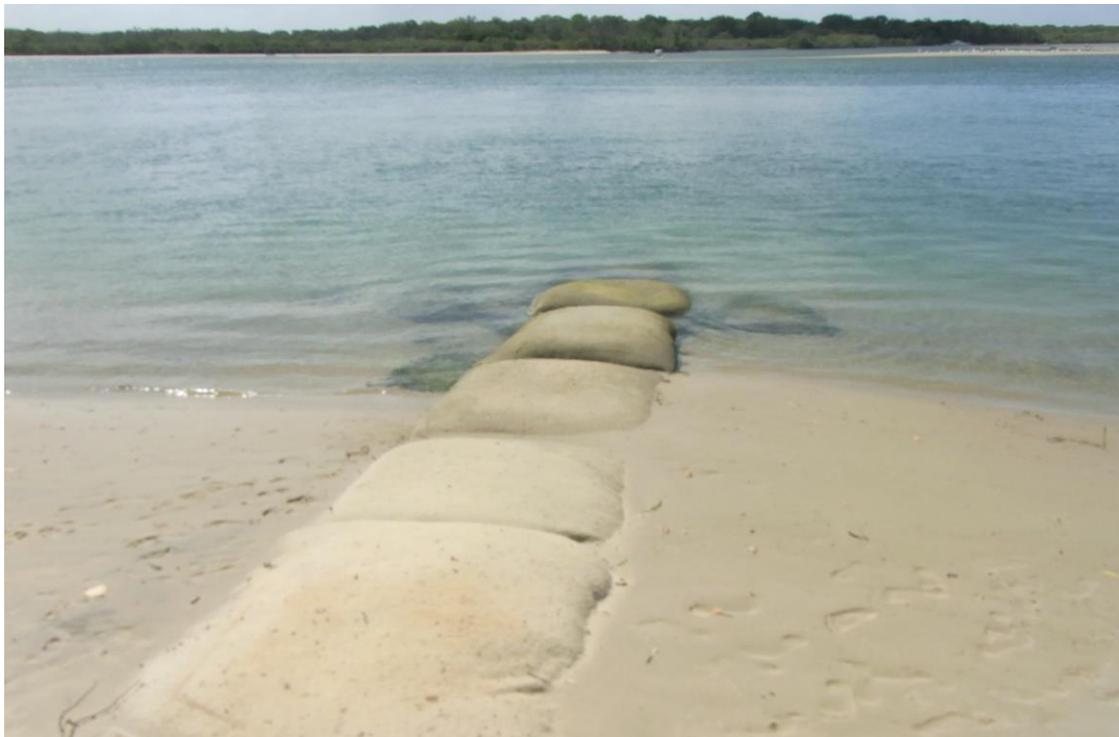
characterised by up to 2m difference in beach width and up to 0.2m difference in beach height (Figure 12).

Figure 12. Photos showing up to 2m change in beach width and up to 0.2m change in beach height at Groyne

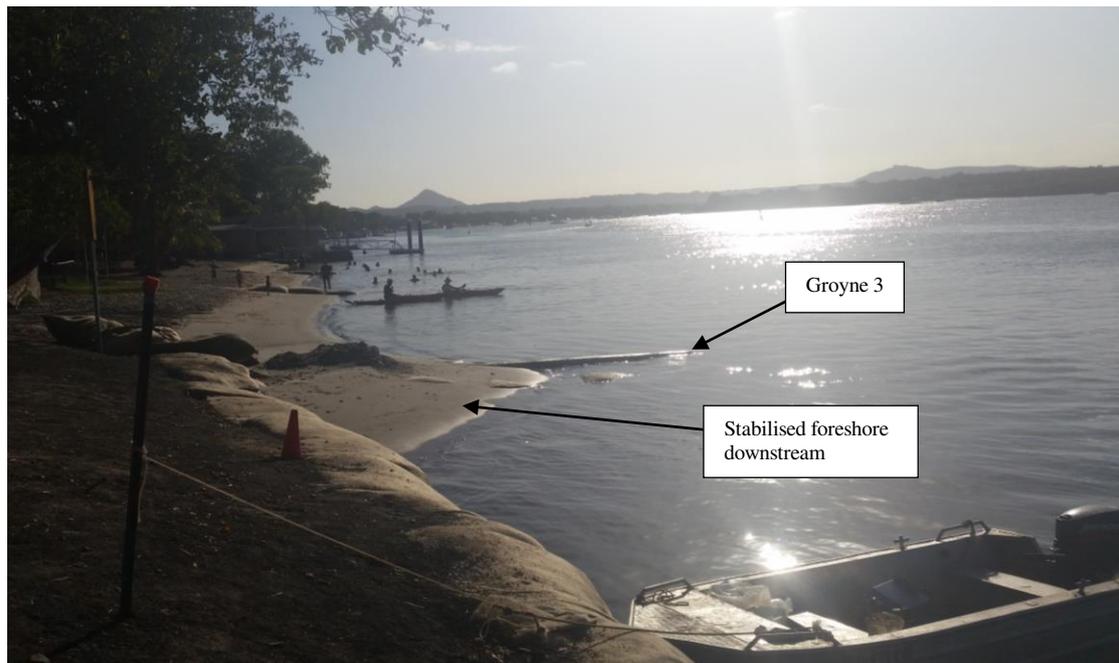
As part of Stage 1, the remainder of the foreshore was nourished without the construction of stabilising groynes. In this area, the beach width rapidly reduced and the seawall was once again exposed. Furthest from the Stage 1 works, the beach was completely lost within 5 months, consistent with the longevity of previous nourishment campaigns. Closest to the Stage 1 works, the beach benefited from the effect of the adjacent groynes and after 5 months a 25-30m length of beach remained. Due to the bi-directional nature of the sediment transport, the length of the stabilized foreshore was gradually reduced to <10m after 14 months (Figure 13).

Figure 13. Photo of slight mid-tide groyne effect north of Groyne 3 after 17 months

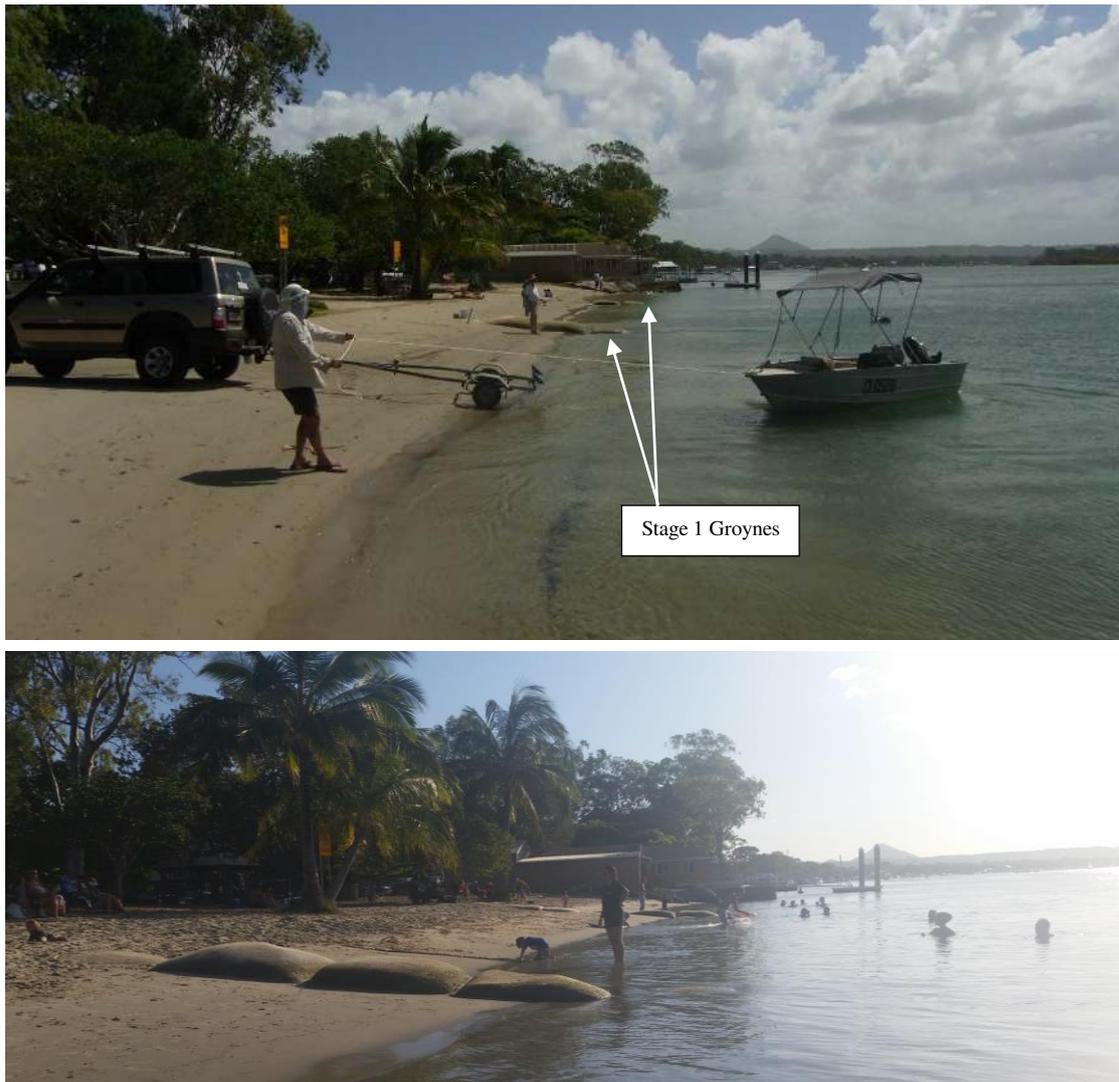
Since construction, the structures have remained predominantly buried. As such, they remain very low impact visually. Recent inspection of the beaches (Figure 14) indicates that the beaches have been very busy and support a wide range of recreational usage including swimming, fishing and boating. As the groynes are soft and only slightly extend above the beach profile, accessibility across and along the foreshore is safe and essentially unimpeded. The groynes are not creating any dangerous currents or eddies.

Figure 14. Beach Usage and Low Visual Impact after construction of Stage 1

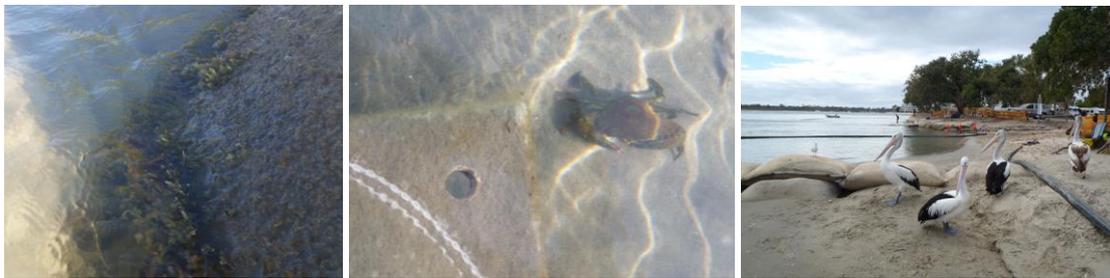
While environmental concerns are not an objective of the project, sand-filled geotextile containers are known to promote marine growth (Jackson et al 2004 and Corbett et al. 2010) and this project has been no exception. Where containers are exposed, algae were observed to establish within days of placement and over time have developed into a range of macroalgae species (Figure 15). The works also support a number of fish, stingrays and crabs as well as being friendly to birds.

Figure 15. Environmental Outcomes from using sand-filled geotextile containers
