Causes and forms of decay of stuccos and concretes from the Roman city of Baelo Claudia (Southern Spain)

The stuccos and concretes from the Roman city of Baelo Claudia, a relatively small location based on the fishing industry (near present-day Tarifa, South Spain), have been studied. As a consequence of this study the nature and composition of those materials and the causes of their deterioration have been established. The main cause of the stucco and concrete decay is biodeterioration.

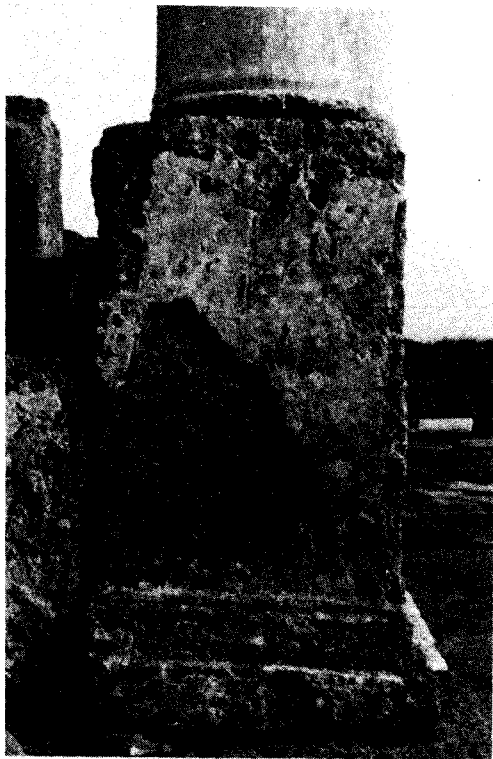
Most of the walls and capitals of Baelo Claudia have distinct layers of stucco covering the supporting stone (Figure 1). Thin section

analysis of these stucco layers showed that their main difference is in aggregate/binder ratio and aggregate size. The innermost stuccos, that is those closest to the supporting stone, had coarser aggregates and higher aggregate/binder ratio (of the order of 3-4/1). The outermost stuccos had very fine aggregates and much higher proportions of binder, with aggregate/binder ratios of the order of 1/4.

Figure 1. Deteriorated stucco of the Forum of Baelo Claudia.

One of the phenomena observed in the archaeological site of Baelo Claudia is the loss of bonding of the stuccos with the supporting stone. The innermost part of the stucco in contact with the stone is separated and totally disintegrated. The stone (calcarenite in many cases, limestone in others) is a highly porous material able to absorb a large amount of water. This water moves within the stone, trying to escape by evaporating through the stuccoed coating.

The high water-accessible porosities in the studied stuccos shows that all of the latter have high permeability; nevertheless, this liquid water can become stagnant and thus favour the partial disintegration and solubilization of the calcareous stone, leading to the disintegration phenomena described. When this process of decay begins it can be intensified by the development and growth of microorganisms in the already altered area. These provoke and enhance the total loss of bonding since they inhabit holes, cracks and fissures which form in the separating layers of stucco, leading to the decrease of its cohesion and consistence. The excretion of organic acids and the production of CO₂ as result of cell respiration are important factors in the weathering processes, favouring carbonate dissolution. Also extensive pitting is originated, especially in the lichen/stucco interface, obvious to the naked-eye in the sun-exposed stuccos supporting high lichen colonization.

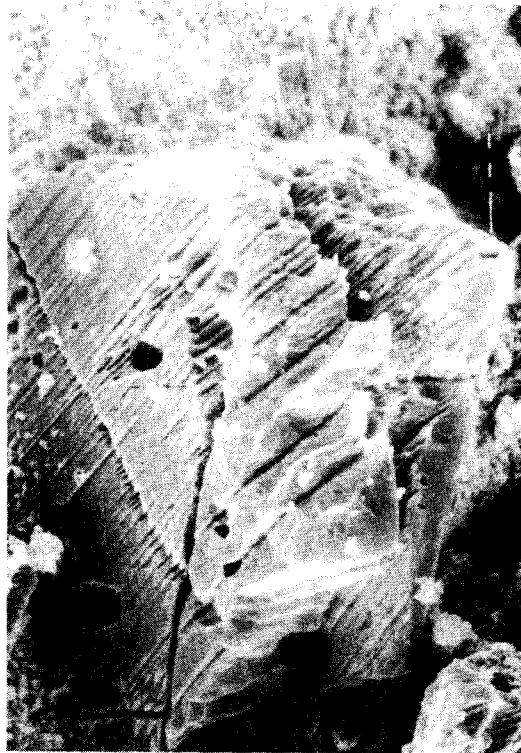
In some of the stuccos studied, both the limestone and silica aggregates of the stucco showed obvious signs of corrosion, as can be observed in Figure 2.

Figure 2. Calcite crystal from sample taken in the stucco shown in Figure 1. Etching, biological dissolution and pitting is evident. Bar represents 10 μm .
