Article

Cavitation Erosion Characteristics of the EN AW-6082 Aluminum Alloy by TIG Surface Remelting

Keywords: TIG remelting; aluminum alloy; cavitation erosion

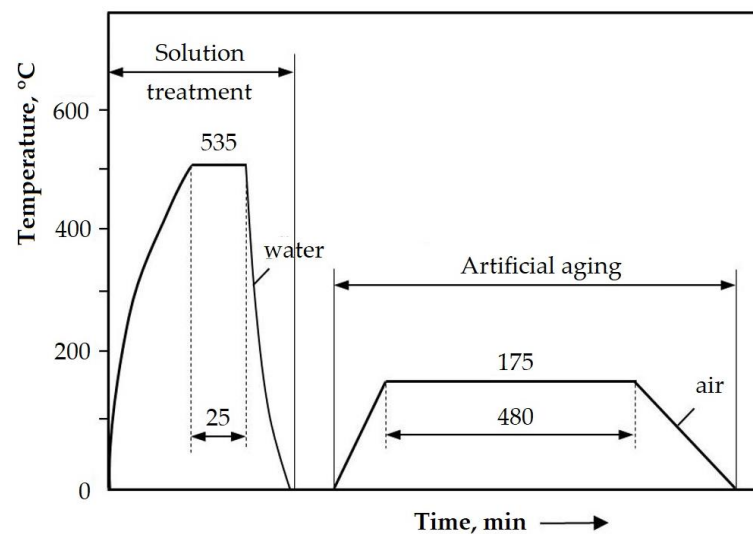
The heat treatment was carried out by applying a solution at 535 ± 5 °C/25 min/water, followed by artificial aging at 175 ± 10 °C/8 h/air (Figure 1).

Figure 1. Heat treatment cycle.

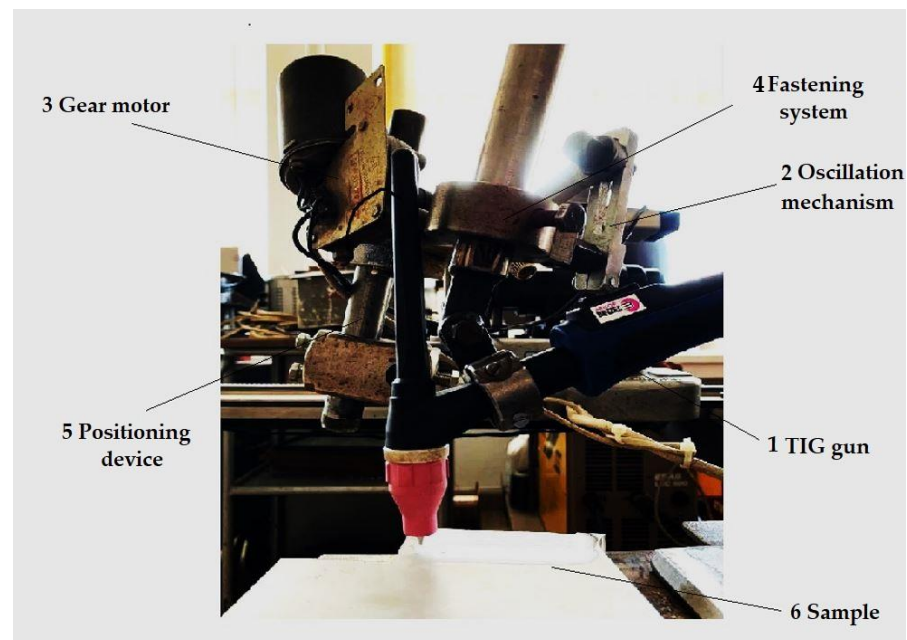
The surface was remelted using a TIG welding equipment (Weld Guru, Buda, TX, USA, Figure 3) in the following working conditions:

- base metal: Al-6082 alloy;
- welding equipment: MAGIC WAVE 300 (Fronius);
- alternating current frequency: 70 Hz;
- nature of current: alternating current;
- balance: 60/40;
- shielding gas: Ar 100%;
- electrode type: EWLa 15;
- electrode diameter: 3.2 mm;
- gas flow: 10 L/min;
- tilt of the gun: 90 degrees.

Figure 3. The welding experimental stand.

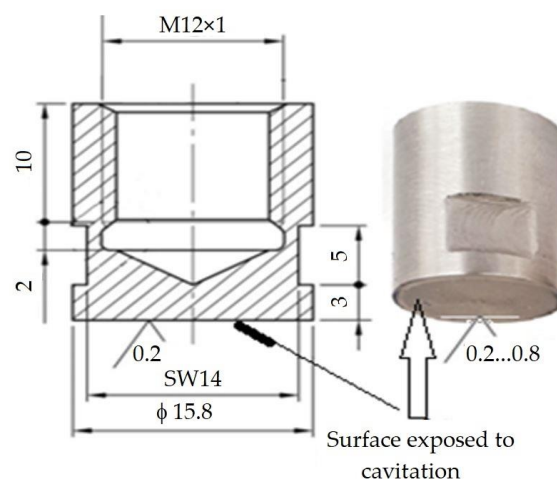
Further, both from the locally surface remelted plates and from the reference ones, cavitation samples were processed by chipping; their shape and dimensions are shown in Figure 4.

Figure 4. Geometry of the cavitation samples (mm).

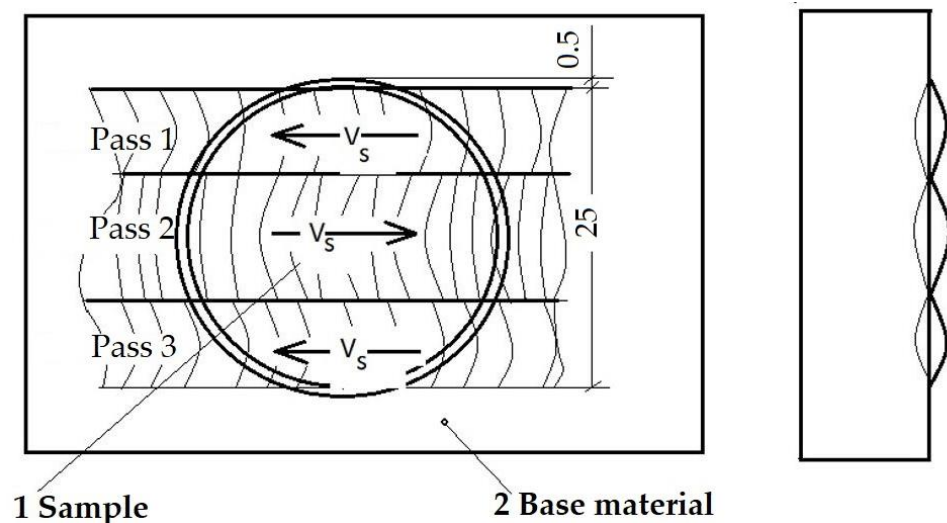
According to the technological recommendations, the base material was preheated to a temperature of 100 °C, and the temperature between passes was maintained at values of 120–150 °C. In order to maintain a constant welding speed, the TIG welding head was mounted on a welding installation, the process being mechanized. For the surface remelting of the samples, parallel passages were made, with a step between passages equal to 2/3 of the width of a passage so as to achieve an overlap of the passages of approx. 1/3 of the width of a passage. The remelting details are shown in Figure 5. This made it possible to obtain a smooth molten surface without welding defects (lack of melting or marginal notches). The passages performed aimed at obtaining a width of the remelted area of at least 25 mm to provide cavitation samples with well-specified dimensions, shown in Figure 3.

Figure 5. Details of the surface TIG remelting process.

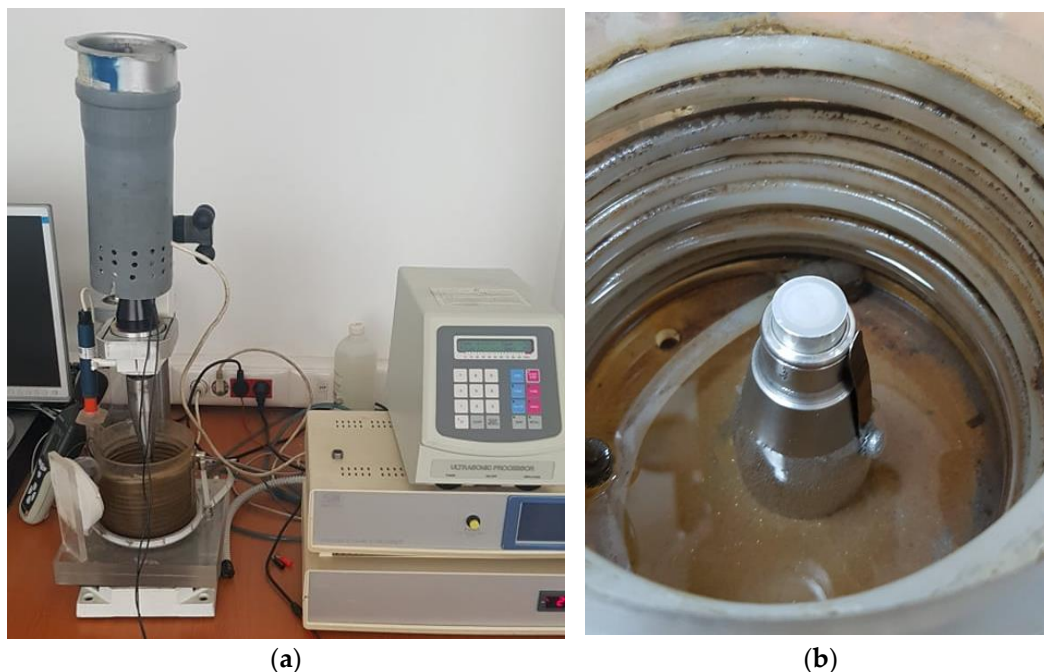
The cavitation tests were conducted on sets of three samples for each remelting regime, using a vibrating device with piezoceramic crystals (Figure 6) [7,8] made in accordance with the requirements of Standard ASTM G32-2016 regarding the indirect testing method [19].

Figure 6. Experimental stand: (a) overview; (b) detail of the sample-fixing system.

- vibration amplitude, $20,000 \pm 1\%$ Hz;
- vibration amplitude, $50 \mu\text{m}$;
- power of the electronic ultrasound generator, 500 W;
- working environment, potable water having a temperature of $22 \pm 1 \text{ }^\circ\text{C}$.

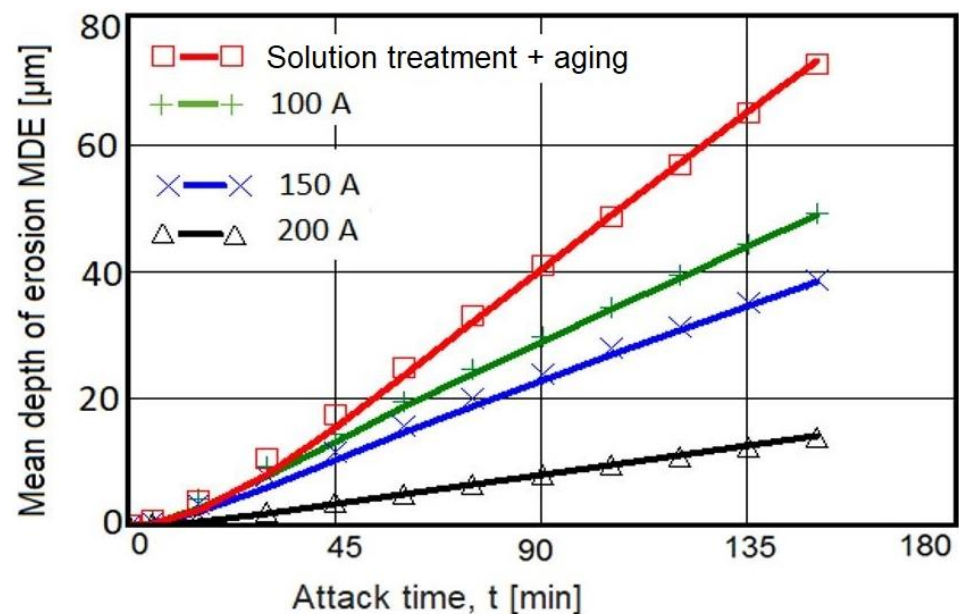
In Figures 7 and 8, the characteristics of the cavitation erosion curves are shown comparatively and indicate the variation of the parameters MDE (mean penetration depth of erosion) and MDER (mean penetration rate of erosion) with the duration of the vibrating cavitation attack, for the three structural states obtained after local surface remelting as well as for the reference material subjected to the solution-based heat treatment followed by artificial aging. It is specified that the experimental values in these diagrams represent the mean values of the three tested sets of samples, for each type of material processing.

Figure 7. Evolution of the mean penetration depth of erosion with the cavitation attack time.

- TIG remelting of the considered alloy surface at the currents $I_s = 100$ A, 150 A, and 200 A caused an increase in the cavitation erosion resistance, R_{cav} , from 1.5 times to 5 times (where $R_{cav} = 1/MDER$, $t = 165$), compared to the conventional heat treatment specific for this material;
- the use of welding currents of 200 A provided the lowest values of the MDE and MDER;
- during the stabilization period, until the end of the test duration (165 min), the erosion rates of the remelted TIG surfaces acquired values of approx. 0.10–0.32 $\mu\text{m}/\text{min}$, and those specific to the age hardening heat treatment were approx. 0.50 $\mu\text{m}/\text{min}$.

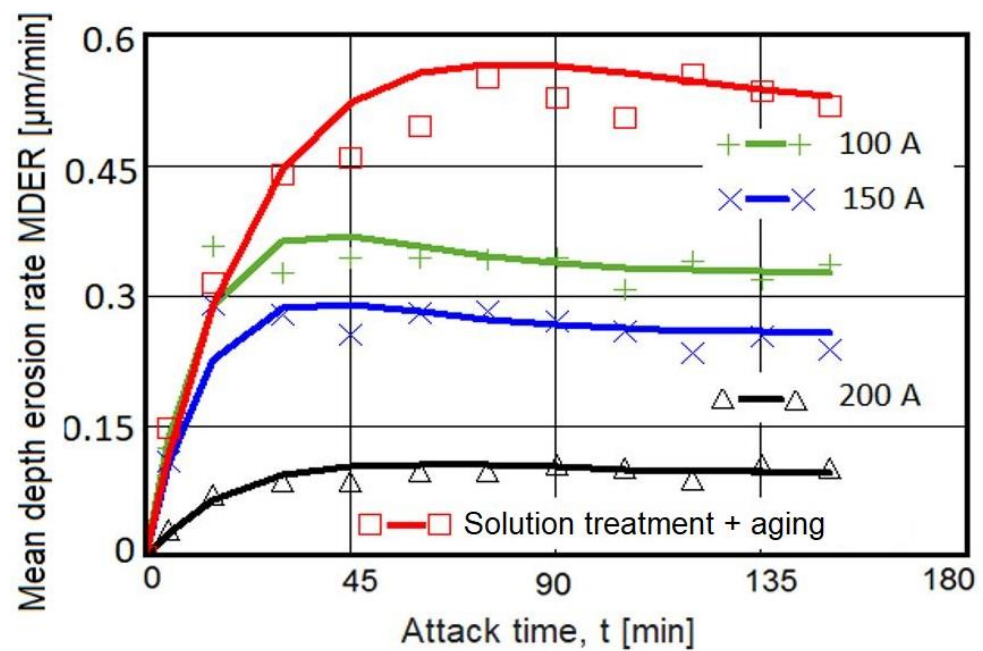
Figure 8. Evolution of the mean erosion rate with the cavitation attack time.

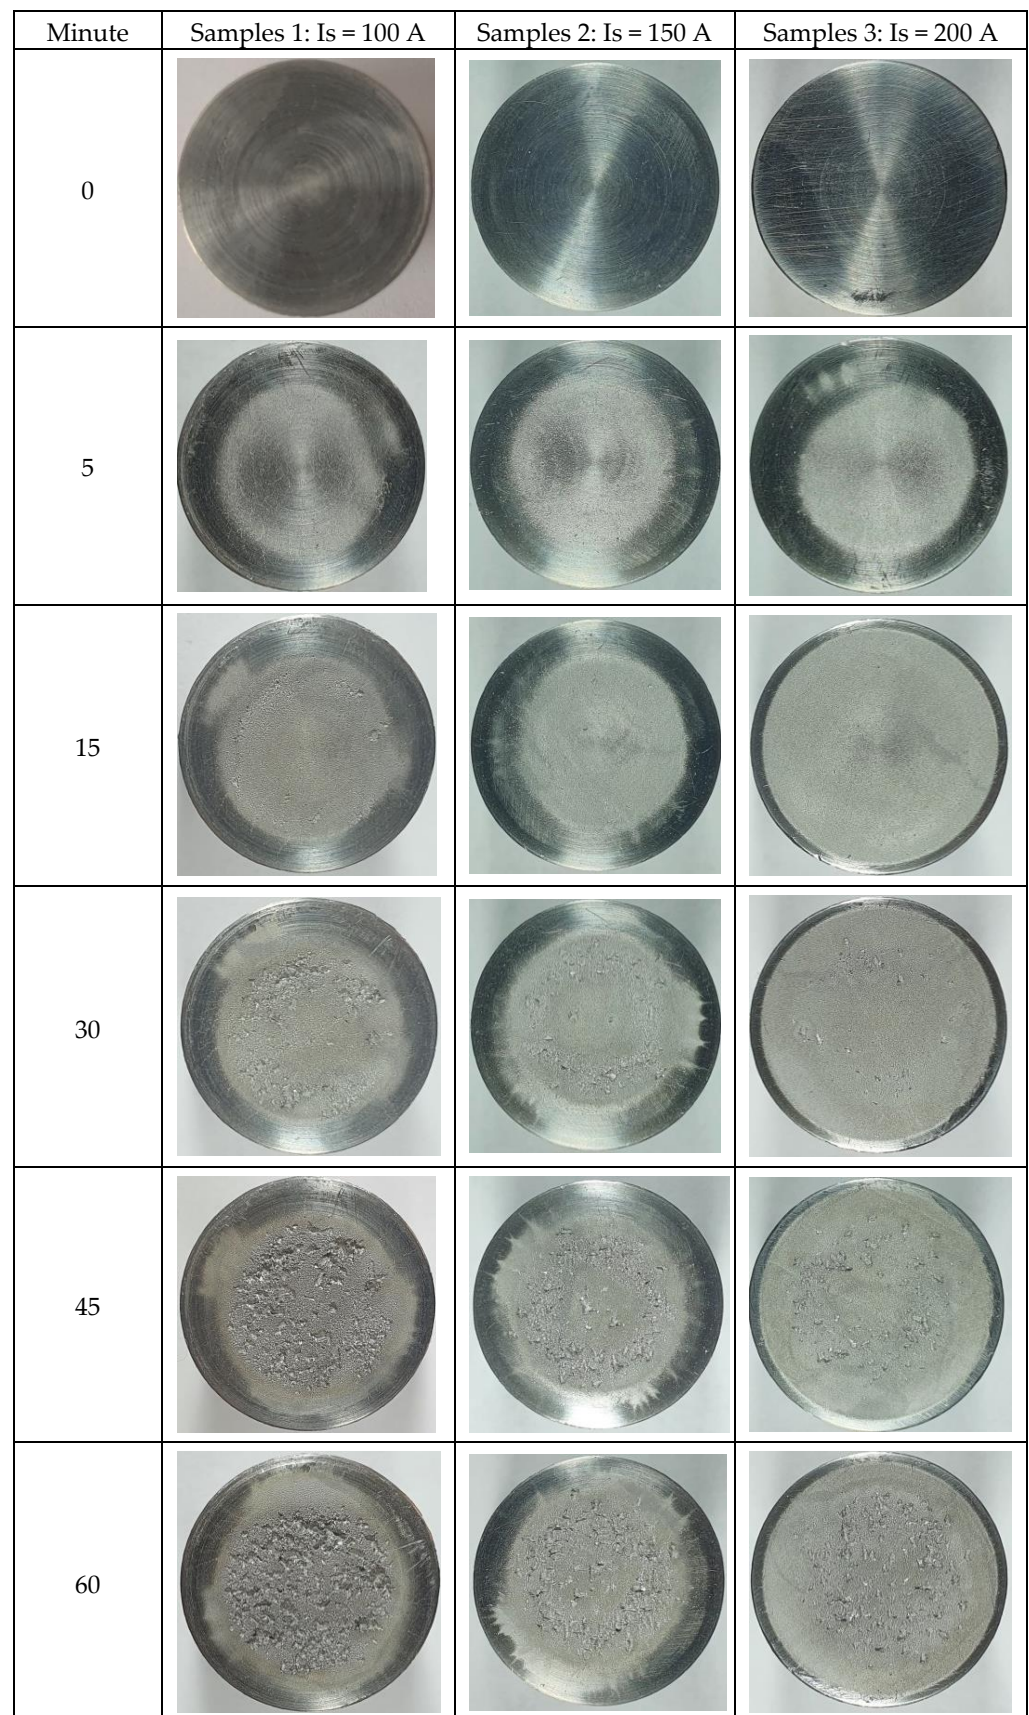
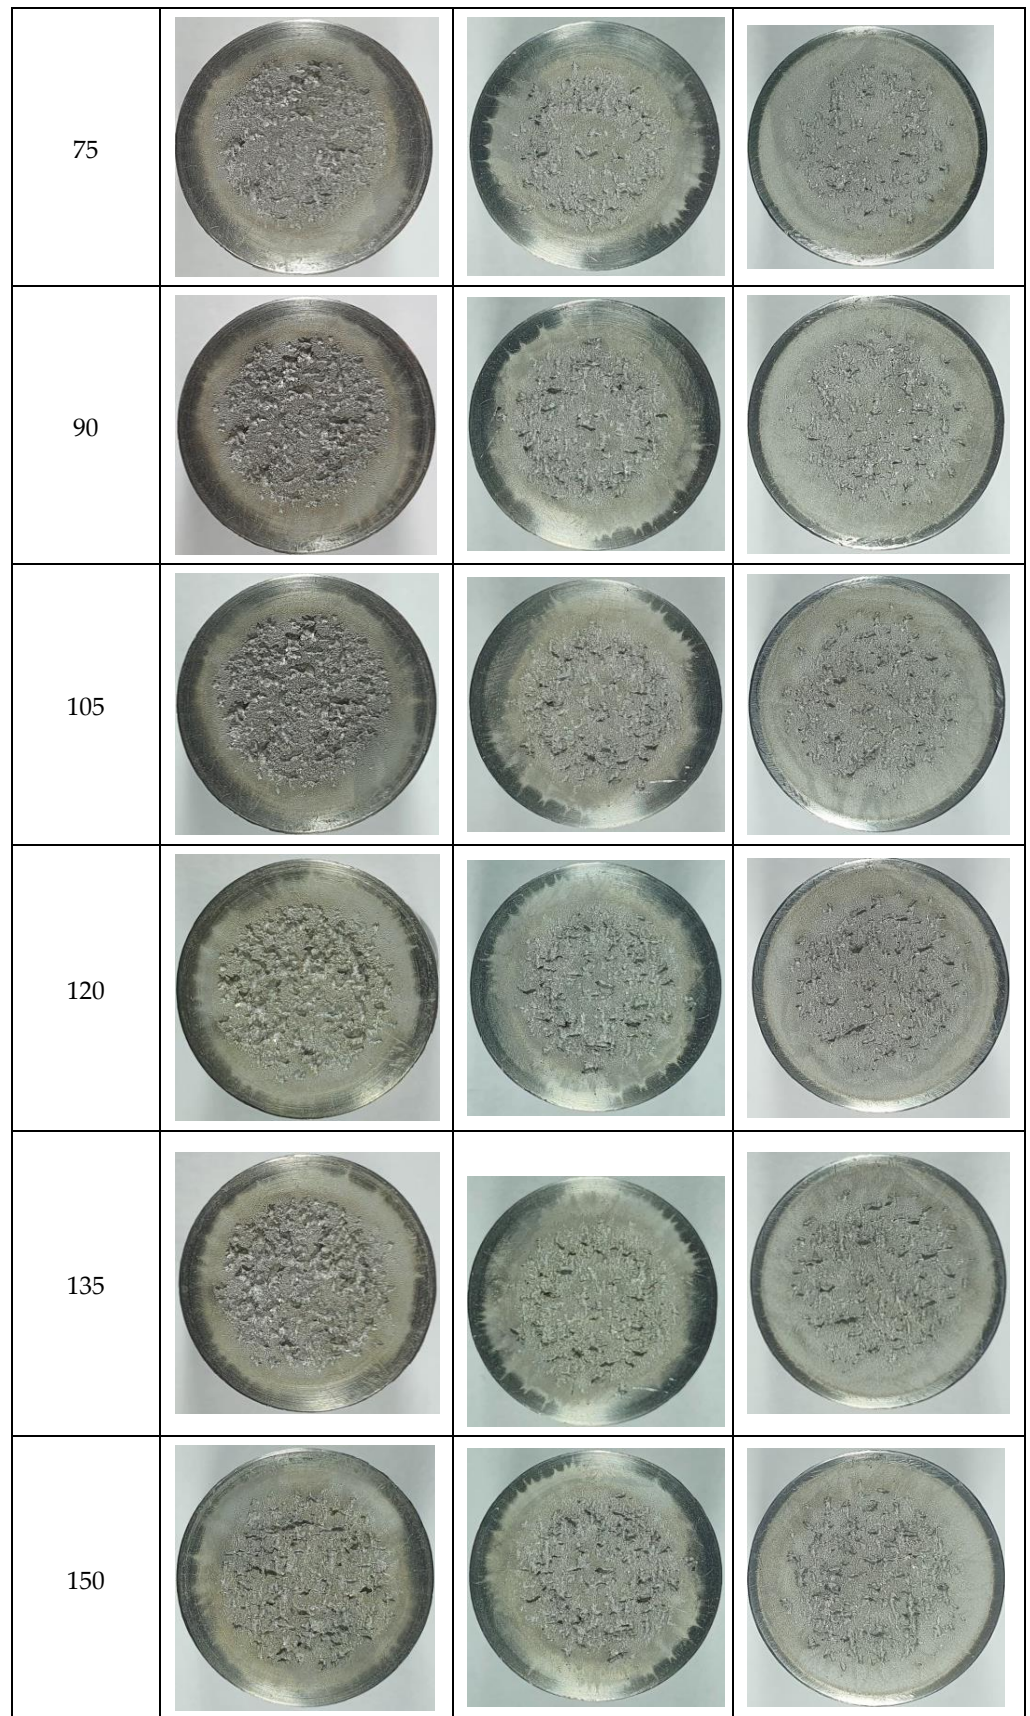
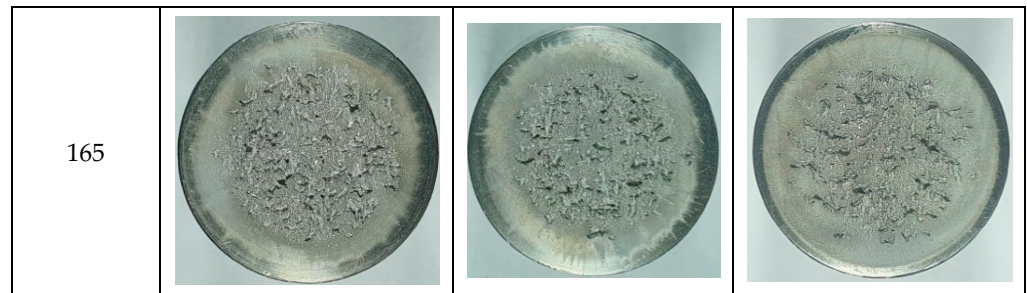
With the help of a Canon Power Shot A480 camera, images of the cavitation exposed surfaces were obtained at each test time. Figure 9 shows these characteristic images for each value of melting current with respect to the linear energy. The energetic impact generated by the collapse of the cavitation bubbles made the samples surface uneven. Up to 30 min of attack, no surface degradation was observed. At longer times, the formation of a ring from the surface periphery together with more and more microcraters (pinches) with variable sizes and uneven distribution was revealed. Thus, for cavitation attack times greater than 90 min, the remelted samples surfaces, especially with $I_s = 100$ A and $I_s = 150$ A, became very rough, which implies a strong damage to them. On the contrary, the degree of surface damage of samples remelted with $I_s = 200$ A was lower, which proved that their cavitation erosion resistance was significantly improved. The main reason for this phenomenon can be the existence of fine grains and a microstructure with a uniform distribution of the constituent phases. After cavitation erosion for 165 min, the pinches on the material surface developed into an irregular group of cavitation craters.

Figure 9. Macrographic images of the surface in cavitation tests of variable durations.

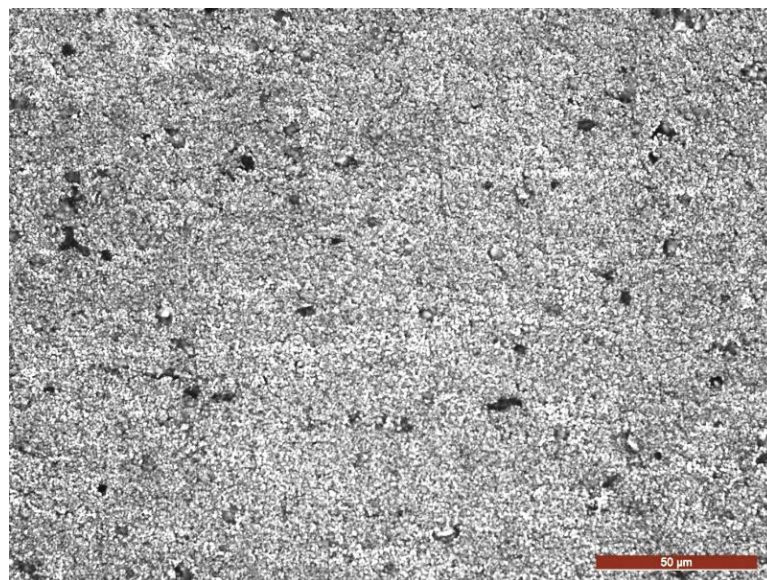
After the TIG remelting process, the surface of the material solidified at a higher degree of subcooling, with respect to that at a lower real temperature than the equilibrium temperature, so that the dimensions of the germs were smaller, their number was larger, and the microstructure obtained was finer. In Figure 10a,b the microstructure of the layer obtained at a current $I = 200$ A and a linear energy $E_l = 15,840$ J/cm is shown. It was observed that it contained small, equiaxed, unoriented crystals of α solid solution with an aluminum base and fine particles of intermetallic compounds [18], a microstructure that provides isotropic mechanical properties and an improvement of the use characteristics due to the strengthening mechanism resulting from the refinement of the granulation. The initiation and subsequent propagation of microcracks in the surface layer occurred at the interface between the particles derived from chemical combinations and the aluminum-based solid solution matrix (Figure 10b). Exposure of the material surface to repeated shock waves and/or repeated microjets led to an accumulation of plastic deformations until microdamages occurred that caused material loss. With the increase of the cavitation attack time, there was a fragile removal of the phases of the chemical combinations, after which a uniform degradation of the solid solution grains took place, the breaking phenomenon having a ductile character.

Figure 10. Microscopic images of a cross section through the remelted layer, with $I_s = 200$ A: (a) OM $\times 200$; (b) SEM $\times 750$.

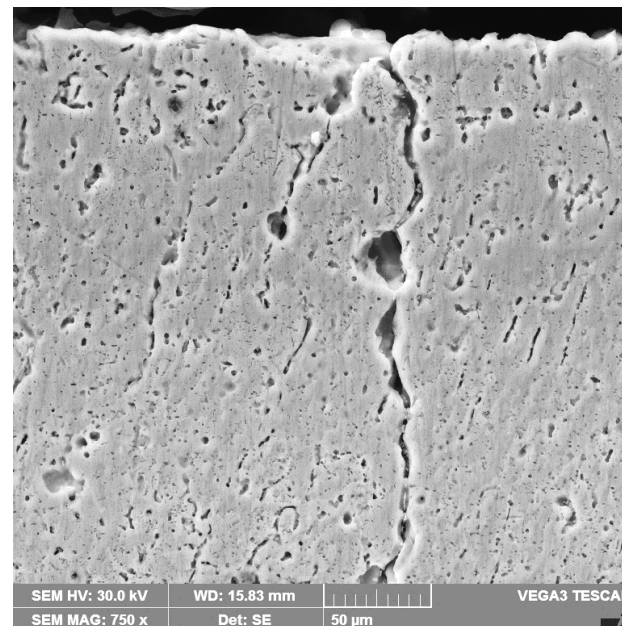
At melting current values over 200 A and linear energies higher than 15,840 J/cm, the very high thermal shock action induced by the surface melting process caused the appearance of microcracks in the edge layer (Figure 11).

Figure 11. SEM image of a cross section with microcracks through the remelted layer, with $I_s = 250$ A.

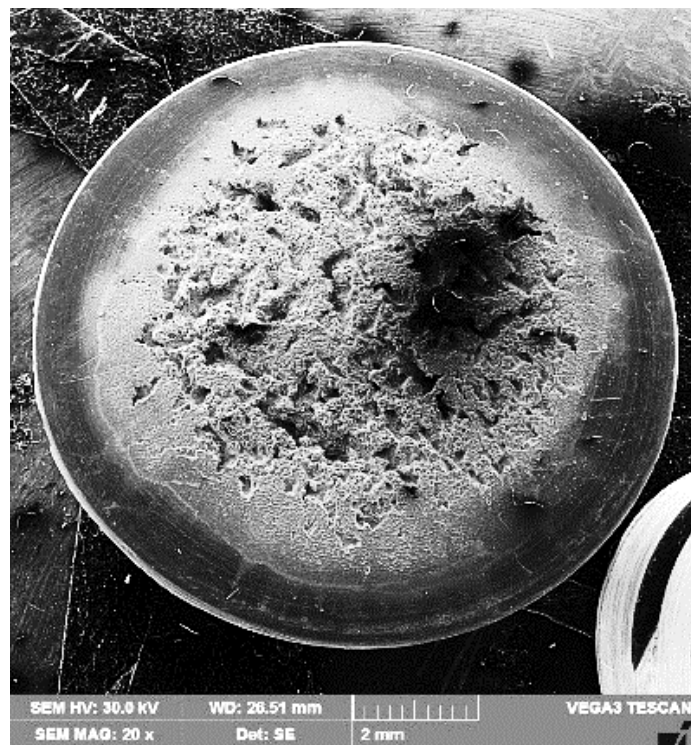
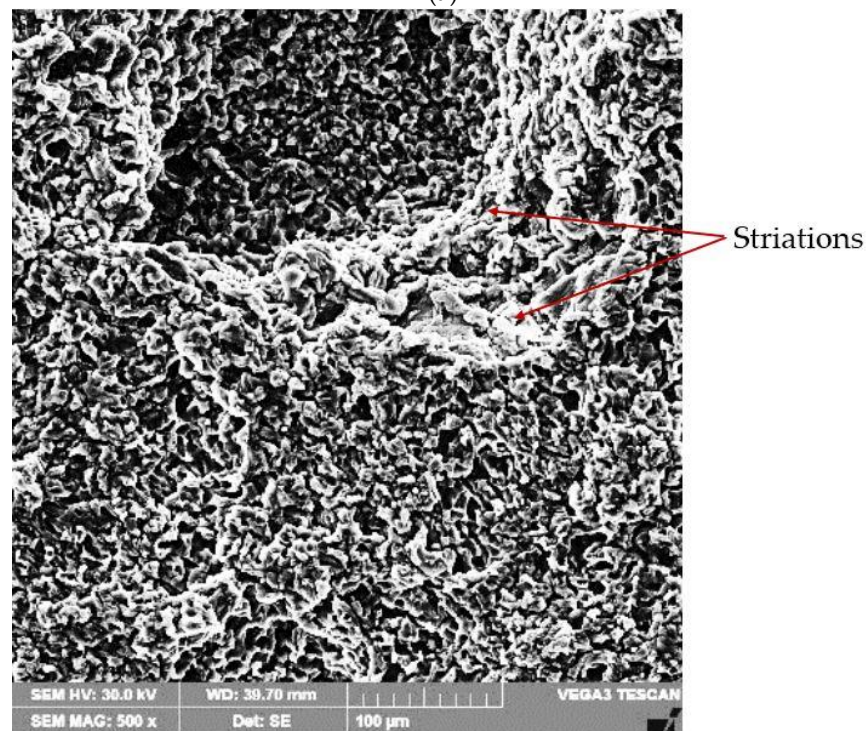
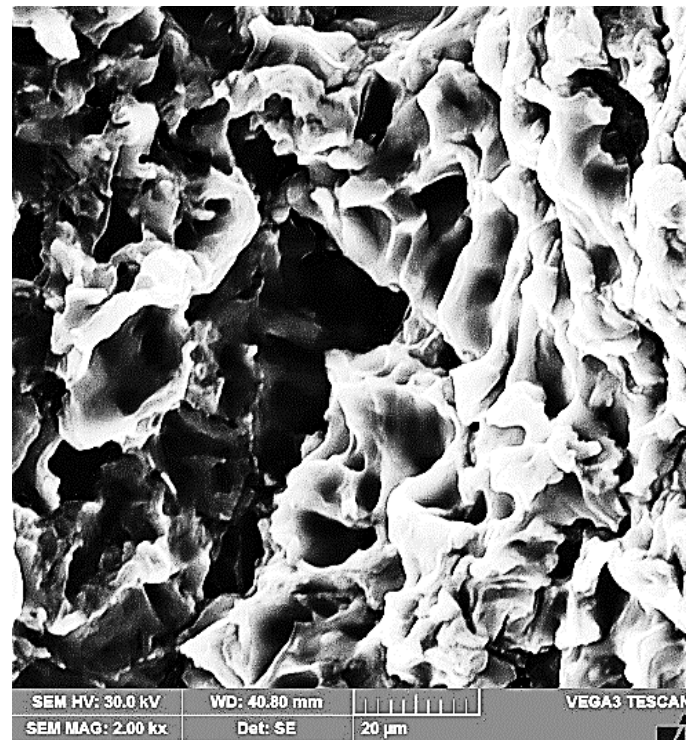
A scanning electron microscope examination of the surfaces tested for cavitation (Figures 12 and 13) demonstrated that the erosion phenomenon occurred in a similar way to that of pure metals with a face-centered cubic lattice, fcc, namely, through plastic deformation followed by a ductile fracture over the entire surface.

Figure 12. SEM image of the remelted surface, with $I_s = 100$ A, and tested after 165 min for cavitation: (a) $\times 20$; (b) $\times 500$; (c) $\times 2000$.

The results of the metallographic investigations carried out with the optical microscope and the scanning electron microscope, in correlation with the hardness measurements, allowed explaining the mechanism of the cavitation erosion phenomenon. The finishing of granulation and microstructure after the local surface remelting process, beside the hardness increase, were responsible for the cavitation erosion improvement, along with the material removal. The high capacity of mechanical embrittlement (low stacking fault

energy) of the solid solution matrix with the fcc crystalline network led to erosion by ductile fracture on the entire surface. The loss of material occurred preferentially in isolated regions, apparently with a random distribution, the formed microcraters showing typical striations similar to the fatigue fractures of aluminum alloys [4,6,9,13].

However, with this alloy containing up to 3% of alloying elements, the material was preferentially lost in isolated regions, apparently randomly, leaving behind striated, flat-bottomed microcraters [1,2,4,7]. The fracture surface of these microcraters was similar to that of fatigue fractures in aluminum alloys. The microcraters expanded laterally to macroscopic sizes without undergoing changes in their topographical characteristics. The diameter of the cavitation microcraters was approximately 20 μm , and some of them reached 50 μm and even 80–90 μm .

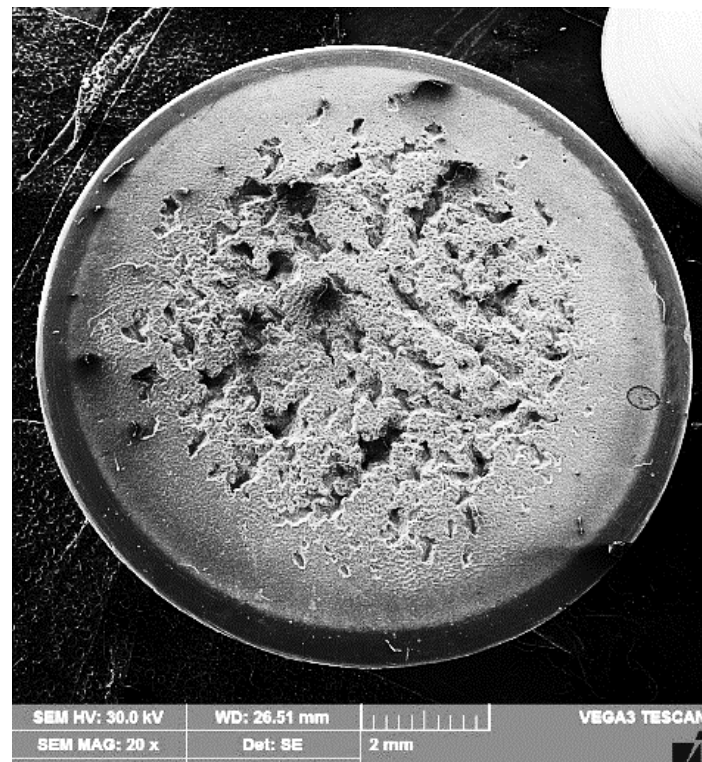
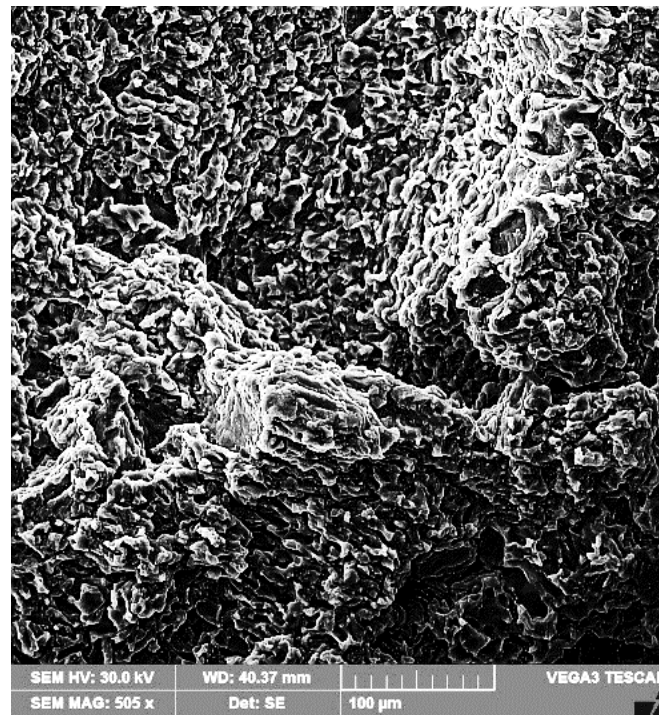
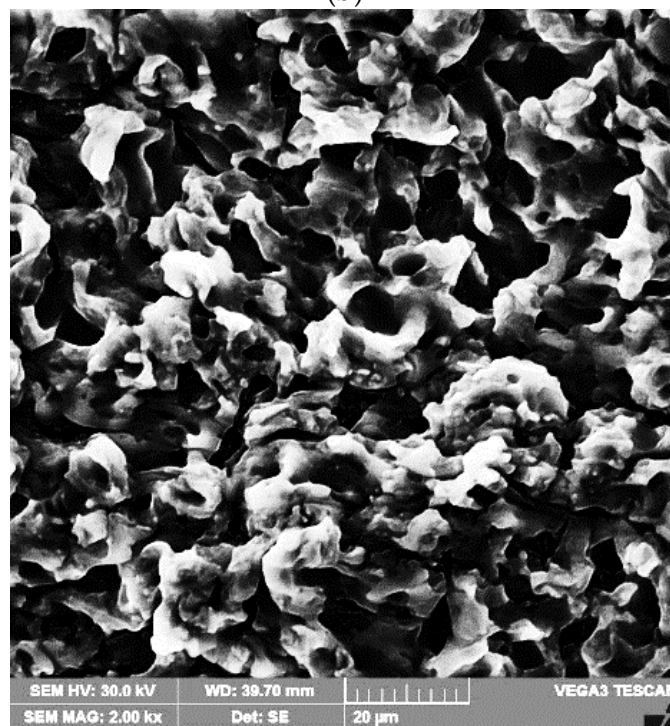
Figure 13. SEM image of the remelted surface, with $I_s = 200$ A, and tested after 165 min for cavitation: (a) $\times 12$; (b) $\times 500$; (c) $\times 2000$.
